THE CITY OF KEY WEST  
Urban Forestry  
1300 White Street  
Key West, FL 33040

## Tree Removal Report

**PROPERTY:** 1812 Flagler Ave

**APPLICATION NUMBER:** T2026-0120

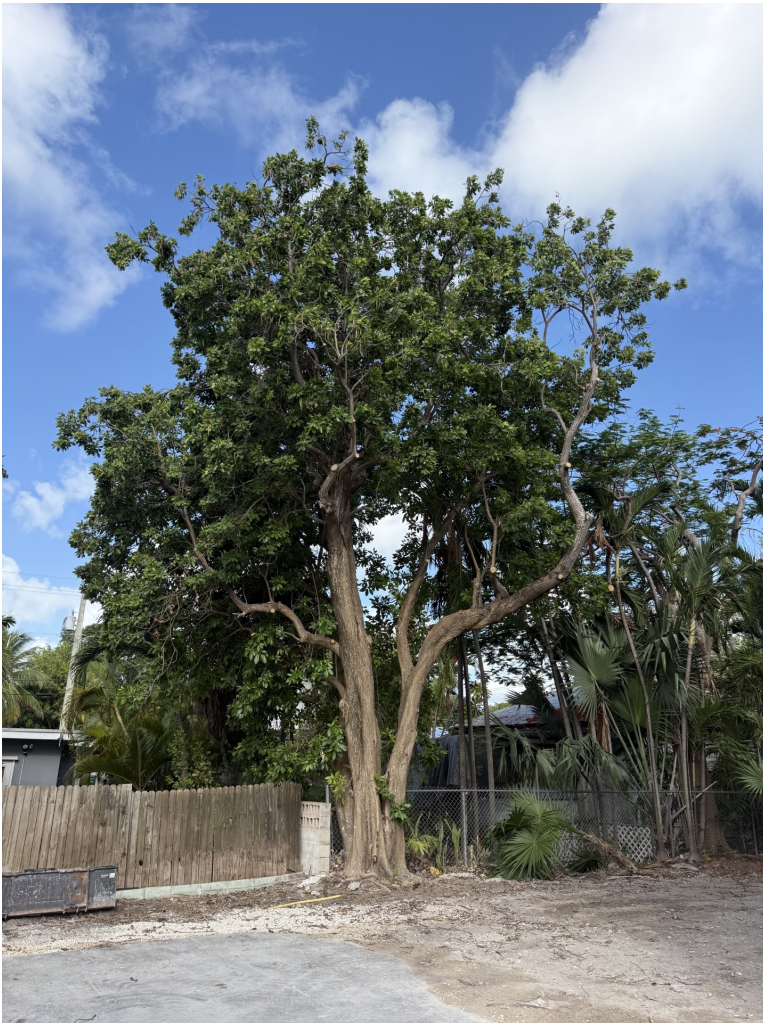
**TREE #1 Pink Tabebuia**

The subject tree is a mature Pink Tabebuia measuring approximately 30 inches DBH. The tree exhibits a multi-stem growth form consisting of three primary stems originating near the root flare. Overall physiological condition is assessed as Fair.

Although these structural defects are present, no evidence of active failure, advanced decay, or significant canopy decline was observed during the visual inspection. The tree currently maintains fair vigor.

**Recommended Mitigation: 19 Caliper Inches**

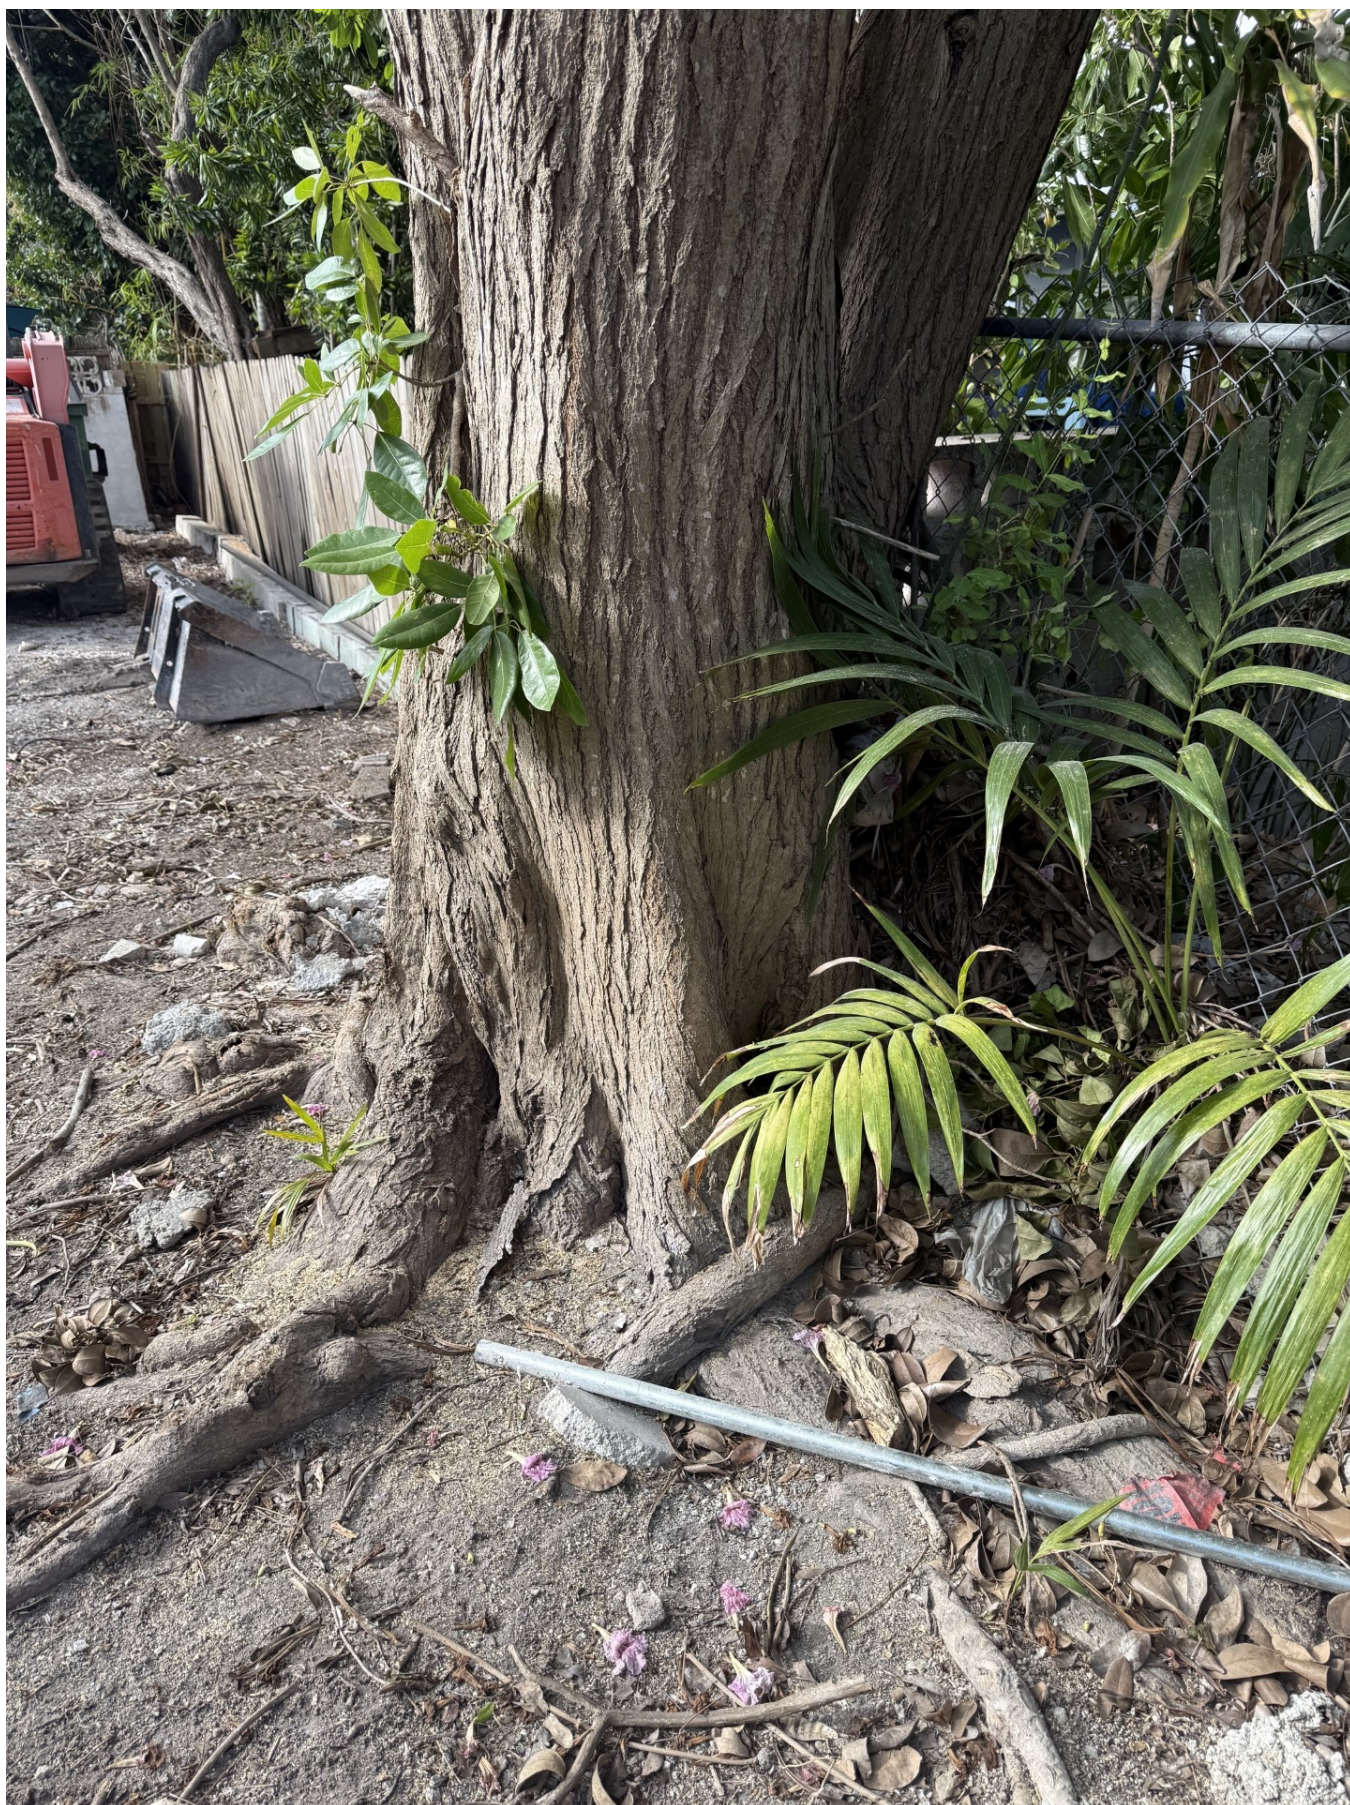
**Codominant Stems with included bark.**

**Condition: 70% Codominant Stems with included bark**

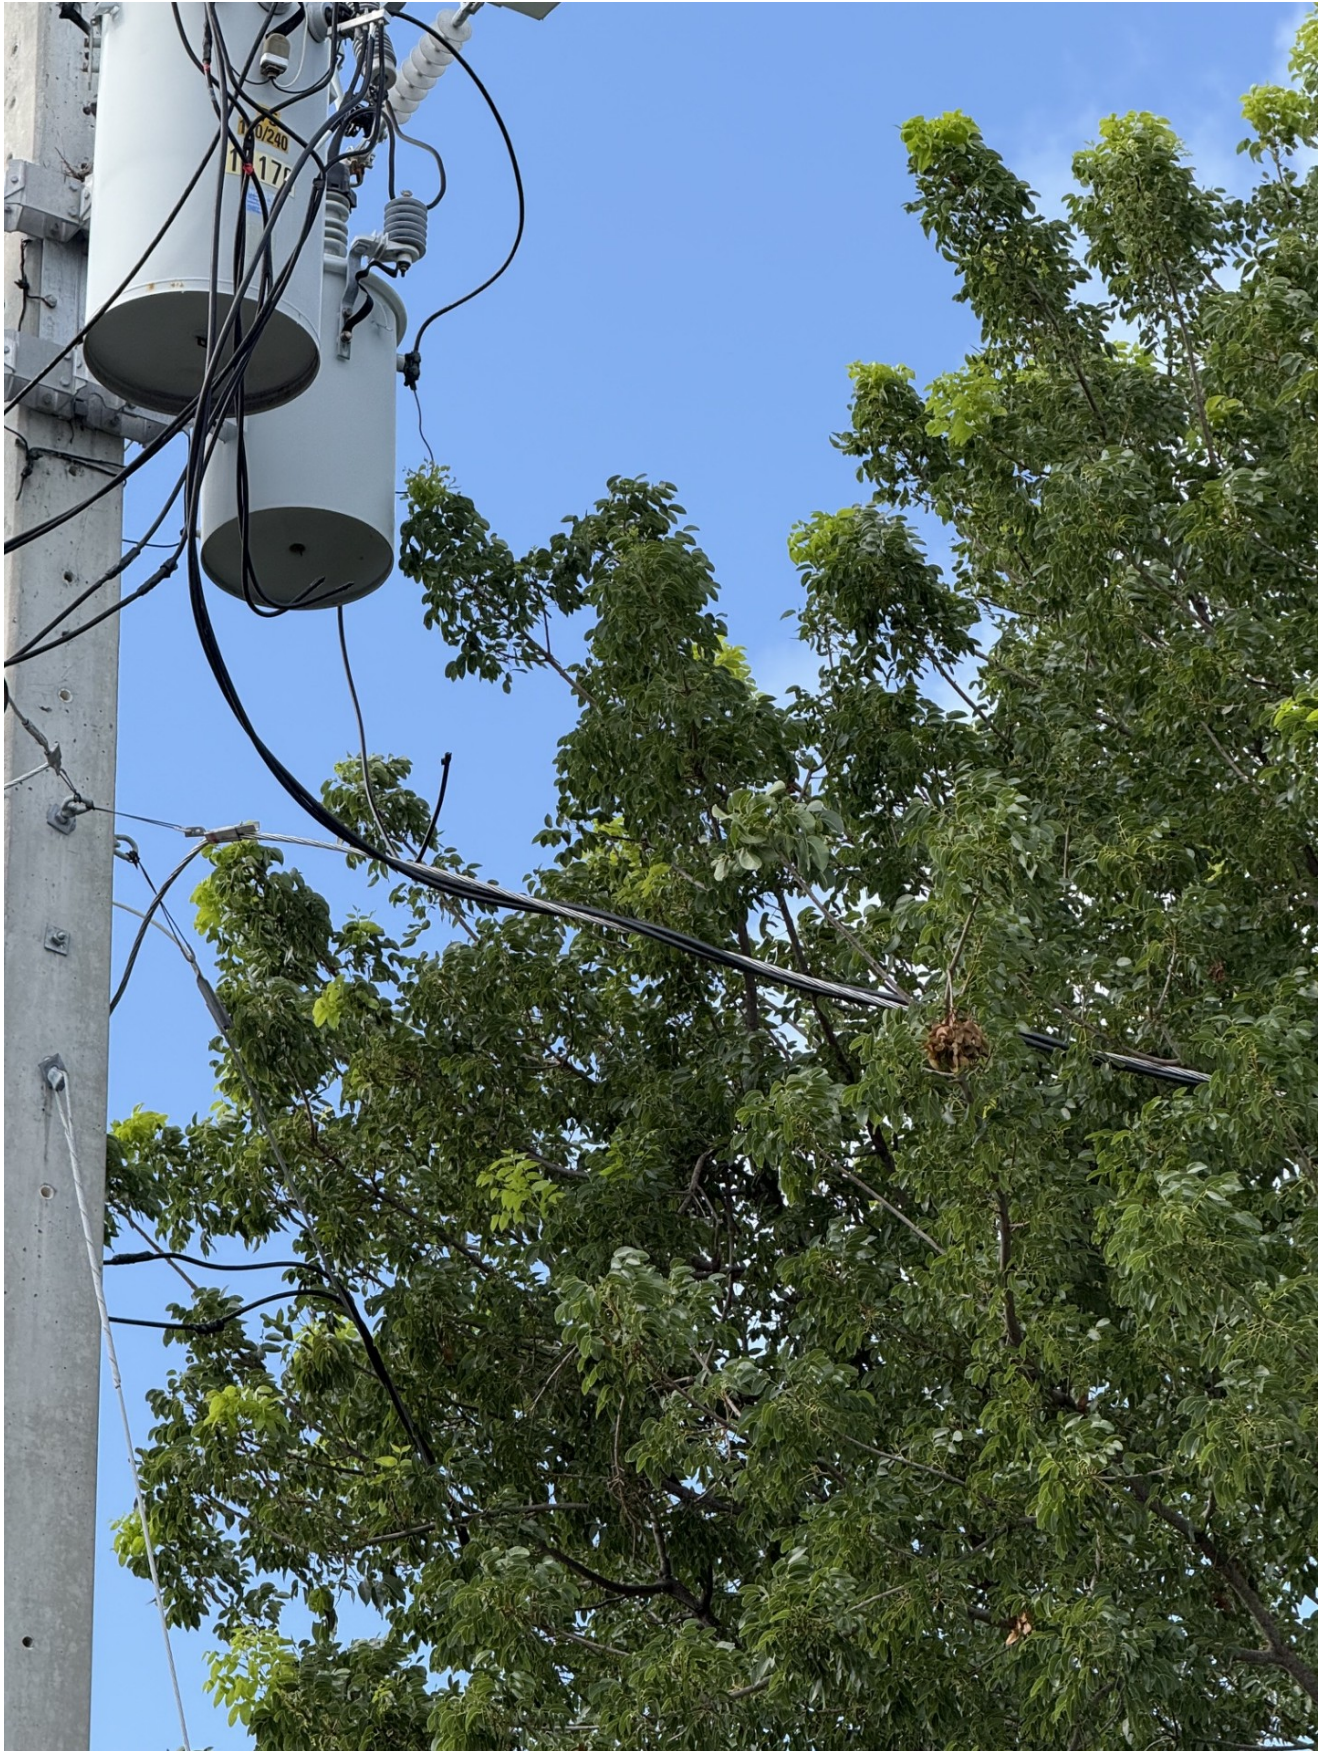
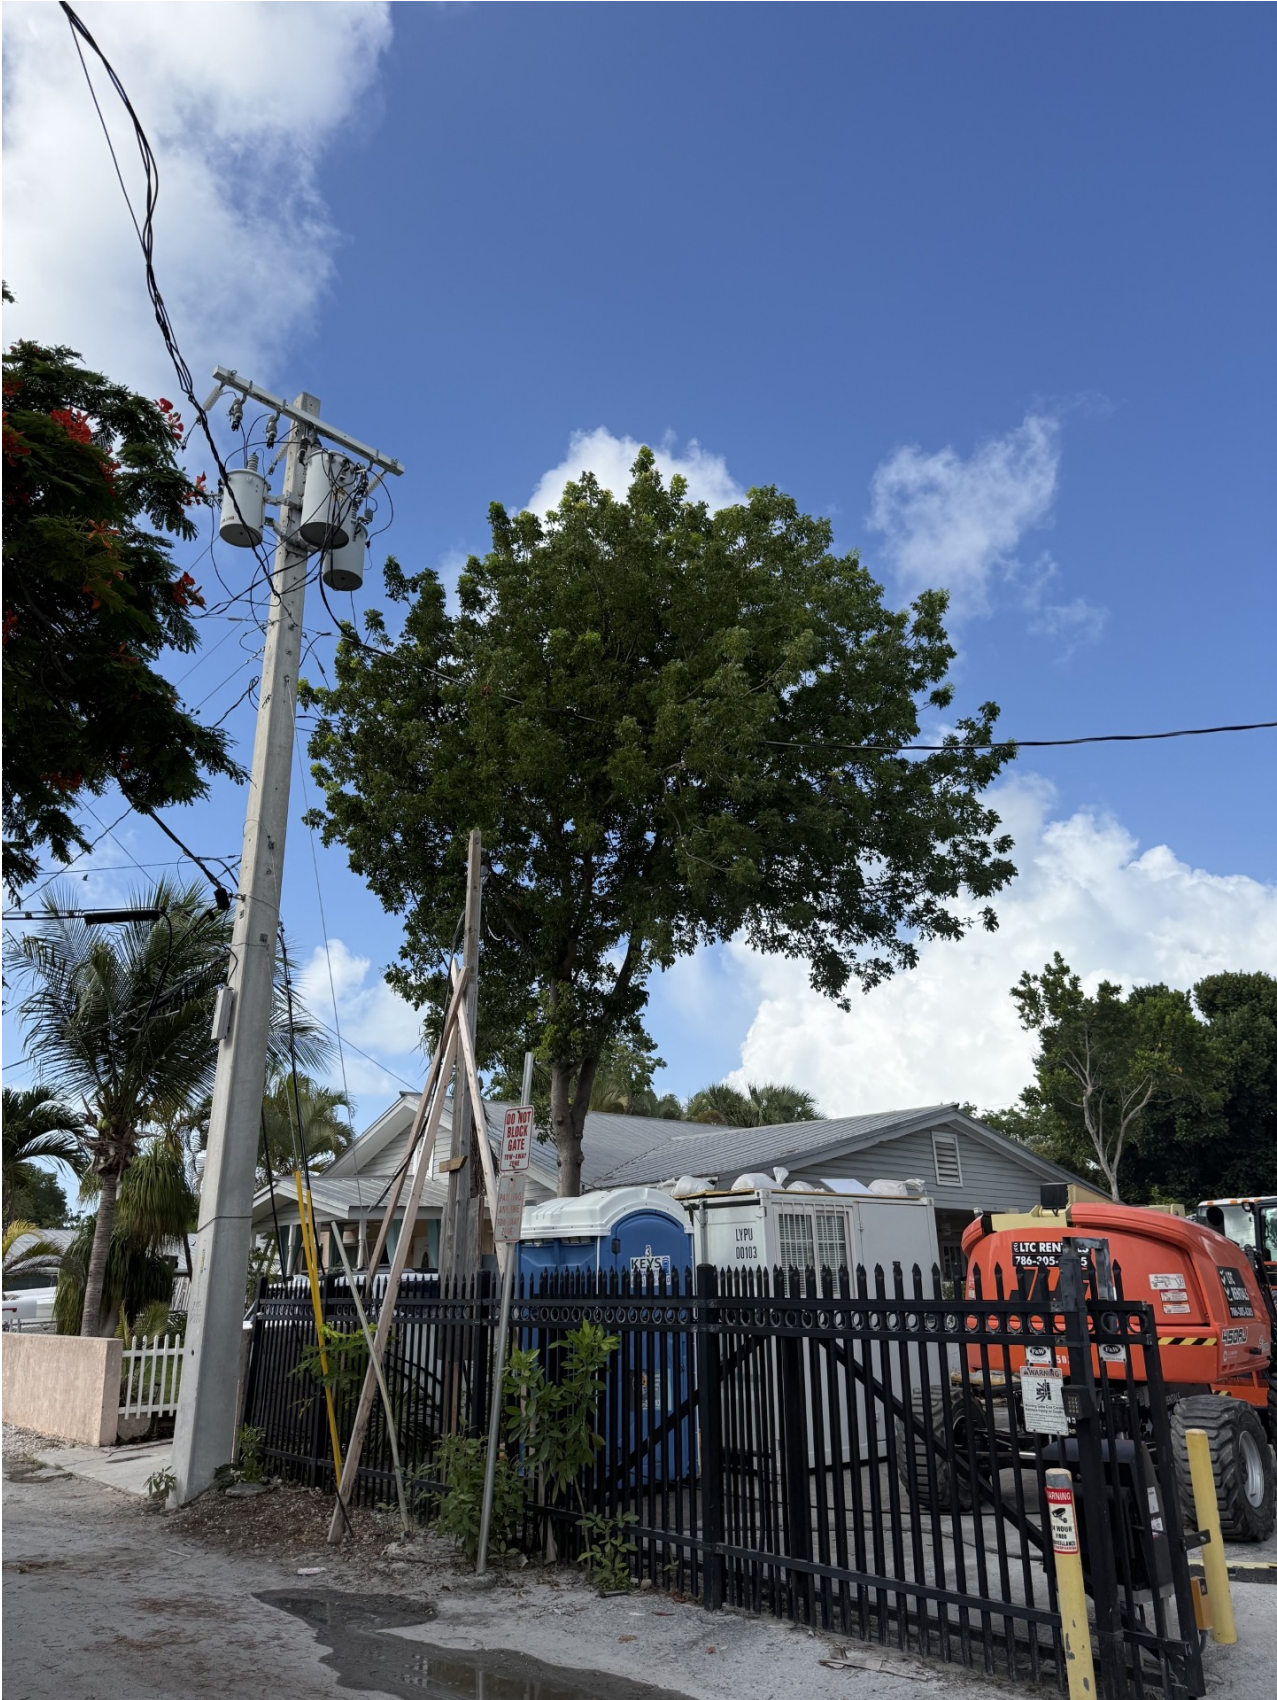
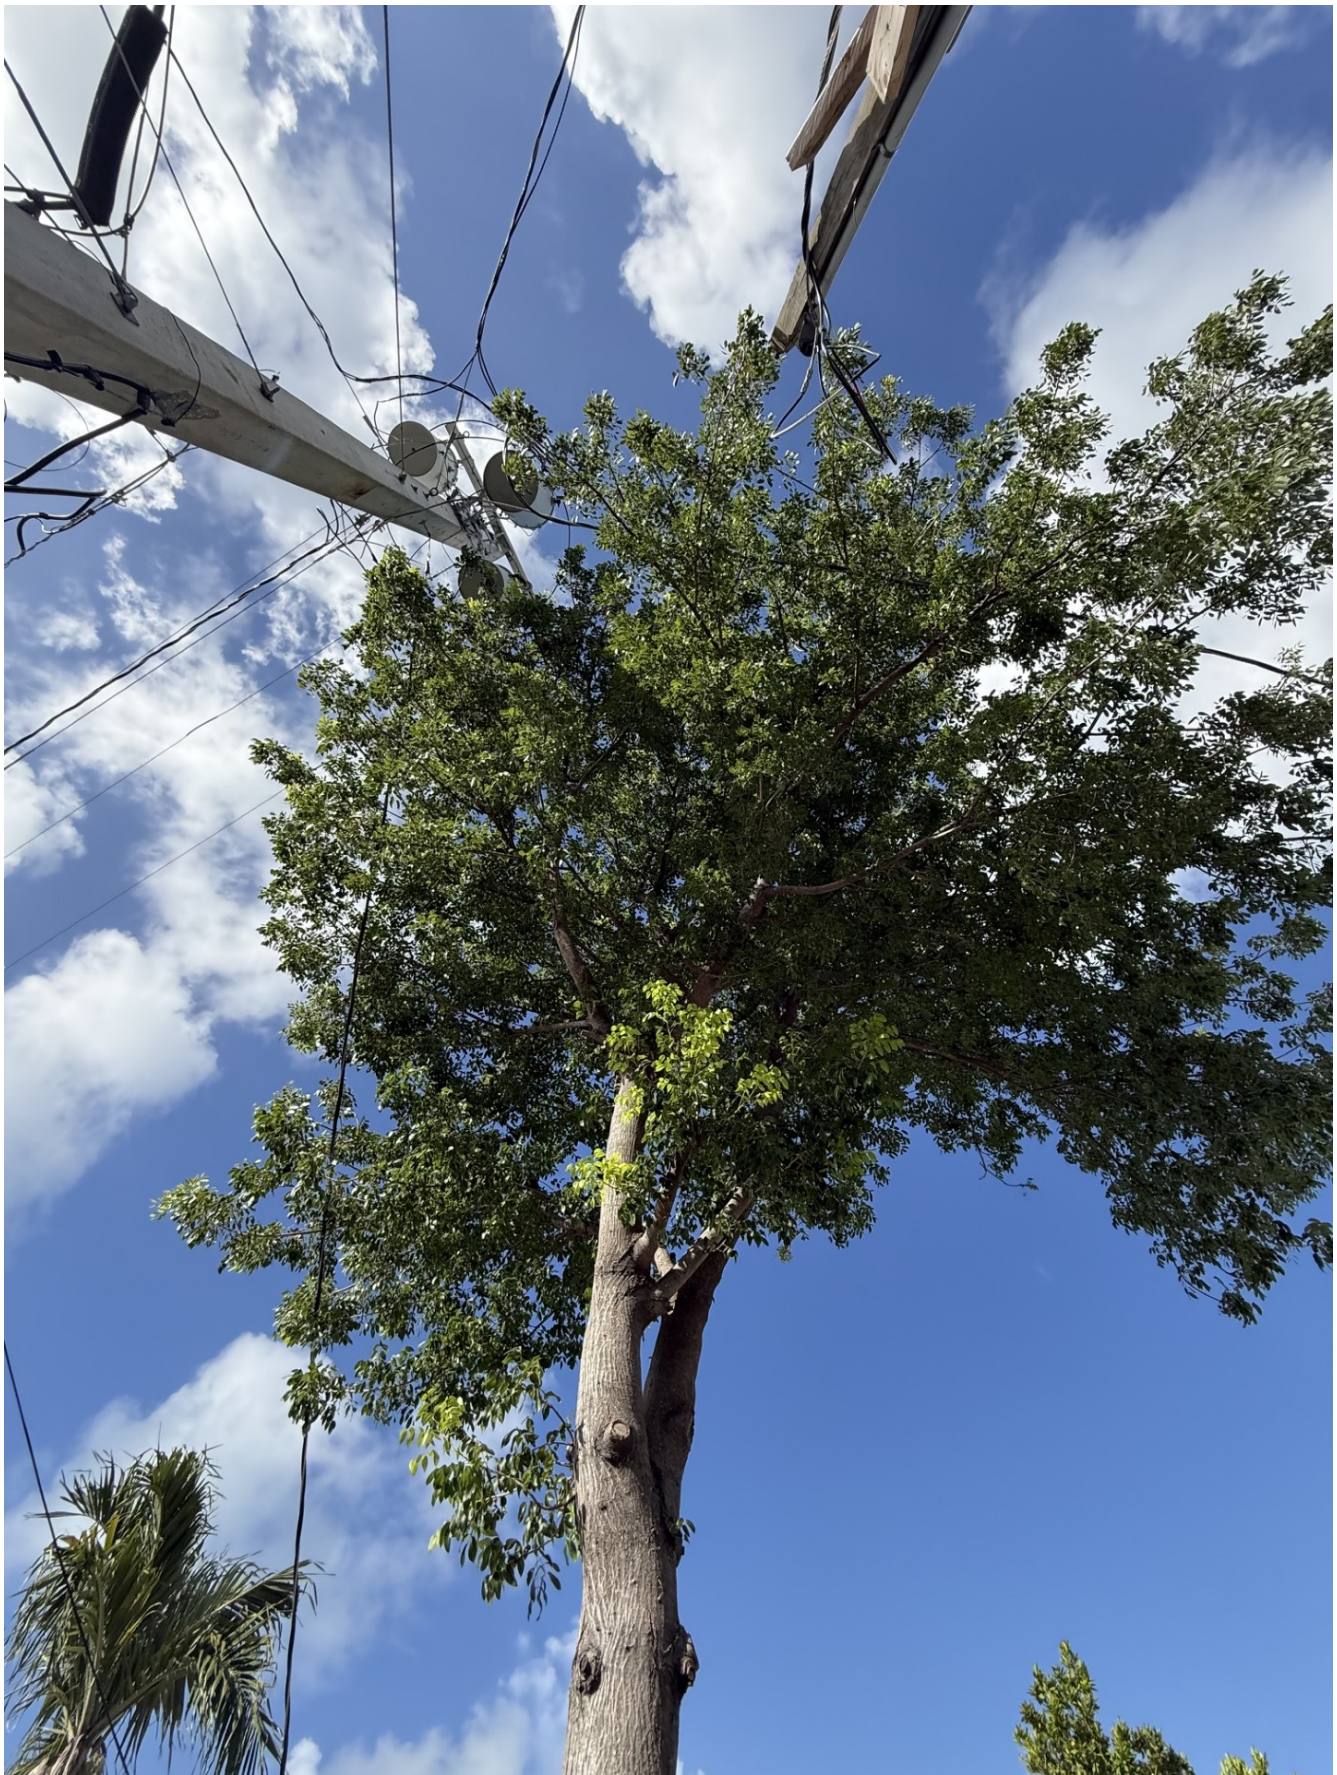
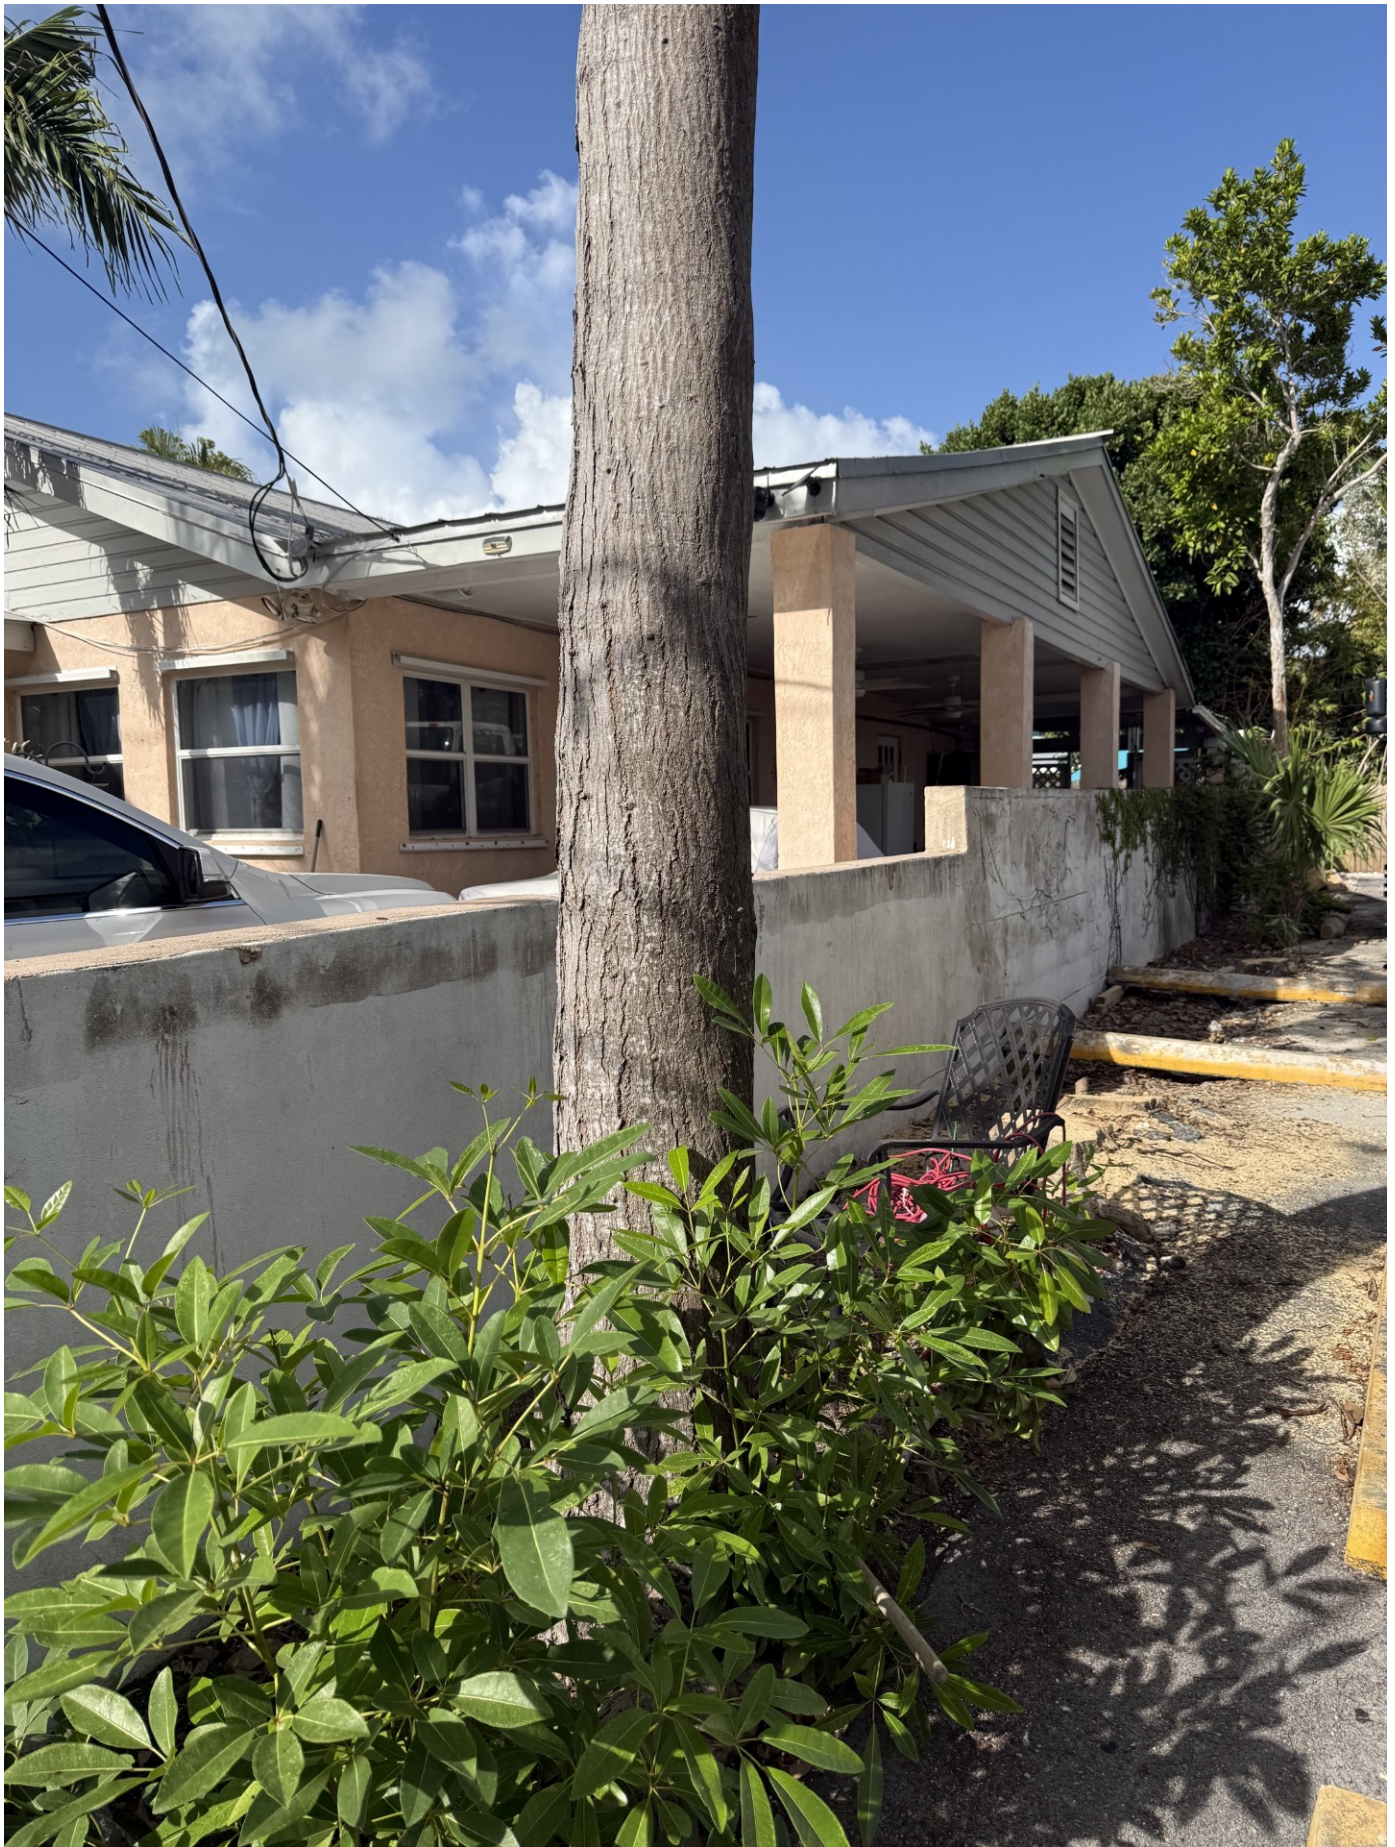
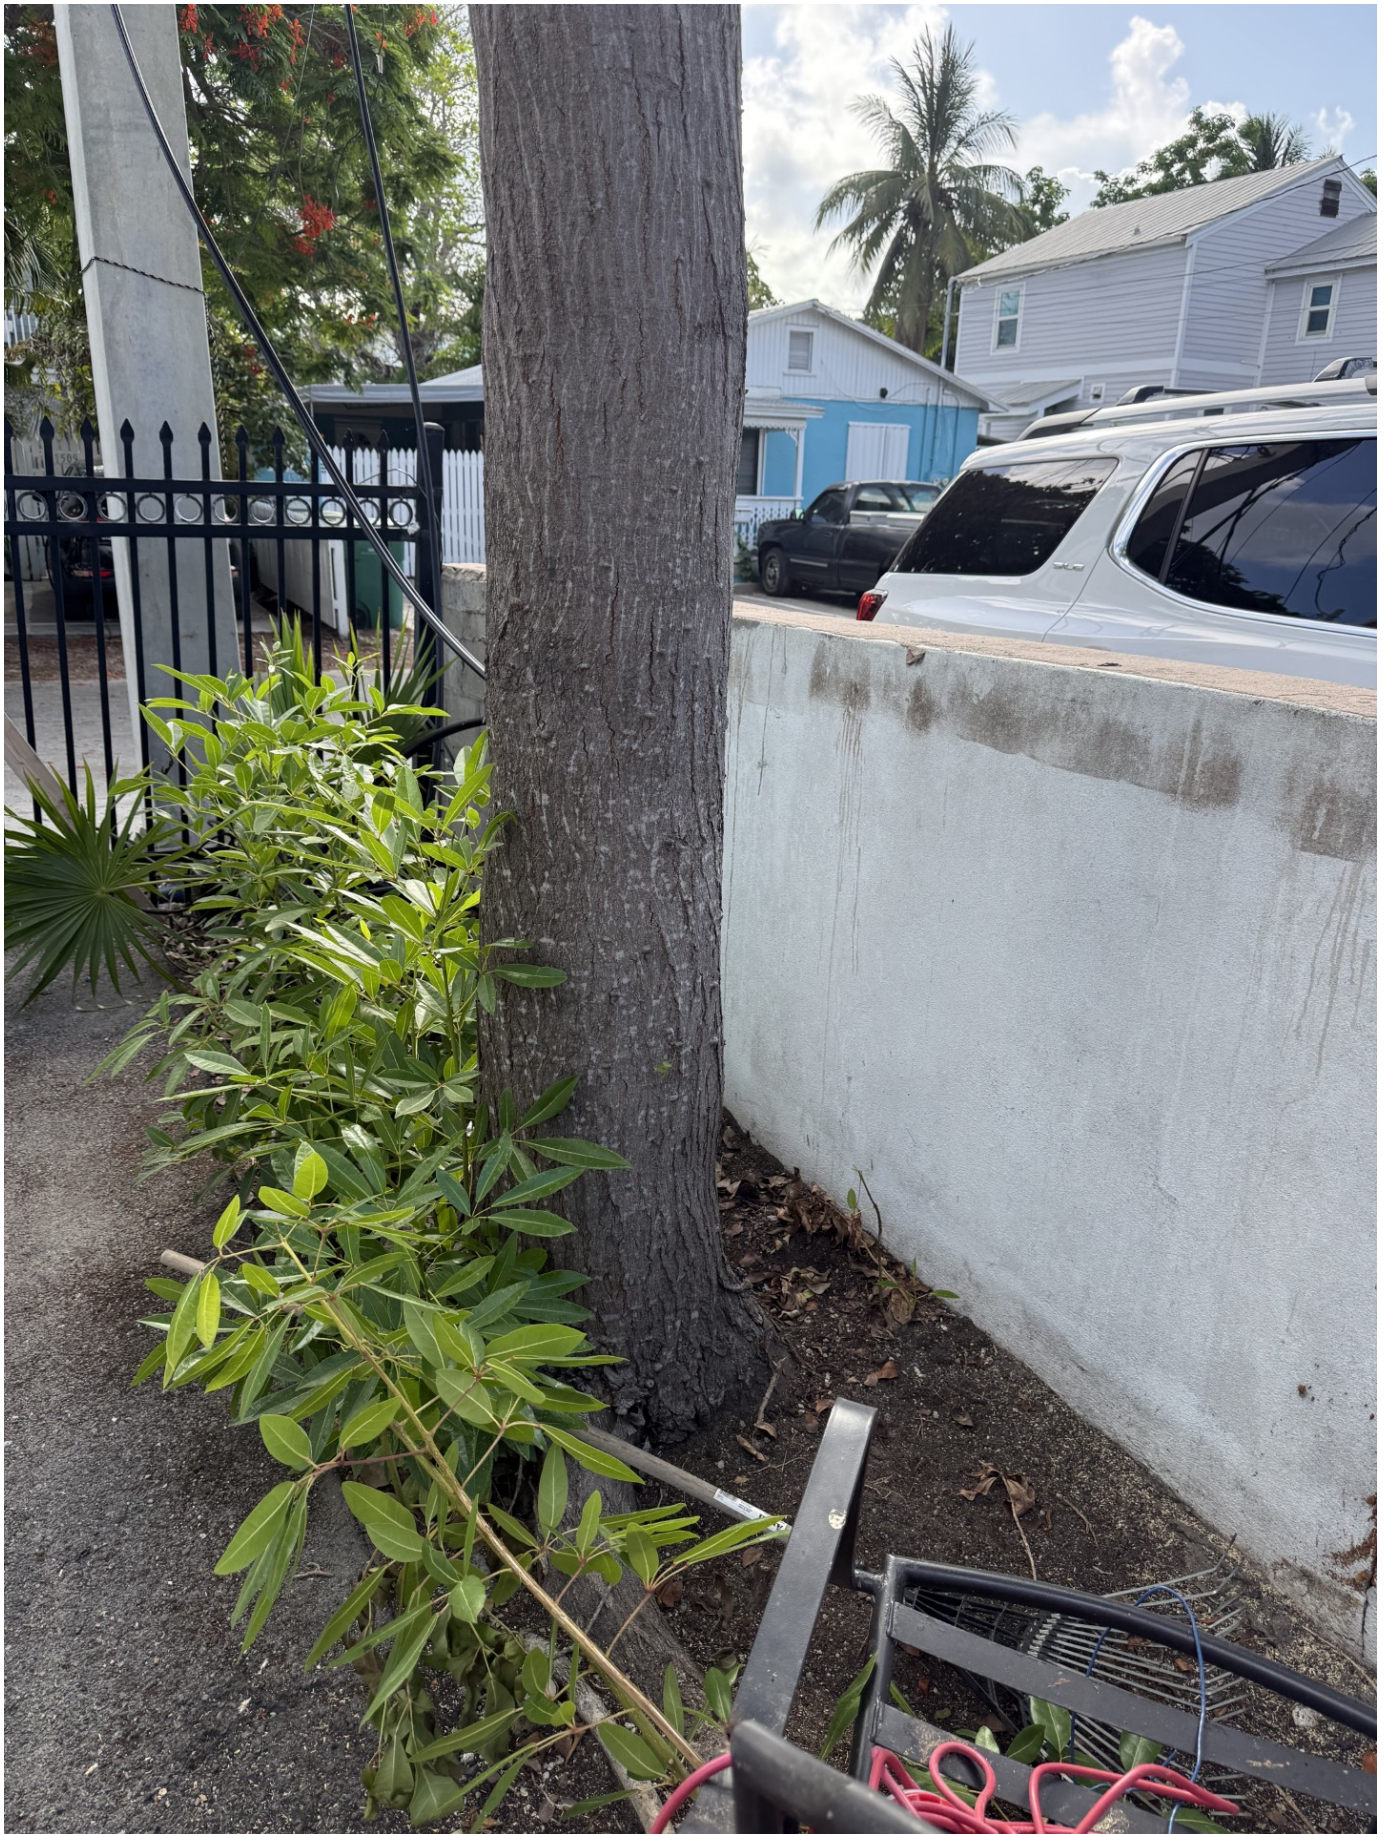
**TREE #2 Cuban Mahogany**

The subject tree is a Cuban Mahogany measuring approximately 13 inches DBH. While approaching maturity, the tree has not yet reached full mature size. Overall physiological condition is assessed as Fair, with no significant indicators of decline observed during the visual assessment.

Additionally, the trunk is located less than one foot from a concrete masonry wall defining the property boundary. The planting location is inconsistent with recommended species selection and spacing guidelines for a large-maturing canopy tree and appears more indicative of a volunteer tree than an intentionally planted landscape specimen.

The canopy has been raised considerably through previous pruning, resulting in a pronounced lion's-tail effect. Consequently, the tree exhibits a lollipop-shaped canopy architecture, likely attributable to repeated clearance pruning. While no significant structural defects such as decay, cracking, or included bark were observed, the altered canopy structure may increase end-weight loading on scaffold limbs and reduce the tree's natural wind resistance over time.

### **Recommended Mitigation: 9.1 Caliper Inches**
