**Concrete Repair Cost Proposal Form for Fredrick Douglass Gym**

**Repair Details SK 1 – 10**

**Frederick Douglas Gym**

**McCarthy Project No. M13178**

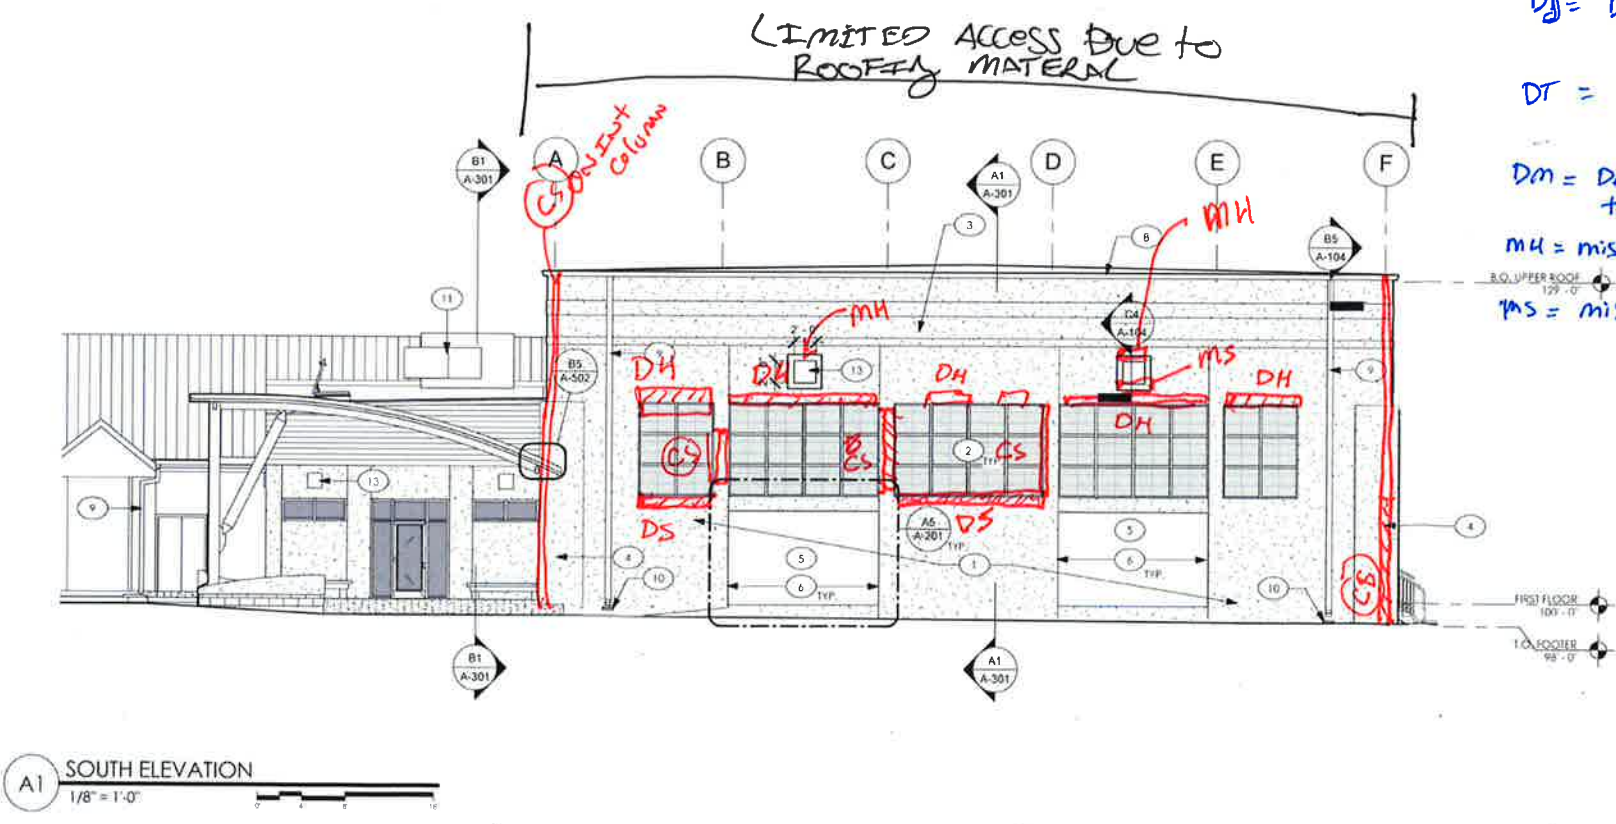
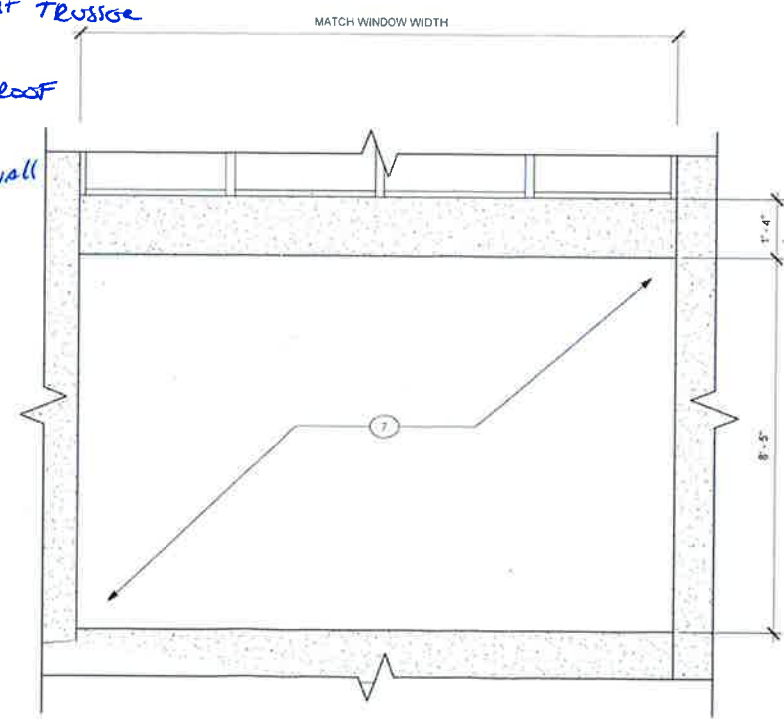
A1 SOUTH ELEVATION  
 1/8" = 1'-0"

- CS = Concrete Sill  
 DH = Damaged Header  
 DS = Damaged Sill  
 MC = Masonry Crack  
 DJ = Damaged wall at Truss Tie Seat  
 DT = Damage High Roof Tie Beam  
 DM = Damaged MED Wall Tie Beam  
 MH = Missing Header  
 MS = Missing Sill
