*Final Preliminary Design Memorandum*  
(PDM)

# **Fleming Key Bridge Pipe Support Piling Repairs**

Prepared for  
**City of Key West, Florida**

November 14, 2013

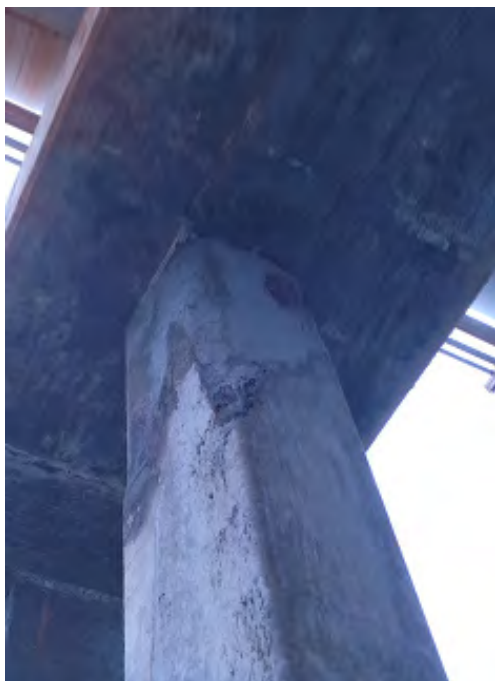
**Photo No. 18: Northwest Corner of Pile 6, where the top of the pile intersects the concrete pile cap.**

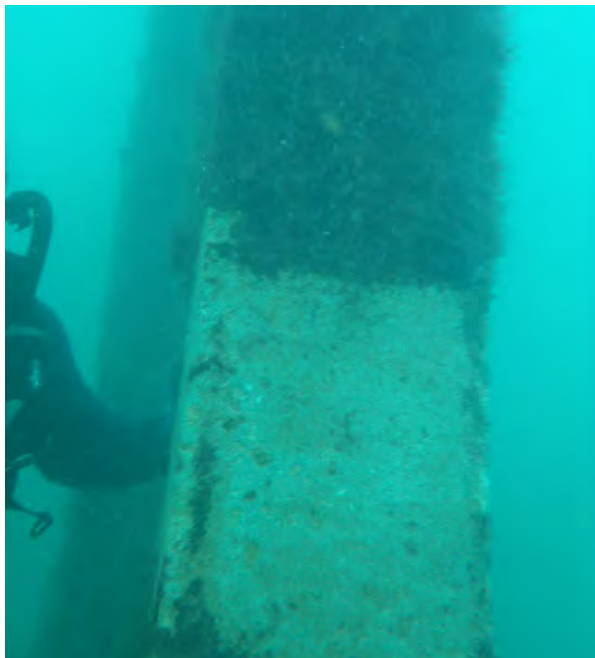
**Pile 9:** No cracks were found in the pile. Minor pitting up to 1/4 inch deep was noted around the pile. Pile 9 is considered to have a Condition Rating of 6 and is in Good Condition.

**Photo No. 24: View of East Face of Pile 9.**

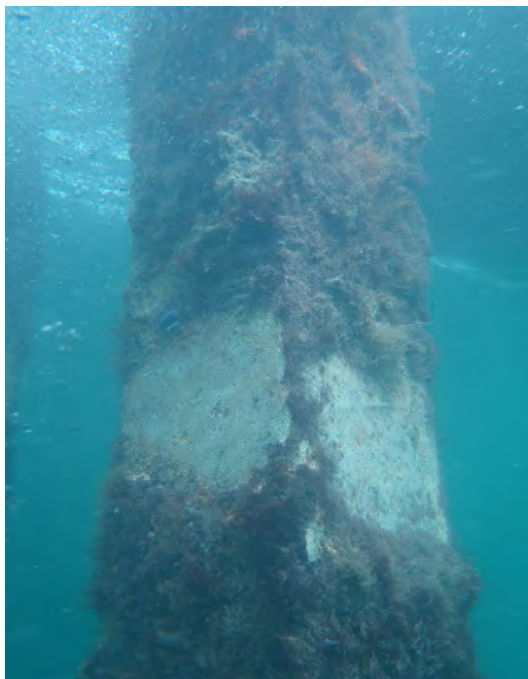
**Pile 10:** No cracks were found in this pile. Pile 10 is considered to have a Condition Rating of 6 and is in Good Condition.

**Photo No. 28: View of Southeast Corner of Pile 10.**

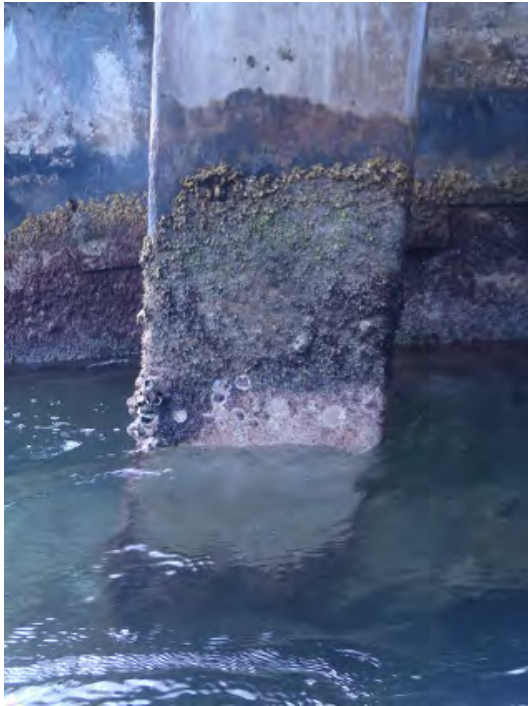
**Pile 14:** No cracks were found in this pile. Pile 14 is considered to have a Condition Rating of 6 and is in Good Condition.

**Photo No. 30:** View of Pile 14 North Face above water.

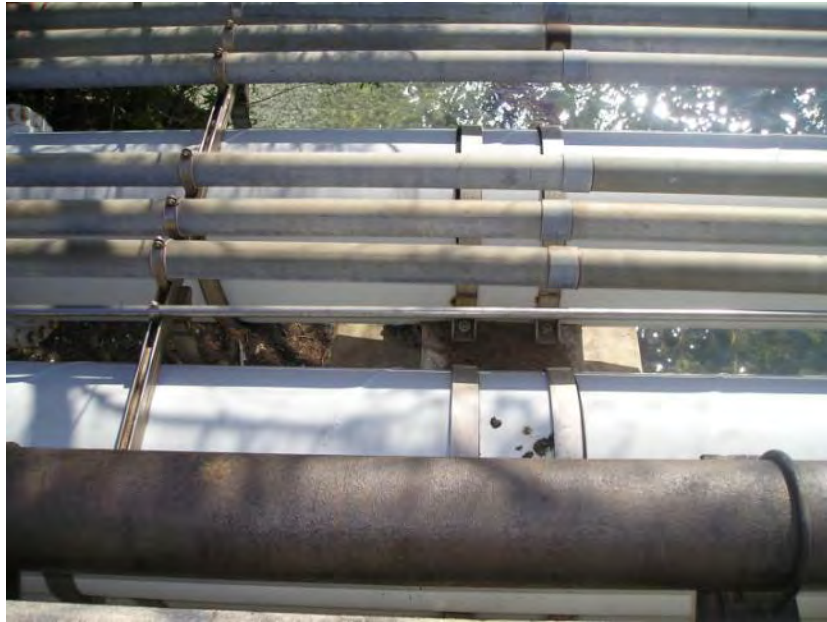
The top surface of the Pile Cap 12-13 is in good condition. A spall is visible on the underside of the pile cap above Pile 13, as may be seen in Photo No. 34. The underside and sides of the pile cap have a visible crack at Pile 12, as may be seen in Photo No. 35. Access could not be gained to the underside of the pile cap, to sound the concrete and determine the severity of the cracked and spalled section. The crack does not appear to be affecting the structural integrity of the pile

**Photo No. 33: Top View of Pile Cap 12-13, showing the two 30-in water mains and numerous electrical conduit.**

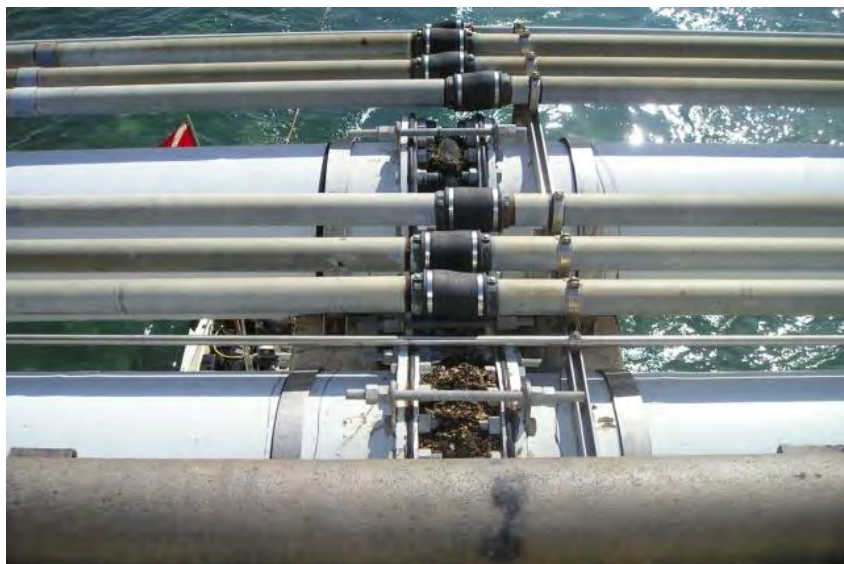
Pile Cap 1-2 appears to be in Good Condition. Both piles, Pile 1 and Pile 2, appear to be in Good Condition above the waterline.

**Photo No. 36: Top view of Pile Cap 1-2.**

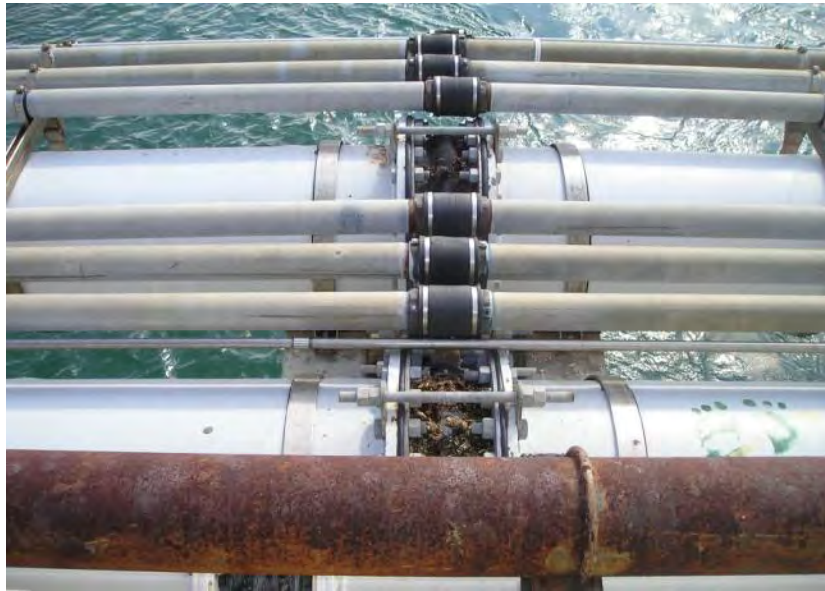
Pile Cap 3-4 appears to be in Good Condition, except for a minor delamination at the north side of the eastern pipe support saddle. Both piles, Pile 3 and Pile 4, appear to be in Good Condition above the waterline.

**Photo No. 37: Top view of Pile Cap 3-4.**

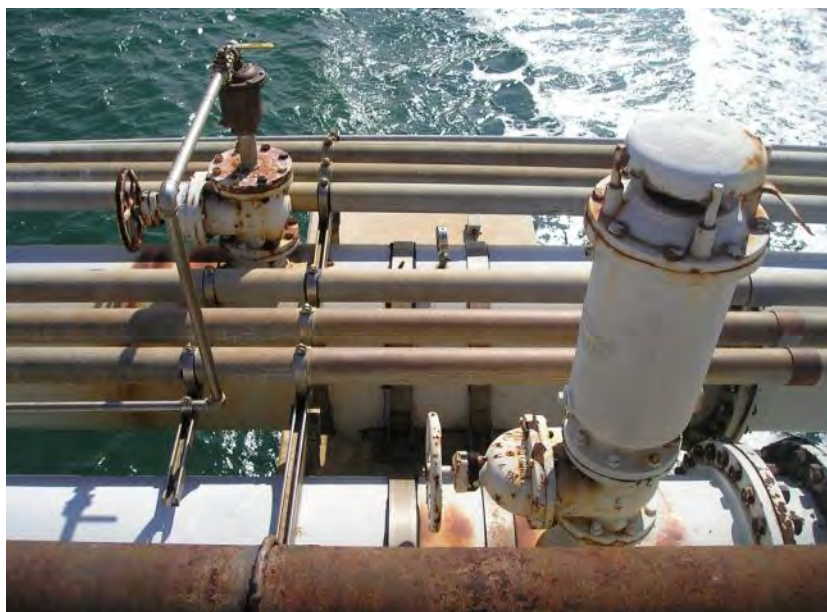
Pile Cap 5-6-7 appears to be in Good Condition. This pile cap is the only cap with three piles. The center pile (Pile 6) was damaged as the result of a mid-1990s boat impact. The pile cap was extended to the east, to accommodate a third, outer pile (Pile 5). Even though damaged Pile 6 exhibits the results of the mid-1990s boat impact, as may be seen in Photos No. 40 and No. 41, as well as Photos No. 14 through No. 21, Pile 6 continues to carry an unknown percentage of the load from the concrete pile cap. The magnitude of the load is indeterminable, because of the possibility of load sharing, by both Pile 5 and Pile 7, in addition to Pile 6. Because of this fact, it is recommended that Pile 6 be repaired by installing a pile jacket from the mudline to the pile cap. Pile 5 and Pile 7 appear to be in Good Condition above the water line.

**Photo No. 39: Top view of Pile Cap 5-6-7.**

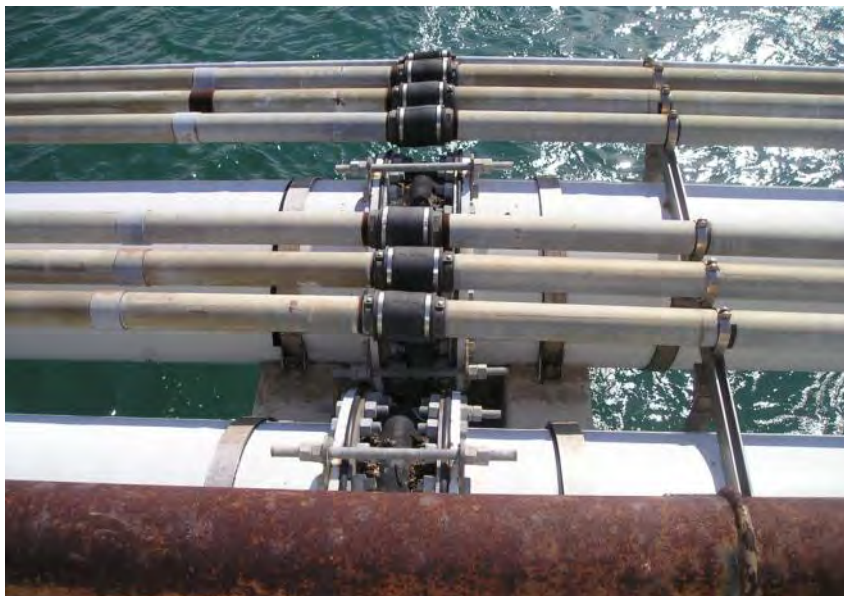
Pile Cap 8-9 appears to be in Good Condition. Both piles, Pile 8 and Pile 9, appear to be in Good Condition above the waterline.

**Photo No. 42: Top view of Pile Cap 8-9.**

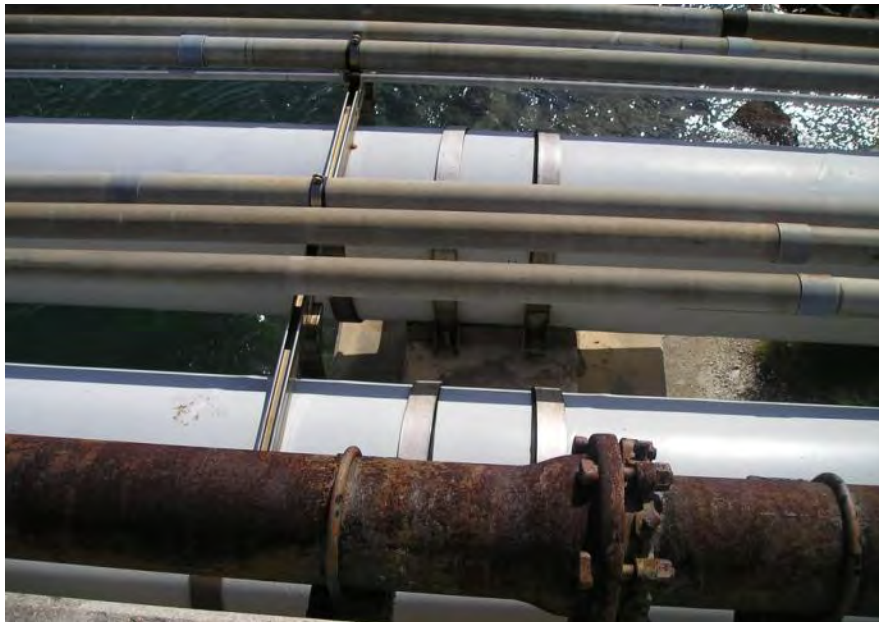
Pile Cap 14-15 appears to be in Good Condition, except for a small concrete spall on the south side of the easternmost pipe saddle and initial stage of concrete delamination on the pile cap soffit. Both piles, Pile 14 and Pile 15, appear to be in Good Condition above the waterline.

**Photo No. 45: Top view of Pile Cap 14-15.**
