## Tree Removal Report

**PROPERTY:** 2600 Patterson Ave.

**APPLICATION NUMBER:** T2026-0132

**REQUEST:** The applicant is requesting removal of (1) Strangler Fig .

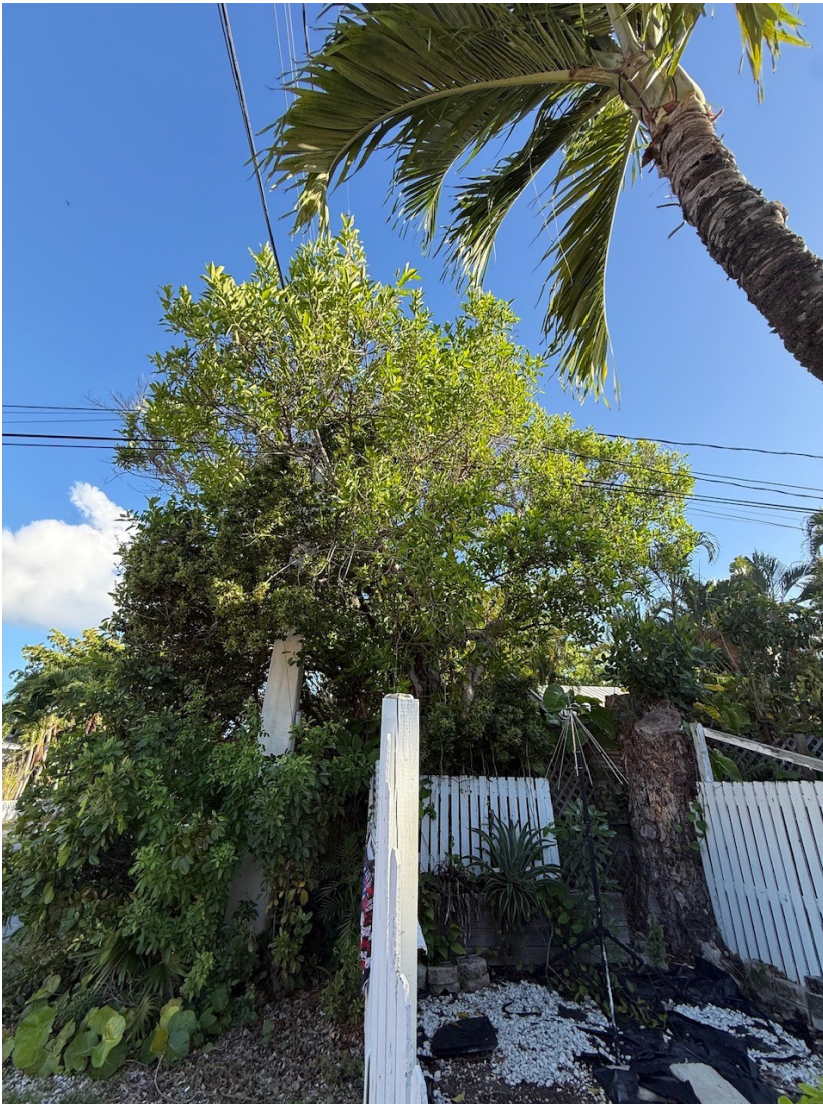
The subject tree is a Strangler Fig (*Ficus aurea*) with an approximate diameter at breast height (DBH) of 24 inches. The tree is in fair overall condition and is growing within approximately 5 feet of a utility pole carrying high-voltage electrical distribution lines. The canopy has grown into numerous communication lines, and the uppermost portions of the canopy are beginning to encroach upon the transformer and primary power lines. Additionally, a guy wire associated with the utility pole extends through the tree's growing space and will continue to interfere with the tree's future development.

The upper canopy exhibits a moderate amount of dieback, and the tree has been subjected to repeated utility clearance pruning. While these pruning operations are necessary to maintain safe electrical clearances, they are not conducive to the long-term health, structure, or natural form of the tree. Given the tree's continued growth toward critical utility infrastructure, additional utility pruning will likely be required on a recurring basis.

Based on this Level 2 visual assessment, the primary concern is not an inherent structural defect within the tree itself, but rather the incompatibility of the tree's location with the adjacent utility infrastructure. The subject tree occupies a constrained growing space where future canopy development will continue to conflict with communication lines, the transformer, primary conductors, and the utility guy wire. The long-term compatibility of this tree at its current location is poor, and the ongoing need for utility clearance pruning is expected to continue for the foreseeable future.

**Recommended Mitigation: 14.4 Caliper Inches**
