MEMORANDUM FOR THE FILE

DATE: October 29, 2012

RE: **1332 Duncan Street**

An application was received for the removal of **two (2) Spanish Lime trees**. A site inspection was done on October 29, 2012 and documented the following:

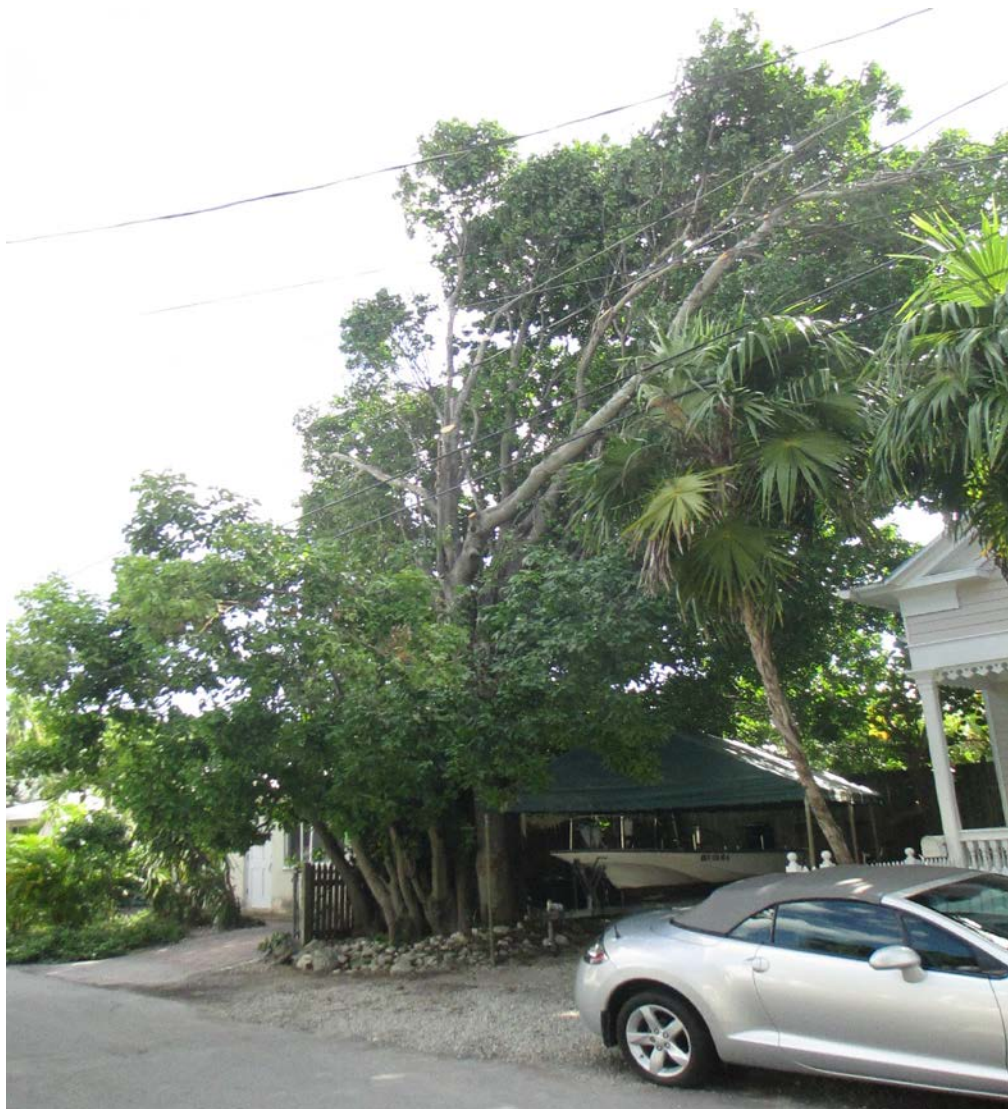
Tree Species: Spanish Lime (*Melicoccus bijugatus*)

Location: 60% - utility lines  
Species: 100% - on protected tree list  
Condition: 60% - fair health

Recommendations: **Staff recommends approval of the permit.**

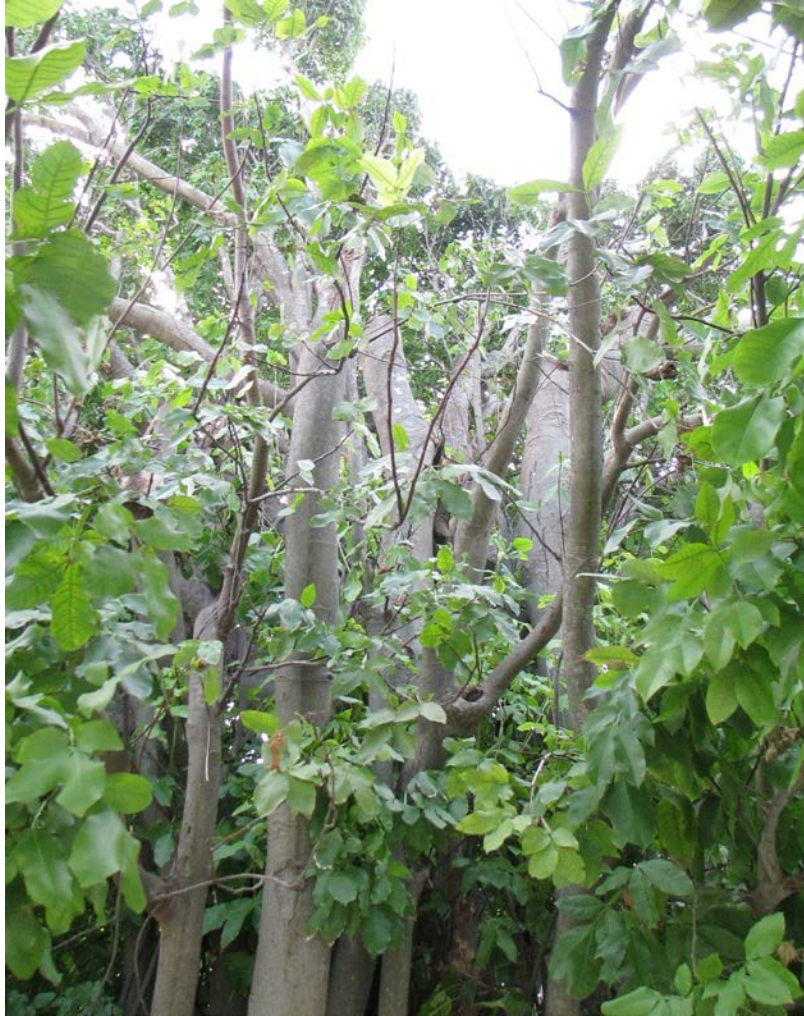
Diameter: Tree# 1 - 40 inches DBH  
Tree# 2 - 7 inches DBH  
**Total Diameter 47 inches DBH**
