# PEARY COURT PROPERTY REPORT

**ATKINS ENGINEERS, INC.**

JULY 17, 2013

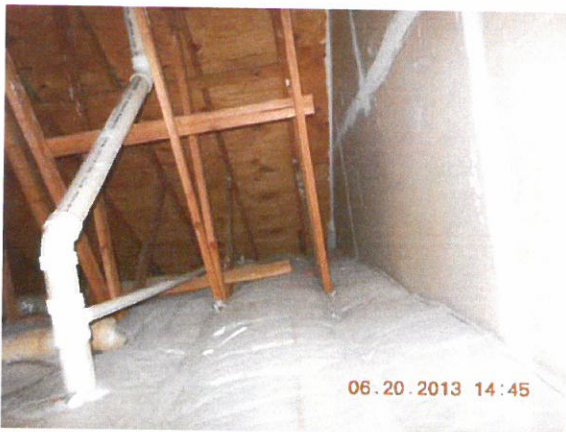
Occupancy is classified as Residential, Group R-2, Type VI construction and one hour fire rated construction. Section #403.5 of the SBCCI states that for buildings less than 3 stories requires 2 hour rated common walls up to the roof decking, with either non-combustible roof sheathing or fire retardant treatment. FRT plywood could not be identified but we found fire rated drywall demising walls in the attic space that was secure and taped. Insulation was found to be properly place and sealed. A general observation was that the roof attic structure and construction look to be in an "as-new condition"

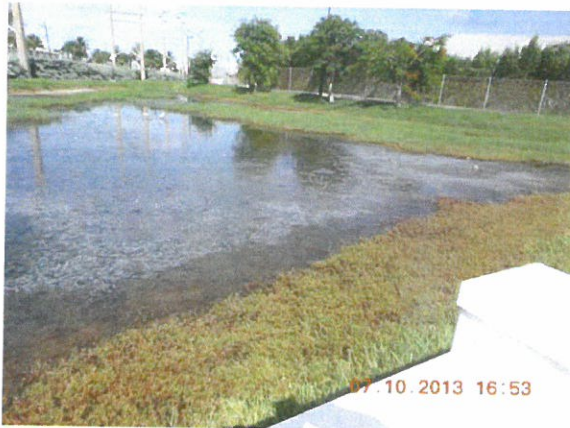
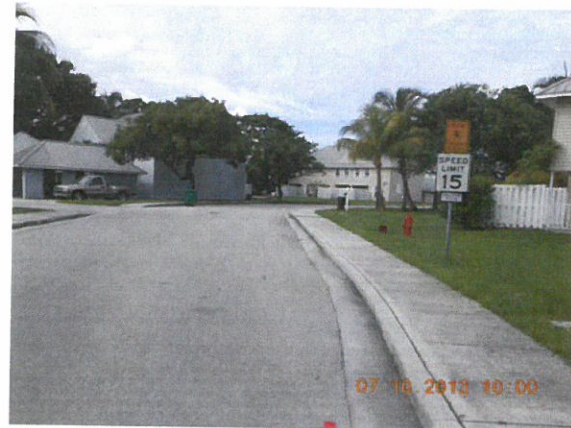
The driveway and parking areas are asphalt and these areas were in fair condition. The paved areas exhibit signs of wear and some cracking. Recoating is a normal maintenance activity and is required more frequently in south climates. The concrete curbs and sidewalks are in fair condition. Concrete sidewalks exhibit some shrinkage cracks and miscellaneous cracks when in close proximity to large trees.

Landscaping is considered light to medium but consistent with rental communities in the area. Storm water is collected and drains into retention ponds. There are several retention ponds located along Palm Avenue that service this community. Exterior photographs are also included in Exhibit 3.

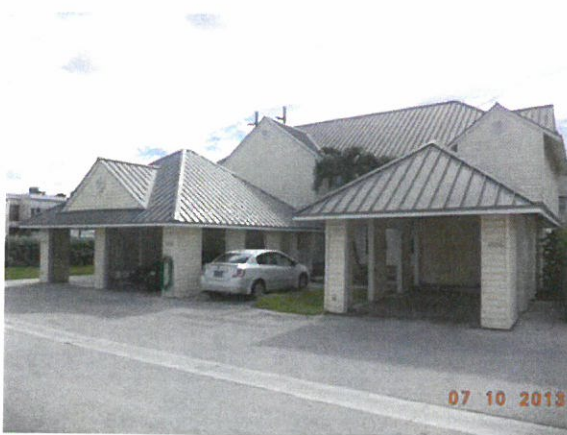
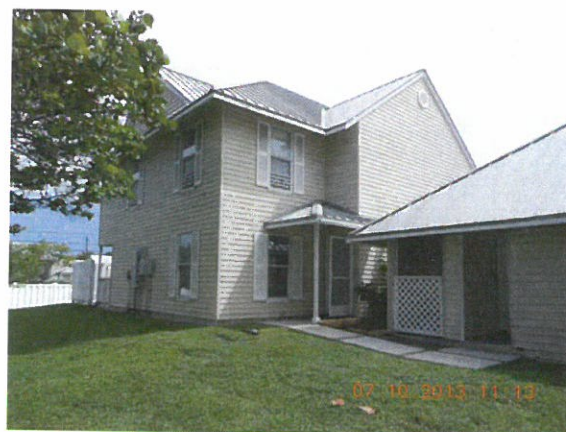
The structures are one and two story wood framed buildings. Our review of the construction drawing that were prepared by McCall & Associates Inc. Architect of Montgomery, Alabama indicates that the exterior walls are wood studs 2"x 4" at 16" on center with 1/2" Oriented Strand Board (OSB) exterior sheathing and covered with a layer of vapor barrier sheet stapled to the sheathing. The exterior cladding consist of horizontal vinyl siding. The second floor is framed with 14" deep flat wood trusses. We were able to verify this construction was in general conformance with the drawings.

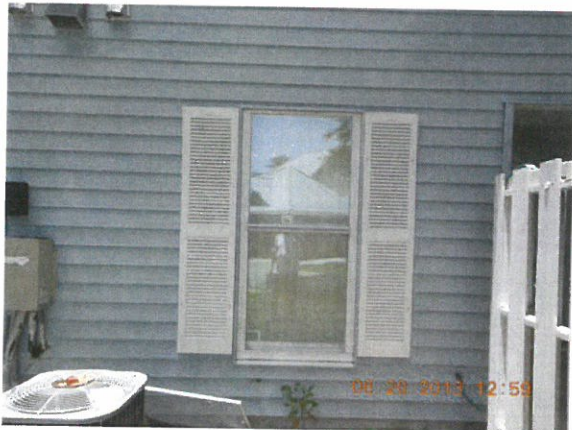
Windows are properly anchored where observed. Windows as indicated by their labeling were AMMA rated at DH-C30 which would translate into a basic wind pressure of 30psf with a minimum structural test pressure of 60psf in accordance with AMMA 101-88. They are not impact. The windows were not required to be impact resistant at the time of construction. Impact glass came in to the industry after Hurricane Andrew and the adoption of ASCE 7 in 1998. The present windows provide the necessary wind load resistance.

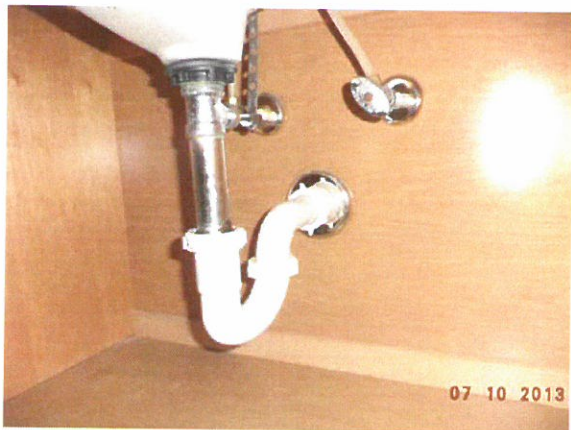
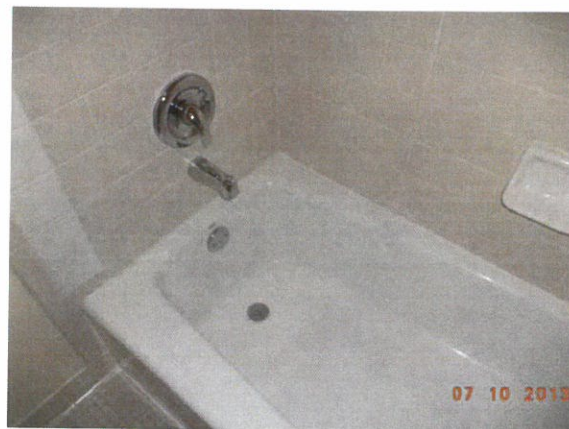
Ground floor bathroom has a toilet and sink, second floor bathroom has toilet, sink and shower/tub combination. Toilet and sinks have individual disconnect valves. Fixtures appear to be in working order and no immediate major maintenance is anticipated.

Plumbing lines where visible in areas such as the water heater closets and under counter areas were PVC and copper. Plumbing was found to be in good condition.
