November 16, 2023

Re: Martin Luther King Pool-Structural Shoring Inspection 11/16/2023
304 Catherine Street

On November 16, 2023 we conducted a follow-up monthly re-inspection of the concrete shoring system and the spalling concrete. The purpose of the inspection was to inspect the shoring, ensure that the shoring is secure and snug to the wood blocking, and to continue monitoring the spalling concrete.

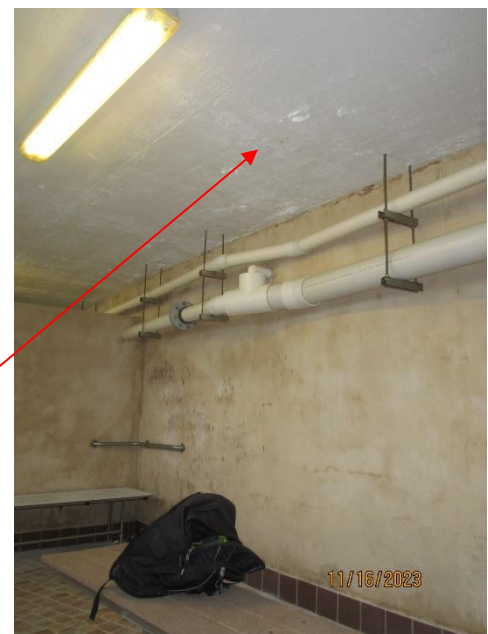
Men's Dressing Room Ceiling

Spalling concrete is delaminating from the ceiling in the Men's dressing room. This area should be repaired immediately or access restricted. The area above the water closets and showers does not exhibit delaminating concrete at this time.

During this inspection additional delamination was observed above the Women's Room water closet stalls, Women's room shower area, and Men's room entrance and dressing room. These areas should be repaired immediately or access restricted.
