# STAFF REPORT

RE: **3338 N. Roosevelt Blvd (permit application # T2019-0017)**

FROM: Karen DeMaria, City of Key West Urban Forestry Manager

An application was received requesting the removal of **(2) Gumbo Limbos (tree# 5 & 6)** and **(2) Sea Grape trees (tree# 7 & 9)** that are being impacted by the redevelopment of the Regal Cinema Movie Theater which was heavily damaged by Hurricane Irma. A site inspection was done and documented the following:

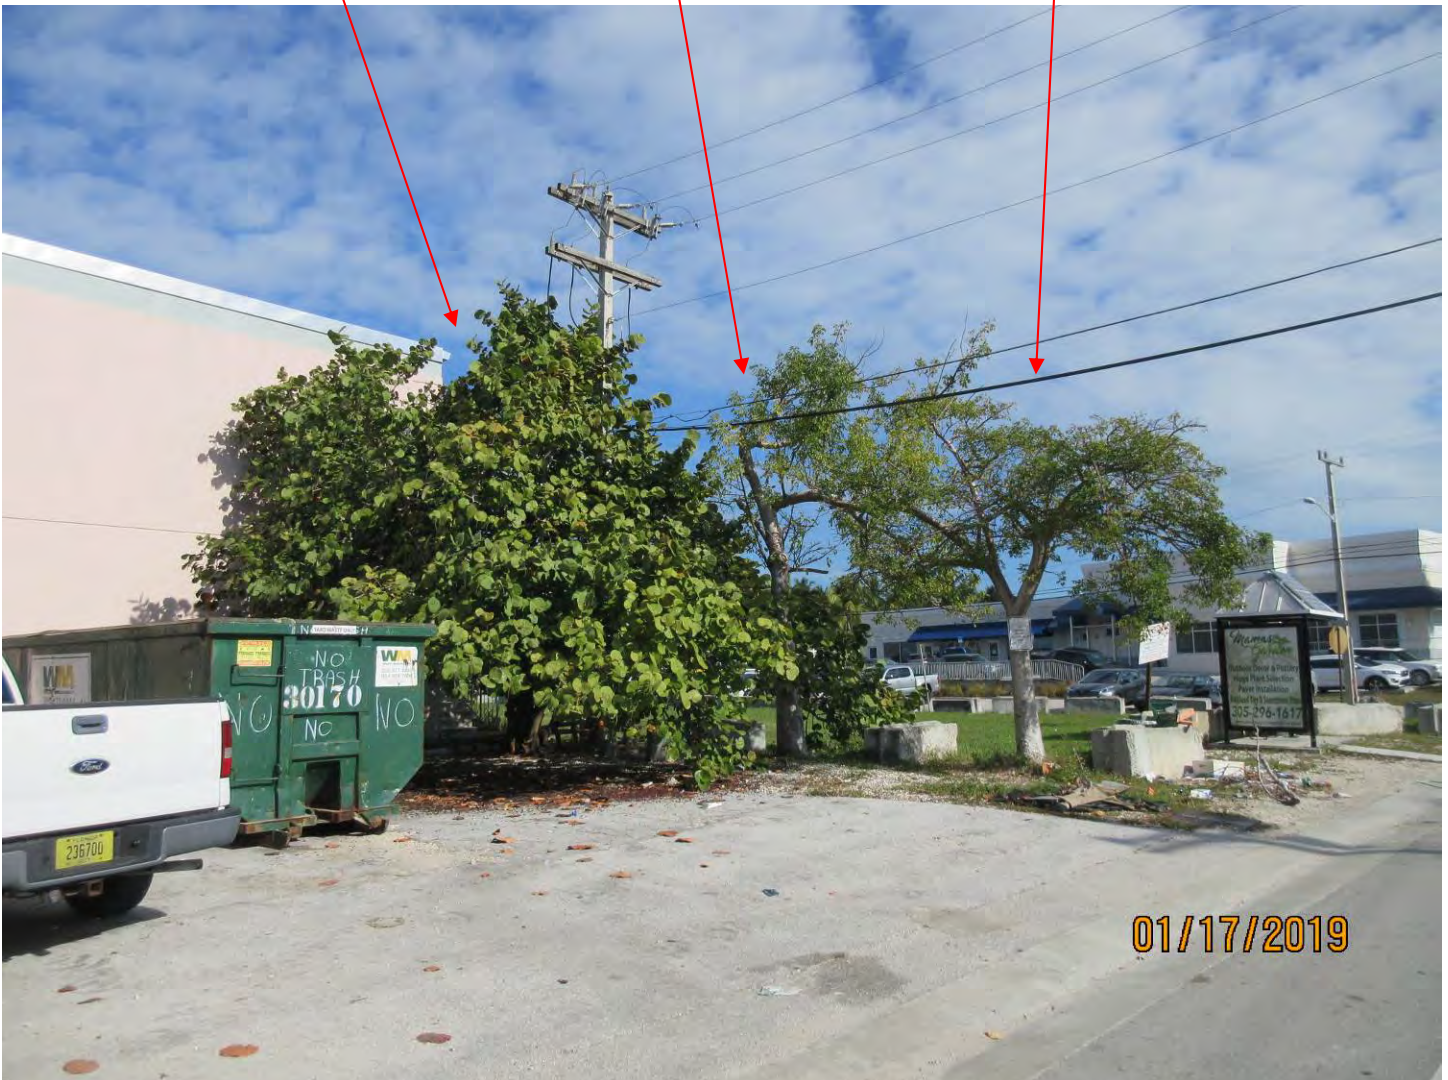
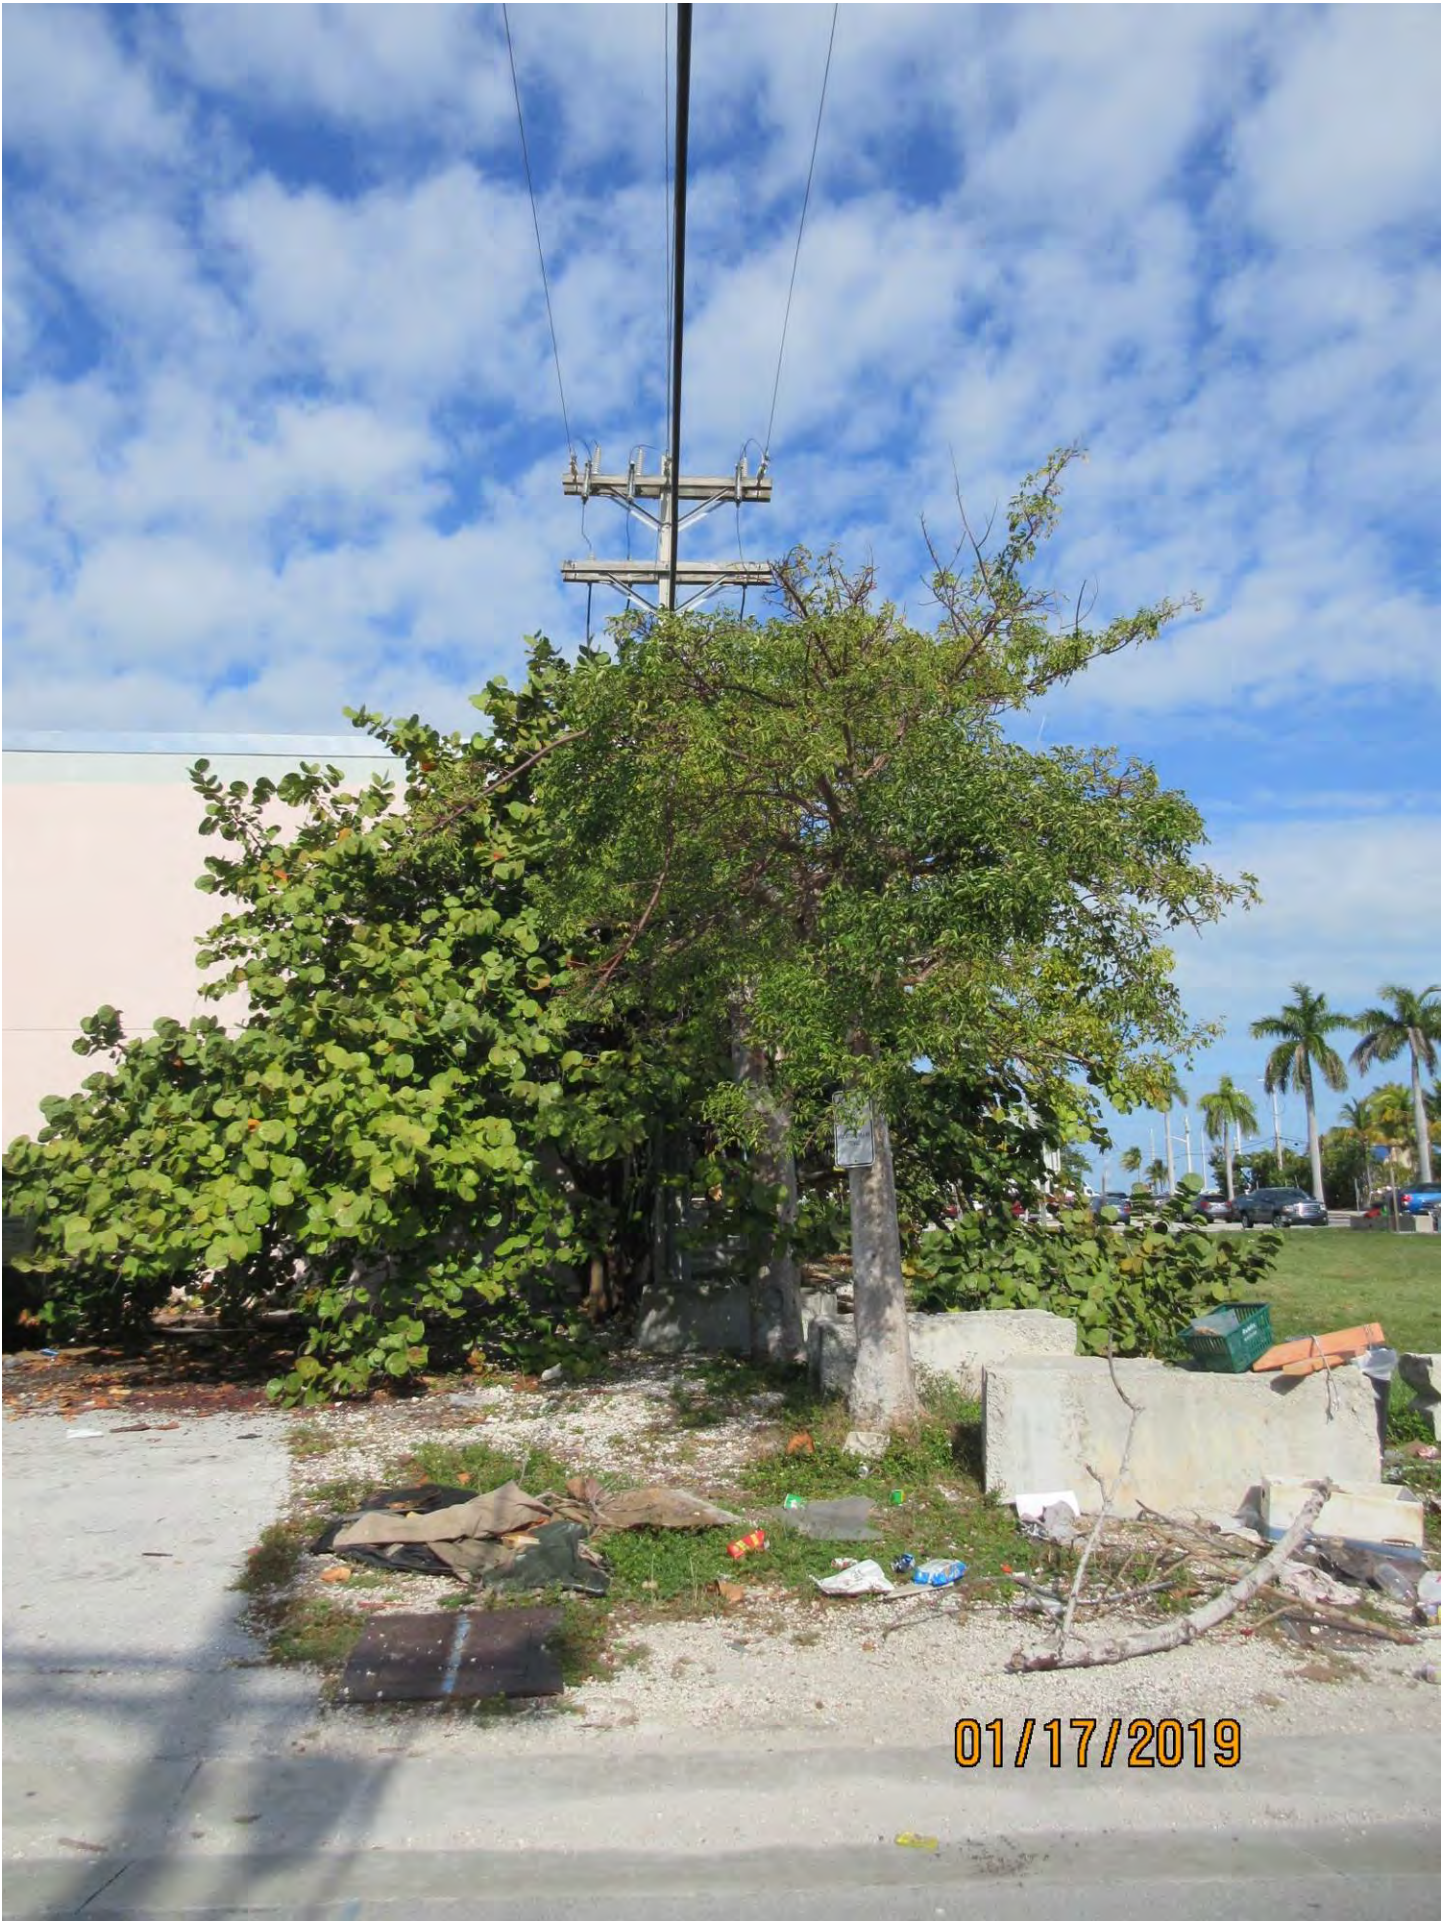
Sea Grape #7

Gumbo Limbo #6

Gumbo Limbo #5

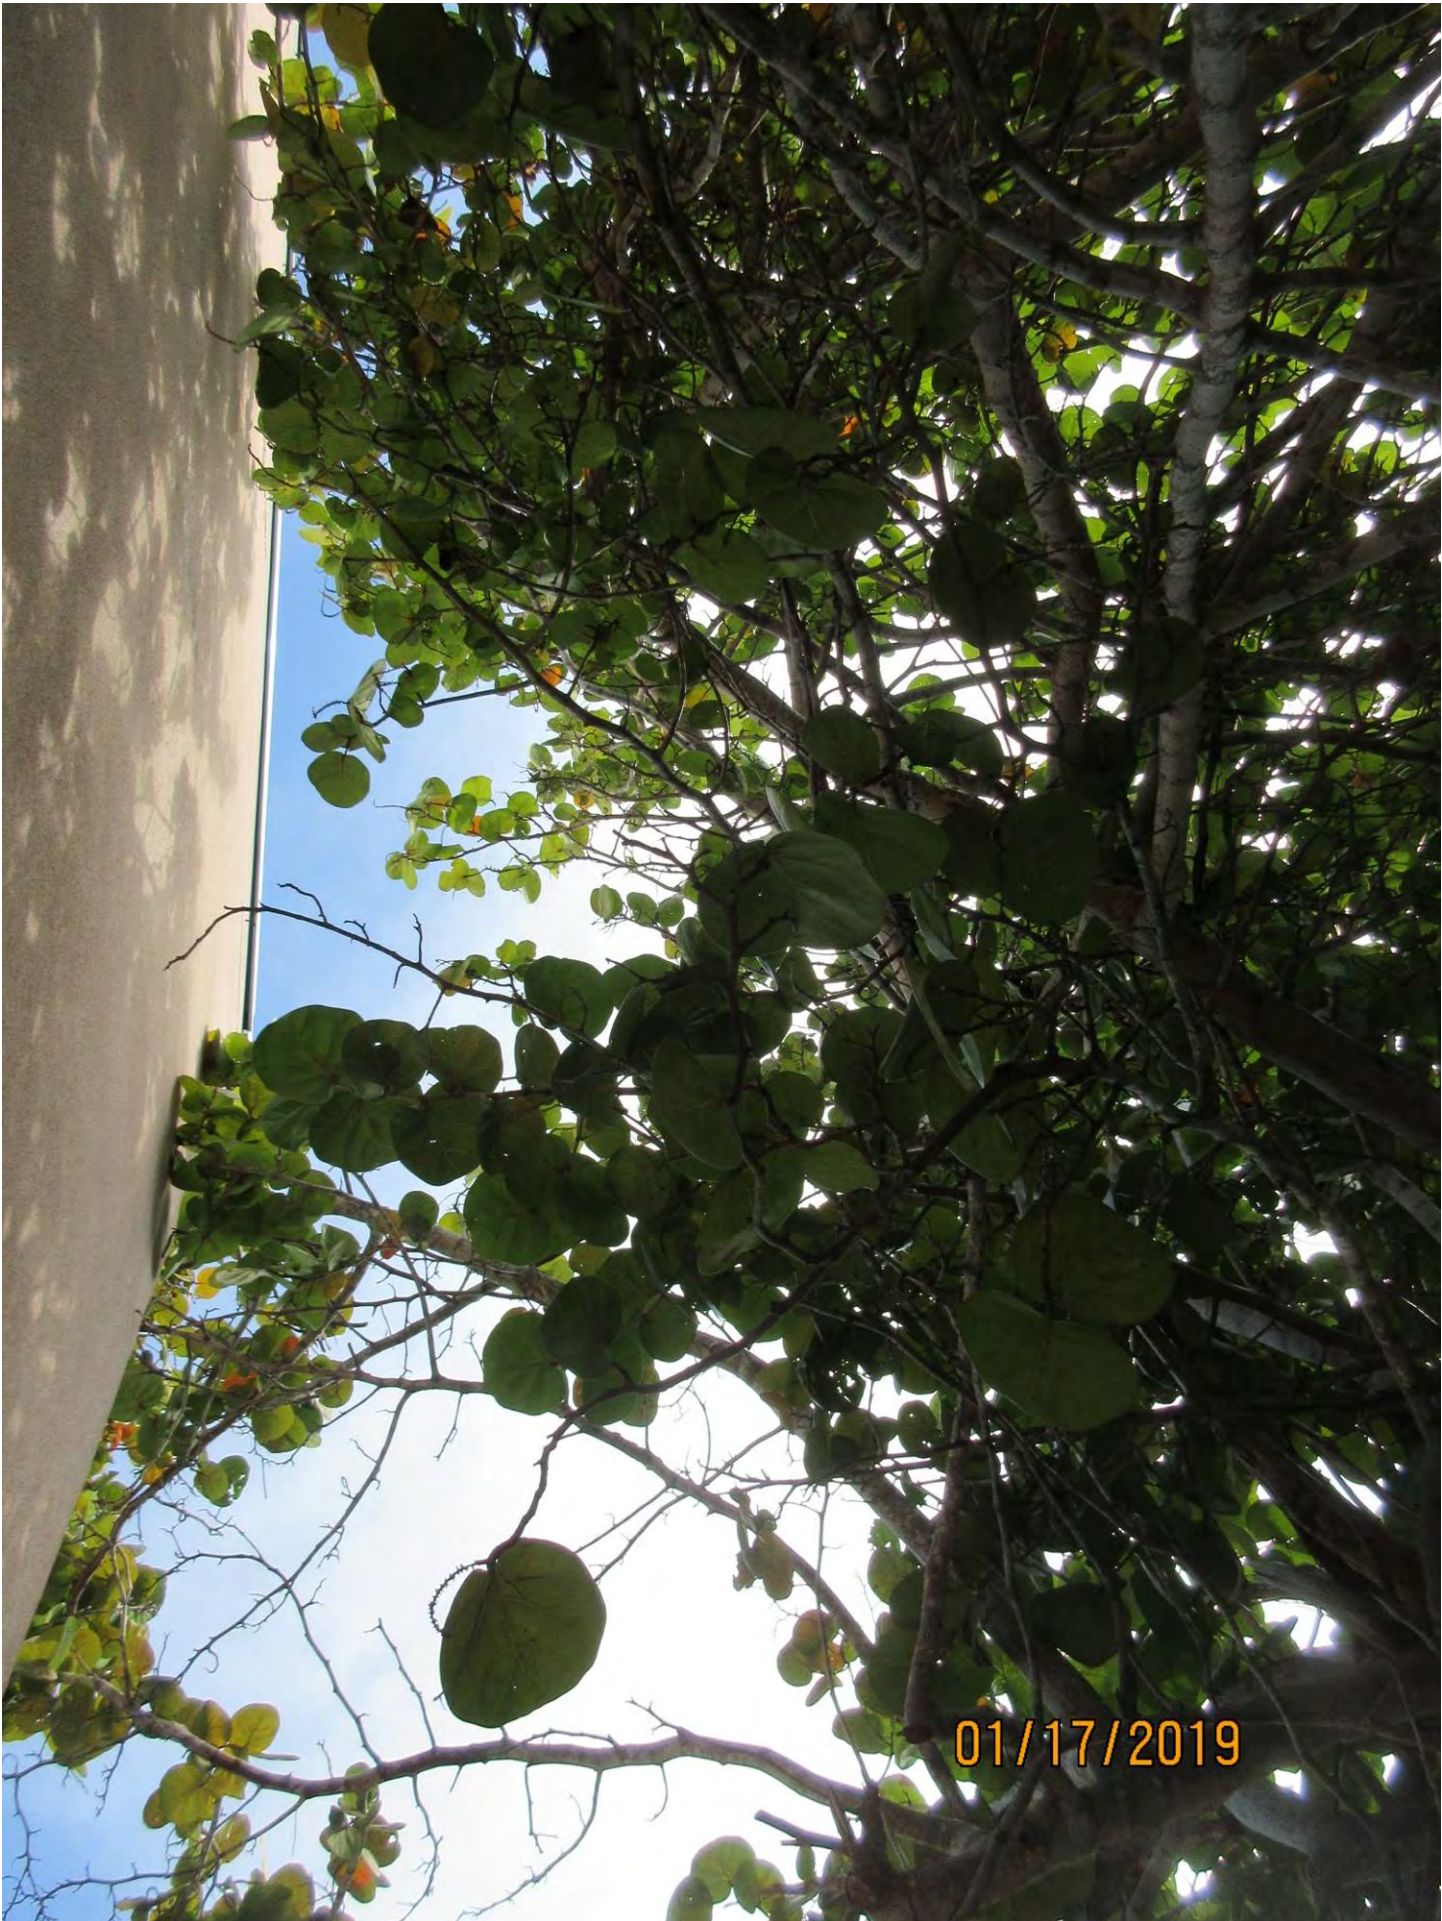
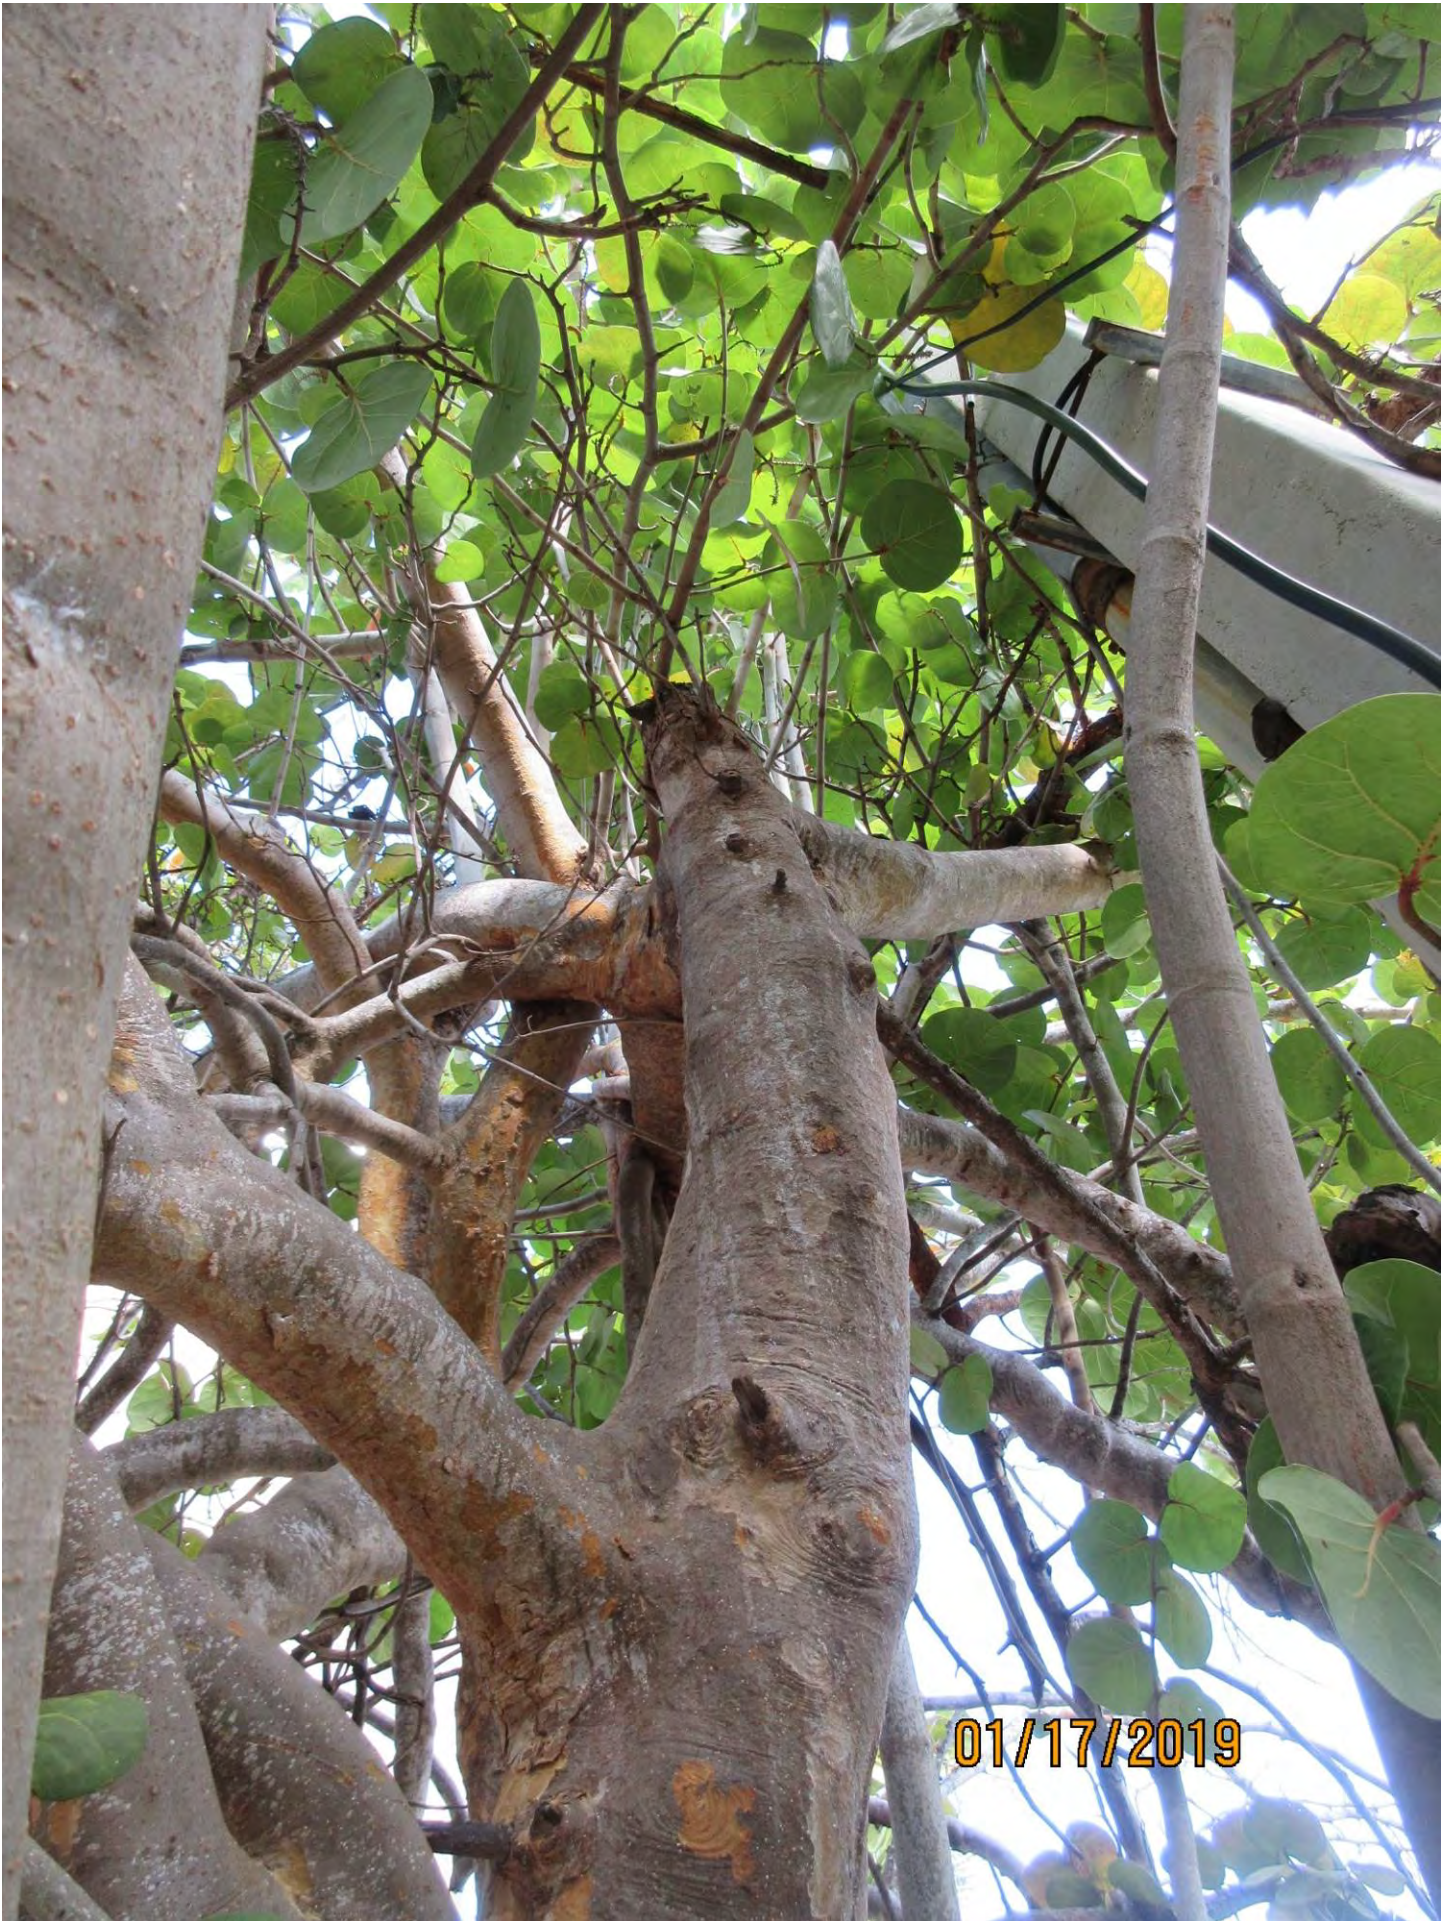
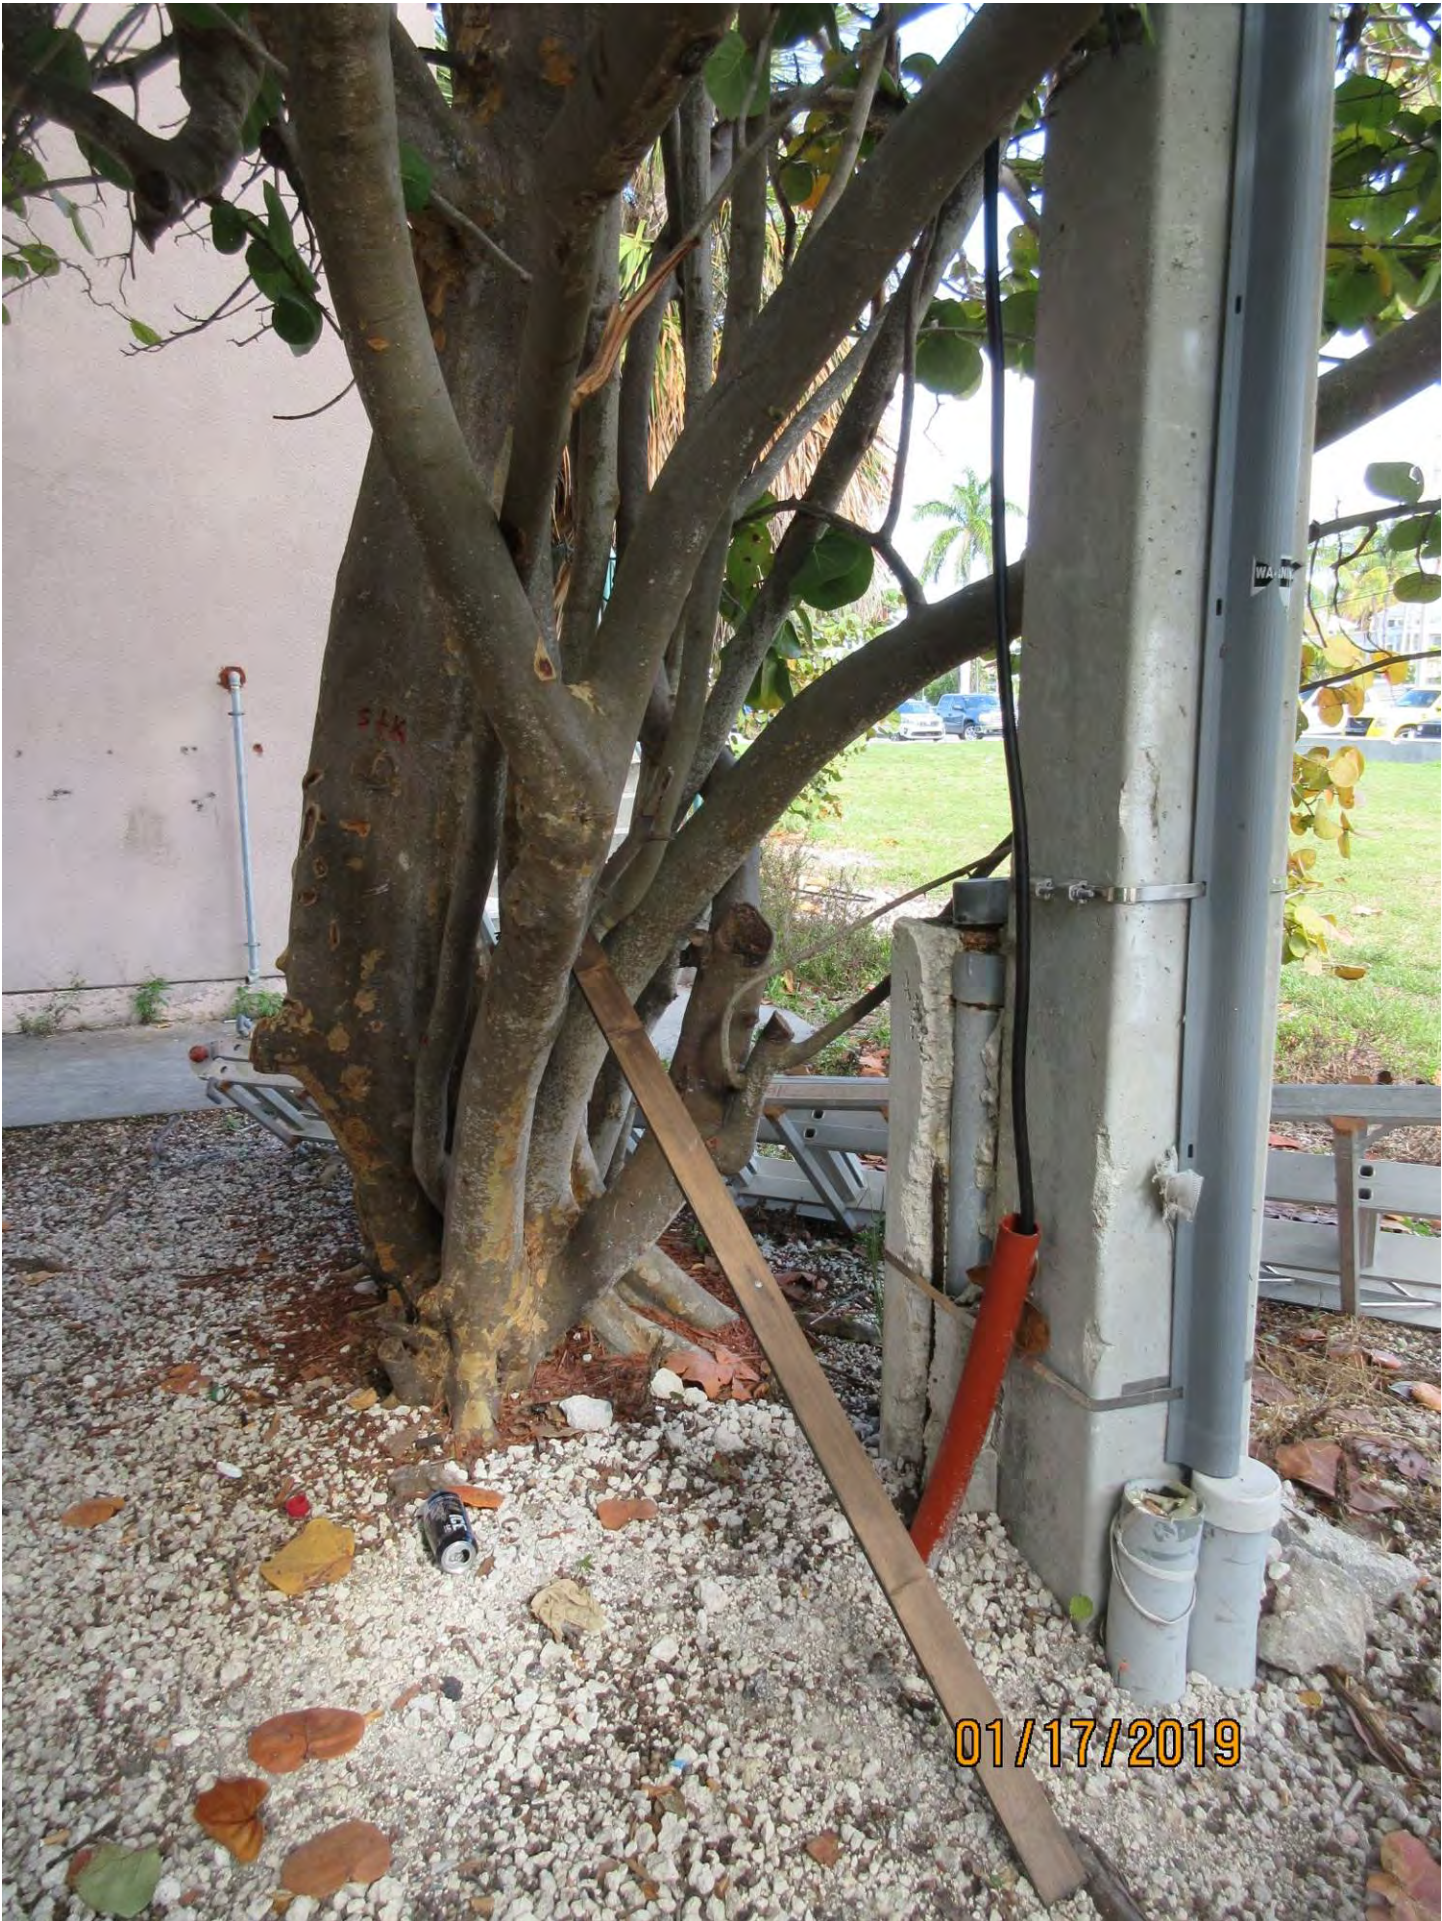
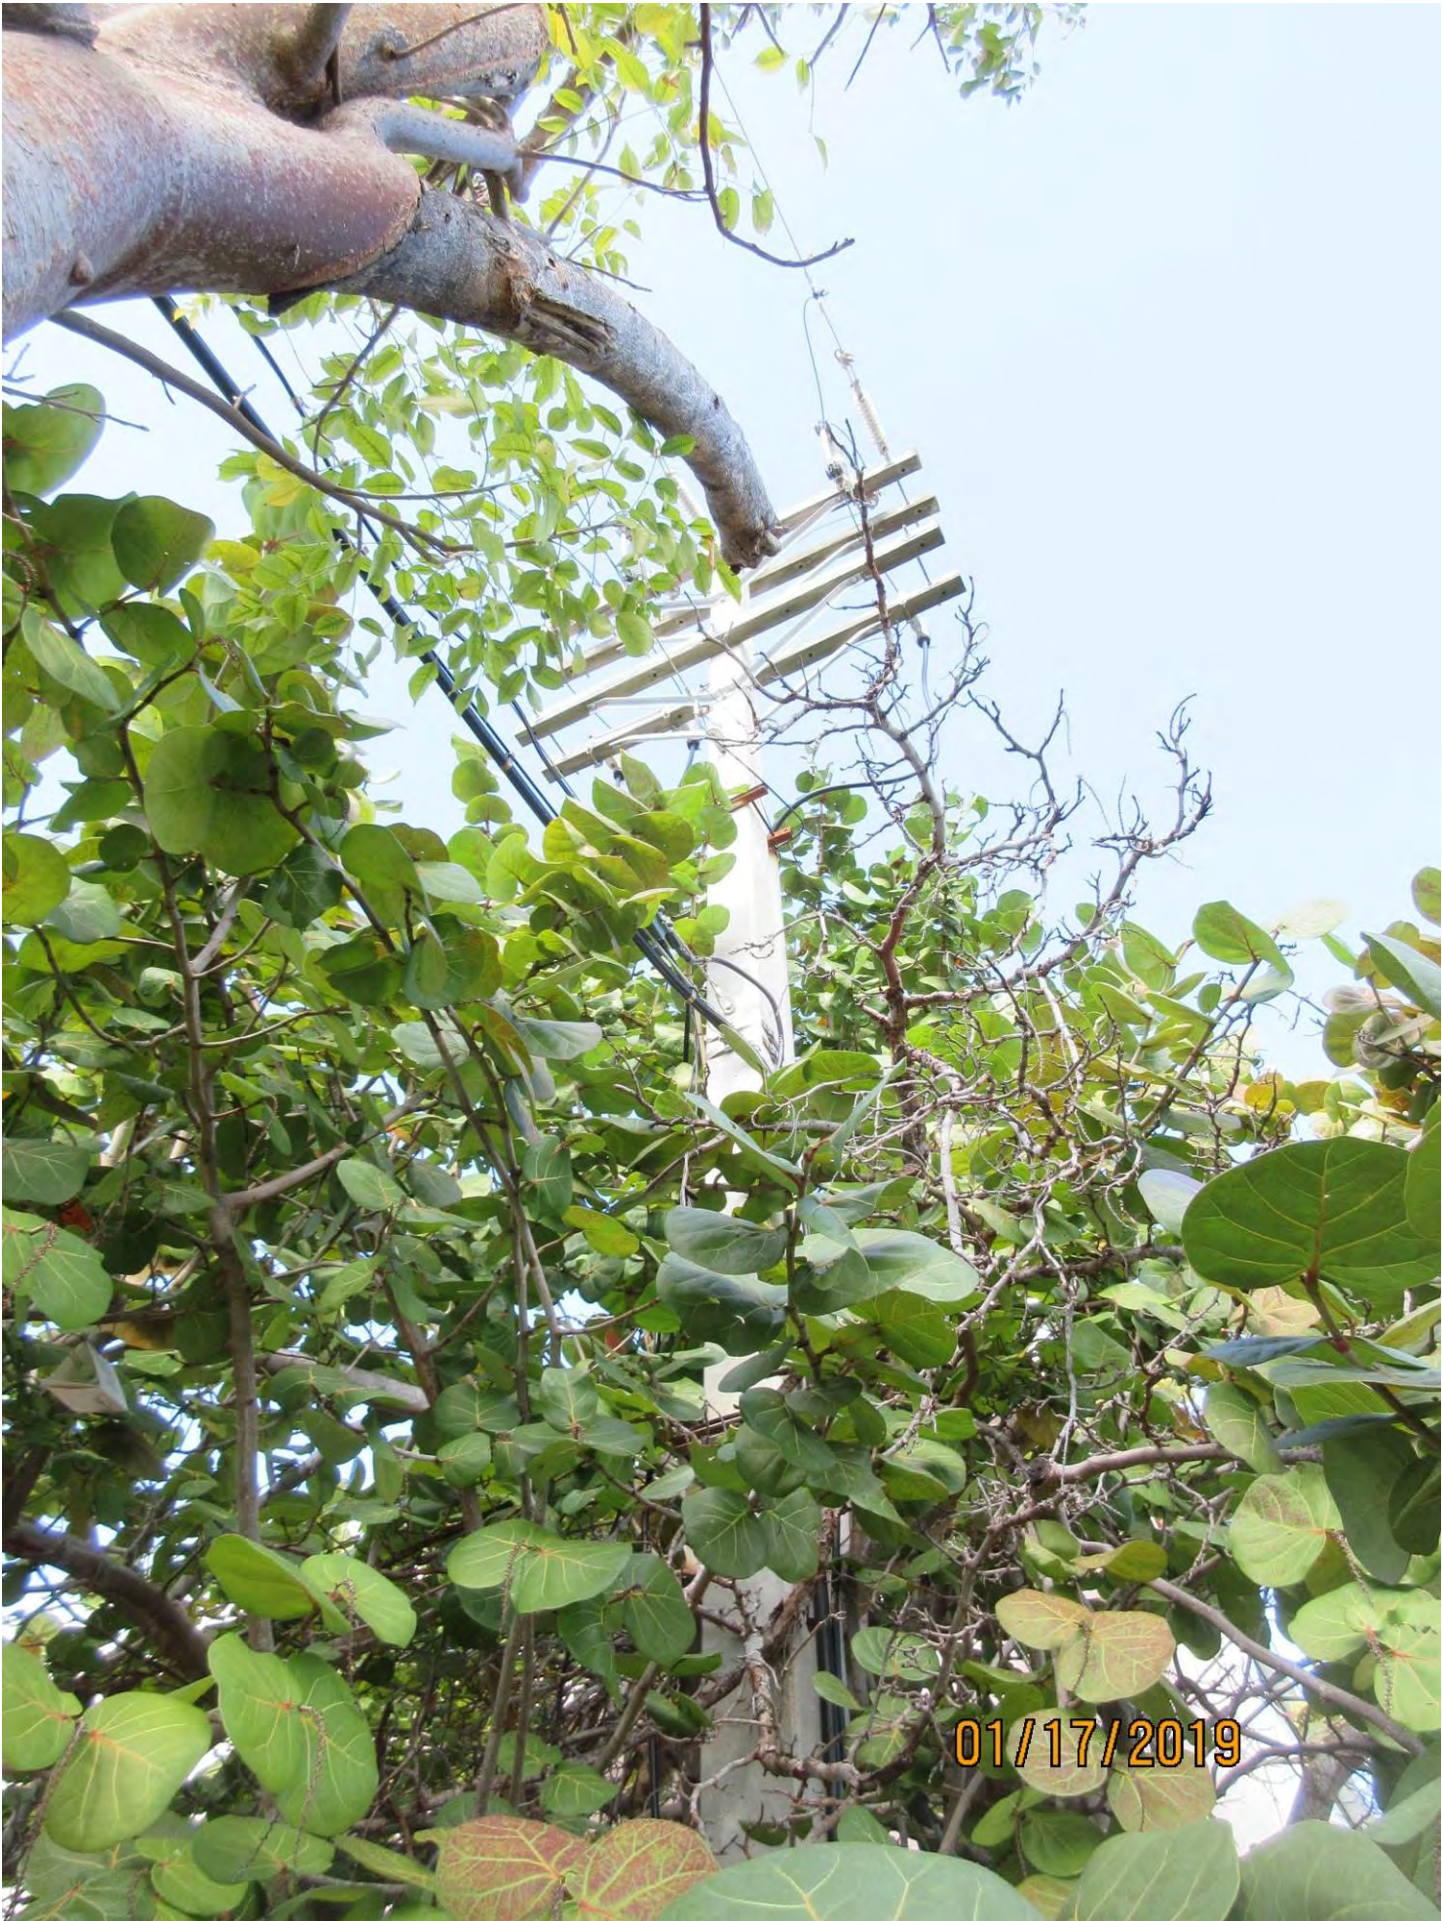
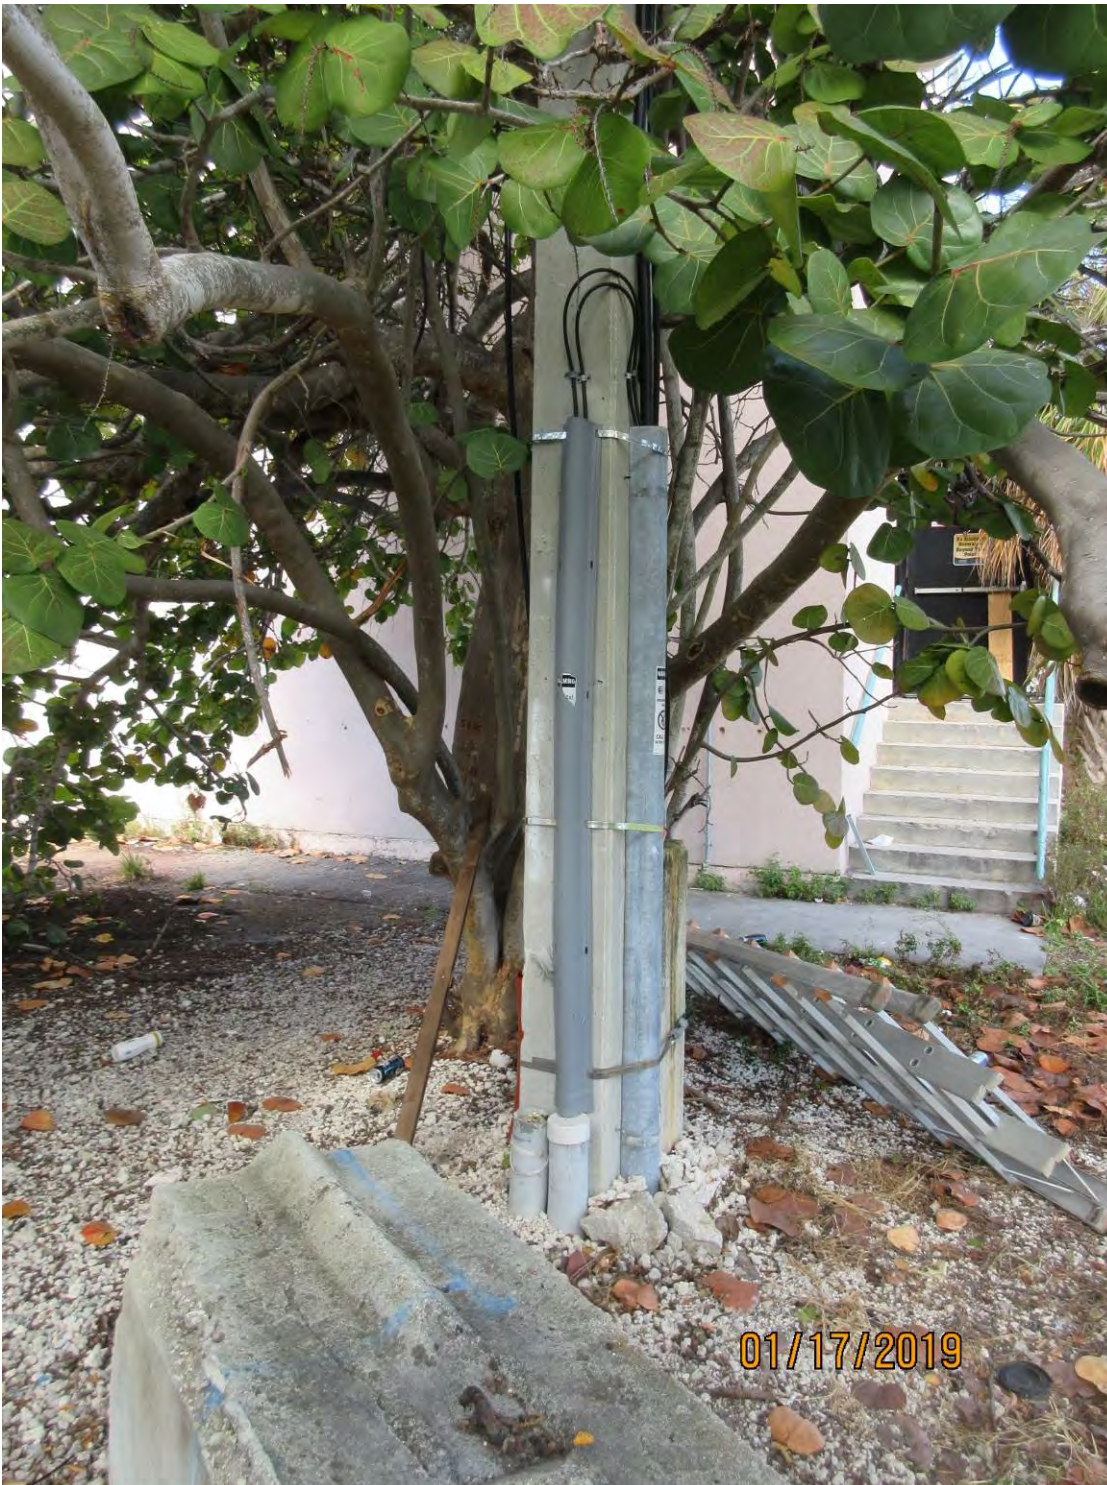
Tree# 7:

Diameter: 49" (multi trunked)

Location: 40% (planted under utility lines, impacting utility pole)

Condition: 40% (poor canopy structure-lots of cross branches, decay in branches)

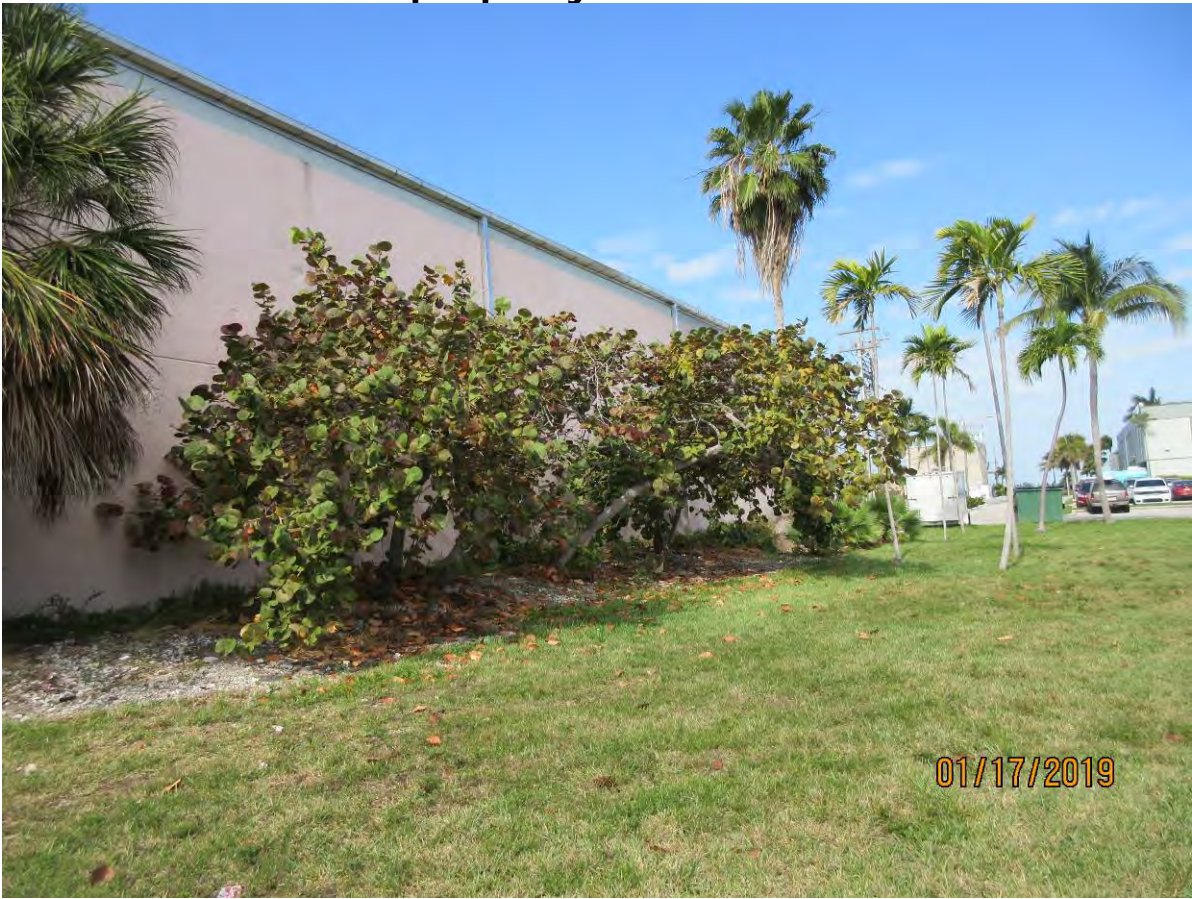
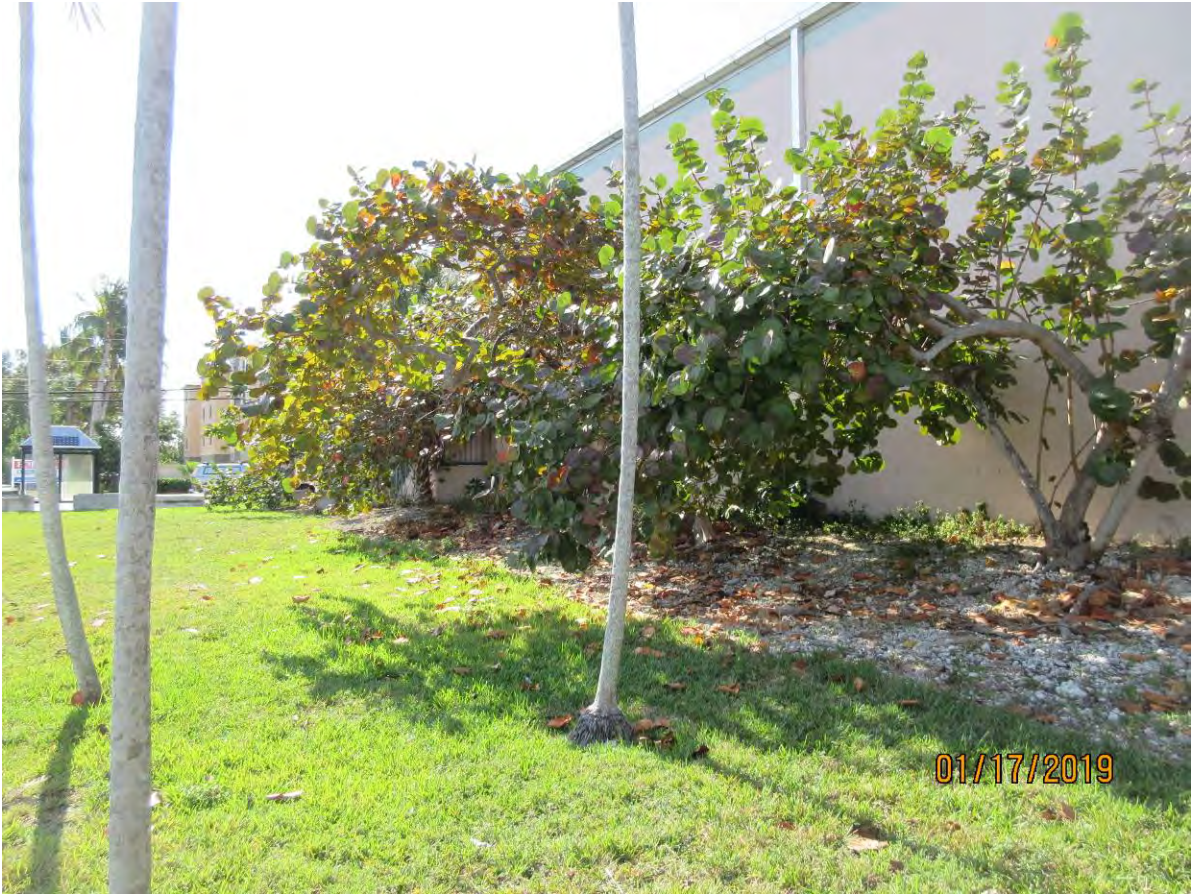
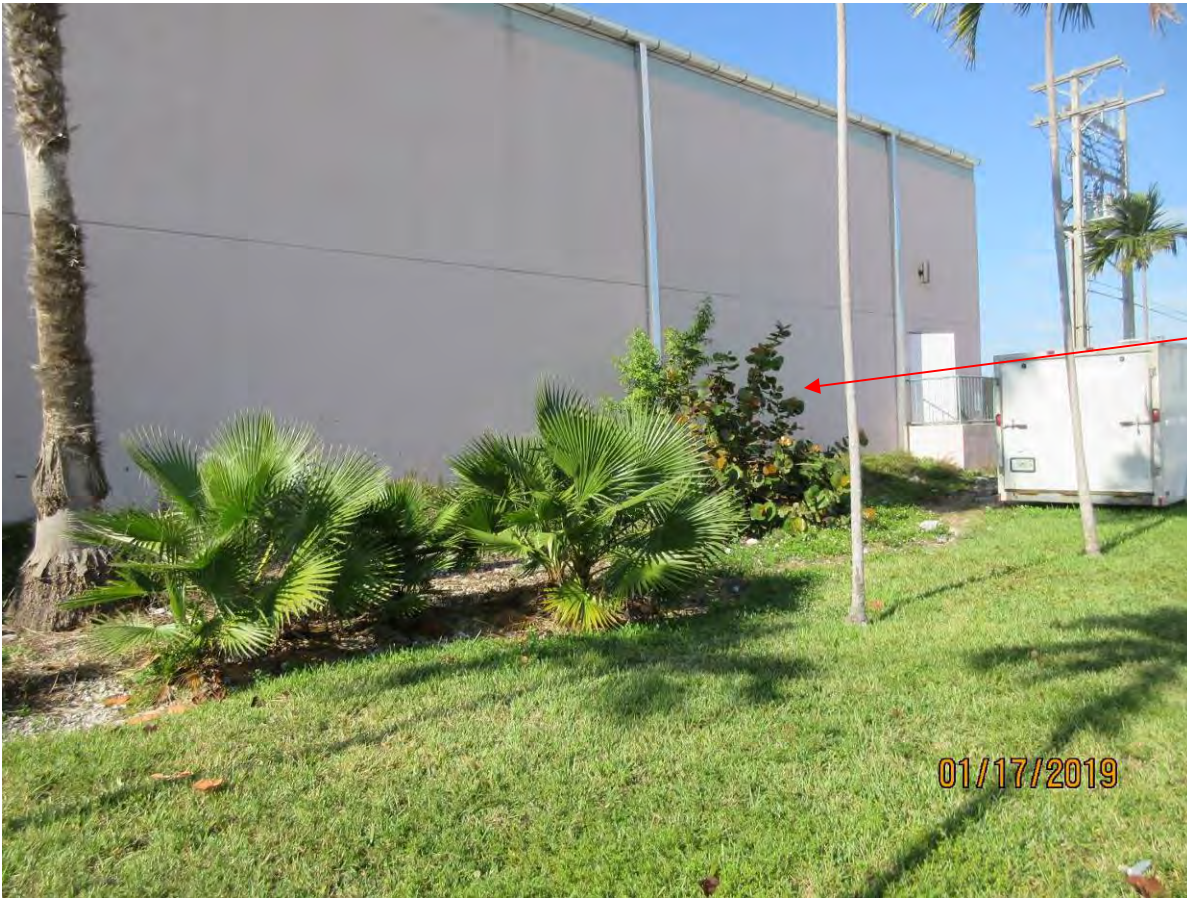
Photos of other trees on property:

Along side of theater, new emergency exit doors and walkways being installed. This work will impact Sea Grape #9 and Sea Grape shrub #13 (both to be removed). Recommend remaining trees on the property be properly trimmed by a certified arborist to correct storm damage and lack of maintenance.
