# STAFF REPORT

RE: **3338 N. Roosevelt Blvd (permit application # T2019-0017)**

FROM: Karen DeMaria, City of Key West Urban Forestry Manager

An application was received requesting the removal of **(2) Gumbo Limbos (tree# 5 & 6)** and **(2) Sea Grape trees (tree# 7 & 9)** that are being impacted by the redevelopment of the Regal Cinema Movie Theater which was heavily damaged by Hurricane Irma. A site inspection was done and documented the following:

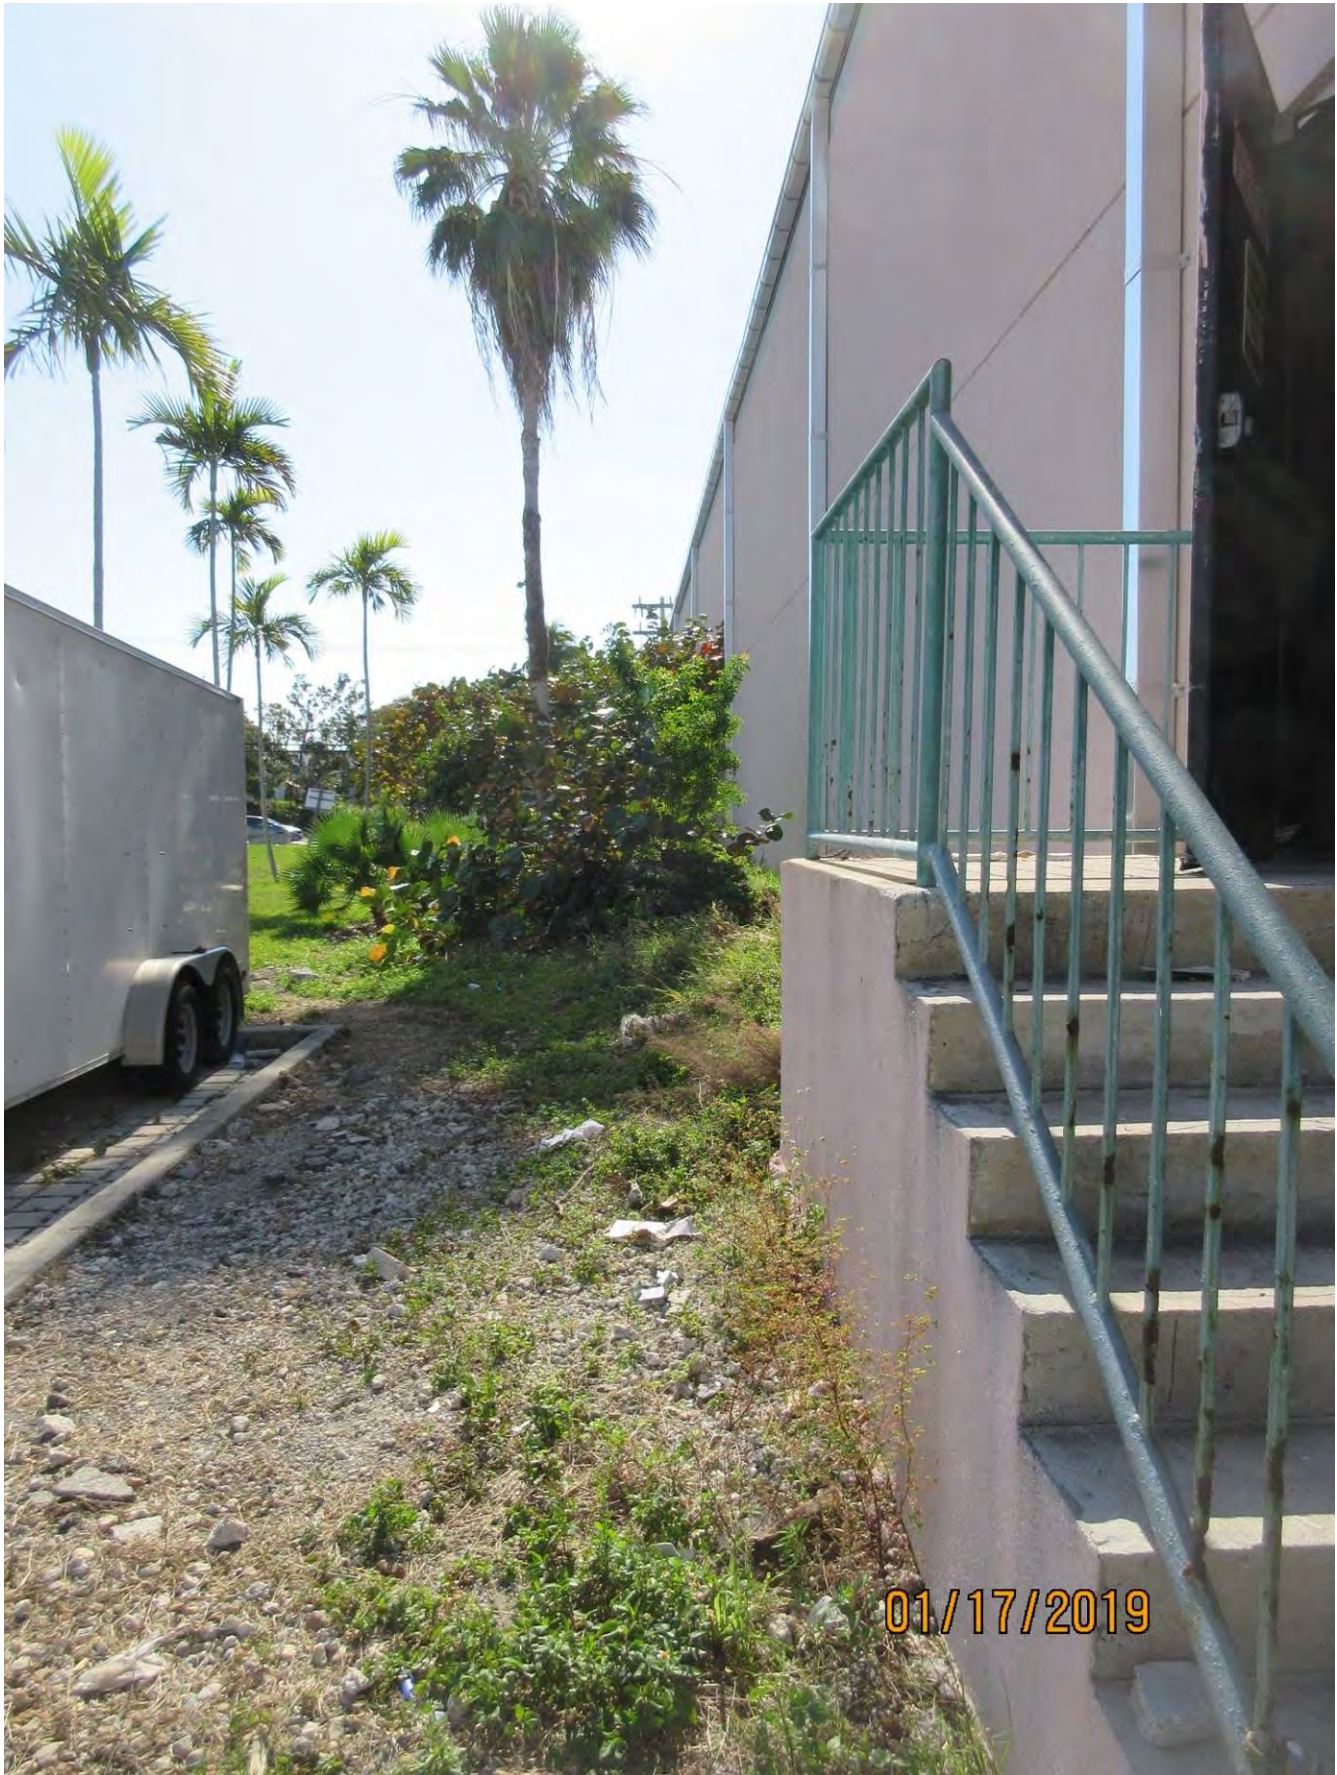
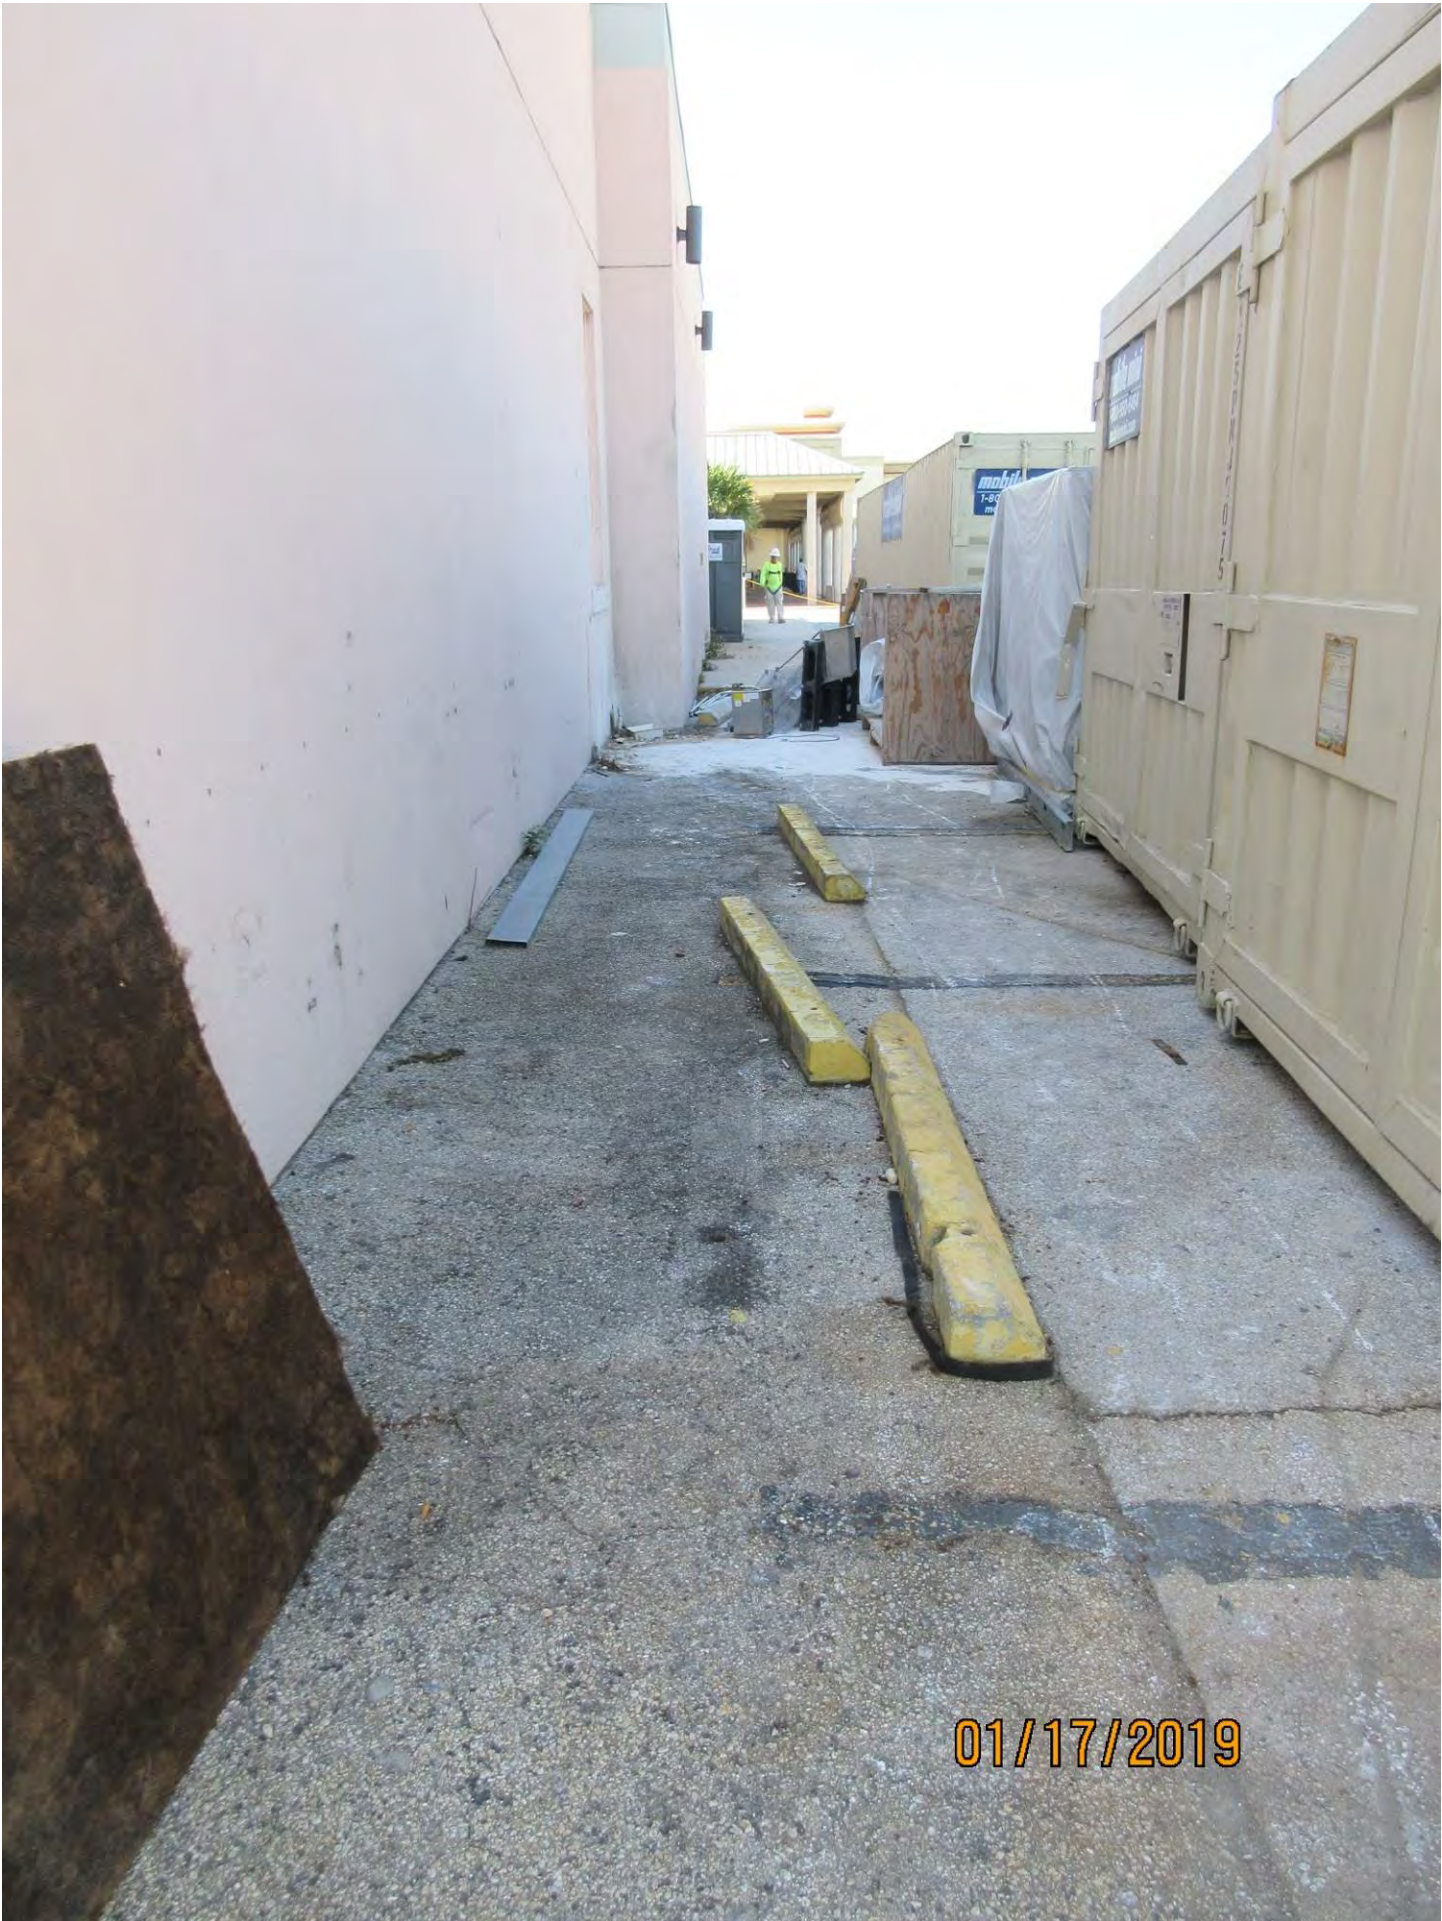
Looking down side property line.
