RESOLUTION NO. 23-314

A RESOLUTION OF THE CITY COMMISSION OF THE CITY OF KEY WEST, FLORIDA, APPROVING AN ENVIRONMENTAL PERMITTING TASK ORDER FOR CHARTER BOAT ROW SEAWALL REPLACEMENT TO TETRA TECH, INC. IN THE AMOUNT OF \$160,952.00, UNDER THE CITY'S ENVIRONMENTAL ENGINEERING SERVICES CONTRACT; AUTHORIZING THE CITY MANAGER TO EXECUTE NECESSARY DOCUMENTS UPON CONSENT OF THE CITY ATTORNEY; PROVIDING FOR AN EFFECTIVE DATE

Tetra Tech is pleased to submit this revised seawall assessment summary report for your review. The report discusses the condition of the City Marina at Garrison Bight (Charter Boat Row) seawall along the Southeast side of the Palm Avenue Causeway and provides our recommendations.

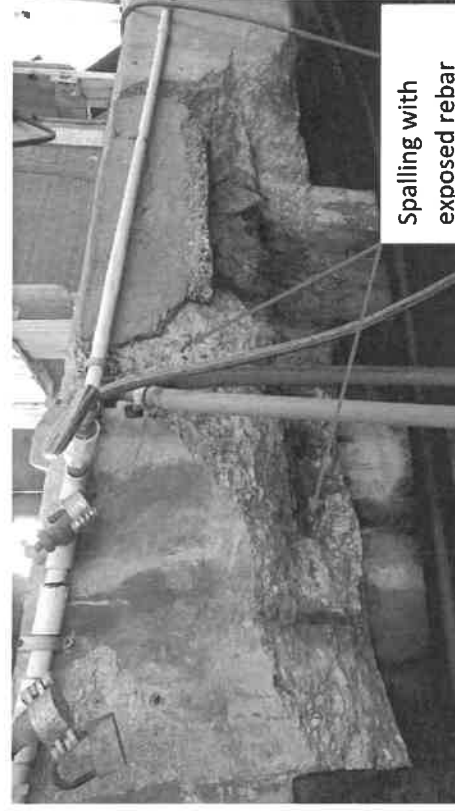
Deficiency A-4: Pile 7 (Station 0+39)

| Figure 10: Critical Deficiencies – [Top] A-4 (Station 0+39), [Bottom] B-45 (Station 4+44) ..... | 21 |

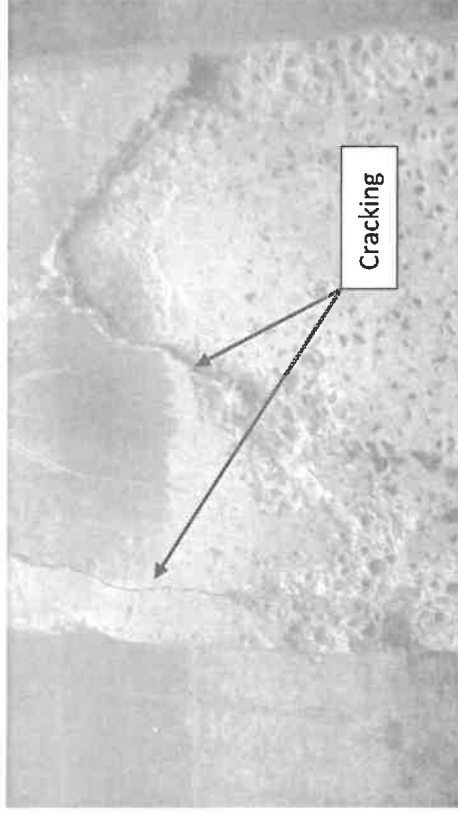
Deficiency A-6: Pile 11 (Station 0+66)

| Figure 9: Typical Major Deficiencies – [Top Left] A-6 (Station 0+66), [Top Right] A-15 (Station 1+67),<br>[Bottom Left] B-35 (Station 3+78), [Bottom Right] B-77 (Station 8+42 - 8+75) ..... | 20 |

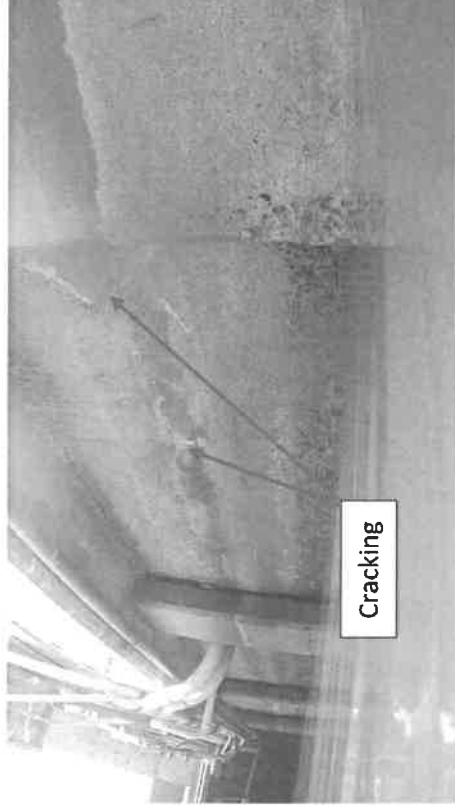
Deficiency B-26: Panel 40-41 (Station 2+86)

| Figure 8: Typical Moderate Deficiencies – [Top Left] B-70 (Station 7+86), [Top Right] B-53 (Station 5+48),<br>[Bottom Left] B-26 (Station 2+86), [Bottom Right] B-102 (Station 10+06) ..... | 19 |

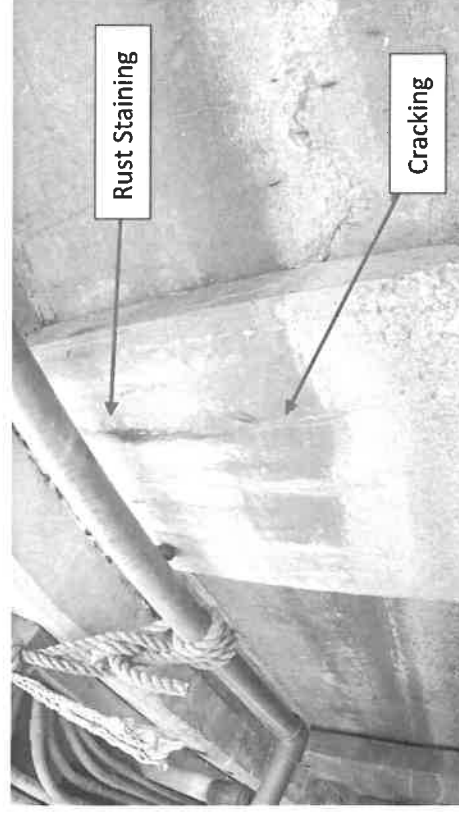
Deficiency B-30: Pile 43 (Station 3+04)

| Figure 7: Typical Minor Deficiencies – [Top Left] A-1 (Station 0+14), [Top Right] B-30 (Station 3+04),<br>[Bottom Left] B-34 (Station 3+62), [Bottom Right] B-59 (Station 6+82) ..... | 18 |

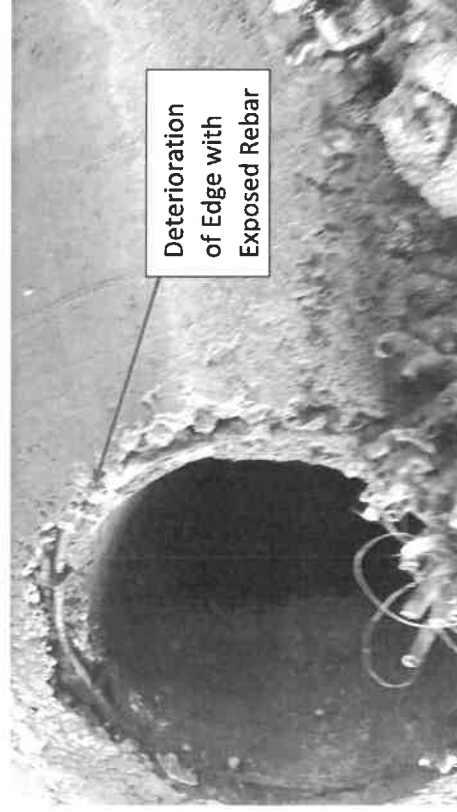
Deficiency B-88: Culvert Panel 128-129 (Station 9+43)

Deterioration  
of Edge with  
Exposed Rebar
