TREE COMMISSION TREE REMOVAL REPORT
CITY of KEY WEST

PROPERTY: 714 Southard St.

APPLICATION NUMBER: T2025-0167

REQUEST: Property owner is seeking removal of (1) Spanish Lime Tree

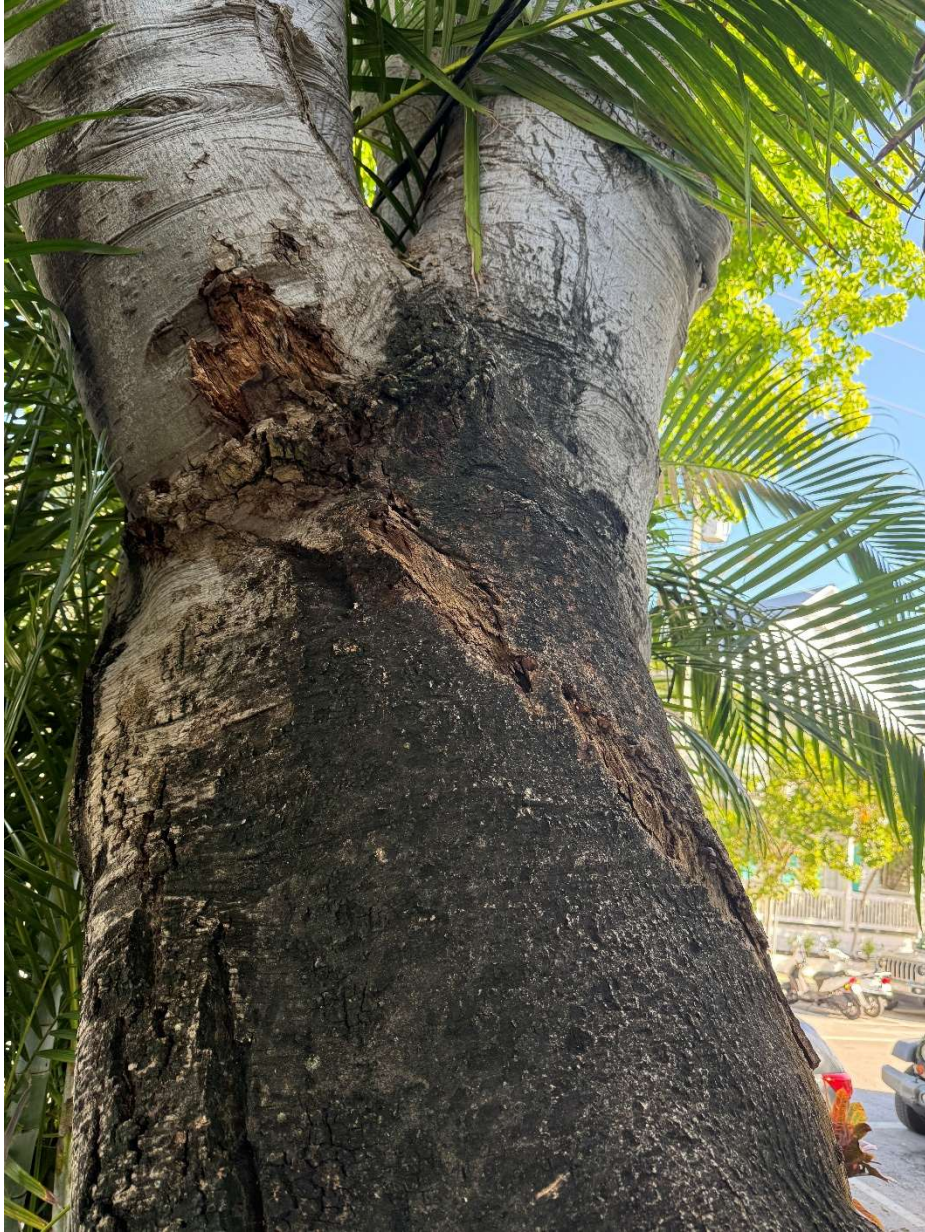
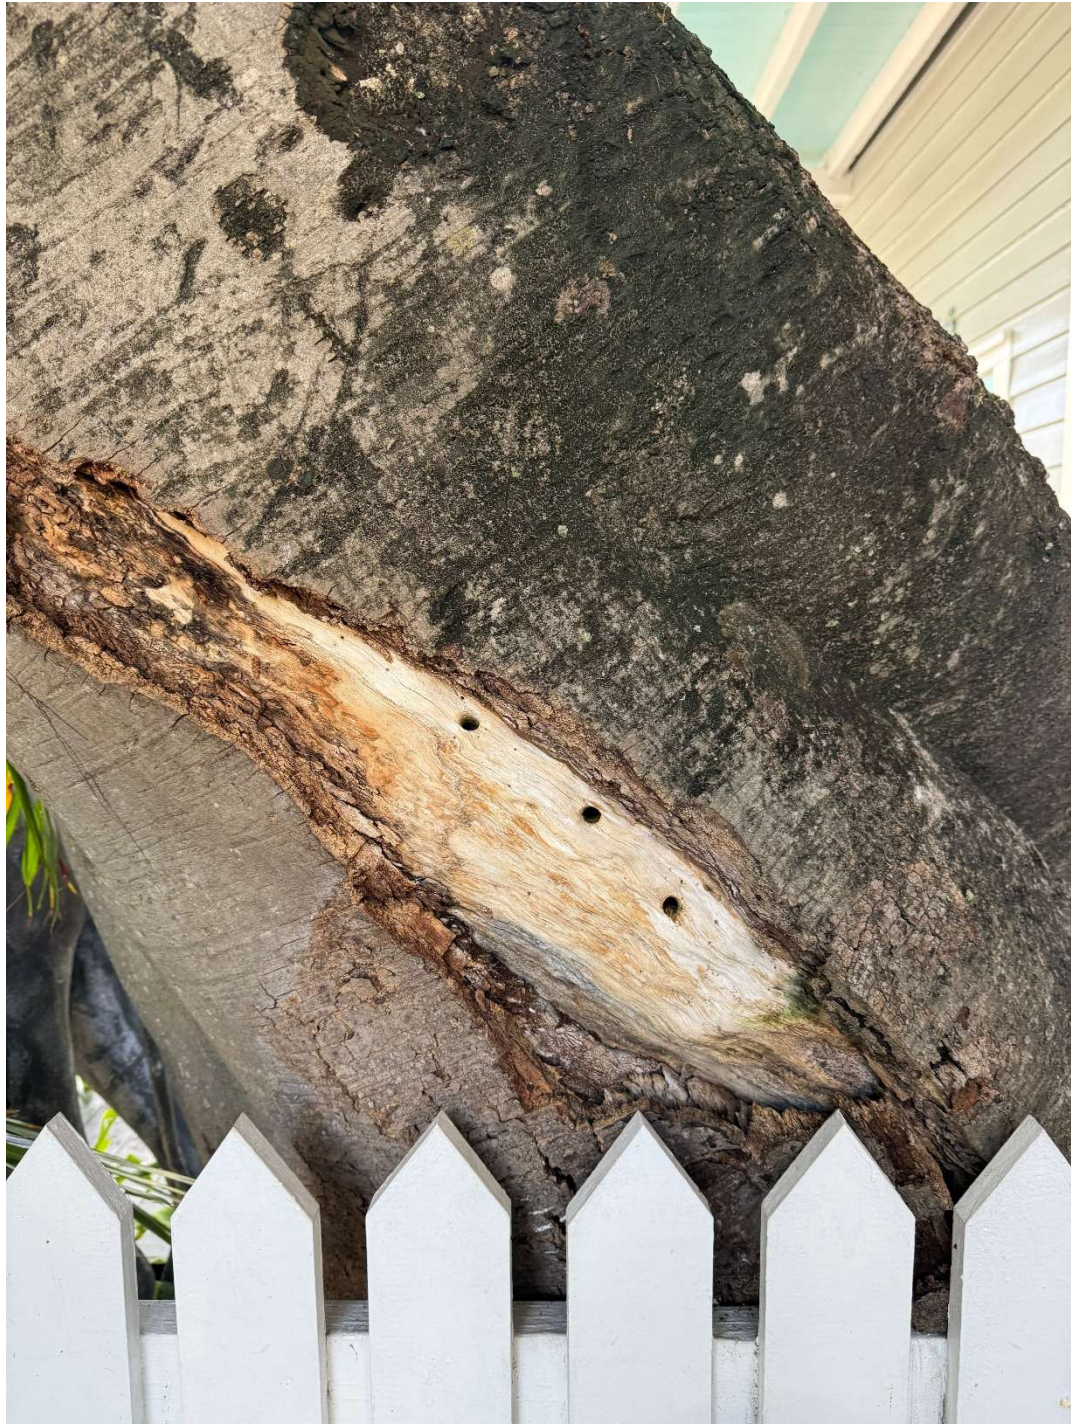
This fungi was pointed out to me by Sean Creedon. He believes it is Ganoderma. A genus of wood-decaying fungi known to cause significant tree diseases, particularly root and butt rot. Due to the fact that many species of fungi produce fruiting bodies such as this I have submitted photos to the environmental horticulture extension agent with University of Florida. I will have more info at the time of the Tree Commission Meeting in hopes of providing some degree of validation to this potential concern.

RECOMMENDATION/NOTES : This tree is very old. Likely over 100 years. The canopy is providing shade on a highly traveled road near Duval. The bark is flaking off in multiple places. The exposed wood has no fungal growth except near the base of the tree. I found no evidence of termites. It is uncommon for this species to have termites as the heartwood is very hard.
