Building Inspection Report and Schedule of Repairs

Inspection Report

Property Address:
231 Margaret St.
Key West Fl. 33040

Historic Half Shell Restaurant

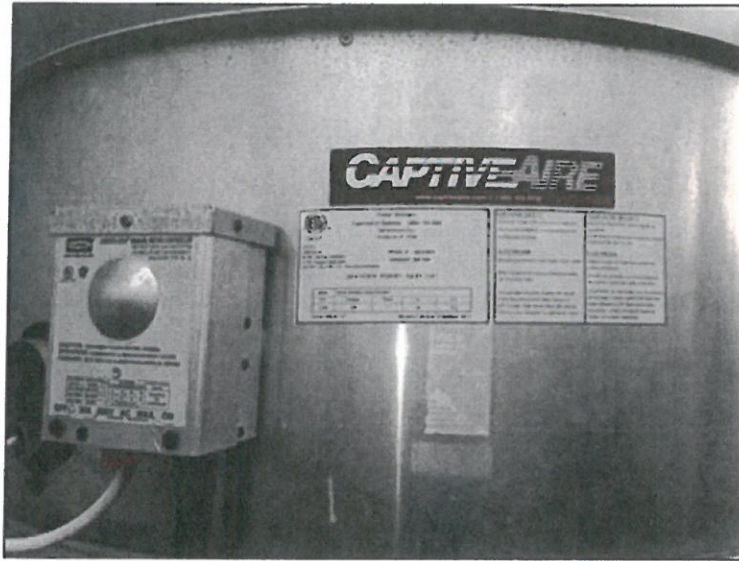
9.4 Picture 1 Distribution Systyem

9.4 The staff maintains the distribution system throughout the building works well and as far as I can tell I agree.
