# EXISTING TREE REPORT and ASSESSMENT

## CITY of KEY WEST

PROPERTY: 1621, 1622, and 1623 Spalding Court

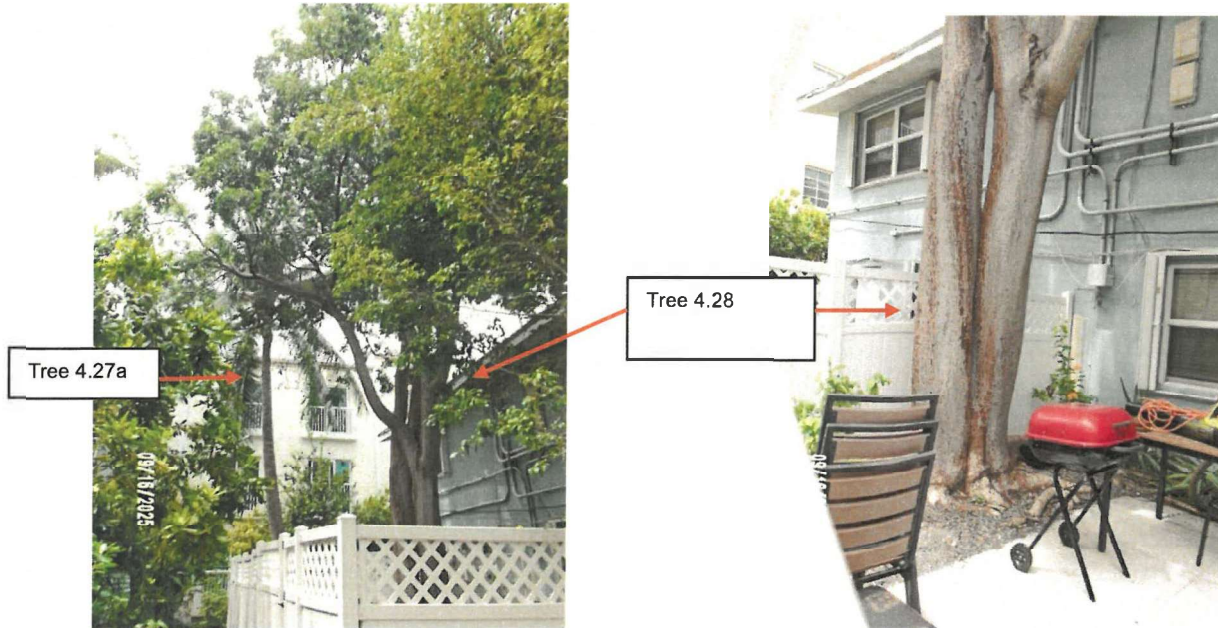
Tree 4.27a: Coconut Palm (*Cocos nucifera*)

Required Mitigation: 1-native palm, 4 ft tall OH minimum

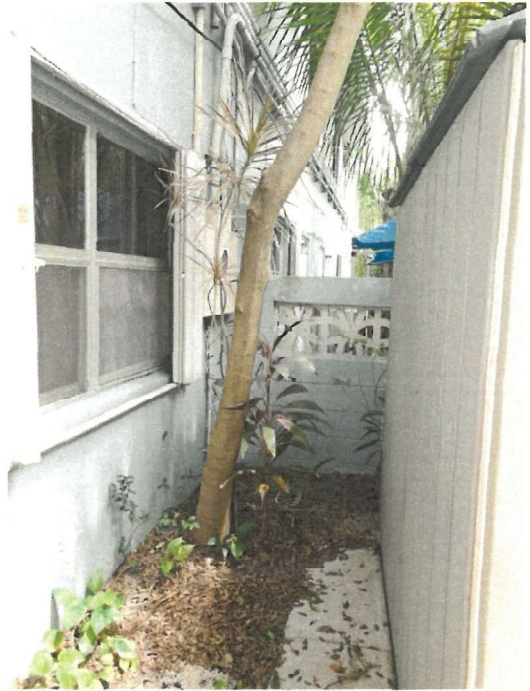
Tree 4.31b: Coconut Palm (*Cocos nucifera*)  
Required Mitigation: 1-native palm, 4 ft tall OH minimum

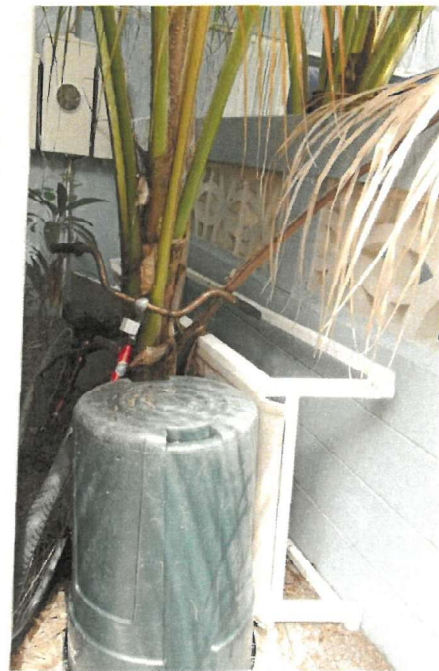
Tree 4.34: Coconut Palm (*Cocos nucifera*)  
Required Mitigation: 1-native palm, 4 ft tall OH minimum

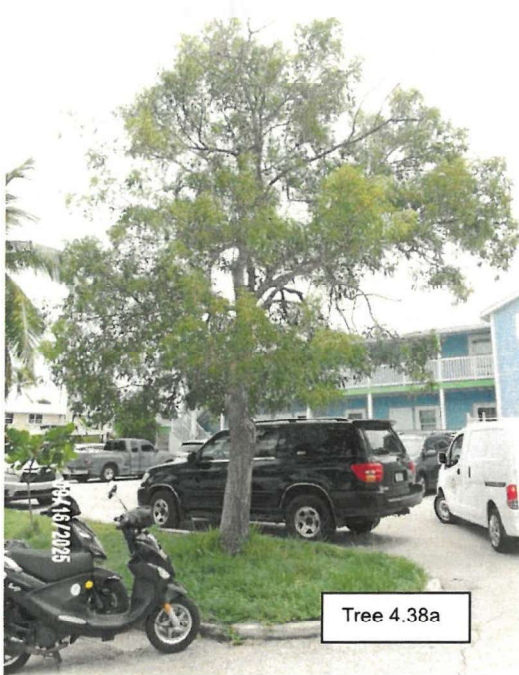
Tree 4.38a: Mahogany (*Swietenia mahagoni*)  
 Diameter: 11.7 dbh  
 Condition: 50% **BM/ZB**(fair, some dieback in canopy)  
 Location: 70% **BM/ZB** (growing in parking lot planter-very visible) Species: 100% (on City of KW protected tree list) Approximated Tree Value: 80%  
 Potential Required Mitigation: 8.6 caliper inches

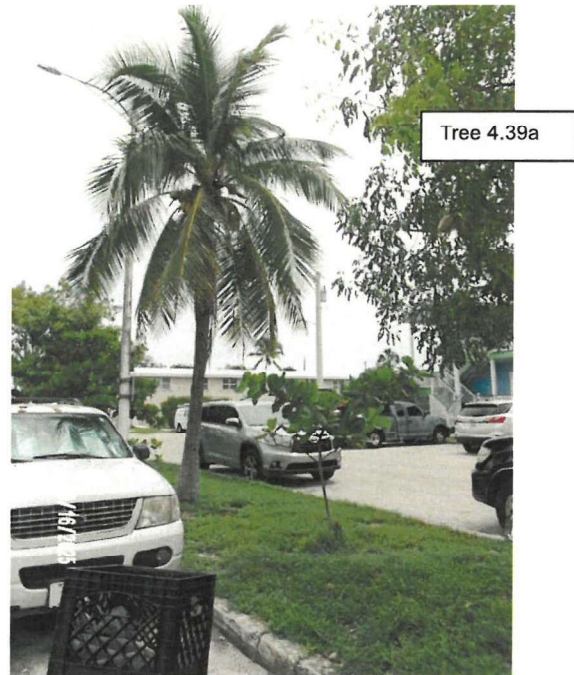
Tree 4.39a: Coconut Palm (*Cocos nucifera*)  
 Required Mitigation: 1-native palm, 4 ft tall OH minimum

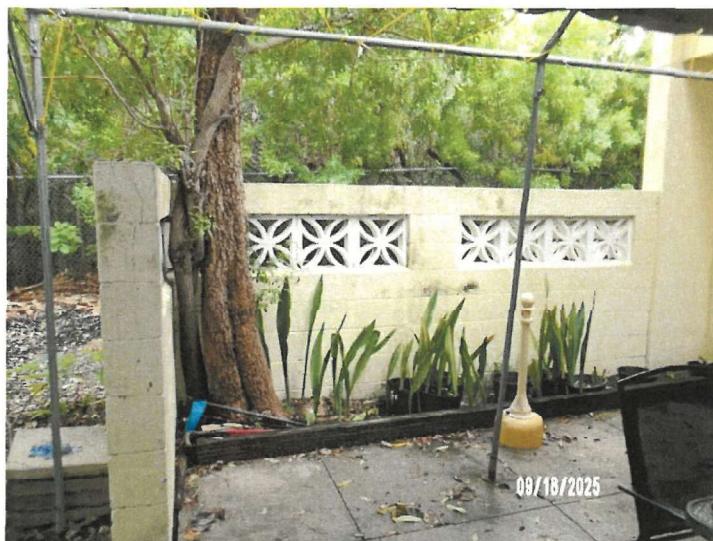
Tree 4.62b and 4.62c

Tree 4.62b: Yellow Tabebuia (*Tabebuia aurea*)

Condition: 50% (poor structure, tall tree with old storm damage in canopy)

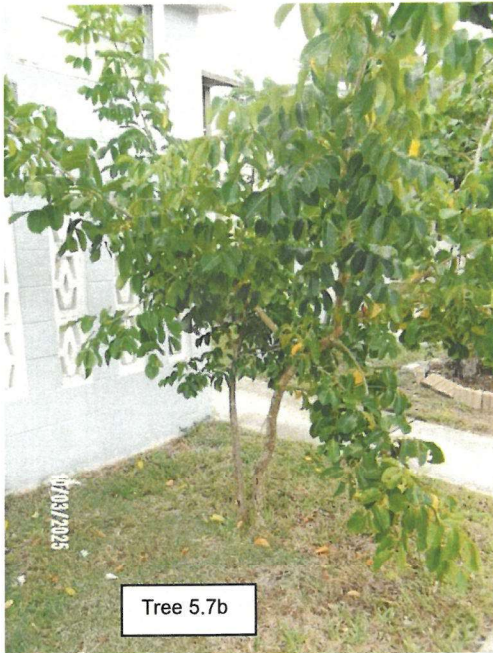
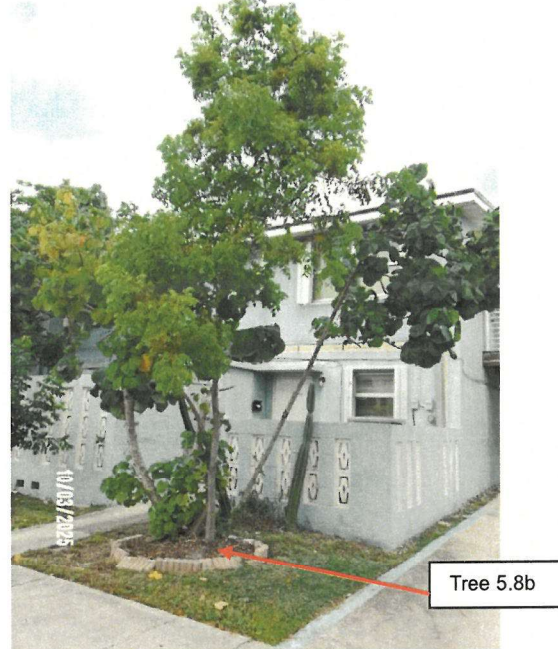
Tree 5.7b: Gumbo Limbo (*Bursera simaruba*)

Diameter: 2.5" dbh total

Condition: 40% (poor structure, two trunks in one rootball, young tree)

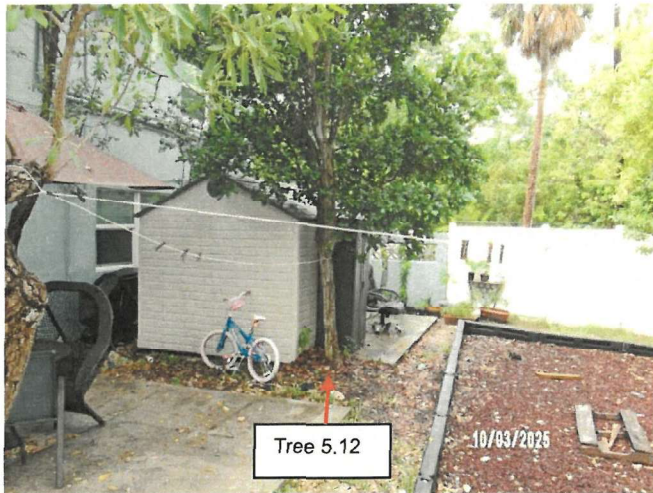
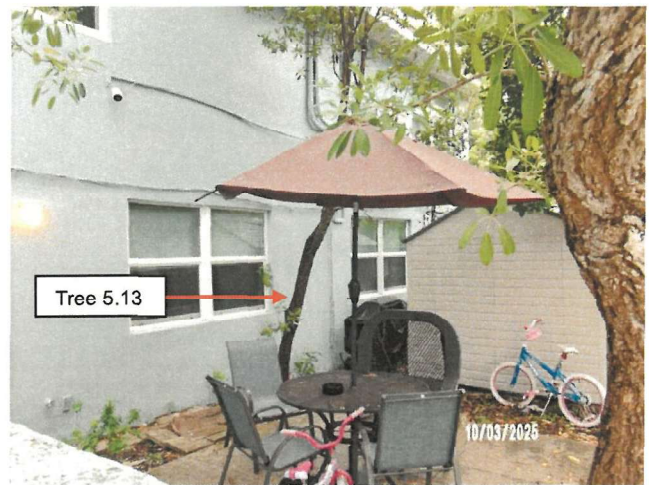
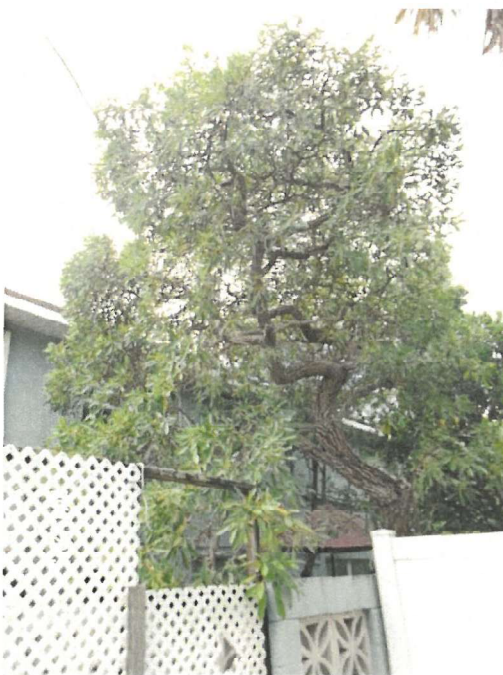
Tree 5.12: Pigeon Plum (*Coccoloba diversifolia*)  
 Diameter: **est 6" dbh (need access to yard and tree for actual measurement)**  
 Condition: 60% (fair)  
 Location: 60% (growing behind main structure)  
 Species: 100% (on City of KW protected tree list)  
 Approximated Tree Value: 73%  
**Potential Required Mitigation: 4.3 caliper inches**
