**RE: Glynn Archer School
Adaptive Reuse Assessment for us as City of Key West Municipal Offices
Executive Summary**

GLYNN ARCHER ASSESSMENT

BACKGROUND

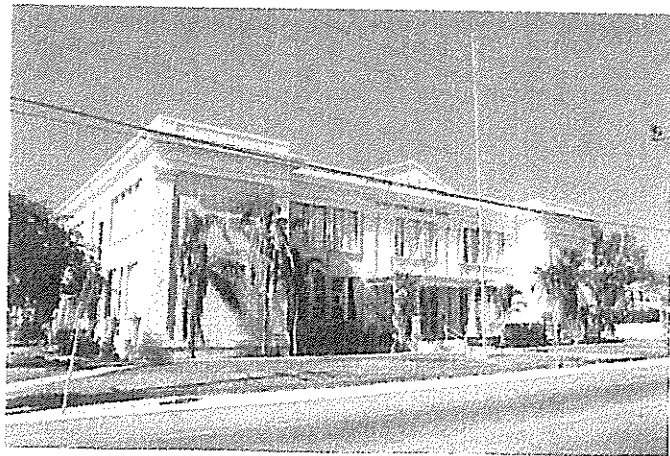
Building A, as seen from White Street.

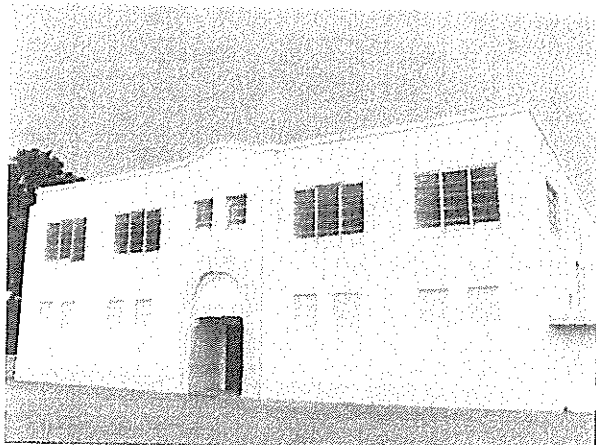
Exterior view of Gymnasium (Building D)

The spalling at the Gymnasium should be repaired. The reinforced concrete columns which make up the wall structure at the gym are accessible from the inside, and should be inspected and repaired. The steel columns and trusses at the Gym should be sandblasted, and the steel should be primed with an inorganic zinc primer, and repainted.

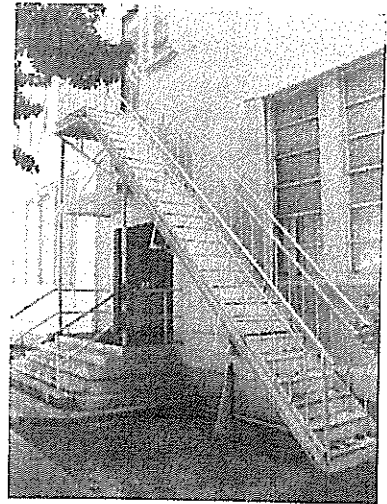
Emergency exits are located at the north and south sides of Building A and Building B.

There are also two emergency exits at the second floor of Building A. Located at the north and south ends of the main hallway, these exits open onto a metal stair leading to grade. Both of these stairs are in a deteriorated condition.

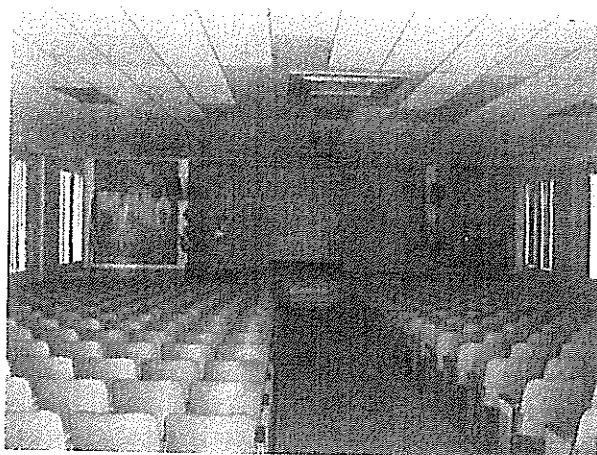
View of interior of Auditorium, showing vinyl tile flooring, stucco walls, and lay-in acoustic ceiling tiles. Also visible are the 1930's WPA murals painted at both sides of the stage.

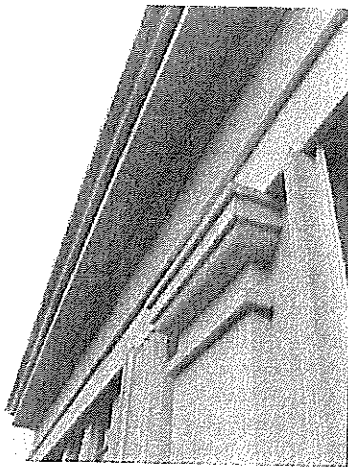
Close up of exterior of Building A, showing the columns and cornice line at the top of the wall. Elements such as this are rare in today's buildings, as they are expensive to build.

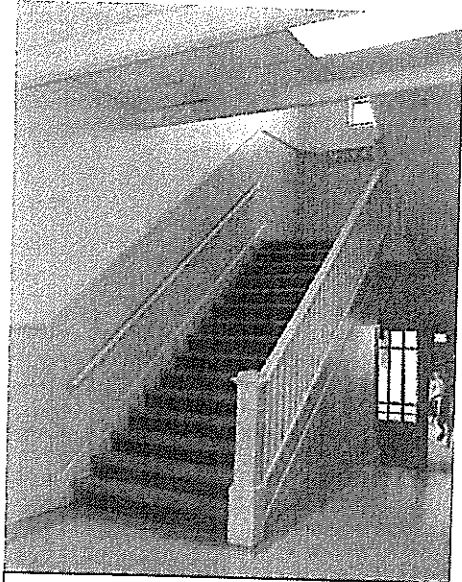
Main stairway at Building A. The stairs have decorated newel posts and wood guardrails, and are important character-defining elements of the building. There are two of these stairways in Building A, and two in Building B.

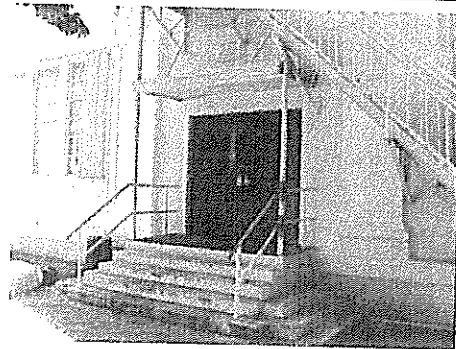
First floor emergency exit stairway at Building A. There are two of these stairways at Building A, and two at Building B.

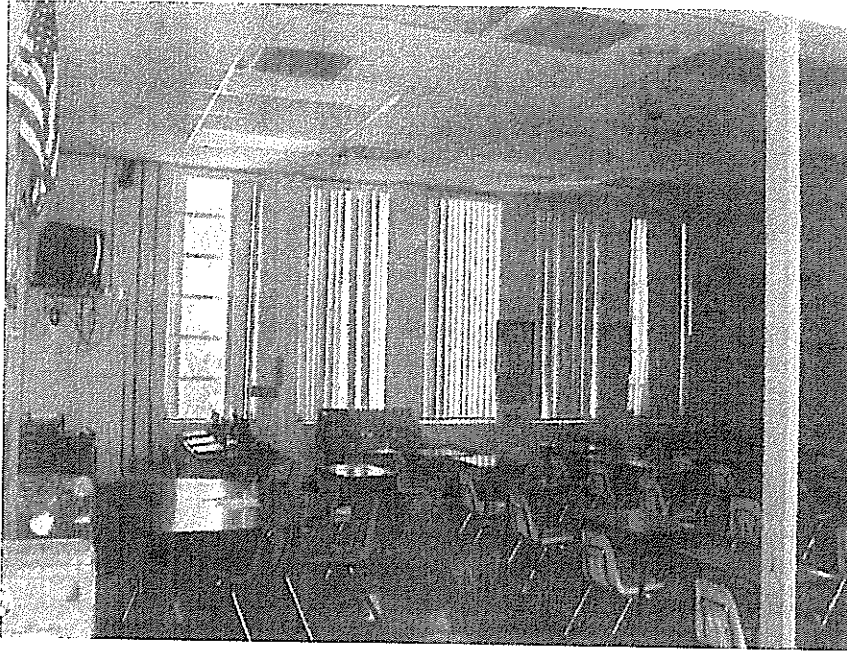
Typical view of a classroom in Building A. The classrooms are large enough to contain entire departments for the City. The high ceilings will be made even higher with the removal of the existing lay-in ceilings. The rooms can be configured with open office plans with moveable partitions.

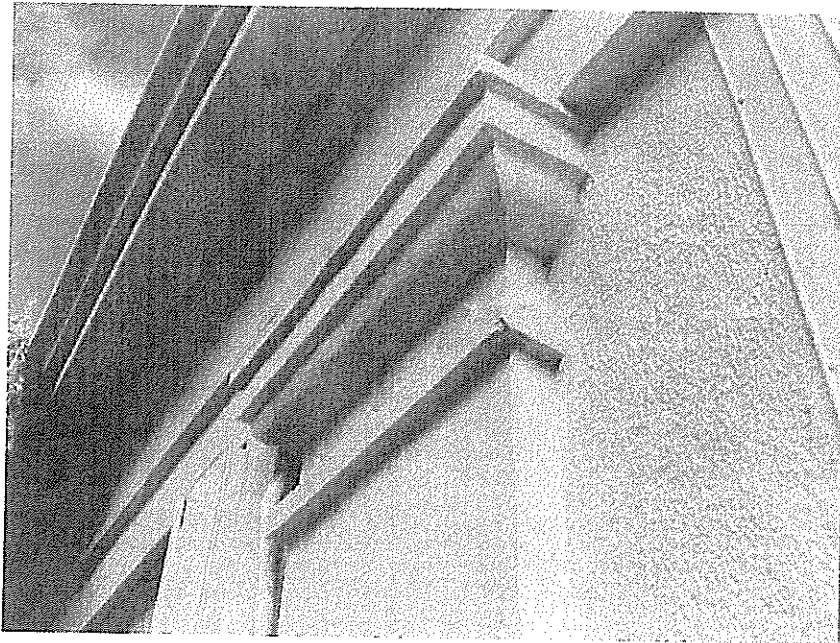
The exterior of the building contains many rich architectural details. This photo shows the top of a concrete column on the front façade, and part of the large cornice at the top of the façade.

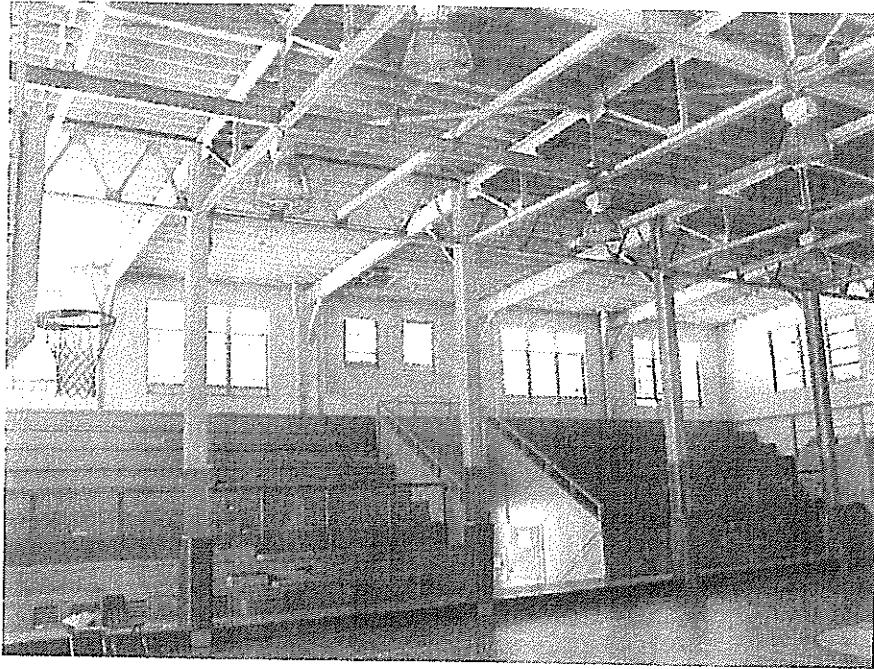
The interior of the Gymnasium building. The ceilings in this building are tall enough to construct an entire second floor mezzanine, effectively doubling the amount of square footage for little cost.
