REPORT AND
RECOMMENDATIONS

**ARCHITECTURAL CONDITIONS
AT THE CORNISH MEMORIAL
A.M.E. ZION CHURCH**

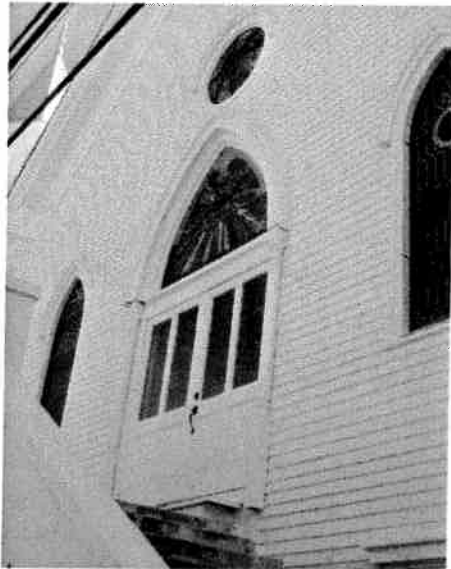
Figure 5 Window Converted Door (Surmised)

A second floor entrance was the purpose of the circa 1899-1912 concrete stair addition. It can be reasonably assumed that the doors were inserted into an opening that was previously the largest stained glass window on the front façade of the church, just above the original street level front doors. The arched transom above the doors, which contains the stained glass “All Seeing Eye” that the church is famous for, was in all likelihood the top part of the original window (Figure5).

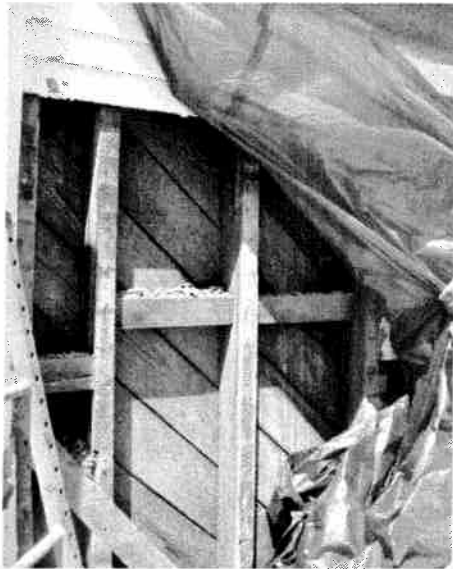
Figure 20 Exterior Wall

Walls are framed with 2"x 6", 3"x 6", and 4"x 6" studs and diagonal bracing (Figure 18), with studs running unbroken from a 6"x 6" continuous sill to a 4"x 6" (est.) top plate. Major studs and diagonal bracing are mortised into the sill and secured with hardwood pegs. Diagonal wood sheathing, 1"x 6" covers the inside face of the studs and 1/2"x 6" wood lap siding covers the stud's exterior face. Sheathing and siding are attached with cut nails. Wall studs and bracing members show little rot and damage (Figure 20). The 1/2"x 6" lap siding shows moderate deterioration through cupping and subsequent cracking.

There is minor evidence of mildew on the interior walls, but the exterior siding, having lost so much of its paint suffers from dry rot, insect damage, and damage from exposure to the elements (Figure 31).

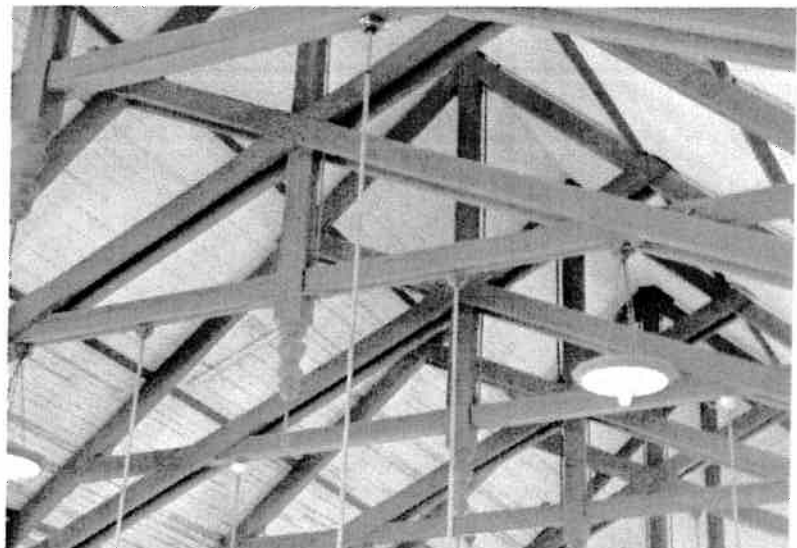
Figure 21 Roof Trusses

The roof structure consists of nine modified wood scissors trusses with collar ties and king posts spaced at 9'-8" and resting upon the top plate of the walls (Figure 19). Upon the trusses and running perpendicular to them to the gable ends of the building are 4"x 4" wood girts spaced at 7'-0". In turn, 2"x 6" rafters rest upon girts approximately 24 inches apart. The rafters are sheathed with 1"x 6" horizontal sheathing on their exterior face and 1x 6 tongue and groove ceiling boards on their inside face. The pitch of the of the roof is 12/12 (Forty-five degrees).

The roof structure appears to be in good condition generally, although the king posts of the trusses evidence stress cracks and the bottom chords of the trusses show slight deflection. (See also Connections and Storm Resistant Provisions, This Section).

4. Strengthen and Repair the Roof Trusses.

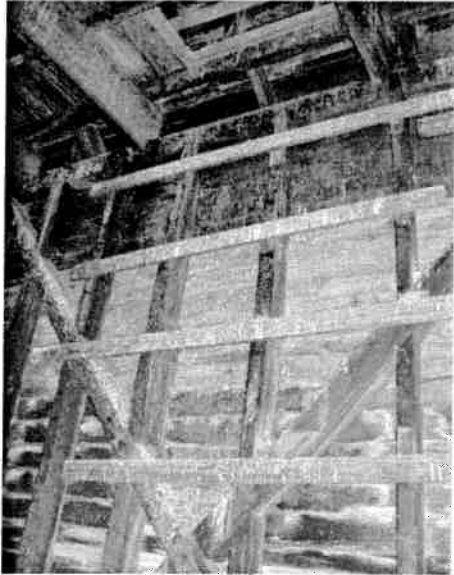
Figure 22 Bell Tower Structure

The bell tower structure is a timber frame with 6"x 6" corner posts, 4'x 6" "X" bracing, and 3"x 6" studs approximately twenty-four inches on center (Figure 22) and lap siding. There is no interior sheathing. The bell tower framing is in good condition. Modern sheet metal hurricane clips of questionable value have been added in various locations.

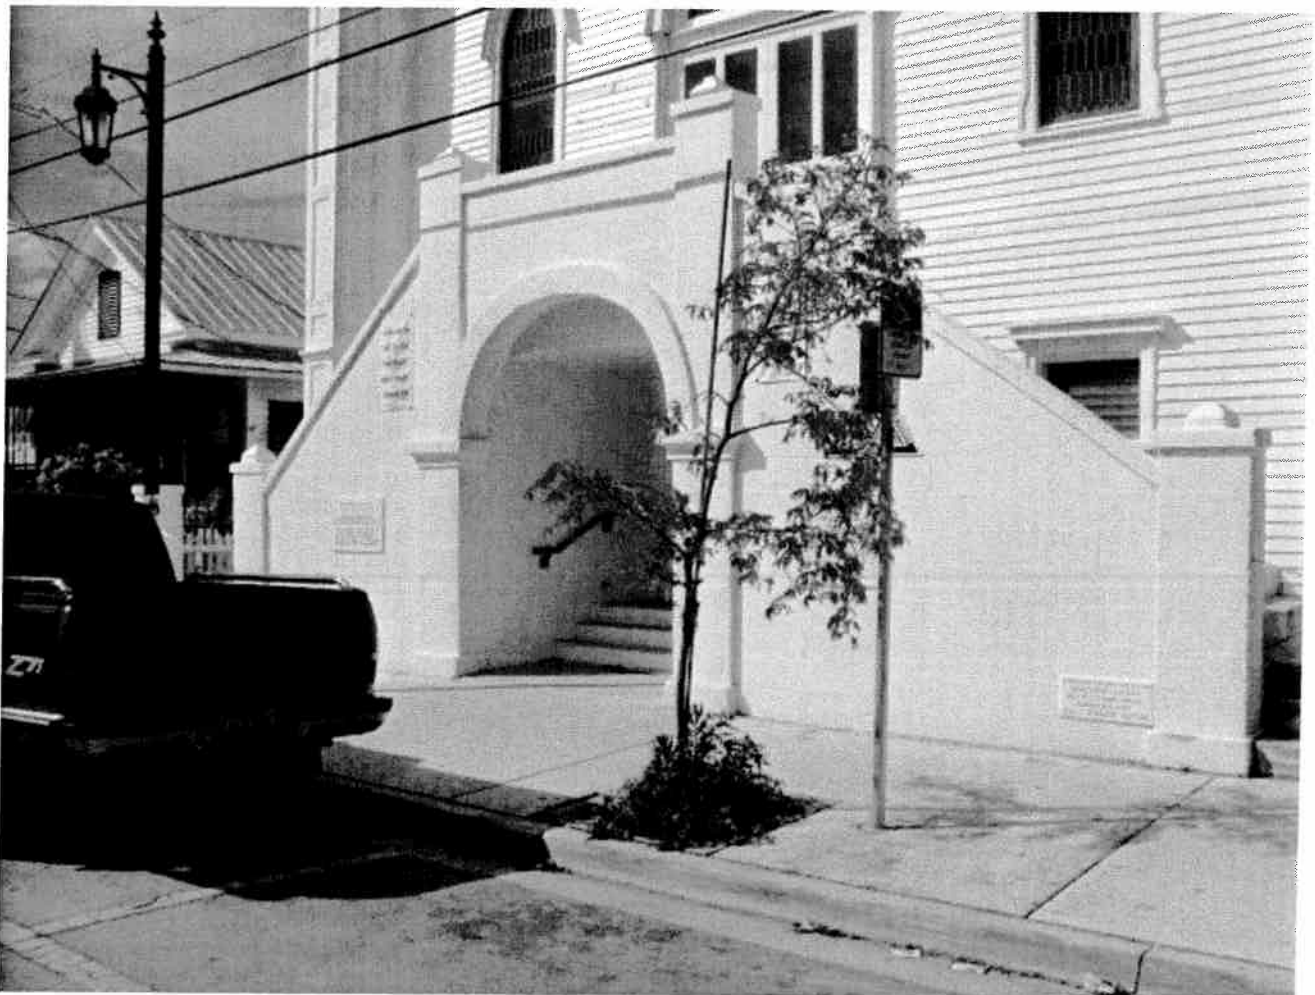
Figure 26 Concrete And Stucco Entrance Stair

The concrete and stucco stair at the East (entrance) side of the church constructed between 1899 and 1912 were likely designed and built to provide a grander entrance to the church (Figure 26), allowing the second floor nave to have an outside entrance directly from the street below. The entire stair structure is constructed of concrete. The type or quantity of reinforcing steel used is unknown at this time, However, the underside of the top landing shows serious

Spalling, a sign of corrosion of steel within concrete. The stairs do not meet the Florida Building Code for tread and riser proportions or handrail provision and can be considered hazardous (Figure 27).

10. Repair/rebuild the concrete stair at the front of the church.

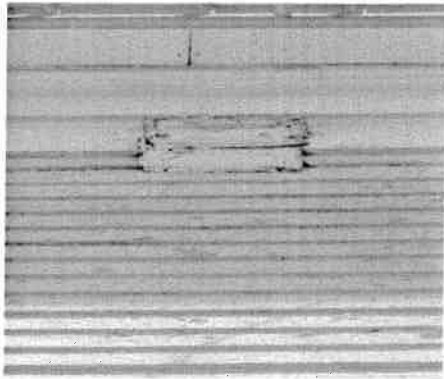
Figure 29 Patch

Unfortunately the rods and ground connections were removed. It is not known when or why. With the exception of one eyebolt—which may or may not have been original--all that remain is one patch on the exterior wall where it is believed a rod emerged from the roof plate (Figure 28).

It is reasonable to believe that the rod and cables were an integral part of the original builder's structural design and that their removal is a cause of the church's lean to the Northwest, as well as the deflection observed in the bottom chords of the roof truss.

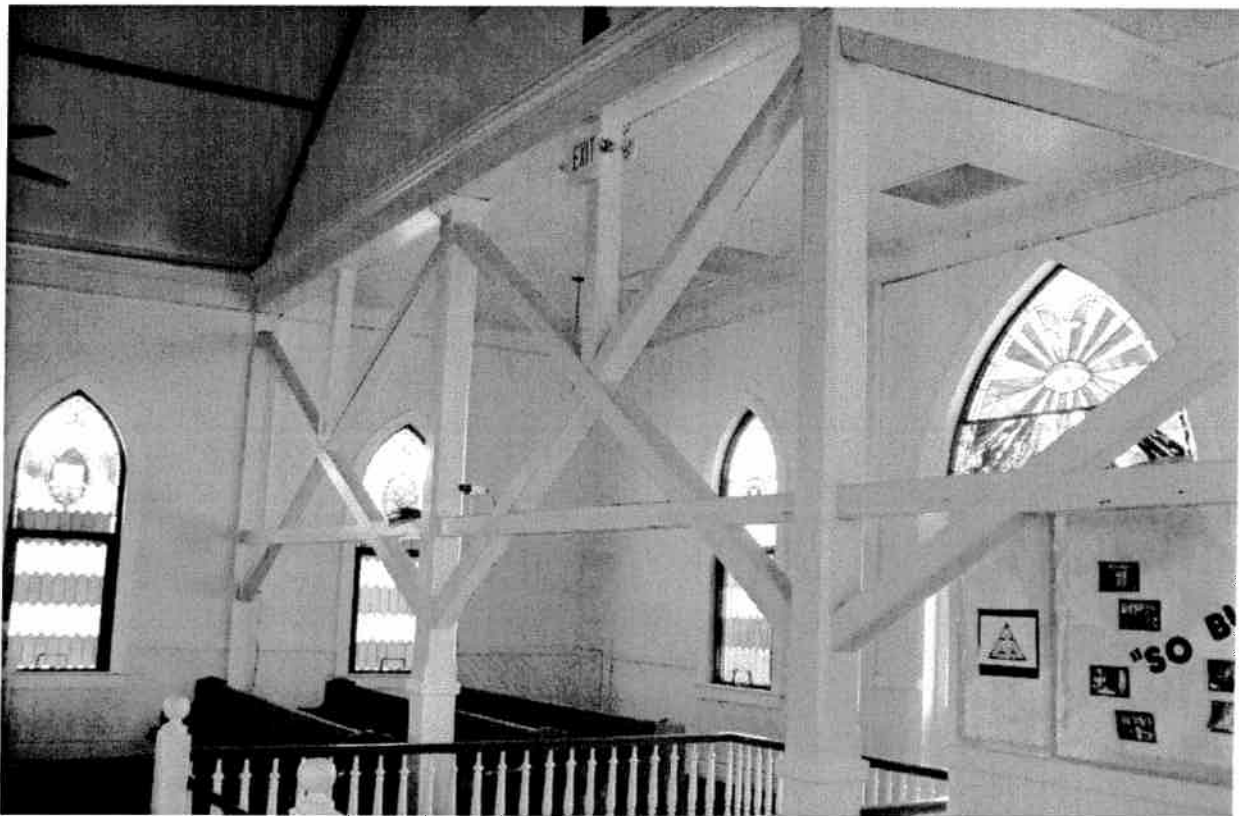
Figure 30 Truss-Like Structure

More recently, a truss-like structure was erected at the first bay of the sanctuary to provide some lateral bracing to the exterior walls (Figure 30). However, this structure does not appear to, in actuality, serve any structural use. It is also architecturally inconsistent with the interior of the church.

11. Remove the truss-like structure at the East end of the nave.

This is an architectural issue. See Finishes Section.

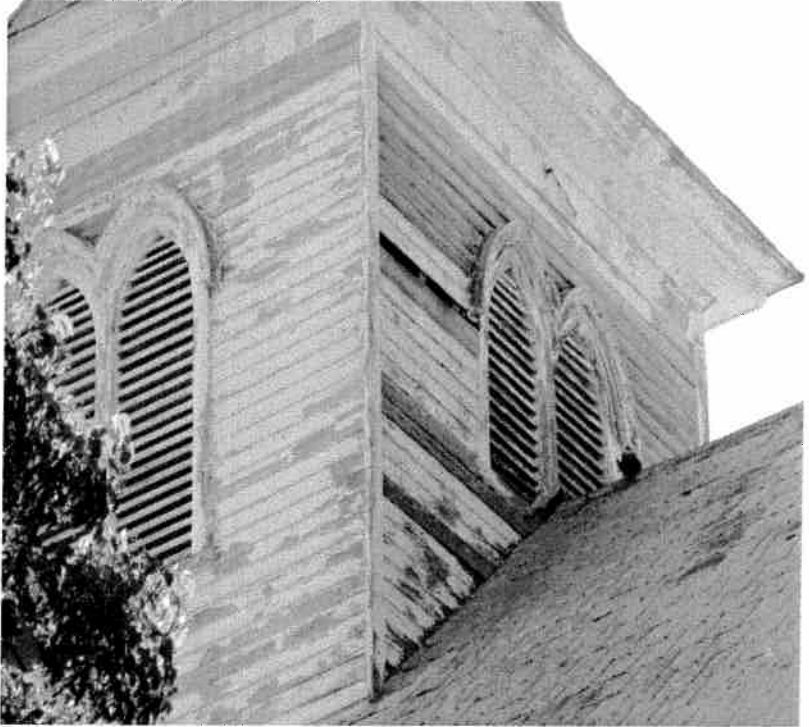
Figure 32 Bell Tower

The walls of the bell tower and turrets are covered in lap siding and louvered ventilation windows are on all four sides (Figure 32).

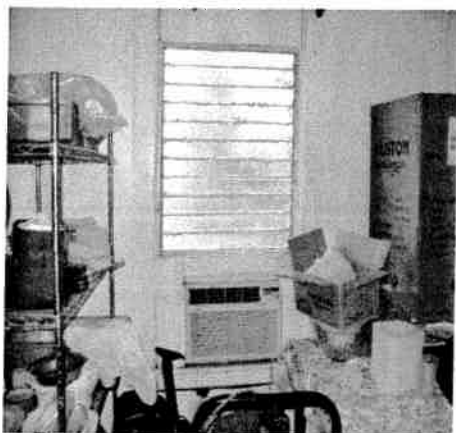
The stained glass windows are in good condition generally, with few broken panes. The jalousie windows on the ground level are in deteriorating condition, largely non-operational and in some instances sealed with exposed expandable foam insulation (Figure 38). The crescent-shaped window frame is badly deteriorated and allows water to penetrate into the exterior wall.

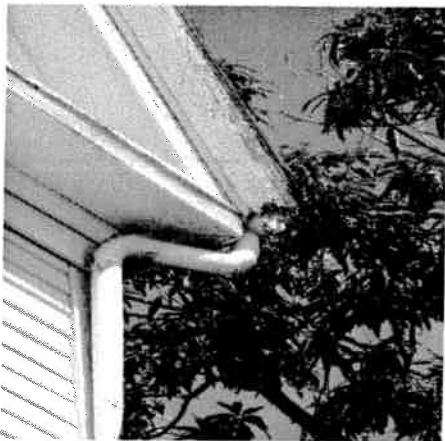
Figure 42 Gable Eave

The eaves, consisting of crown, fascia and soffit are in fair condition everywhere except at the junction of the gutters and downspouts, where dry rot and water damage are evident (Figure 42).

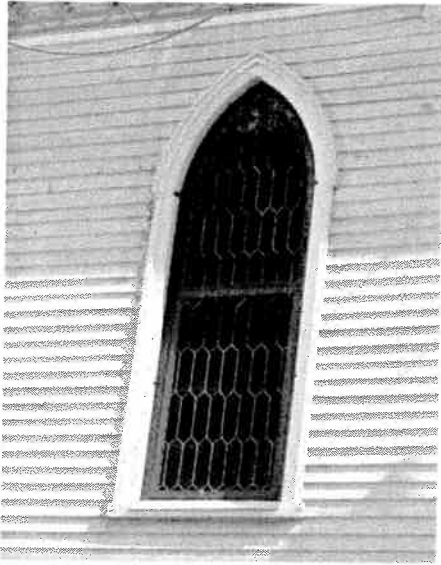
Figure 45 Bronze Finish

The windows and doors are described the previous section of the report as it pertains to weather protection. From the standpoint of their appearance and finish, generally the stained glass windows are good condition, having been replaced in 1990 and show relatively few areas in need of repair (Figure 44). However, it must be added that the frames and mullion are bronze anodized aluminum, which is an inappropriate material for a historic church. In addition to failing to replicate the original painted wood windows the bronze material is dark and renders the window opening as a

“dark hole”(Figure 45). The original windows would have had painted frames and mullions, providing a far richer appearance.

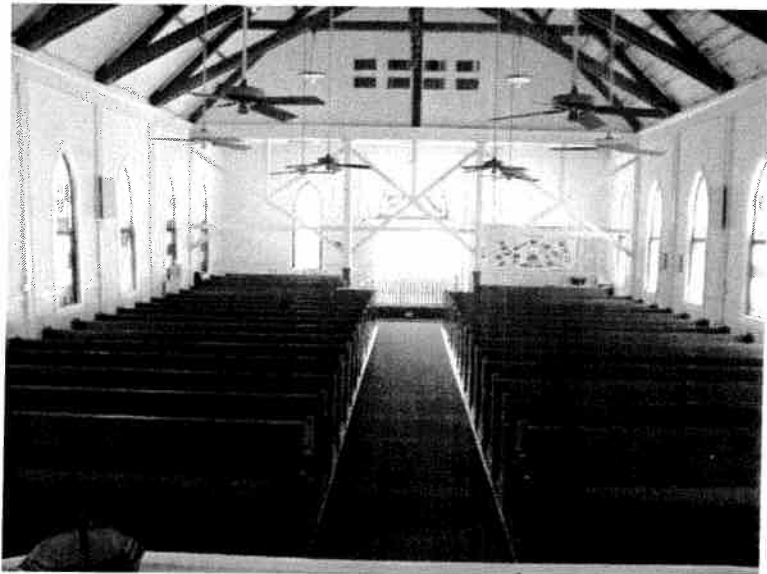
Figure 46 Nave

The nave and sanctuary on the second floor is one large space (Figure 46). The floor consists of the aisles, which are carpeted and the floor under the pews, which is a varnished wood platform, raised three inches (Figure 45). The floor under the carpet is tongue and groove pine as is the raised platform. Both are original and believed to be long-leafed Northern Florida and Georgia first growth yellow pine, known in Key West as “Dade County” pine. The pews are varnished oak and are not original, having been installed in 1964. The backs of the pews are fabric, badly faded.

The floor beneath the carpet is in poor condition owing to layers of carpet glue, and moisture and termite damage. The platform is in good condition.

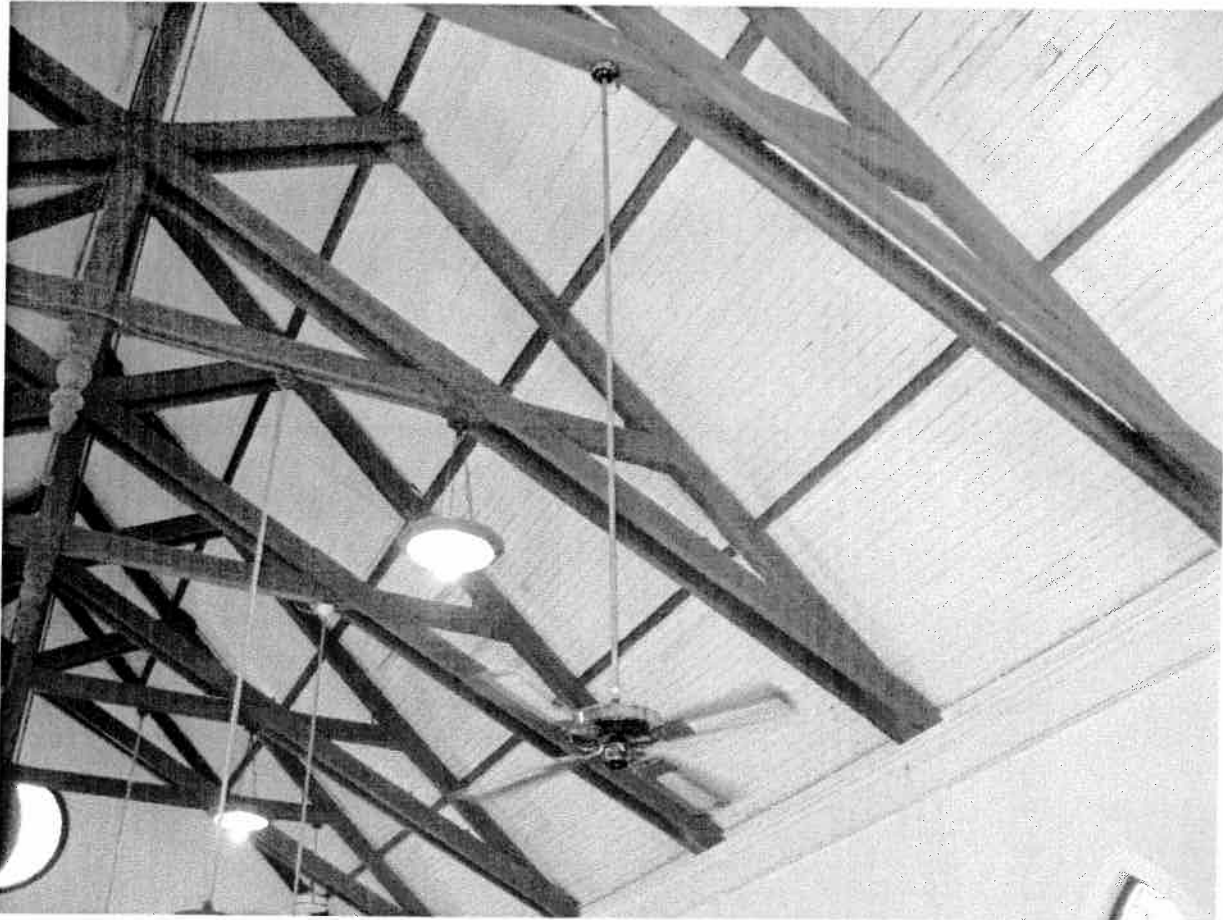
Figure 48 Painted Trusses

The ceiling is painted tongue and groove pine, and shows loss of paint from water damage. The roof trusses, visually the most striking architectural element in the space, are

constructed of large timbers and are painted a matte brown.(Figure 48).

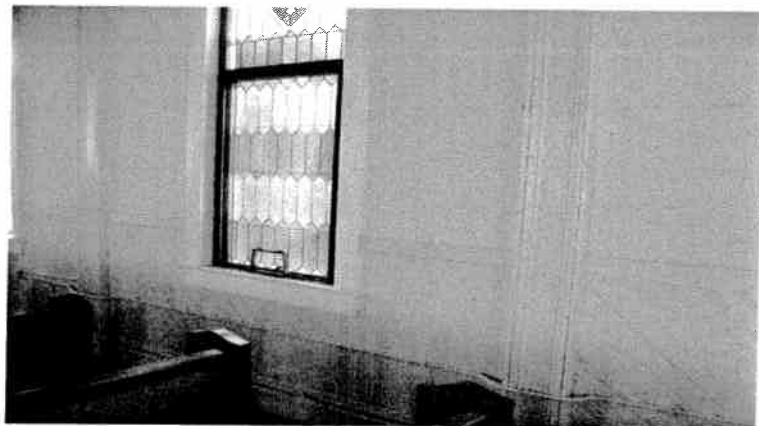
Figure 49 Interior Woodwork

The nave and sanctuary walls consist of wood wainscoting and plaster board walls, all painted. The style is generally Victorian. The wood wainscot consists of a Victorian base molding, diagonally placed bead board dado, and a chair rail, all painted high gloss to match (Figure 49).

All three components, wainscot, pilasters, and cornice are in various state of age and damage and need repair and painting. The plaster walls are painted with a matte white paint that has chalked badly, is discolored, and shows structural cracks due to settlement (Figure 50).

9. Repair and restore all wood work, including wainscoting, window and door trim, crown molding, the alter and choir railings, and other woodwork.

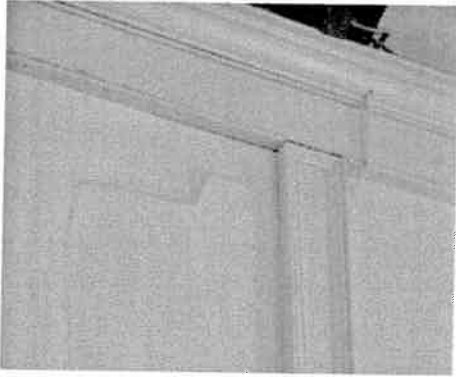
Figure 50 Plaster Wall

Decorative wood pilasters from the floor to the top of the wall are spaced to fall below the ceiling trusses are trimmed with ogee moldings. Atop the pilasters is a continuous wood cornice consisting of a frieze and crowns (Figure 50). The pilasters and cornice are painted to match the wainscot.

10. Repair the plaster walls, either filling cracks and holes or replacing entire bays of wall board.

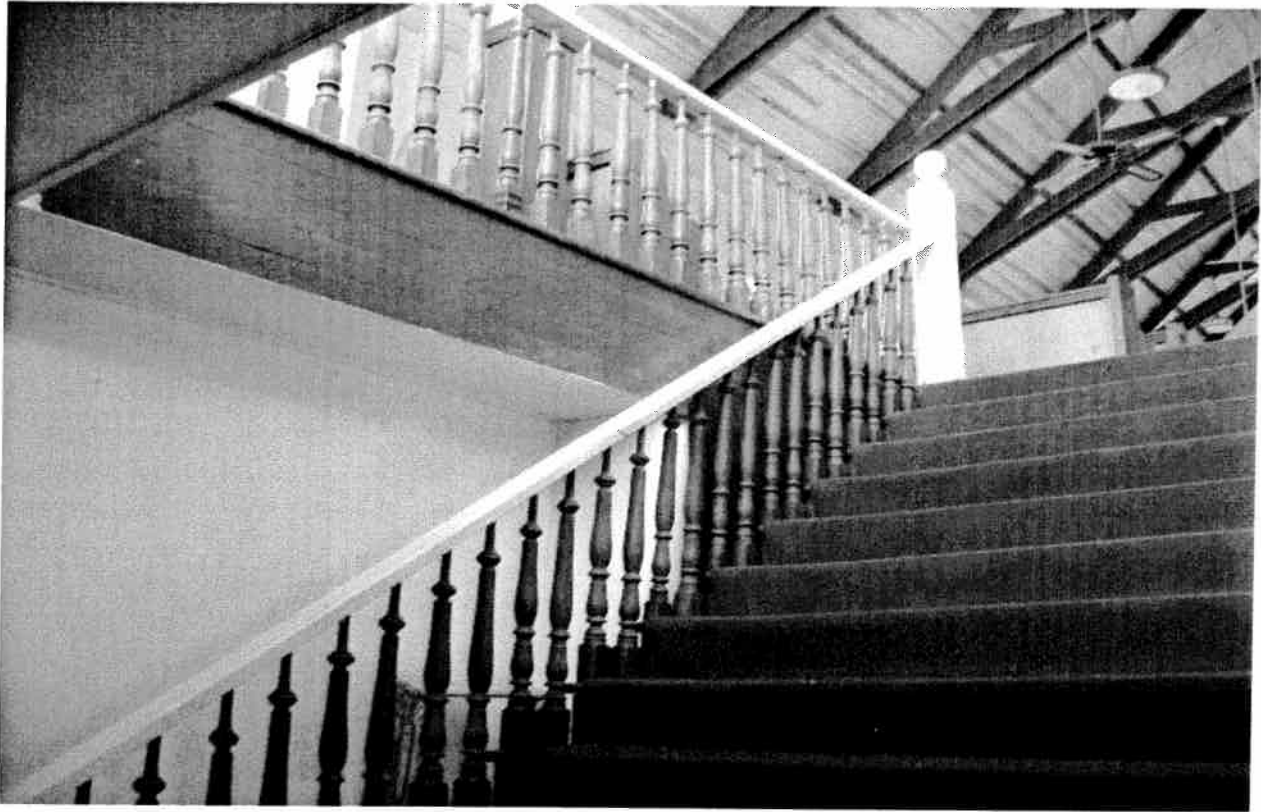
Figure 52 Interior Stair

The interior stair balustrade appears to be partially original, as the turned balusters are Victorian. The banister (the cap) and newel posts, however, are nothing more than painted grade 2x4s and 6x6s (Figure 52). Very likely the original banister and newel posts deteriorated and were thrown out.

8. Replace the banister and newel posts at the interior entrance.

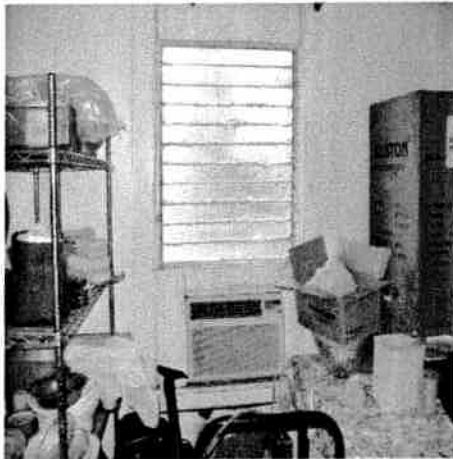
Figure 54 Jalousie Window

The windows are metal with glass jalousies and are generally sealed shut. The metal jalousie windows are old and work poorly or not at all. Some of the windows have been sealed shut with expandable foam insulation, which is unsightly (Figure 54).

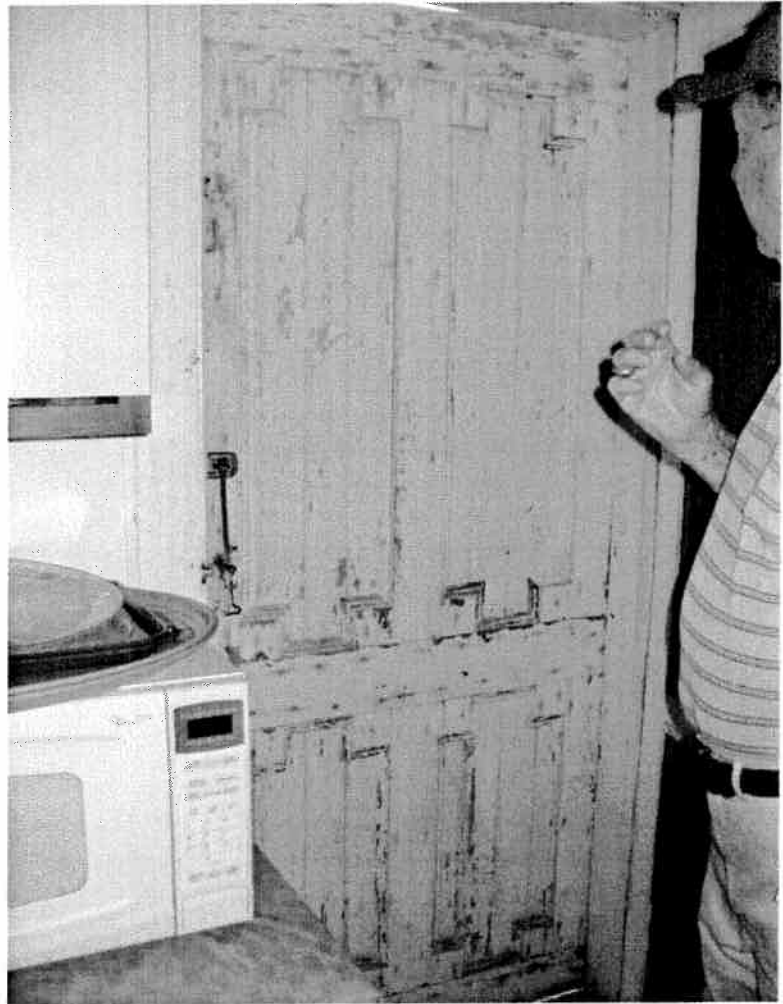
Figure 55 Original Door

The exterior egress doors are metal, without panic hardware. The interior doors are wood hollow core and in more or less poor condition depending upon the amount of termite damage. One door, however, a door leading out to the rear of the church, merits special mention as it appears to be original. This door is off the kitchen at the rear of the church and is a panel door with a liturgical design (Figure 55).

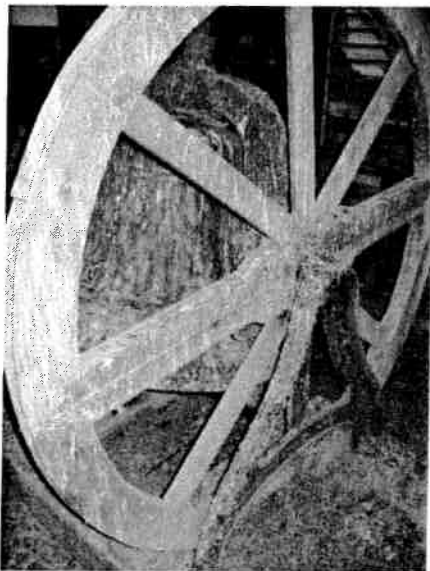
Figure 58 Bell

Within the bell tower is a handsome serviceable cast brass bell that appears to be valuable and worth restoring. It is not known if it is original (Figure 58).

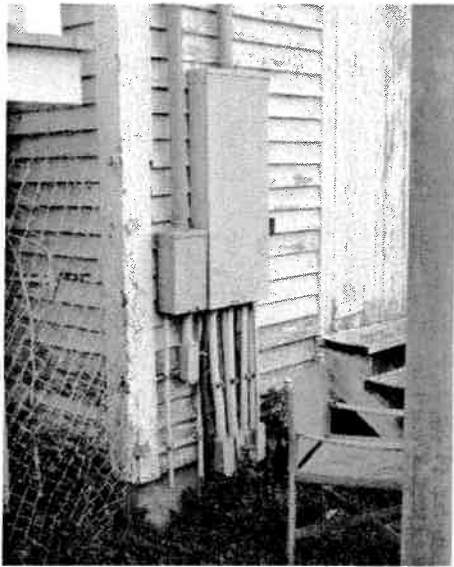
Figure 60 Electrical Service

The existing service is 120/208 volt 3 phase, 4 wire 300 amp service to the NW corner of the building via KES pole B9-3 and B9-3A. The meter is Number 40251 (Figure 60). Each is in serviceable condition and can remain.

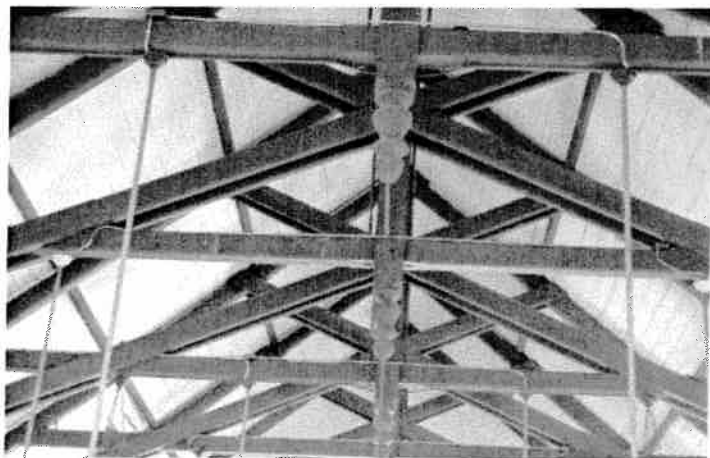
Figure 61 Exposed Conduit on Trusses

A great deal of exposed conduit serving fans and lights is evident and unsightly on the trusses in the main space, the nave of the church (Figure 61).

This is an historic and aesthetic issue, not a safety issue. The church is a historic structure with a considerable investment in its restoration. Running exposed metal conduit on its interior walls is unacceptable in the strict historic sense, and unsightly by any standard. When the exterior siding is repaired and opportunity will open to install conduit in walls from the outside.

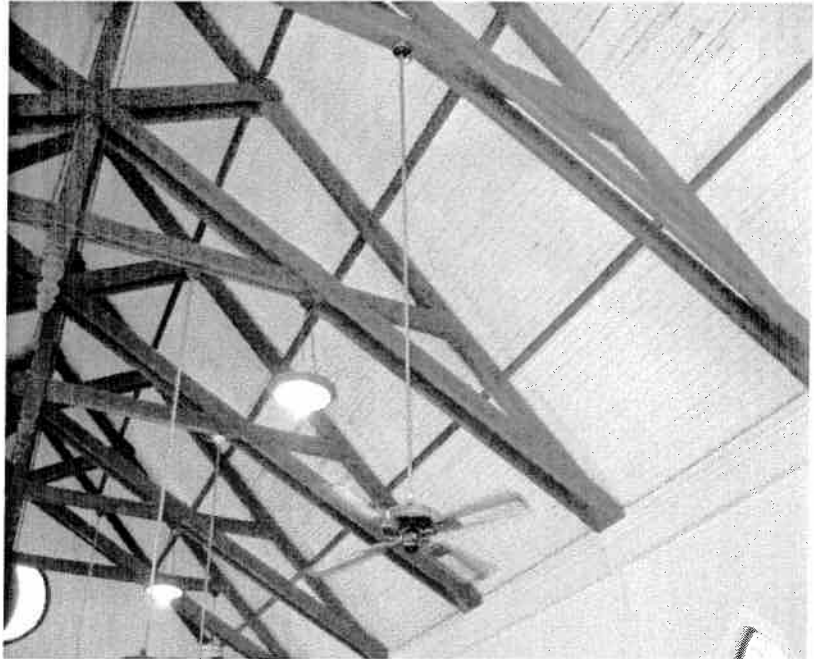
Figure 63 Nave Lighting and Fans

Second Floor Interior: Lighting at the nave and sanctuary (second floor) consists of very old hanging globes approximately twenty feet above the floor. These possible date from the early 20th century. The globes have been removed for ease of changing light bulbs; the light bulbs are bare (Figure 63). At the sanctuary shielded spotlights are mounted on the sidewall and are aimed down toward the lectern. They are portable and are plugged into a wall outlet next to the sanctuary niche. Two small stained glass fixtures hang from the ceiling.

5 Replace fans and lights in the Nave and Sanctuary.

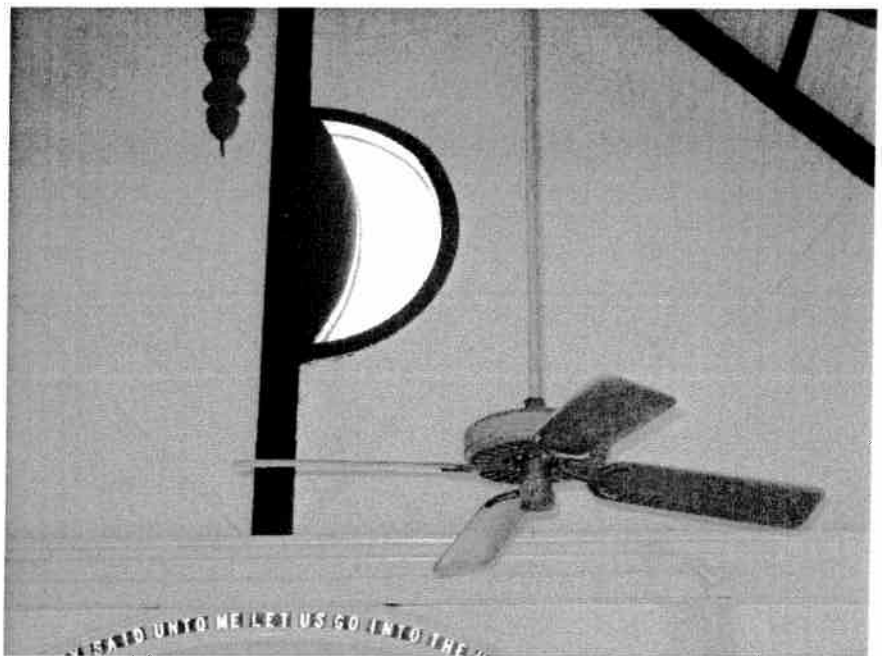
Figure 64 Nave and Sanctuary Fans

Eight ceiling fans suspended by ten foot down rods have been installed over the nave. The fans are a residential type of differing styles and are made by Hunter Fan Company (Figure 64). The fans are below the lights so when on create a stroboscopic effect below them.

Because the church does not need air conditioning in the sanctuary and nave year round ceiling fans are a good means to provide the fans for comfort control. Separate lighting, however becomes problematic as if not placed properly it will cause a discomfoting stroboscopic effect when the fans are running. This is the current condition.

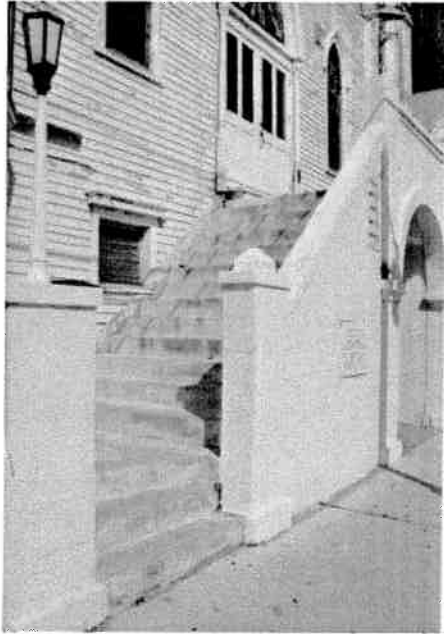
Fixture 65 Pole Lantern

Exterior: At the street the church has only a florescent strip fixture, which is mounted on the ceiling of the ground floor entrance vestibule. Lanterns are mounted on the stair pillars but are not operating (Figure 65).

7 Repair/replace lanterns at the front of the building.

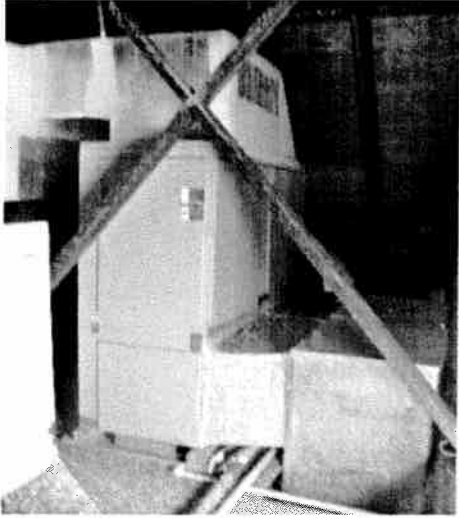
Figure 66 Air Handler in Attic

Second Floor: Servicing the nave and sanctuary, there are three split systems, two 15 ton and one 10 ton. The air handlers are located in the attic mezzanine below the bell tower and distribute air to the second floor through diffusers in the attic wall (Figures 66 and 67). Condensers for the units are located on concrete pads outside the building's North wall (Figure 68). The units are manufactured by Trane and have been in service for eleven years.

As this air conditioning is used only for weekly services and the occasional Wedding or Funeral and thus have “low mileage” both the condensers and air handlers are in good serviceable condition. The coils have been inspected for this report and are not brittle.

Because the central air conditioning system has been used relatively little (for Sunday service, and special services only, during hot months), yet is over ten years old it should be inspected and maintained on a regular basis. Filters should be changed every two to three months and the condensate drain should be blown out at the same time. A full maintenance check and coil cleaning should be done once a year.

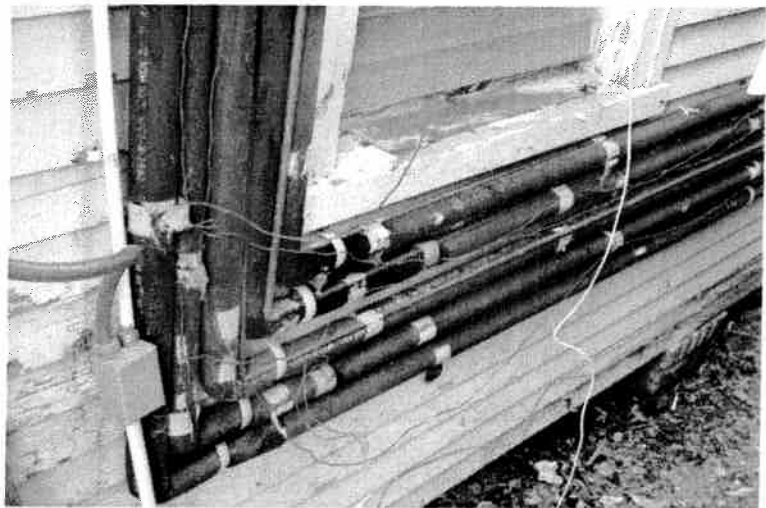
Figure 69 Refrigeration Lines

Refrigeration, vacuum, condensate, and electrical lines are run against the outside of the North wall up to the attic level, where they enter the building (Figure 69)

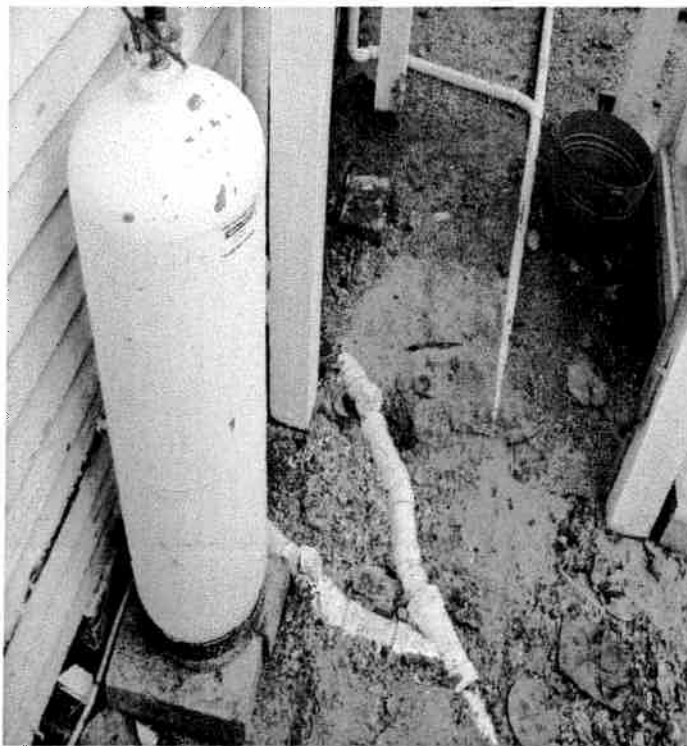
Figure 71 Propane Tank

Hot water is provided by an electric hot water heater and cook tops are served by propane gas from a tank mounted on the ground outside the North wall, adjacent to the kitchen (Figure 71).

- 1. The plumbing must be brought up to code.**

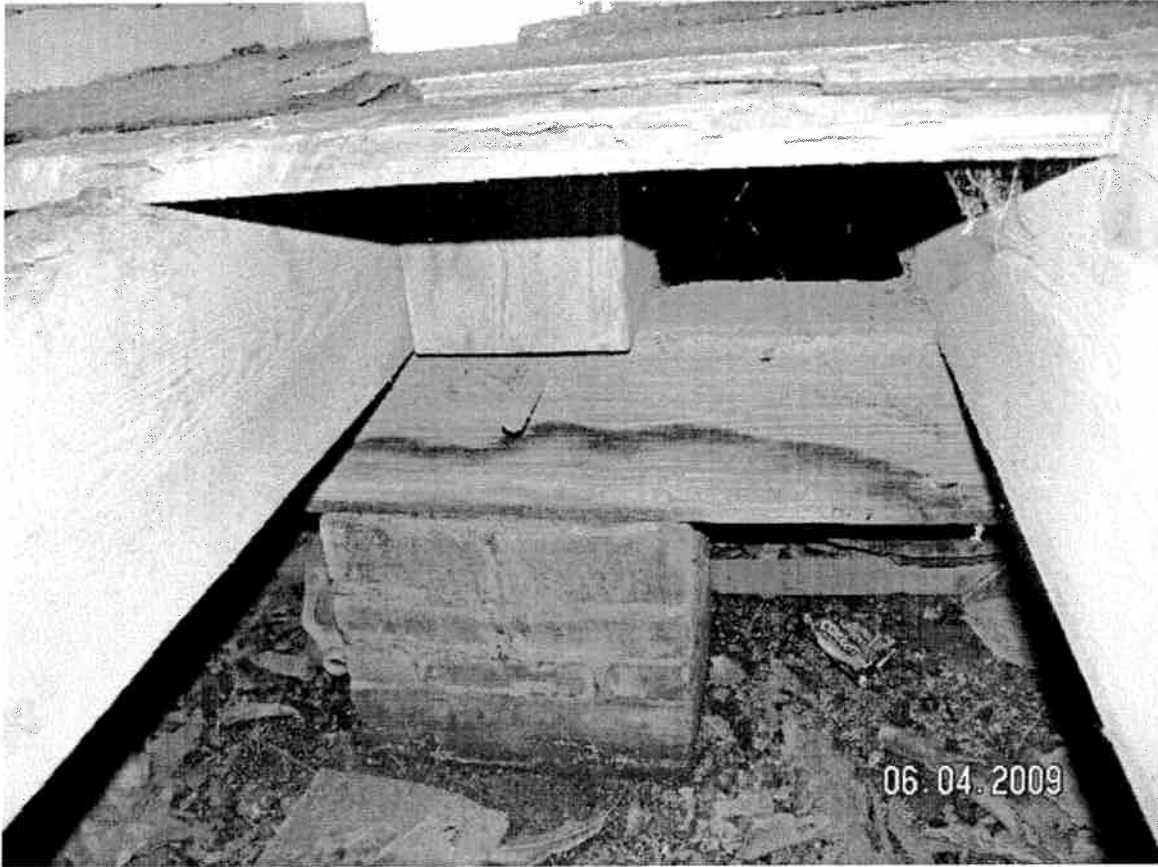
The columns are connected to the floor beam (6x8) by a mortise and tenon joint. This consists of a wood pin through a "tongue" of the column and a "groove" cut into the beam. This type of connection is common in buildings of this age. Due to the load from the Nave floor, the columns have rotated slightly at this connection causing the columns to fall out of plumb. The columns remain in good condition but realigning the columns and a stronger connection should be investigated. See photo on next page.

Note the brick pier with the 6x8 floor beam running over and the column attached by mortise and tenon joint with a wooden dowel. The 4x10 joists are shown on each side. It would appear that there is no positive connection from the pier to the beam to the joist. The South wall of the building exhibits some differential footing settlement. The Ground Floor appears level along the North wall and at the center but has a 6" fall to the Southwest and 1 1/2" fall to the Southeast. Many historical buildings in Key West have piers that have settled differentially.

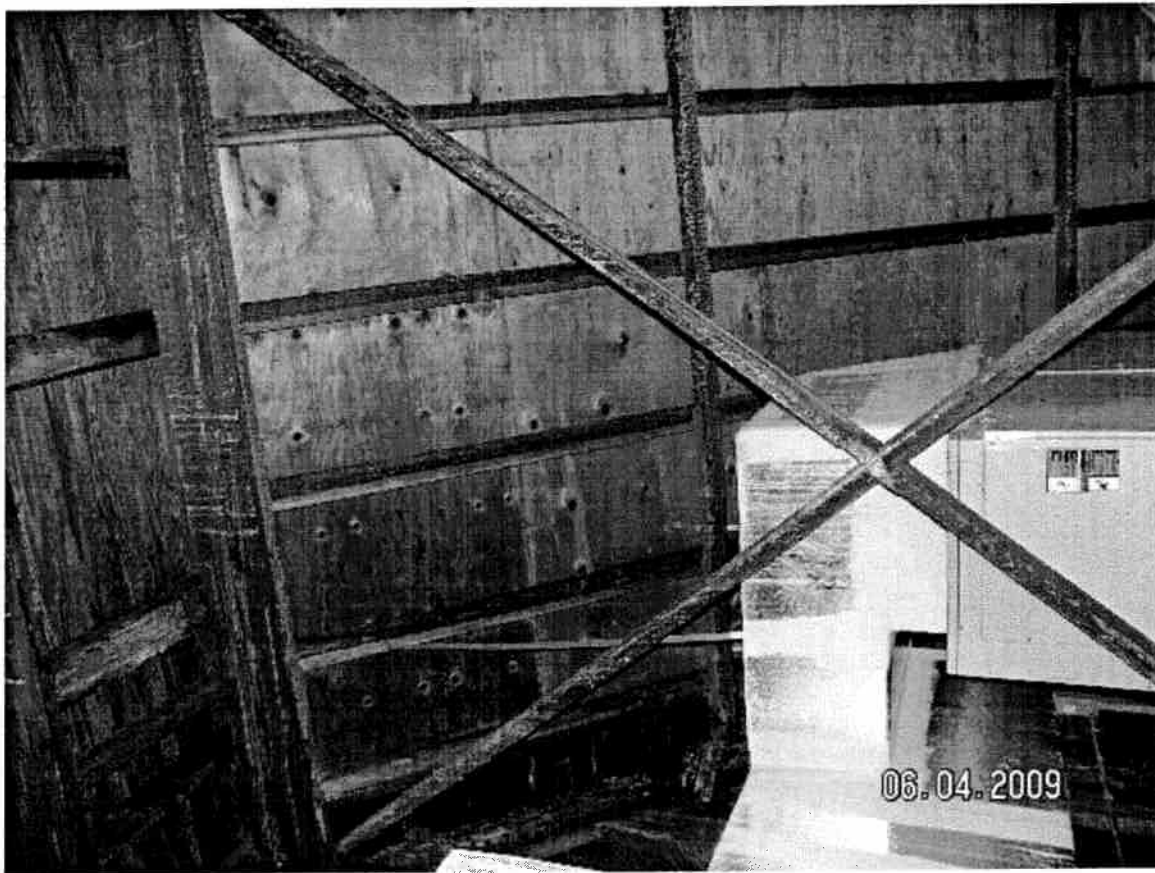
Wall between AC Loft and Nave

The AC Loft floor joist, 3x6 at 24" on center and spanning 12', are inadequate to safely support the existing AC equipment. The plywood floor deck needs to be replaced. The burned X-members removed. The wall separating the Nave needs to have additional plywood installed, if the truss style X-bracing below is to be removed. See page 14.

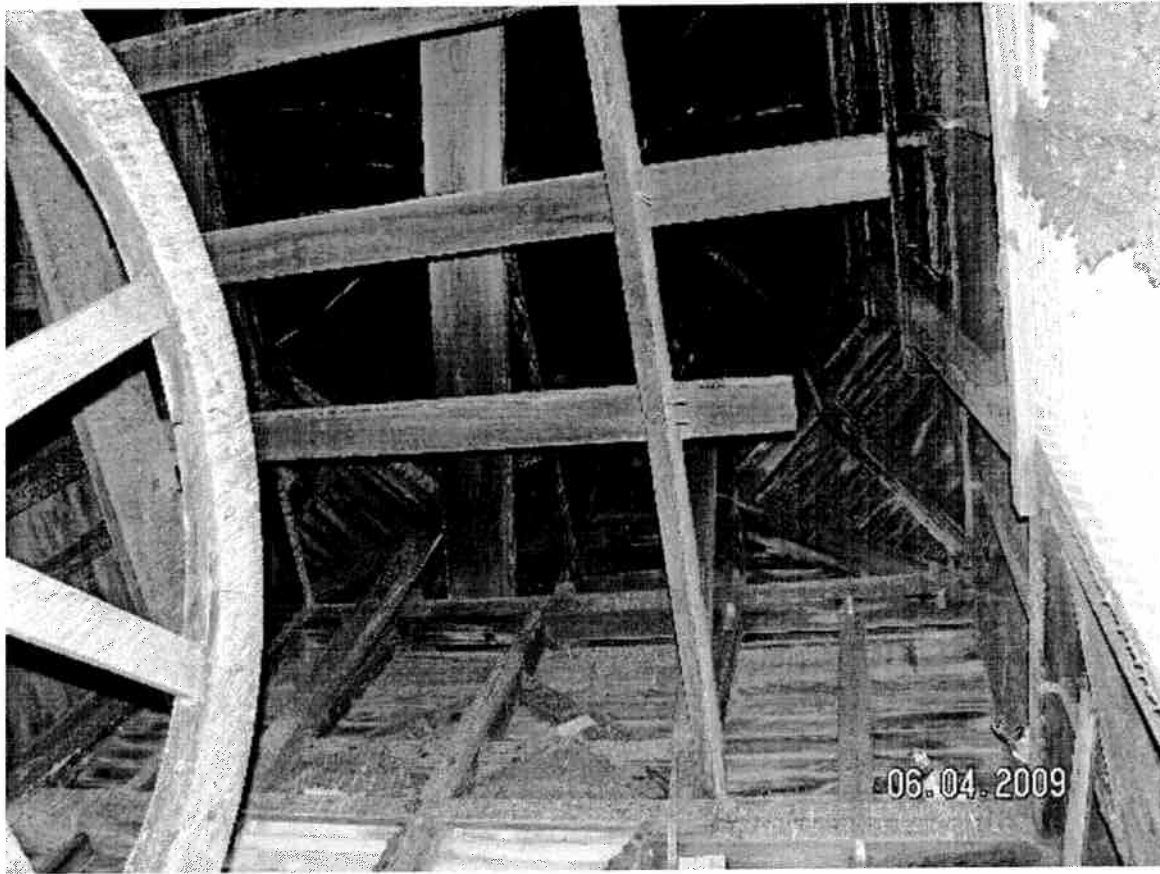
Looking up into the Belfry with a Steeple above.

The steeples and belfry can be stiffened considerably with steel straps and plywood. The steeples are currently having the exterior siding replaced and screwed into supporting members. This with some minimal strapping may be as stiff as can be expected. The attachment at the base of the steeples should be investigated. The Belfry also can be helped with some plywood and strapping on the walls.

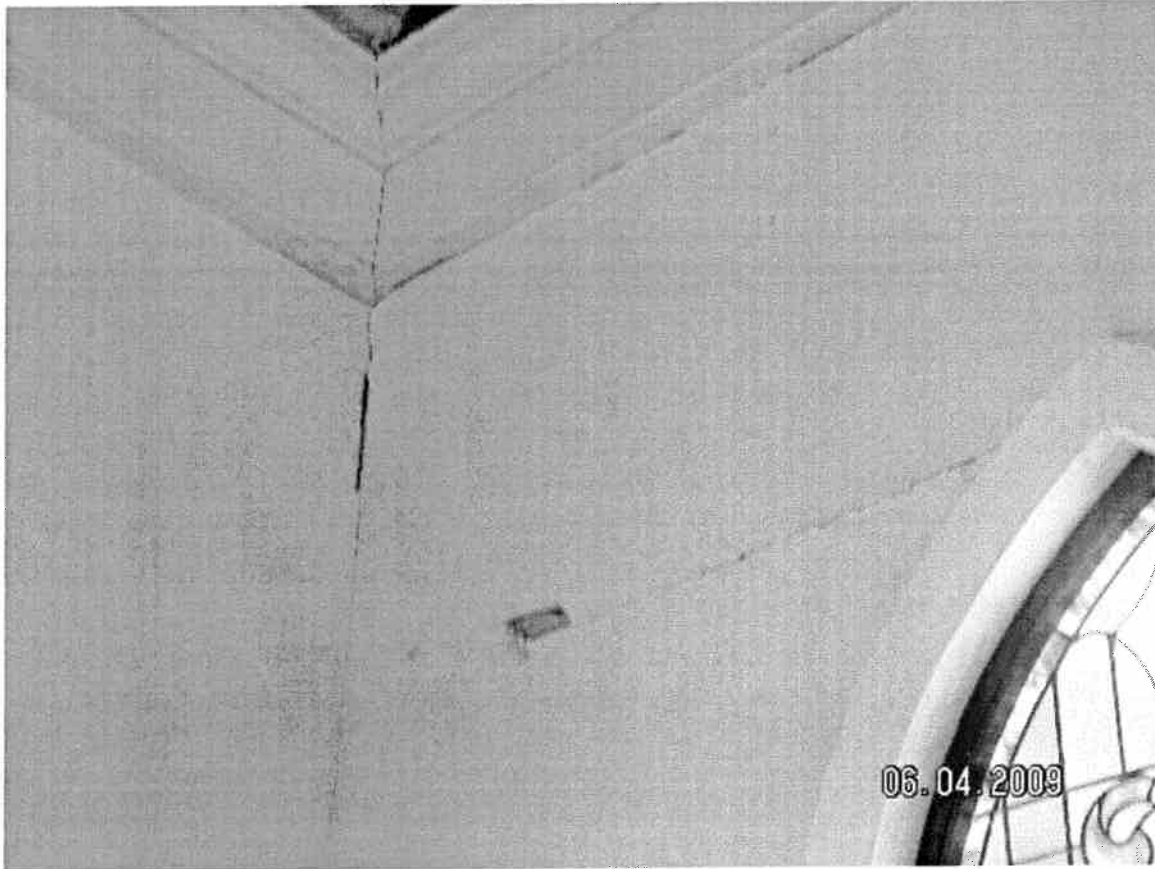
Nave wall, SW corner

The main walls of the church in the Nave are 16' from floor to roof truss attachment. The wall studs are 2x6 (actual) at 18-24" on center with 1"x6" diagonal sheathing. With the large roof load and long span, the wall studs must be over-stressed. This is particularly true when the walls must resist lateral wind loads. This can be evidenced by the cracks on the interior face of the walls. Along with the roof trusses, it is critical that the exterior walls be strengthened by additional studs or additional sheathing or a combination of the two.

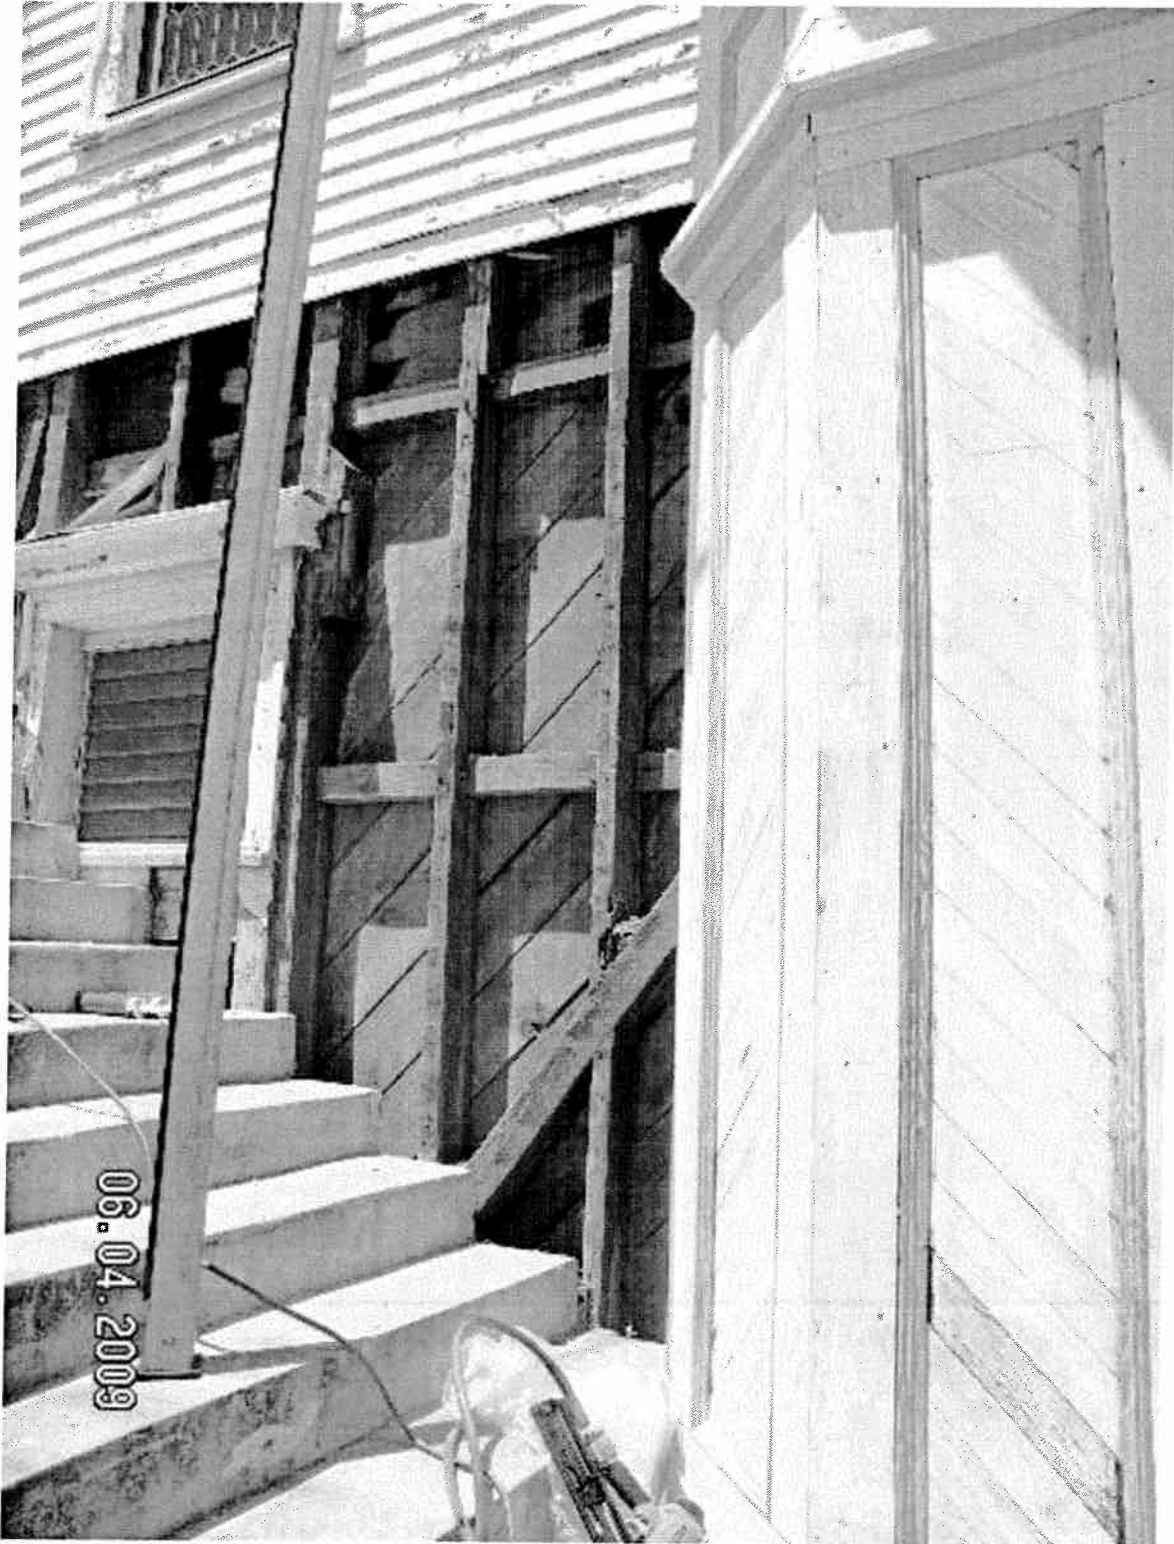
Front wall by entrance.

The truss style X-bracing below the AC Loft near the entrance may be removed with the proper strengthening of the AC Loft and the exterior walls. See Page 8 & 11).
