**TREE COMMISSION TREE REMOVAL REPORT
CITY of KEY WEST**

PROPERTY: 1716 United St

APPLICATION NUMBER: T2025-0279

REQUEST: The applicant is requesting removal of the Sapodilla tree & Strangler Fig.

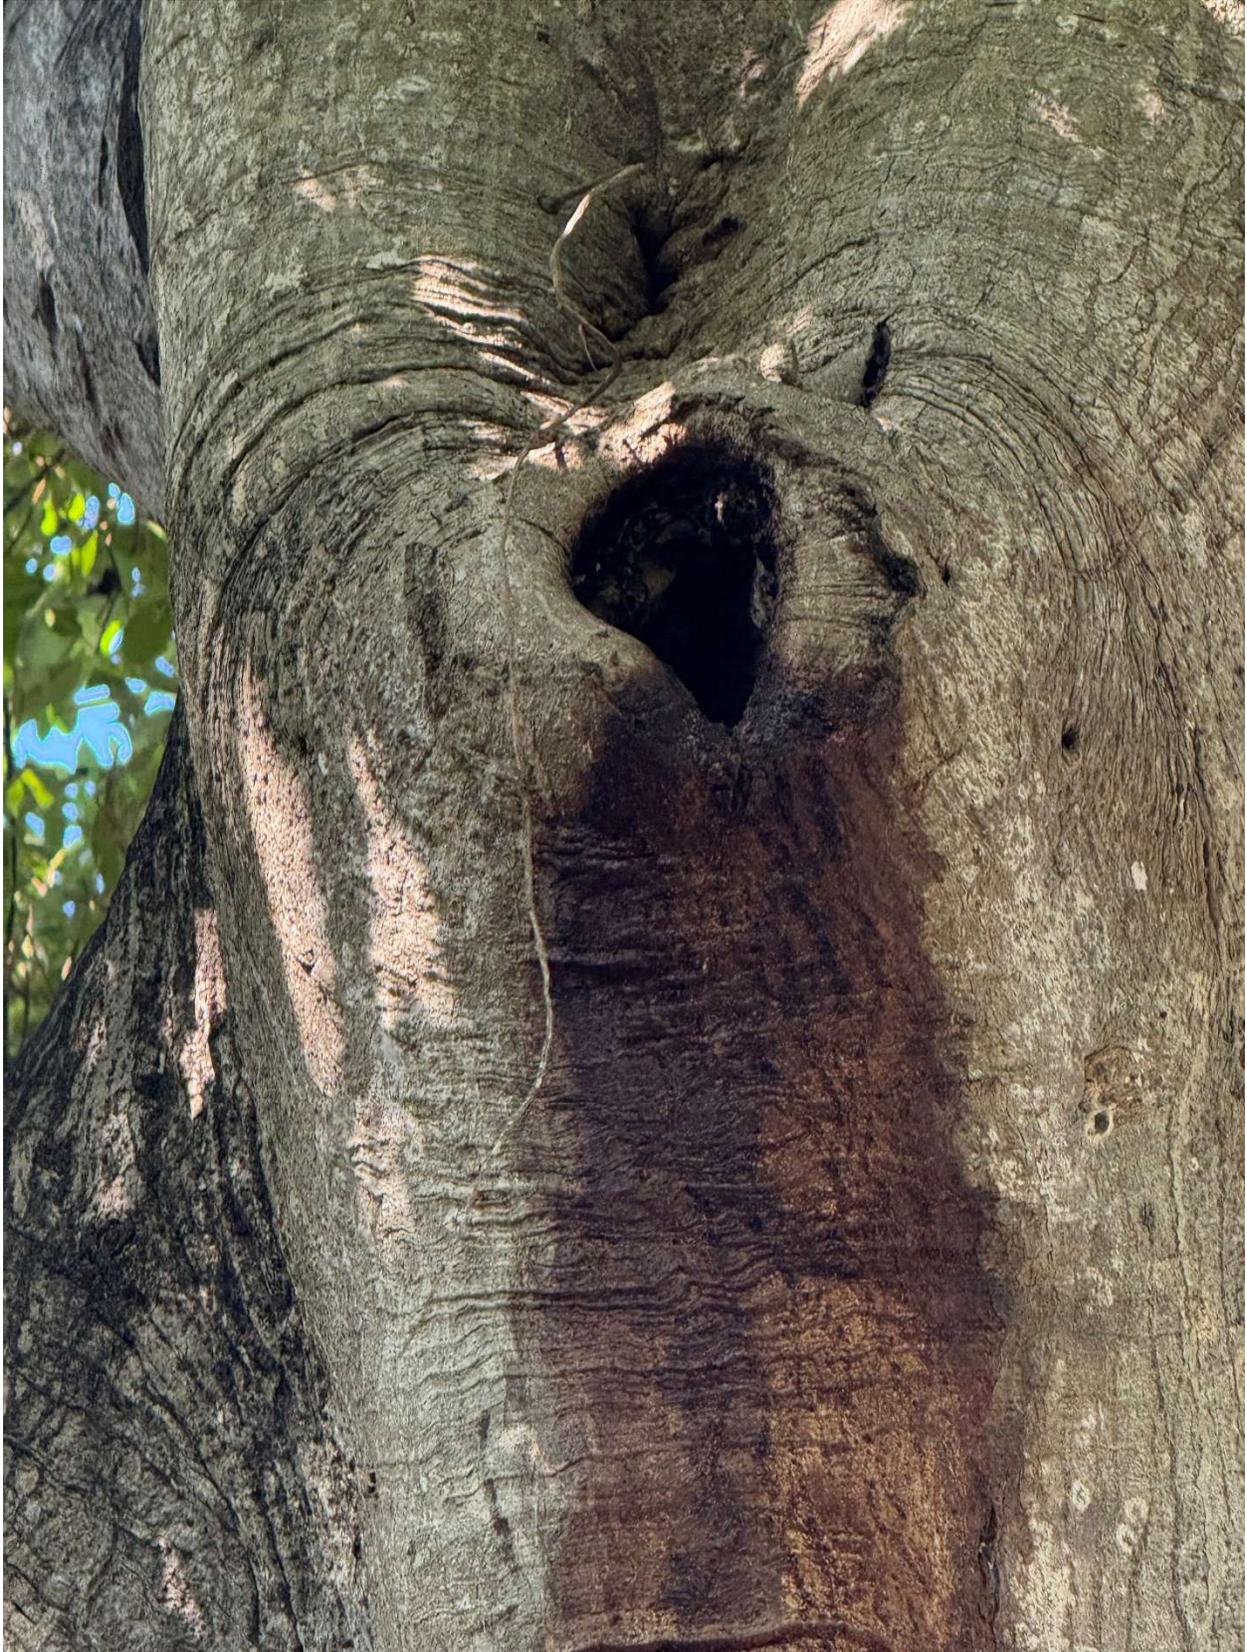
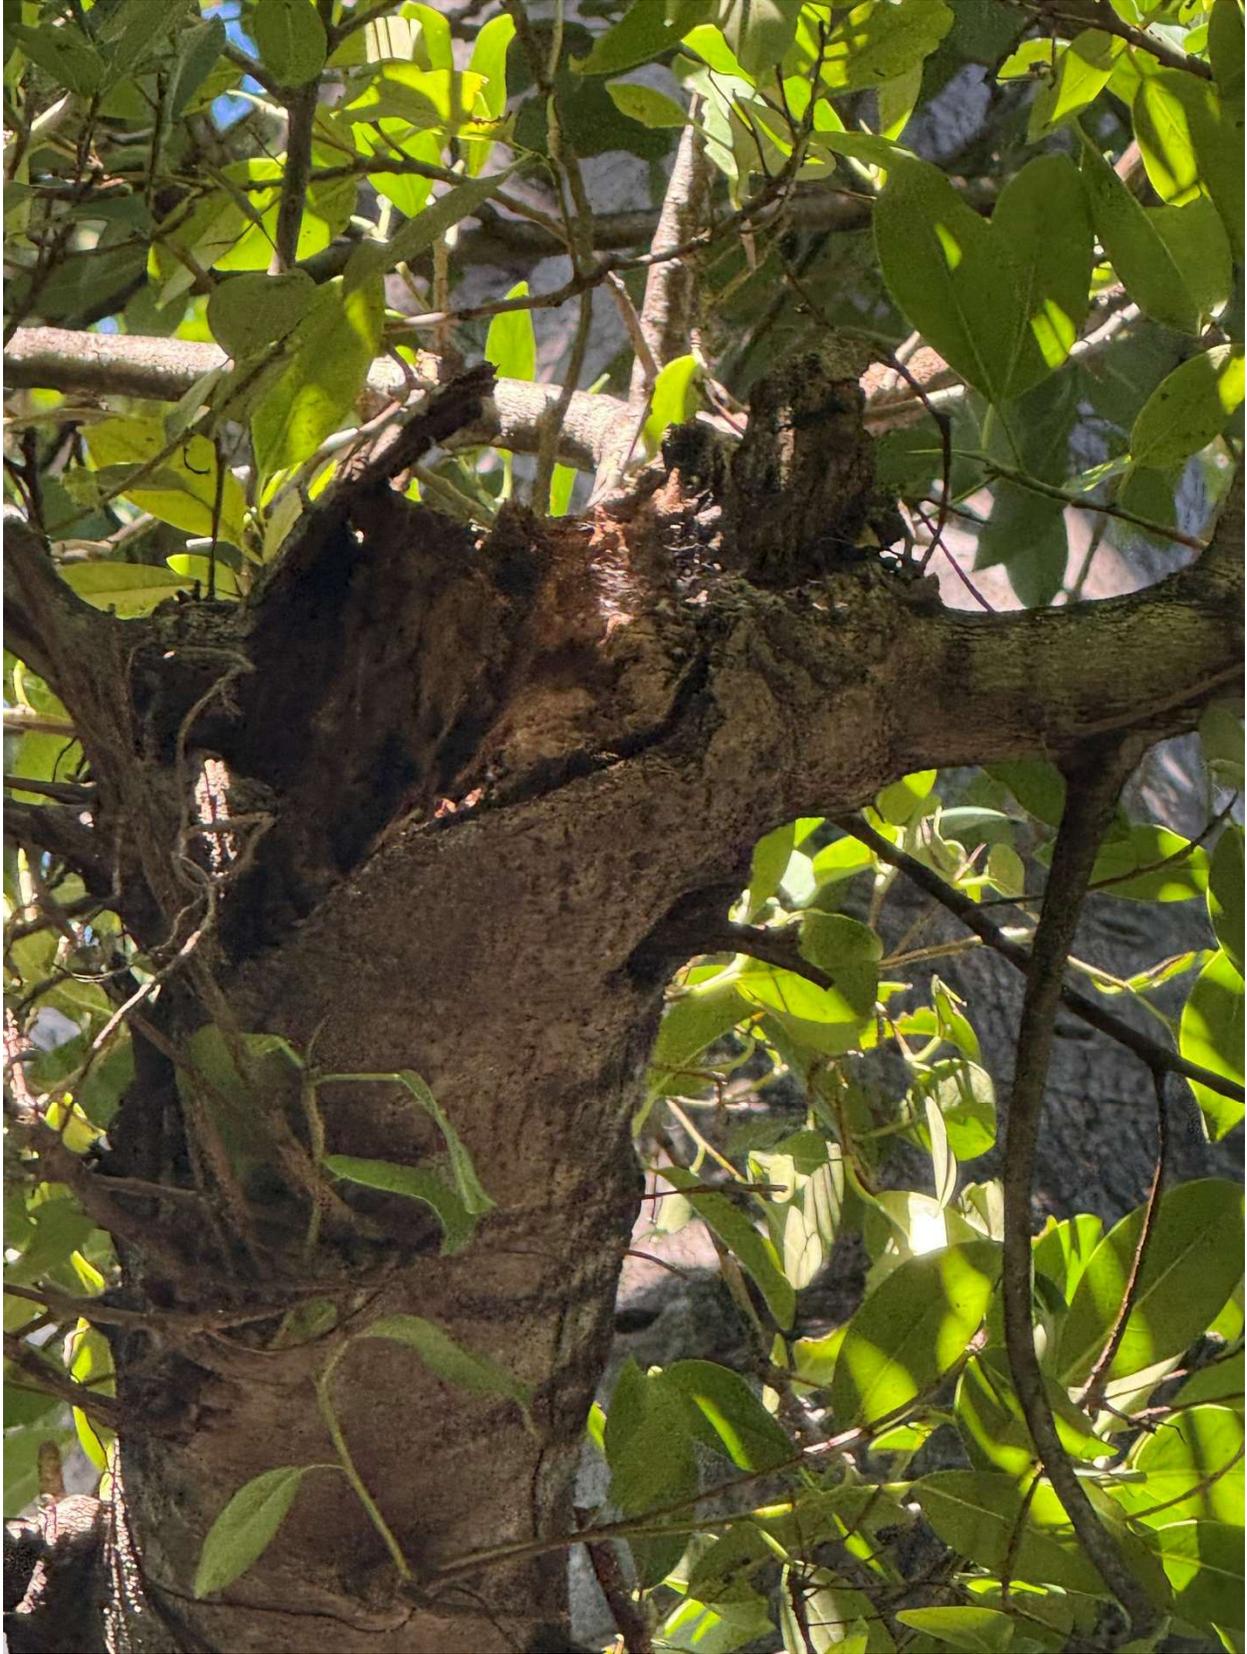
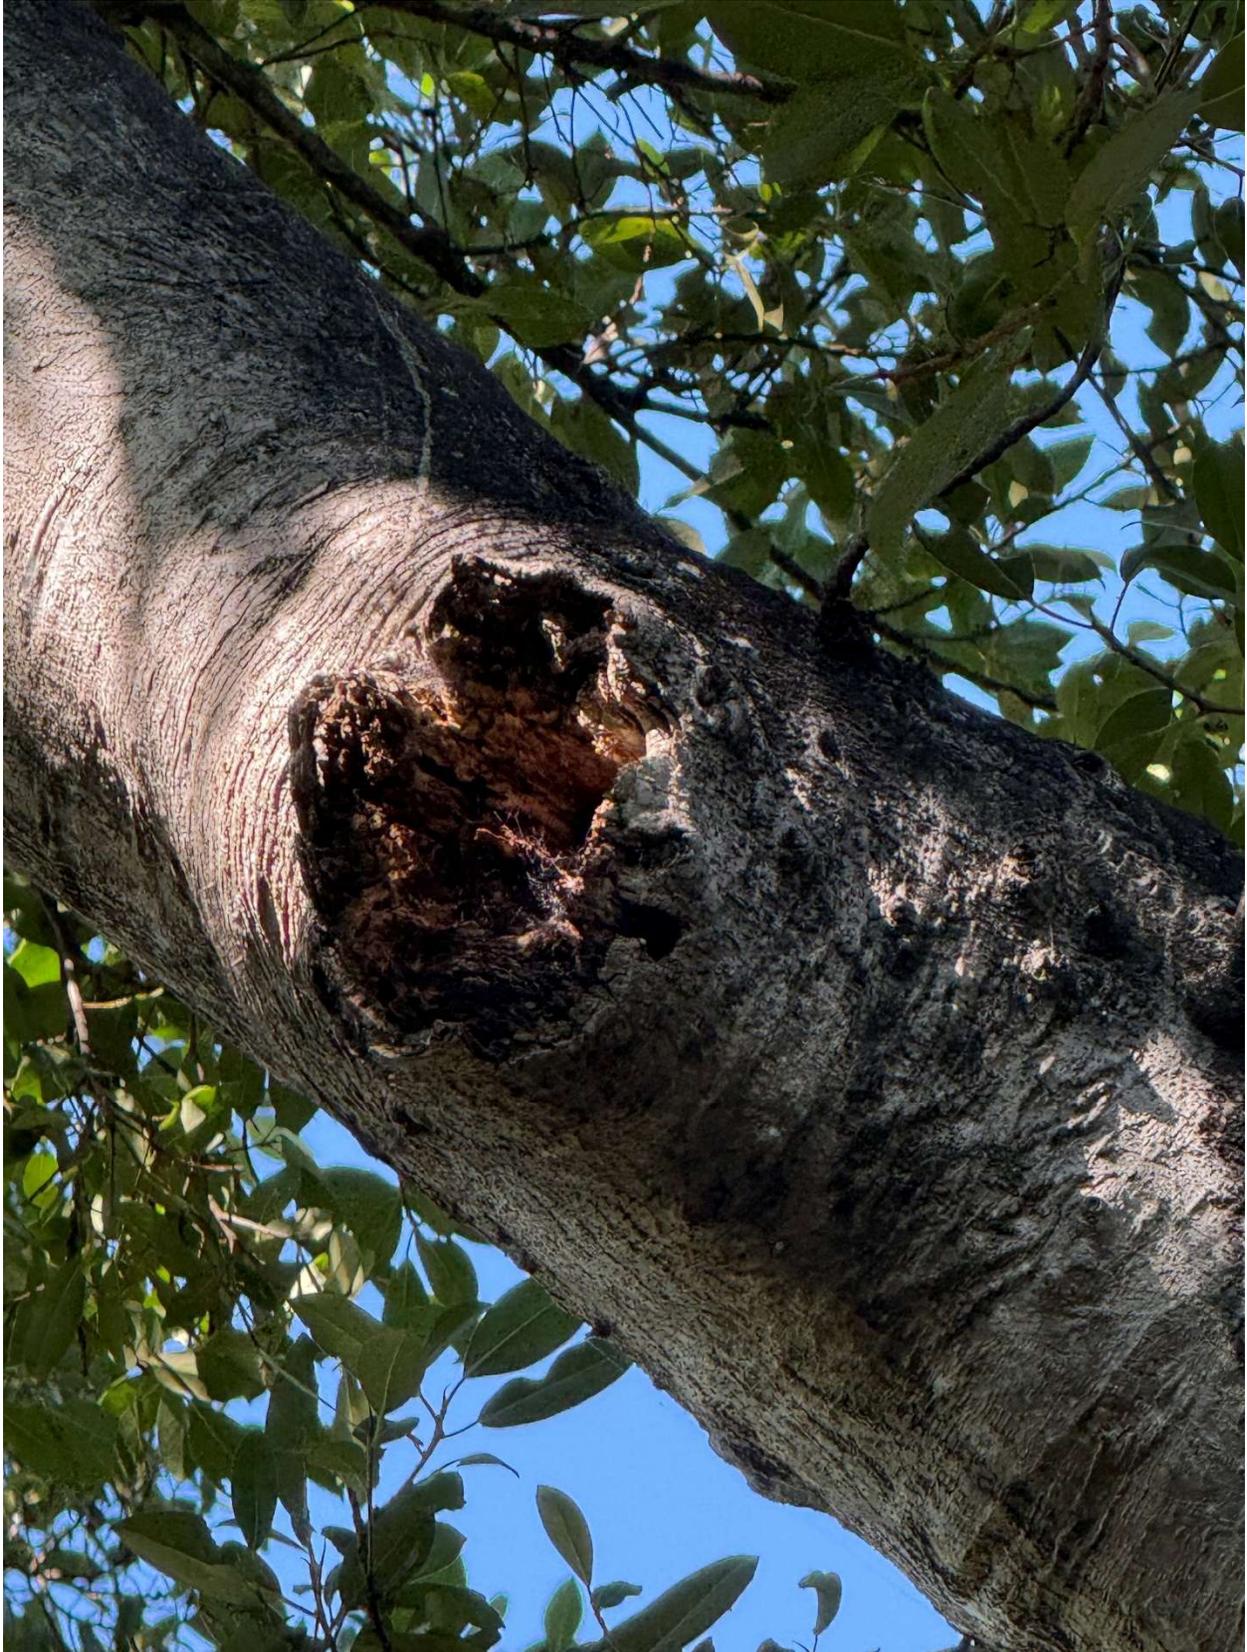
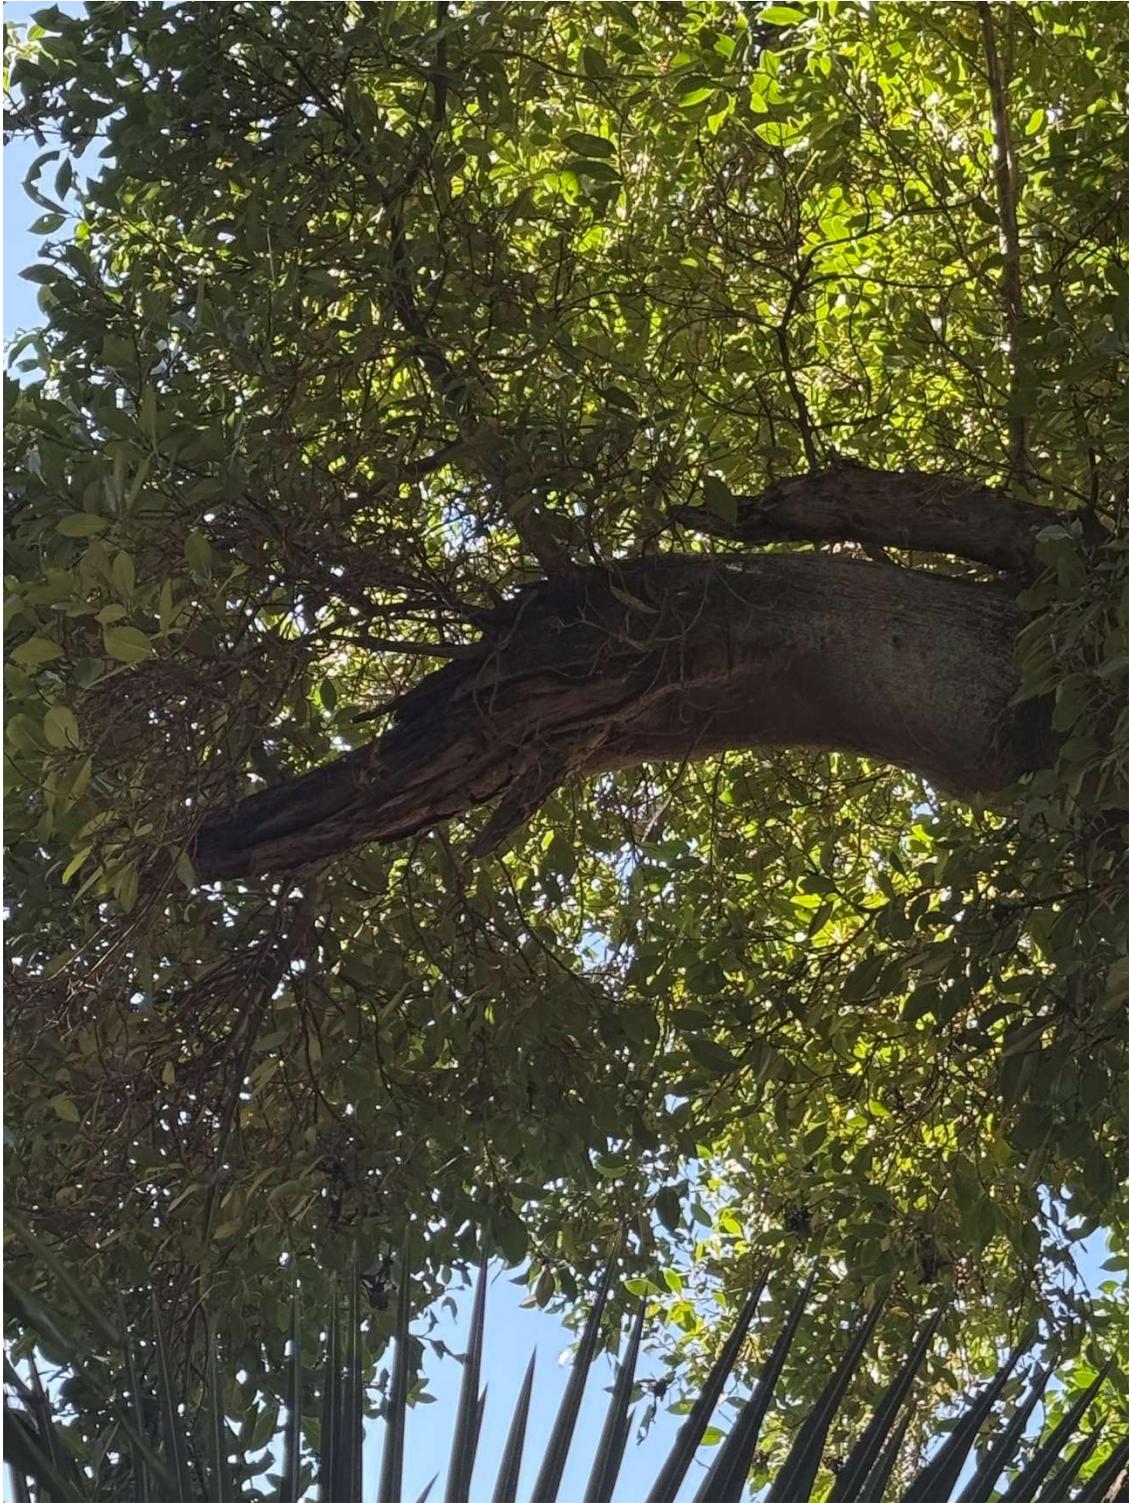
Stangler Fig is quite large but has numerous torn branches from having never been maintained and surviving storms.

Condition: 60% (numerous torn and decayed branches)

Recommended Mitigation: 46 Caliper Inches

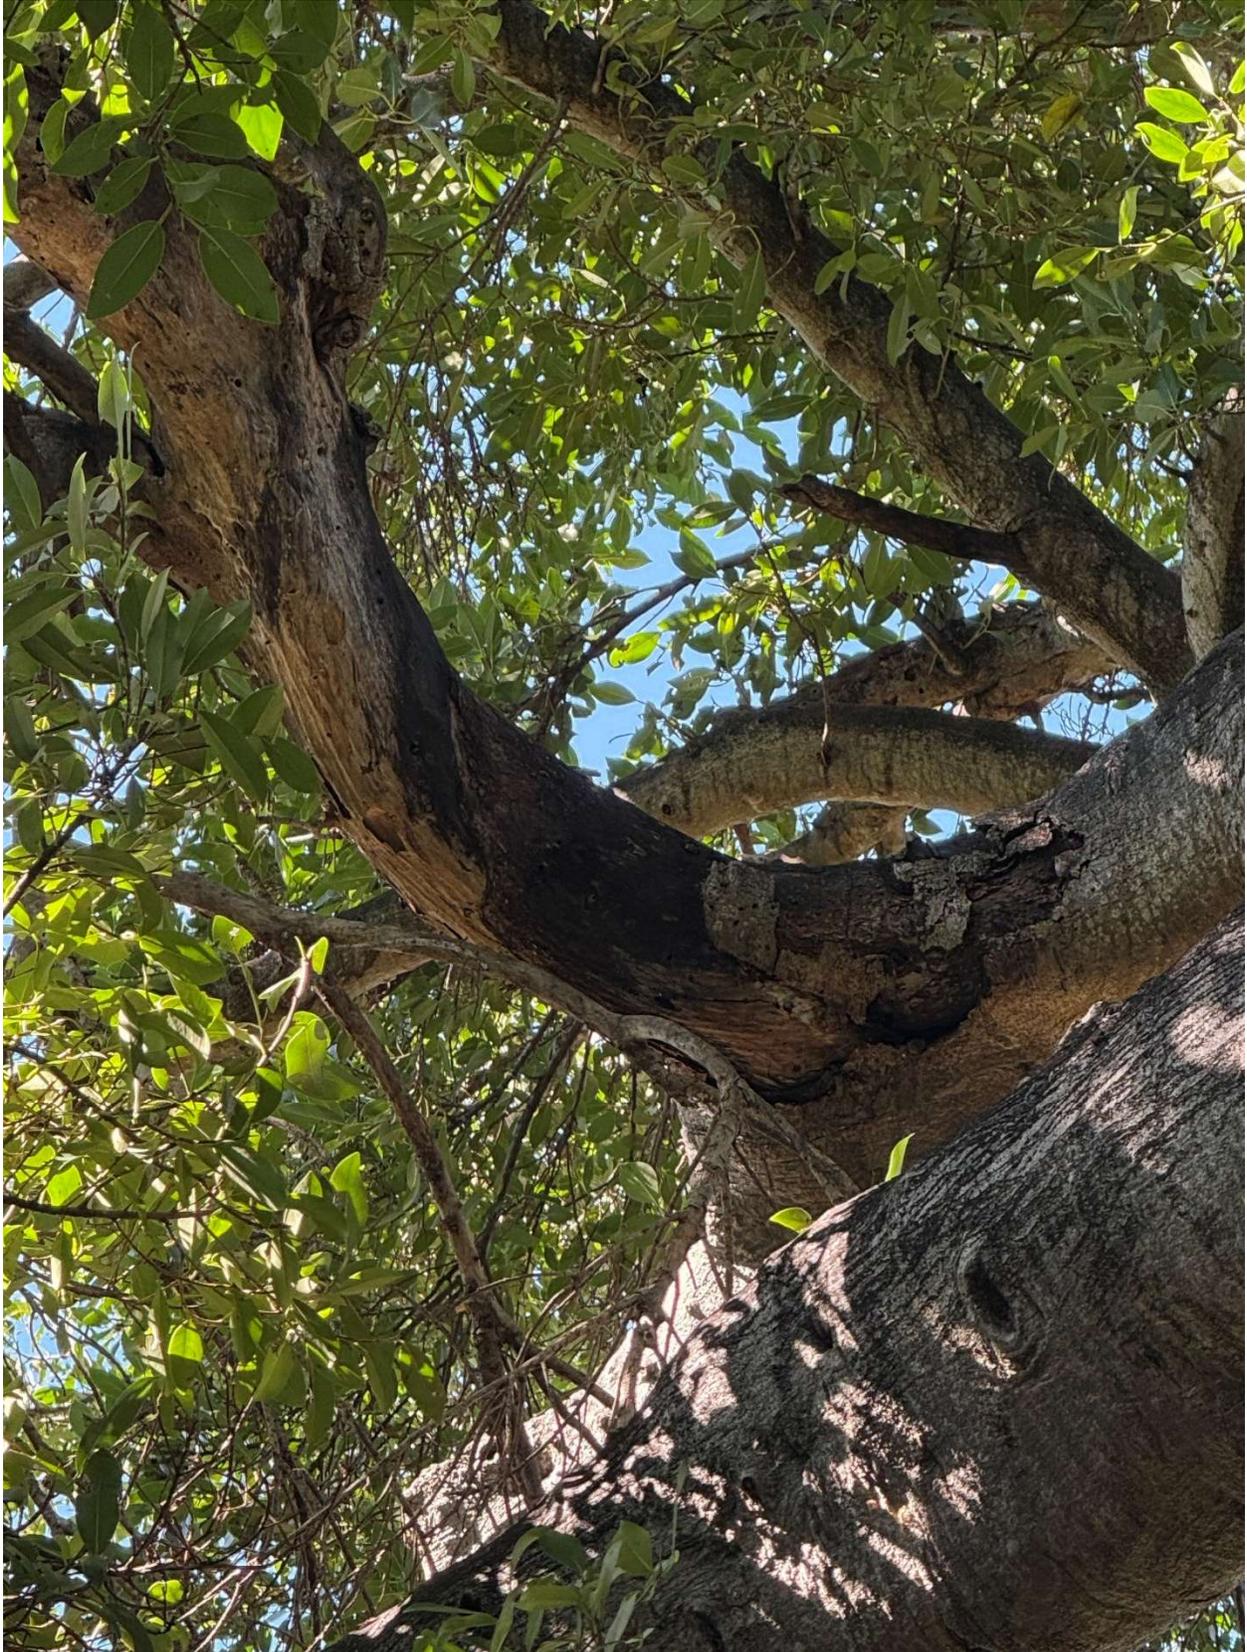
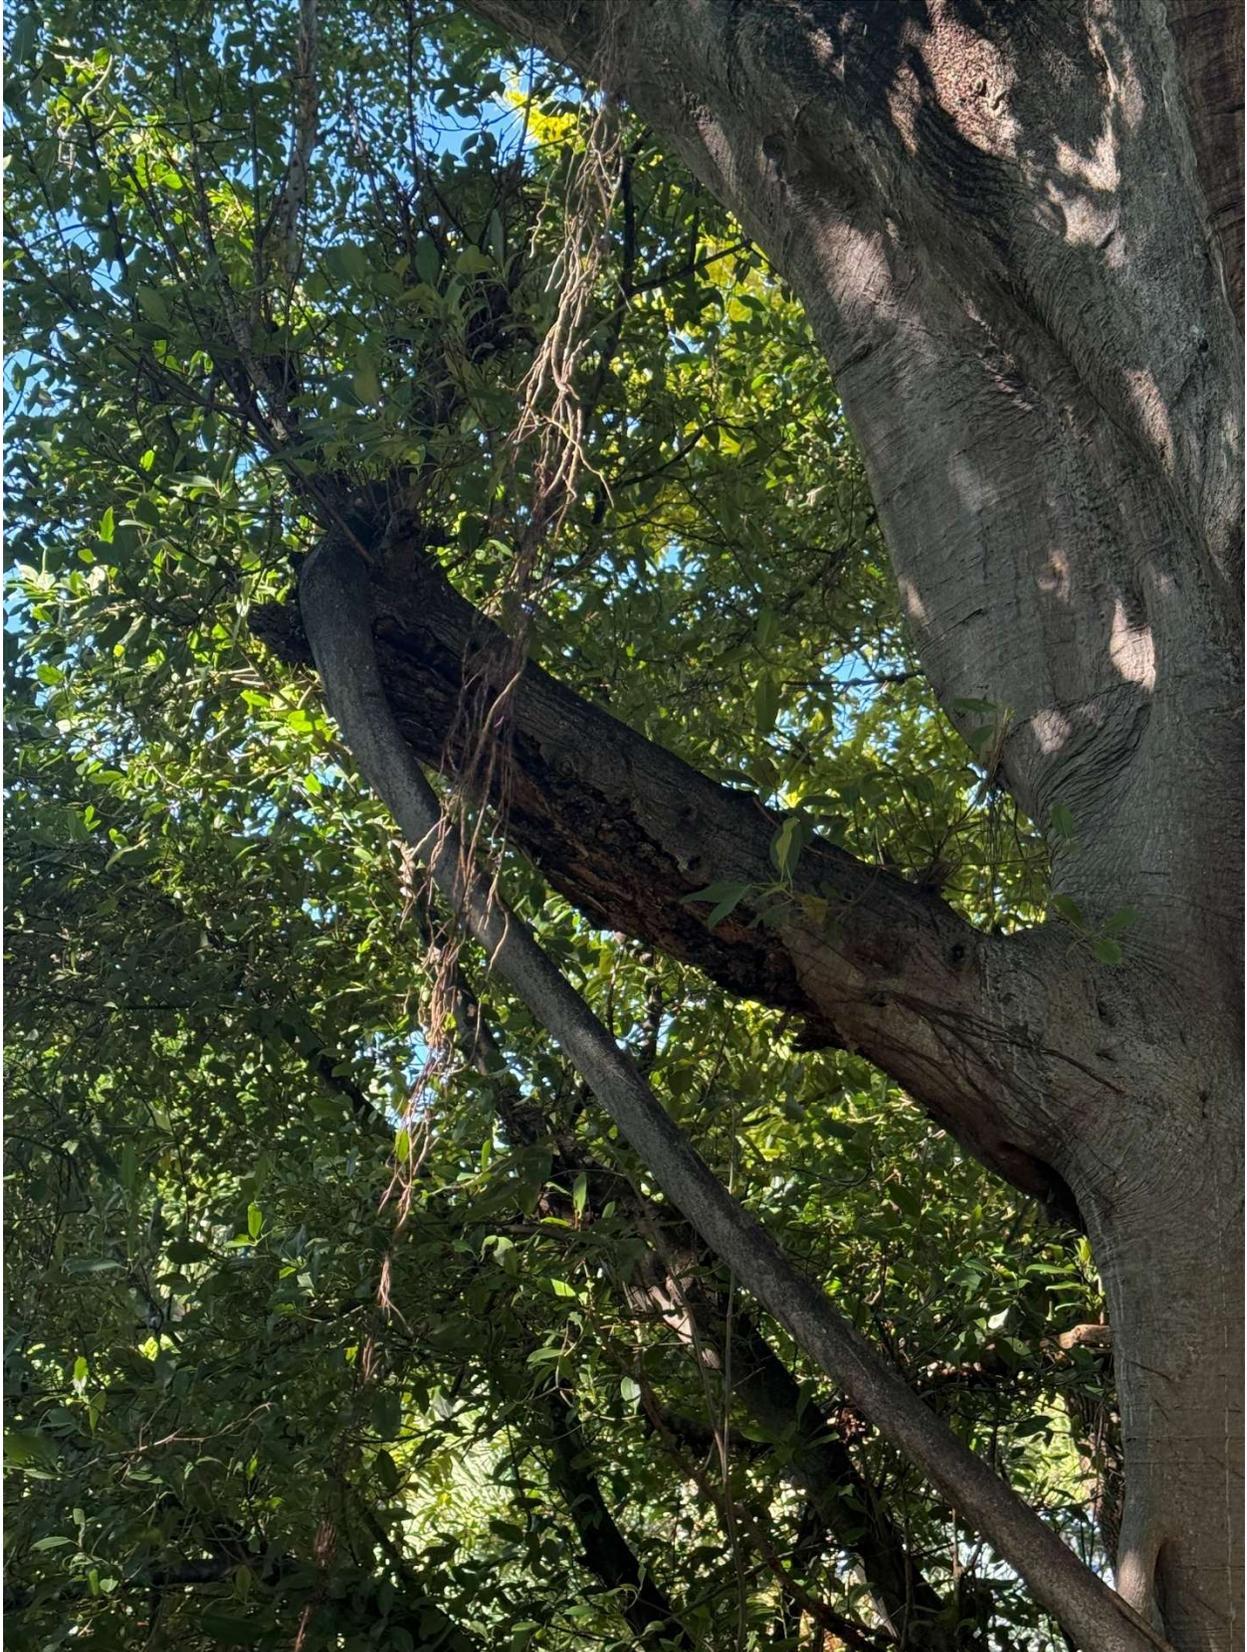
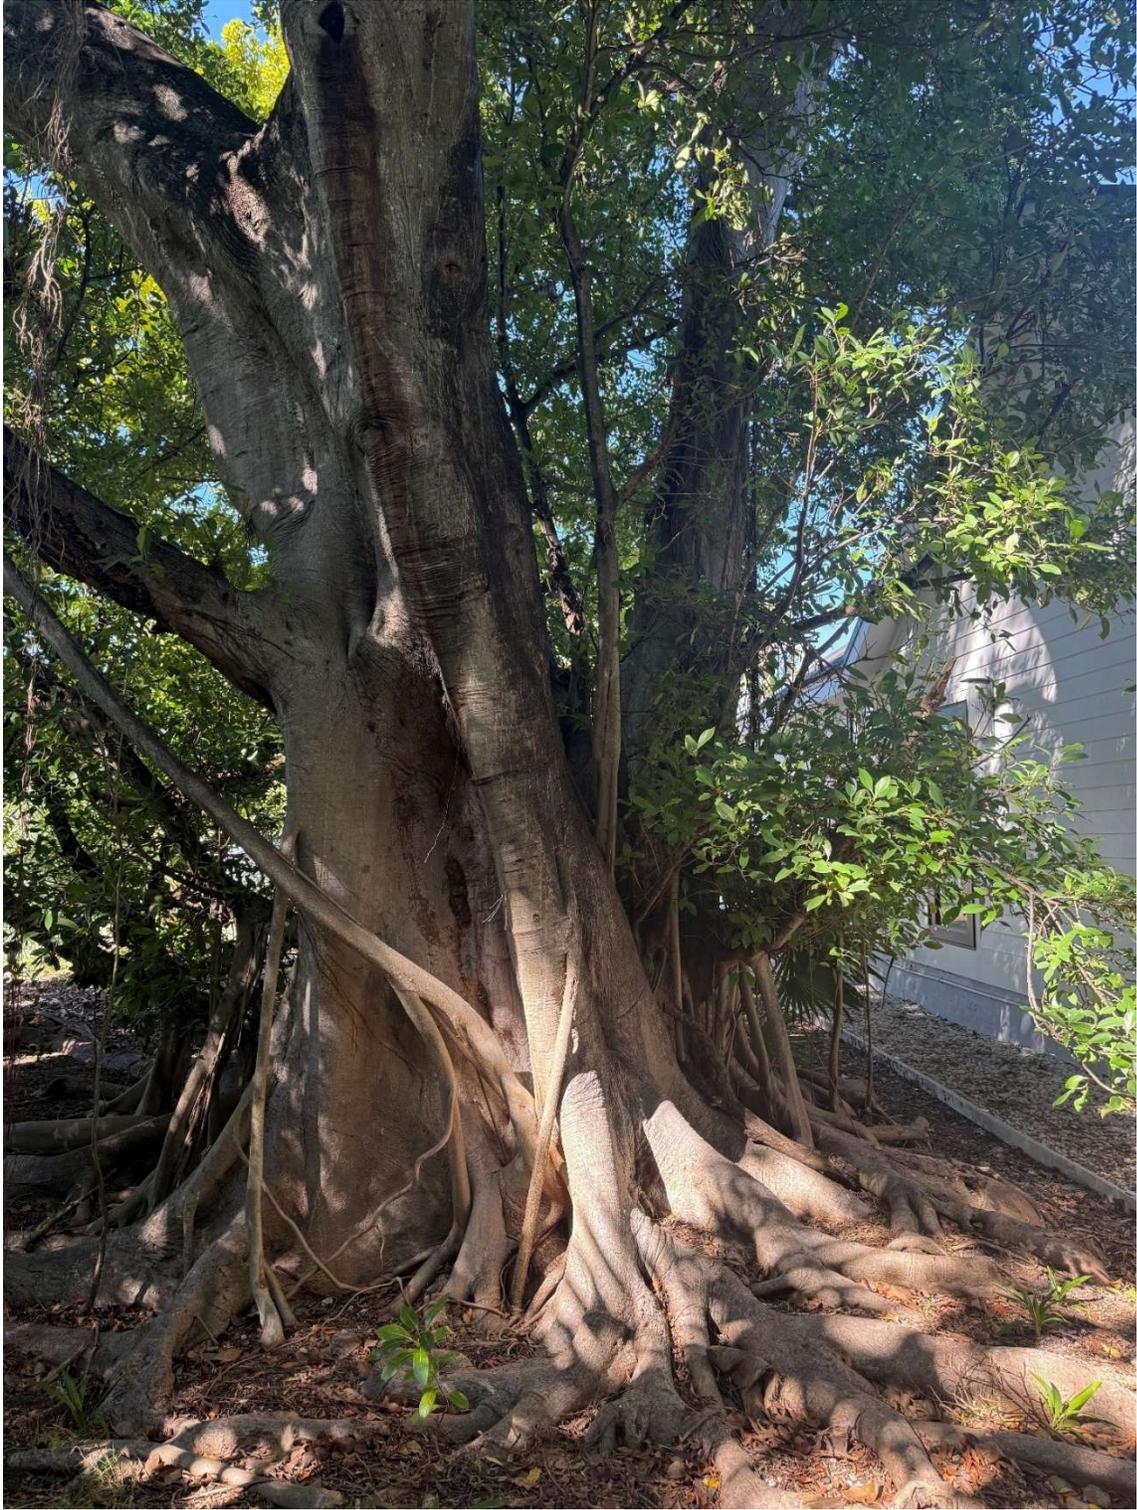
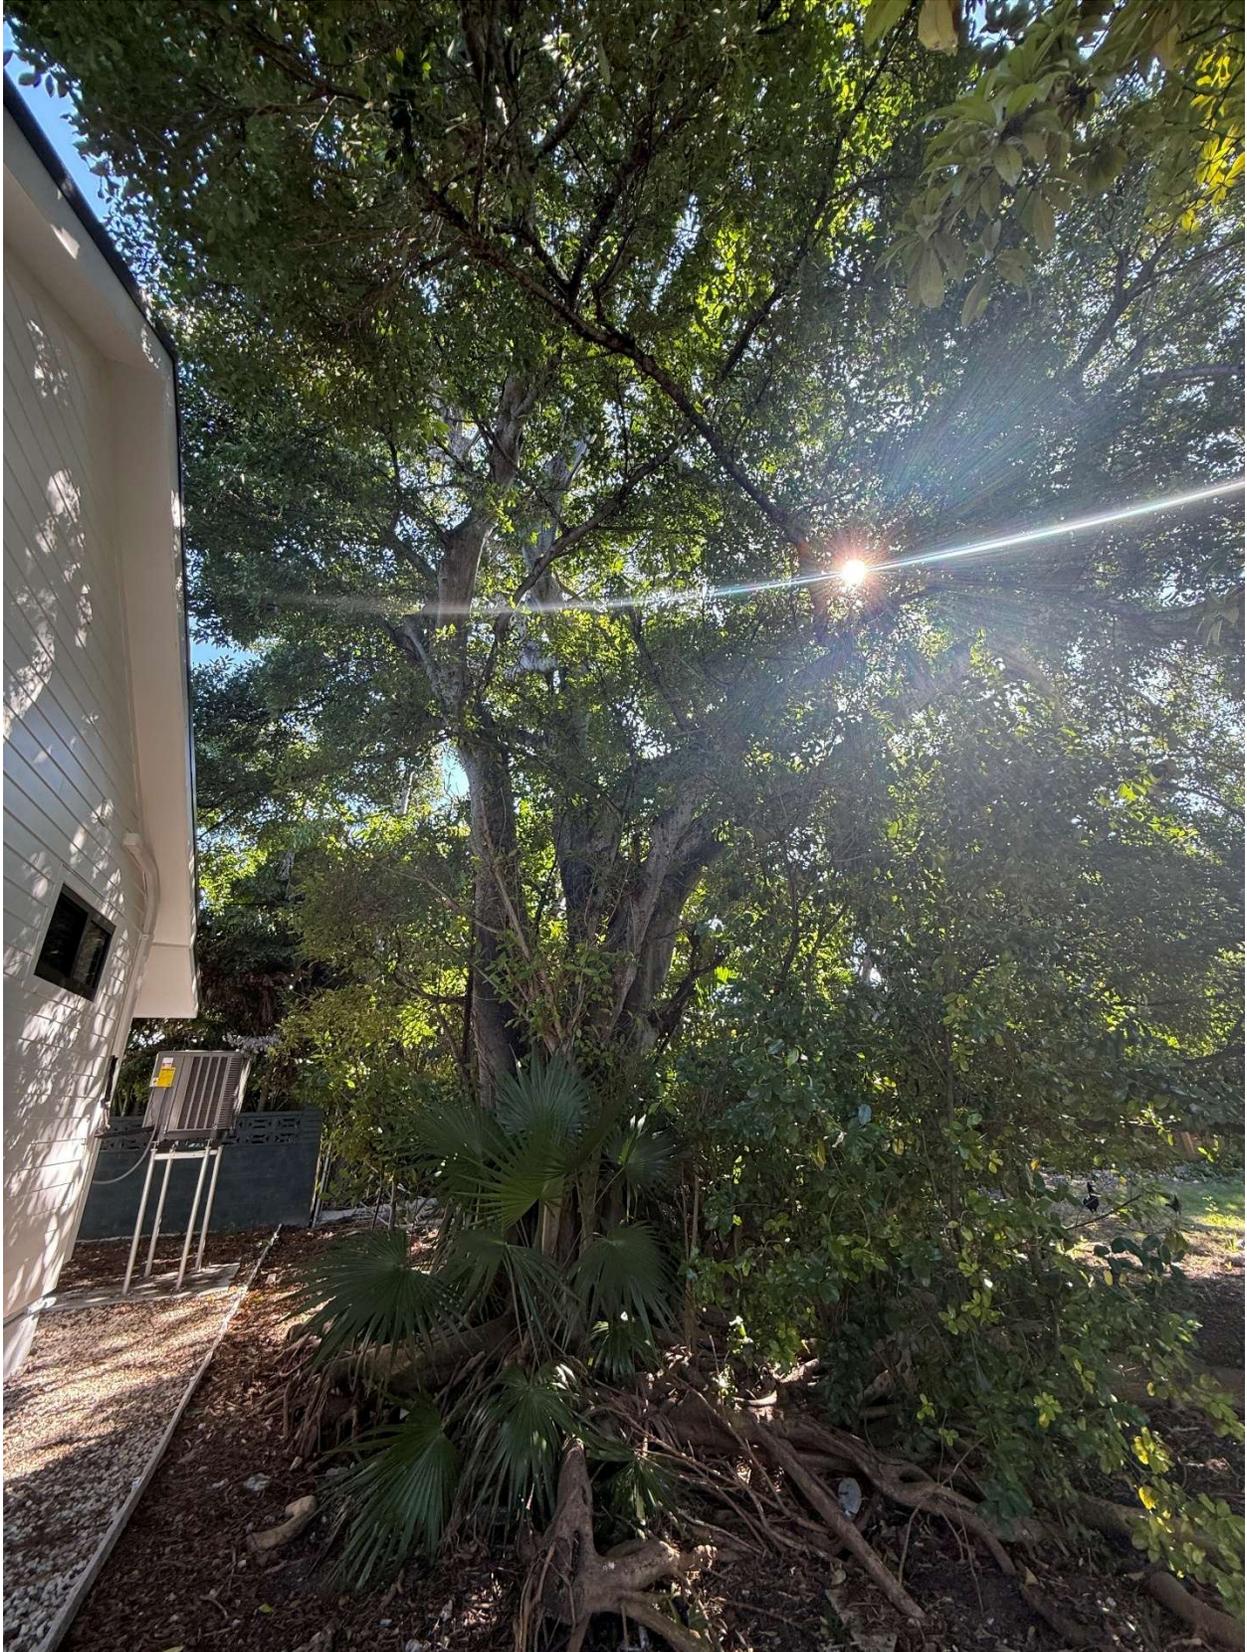
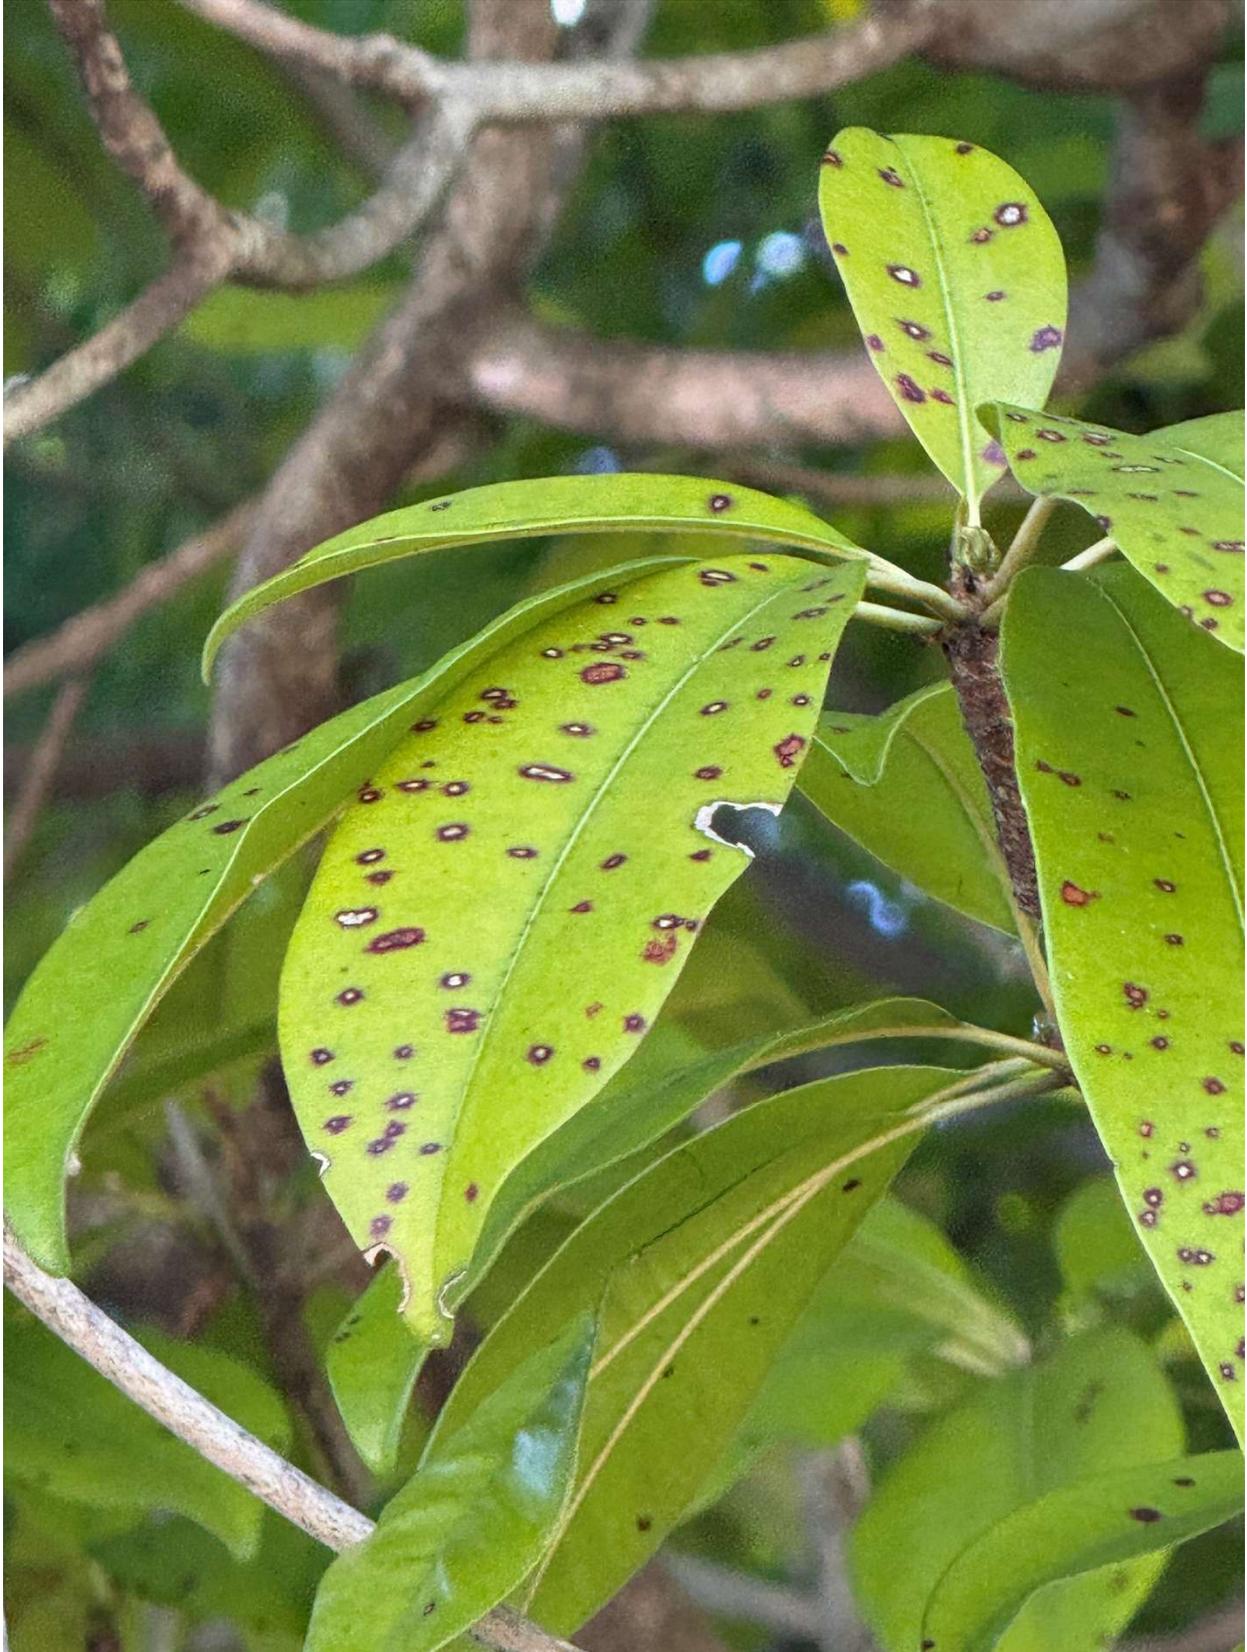
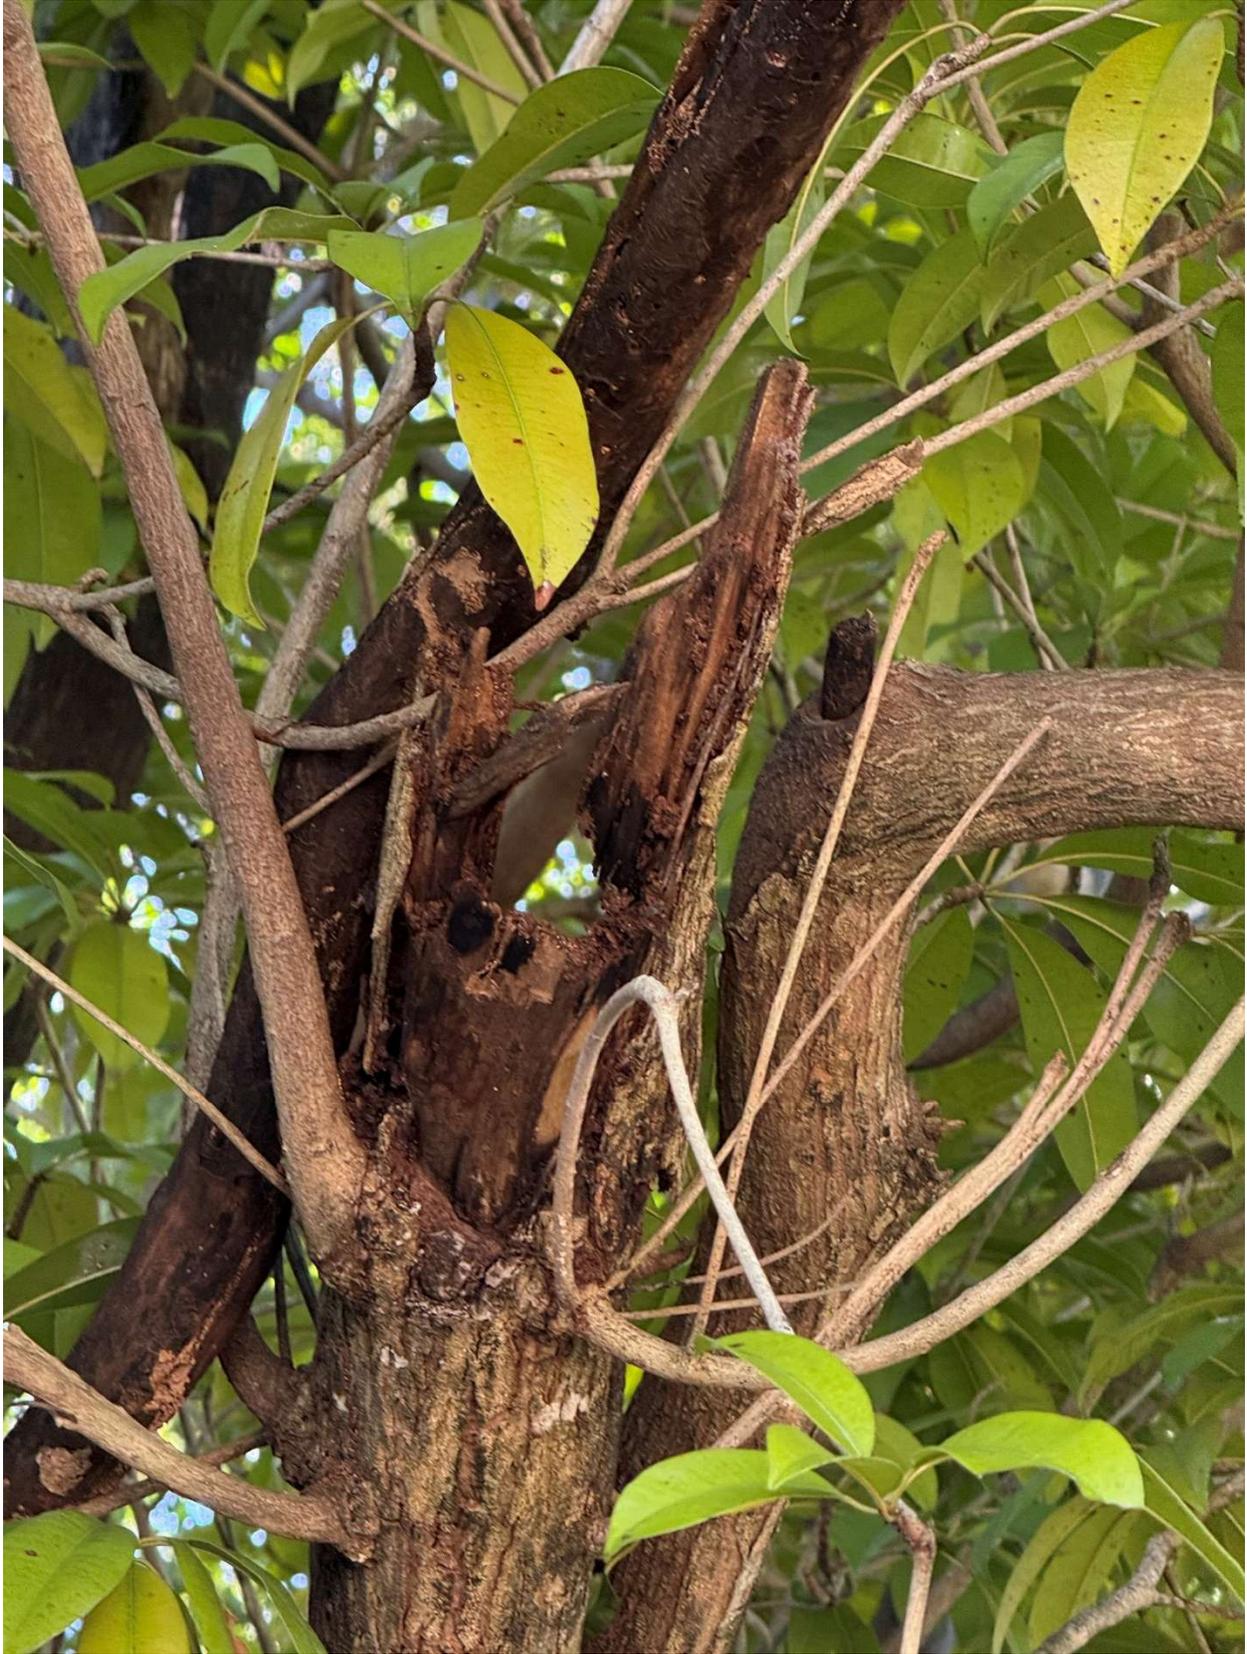
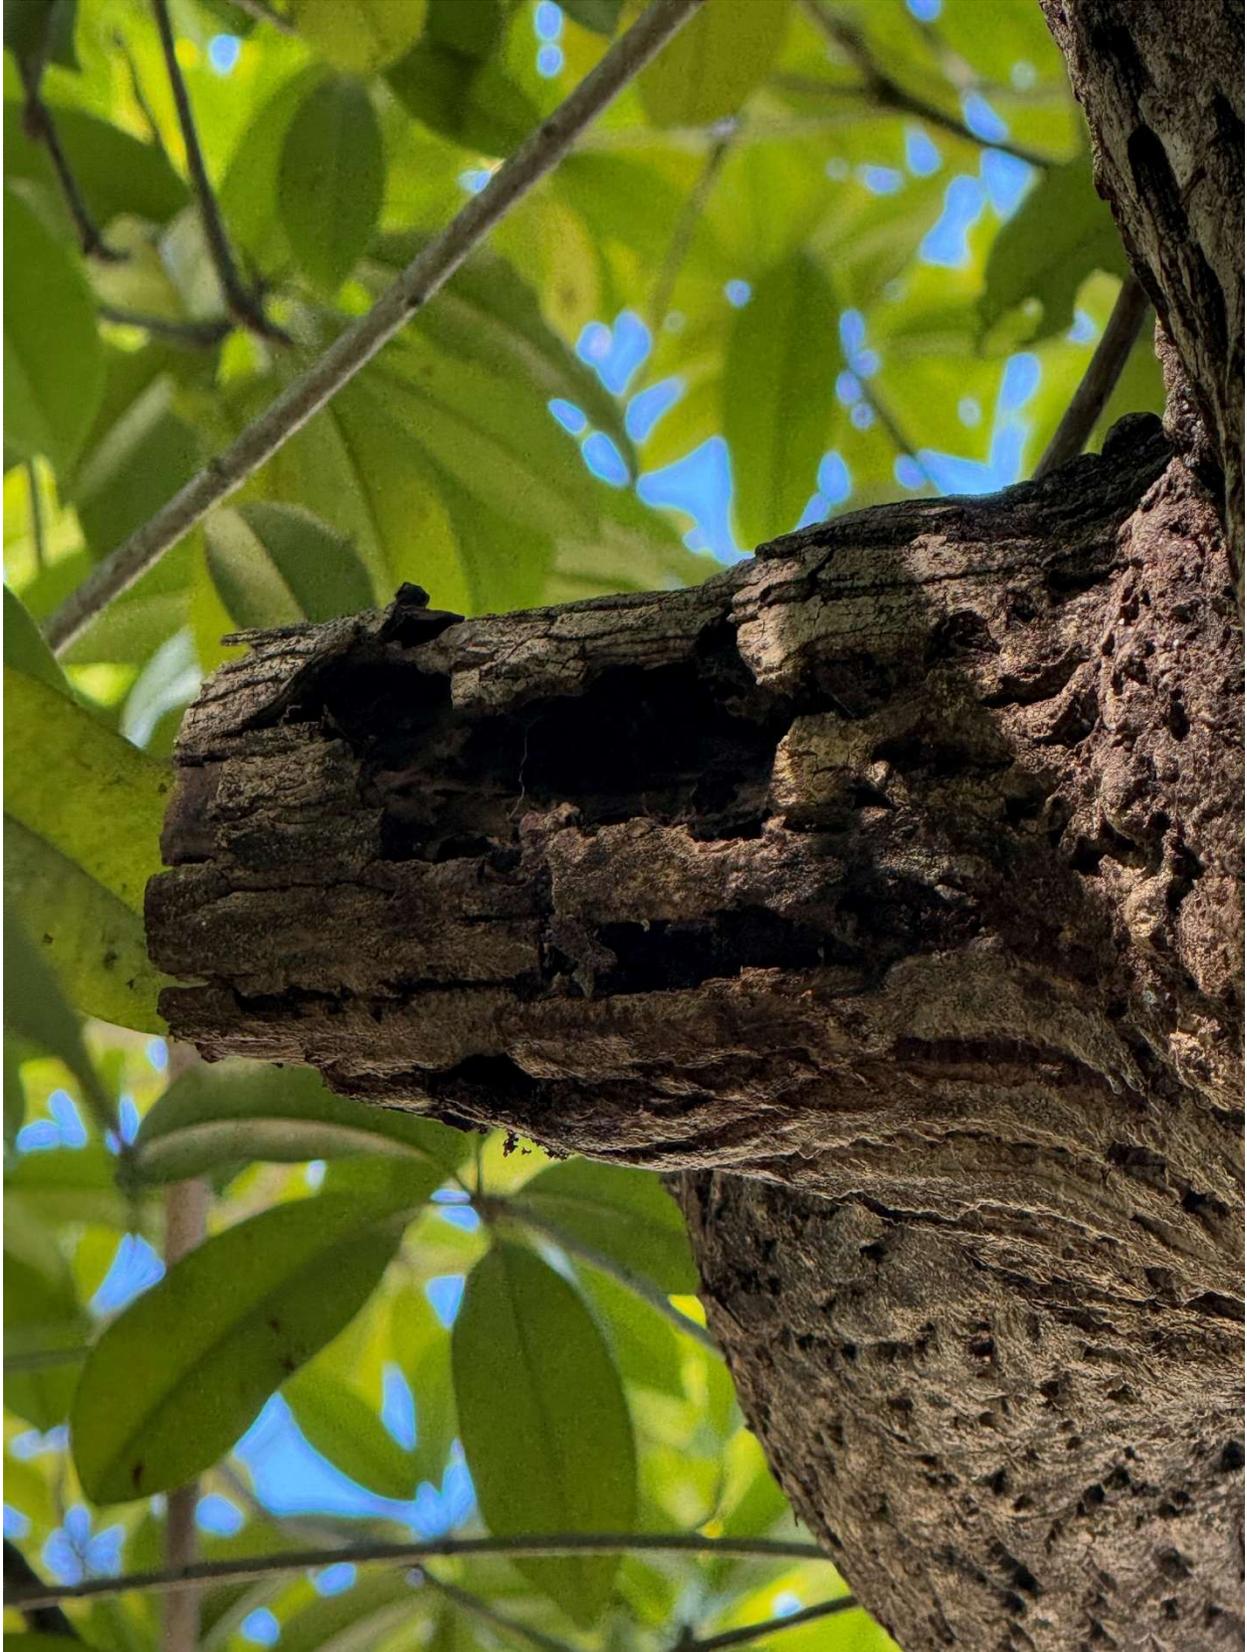
When branches are torn off trees outcomes can range from minor setbacks to serious trouble. Outcomes include disease, pests, and decay.
