# STAFF REPORT

RE: **5220, 5224, 5228, & 5230 College Road**  
**(permit application # T2019-0135)**

FROM: Karen DeMaria, City of Key West Urban Forestry Manager

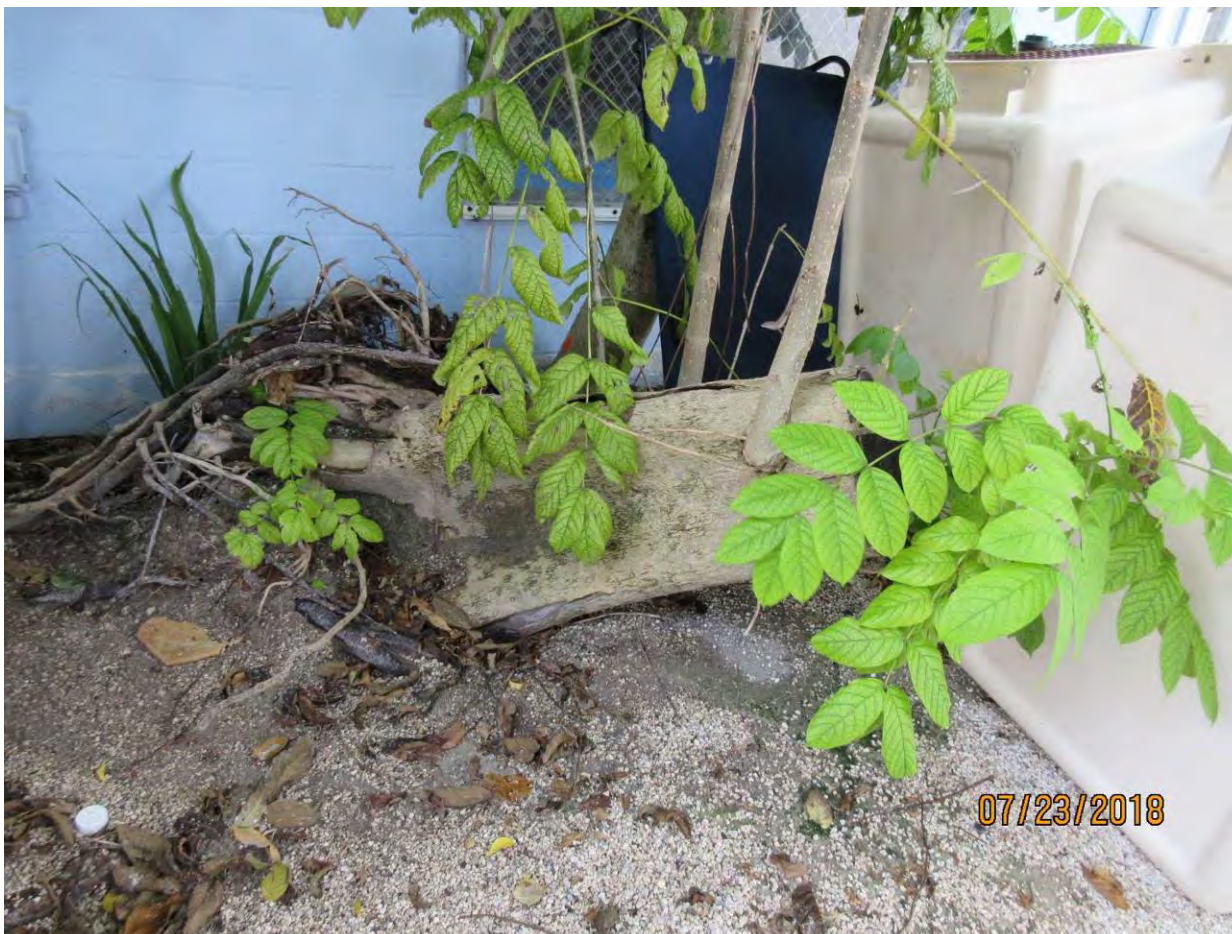
Tree  
#36b

**Tree #36b:**

Diameter: 7.9" (double trunked)

Condition: 40% (codominant trunks, poor structure)

**Value x Diameter = 3.9 replacement caliper inches**
