# Mallory Square Wharf Assessment

## Final Report

### Key West, Florida

June 17, 2025

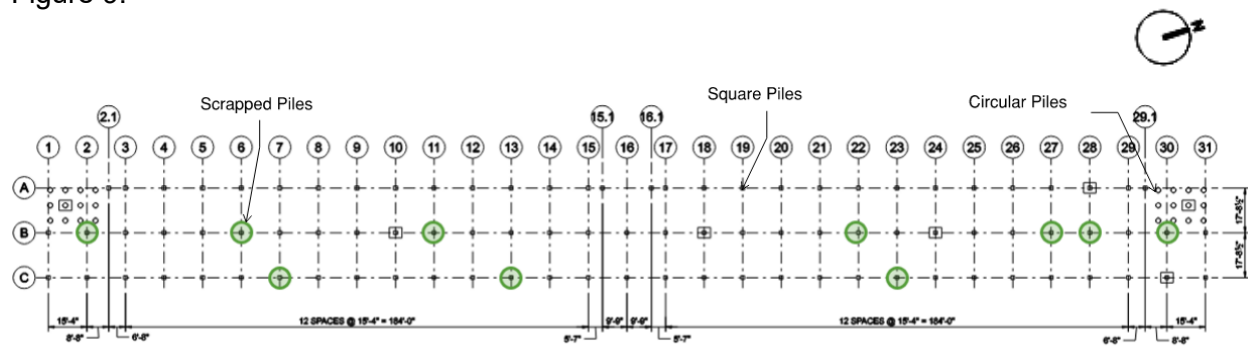
Figure 10 – Design Drawing: Wharf foundation plan

Due to marine growth, limited visual observation of the piles was possible. About 10% of the piles were scraped to be examined at random locations, as shown in Figure 10. The piles were scraped on the shoreside face at isolated locations near the splash zone of the pile. Of the exposed concrete piles, there was no major spalling or exposed reinforcement present. Based on the findings, the concrete piles were found to be in fair condition.

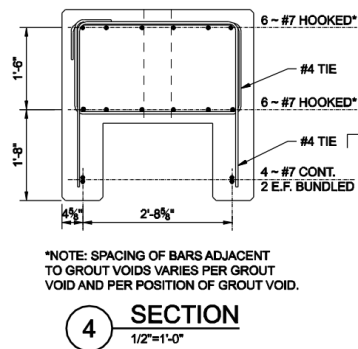
A majority of the precast pile caps were found to have grout failures around the pile connection. The plans show the piles were to be grouted in a 2ft x 2ft pile pocket. The extent of the grout failures above the piles and within the pile cap connection could not be determined without destructive testing.

Figure 15 – Design Drawings: Pile Pocket Section

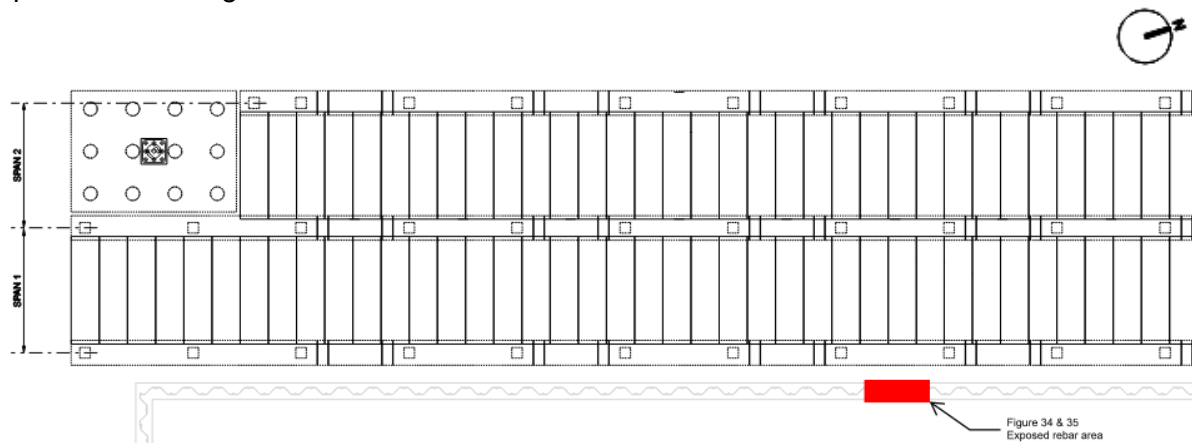
On the west side of the cap face there are instances of additional spalling. There was a section of major spalling located between Piles 8 and 9, measuring 56-inch long by 10-inch deep extending the full height of the cap. The reinforcing steel on the side of the pile cap was exposed and showed 100% surface corrosion on the horizontal and vertical reinforced steel. This resulted in a section loss of about 10% on both the vertical and horizontal reinforced steel. There were two more instances of exposed reinforcing steel on the pile cap, one instance on the bottom face and another along the west face. Both instances exhibited small spalling areas with corrosion on the exposed reinforcing steel.

Figure 36 –Design Drawings: Exposed reinforcing steel on sheet pile cap

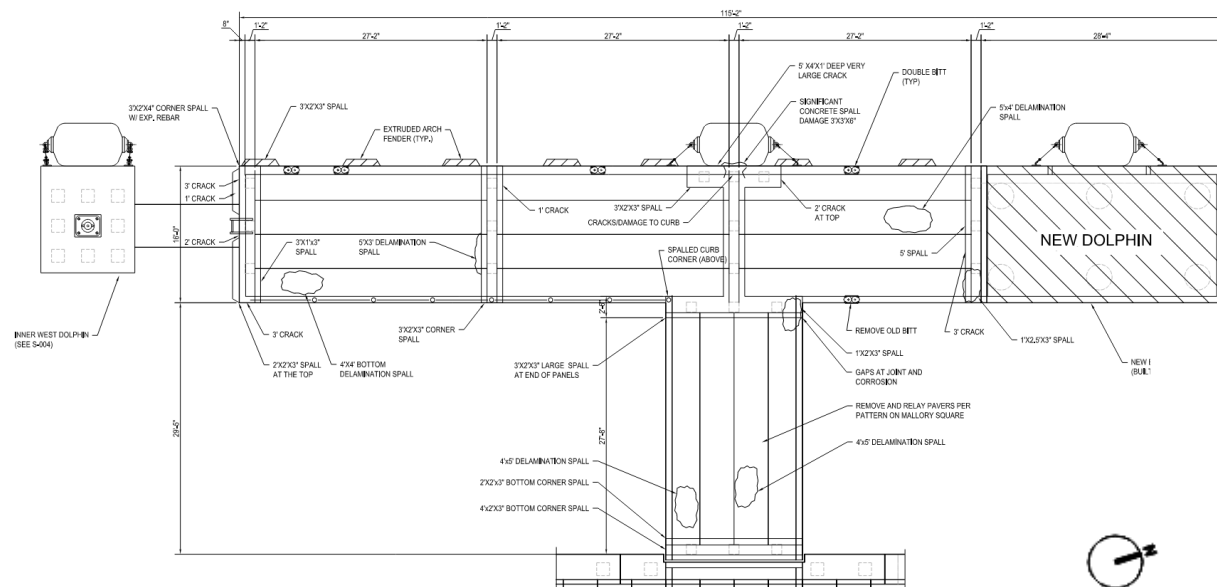
Figure 41 – T dock overall layout

Overall, the components of the T-dock were in fair condition. The underside of the walkway had utilities running along the bottom of the concrete slabs. The bottom of the concrete slabs had large spalls and showed signs of delamination. On the existing walkway there was a spalled area which had exposed reinforcing steel along the north/south direction. The concrete piles appeared to have minor spalling along the corners. Rust staining were present along the concrete pile caps and longitudinal cracking. On the corners of the T-dock where the large cruise fenders are located, there were large cracks and spalling. Overall, the components of the T-dock were in fair condition.

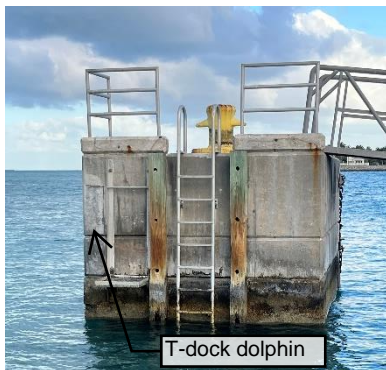
Figure 47 – South T-dock dolphin

The dolphin adjacent to the T-dock on the south end has spalling and cracking on the corners of the pile cap. A protective fender is located on the west side of the dolphin and is attached to the pile cap with several anchor bolts. Cracking was observed at the location of these bolts. The concrete piles were observed to have minor rust staining, with most of the piles covered by marine growth.

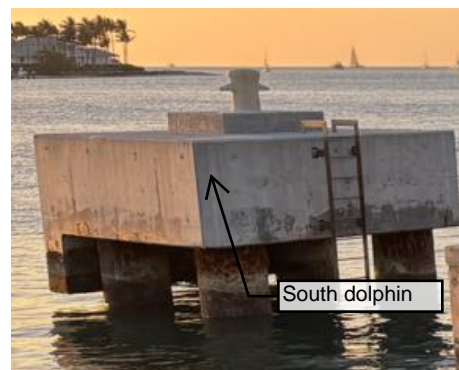
Figure 48 – South dolphin

The south dolphin was observed to have delamination and spalling at the underside of the pile cap. There was no exposed reinforcement present. Large cracks and rust stains were visible on three sides of the pile cap. The steel piles were found to have rust staining along the outside surface through the marine growth. No section loss of the steel pipe piles was observed.

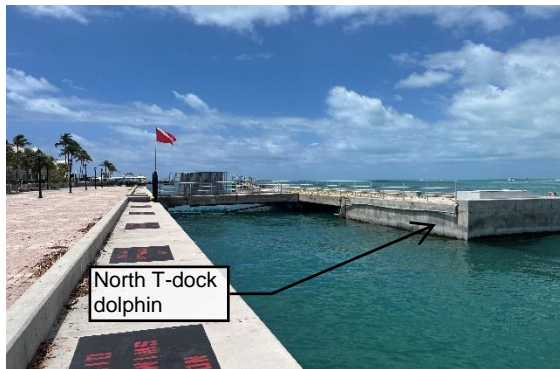
The north T-dock dolphin was found to be in good condition. There was minor spalling on the outside corner of the pile cap. The piles were observed to have minor rust staining through marine growth. No section loss of the steel pipe piles was observed. The pile caps were observed to have scaling in the splash zone.

Figure 53 – Overall north T-dock dolphin
