# Structural Condition Assessment Key West Diesel Plant Key West, Florida

AES Project No. 316-048  
August 3, 2016

Re: Structural Condition Assessment  
Key West Diesel Plant  
Key West, Florida

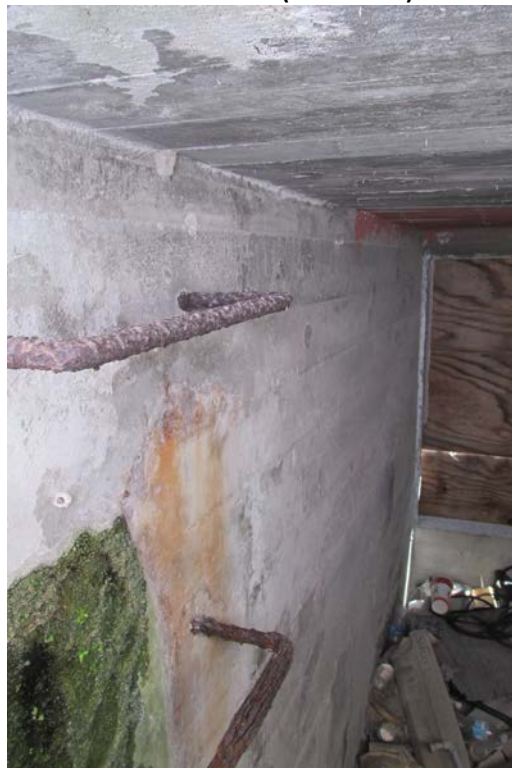
PHOTOGRAPH 50 (BUILDING V)

- V. The concrete exhaust building (Building V) is in good condition with corroded steel ladders; a badly corroded pipe support, a cracked housekeeping pad and a hairline crack in the roof parapet (see Photographs 50, 51, 52 and 53). The exterior pit and chute walls are in poor condition with cracked and spalling concrete with corroding reinforcing (see Photograph 54). All of the interior pits are full of water and breeding mosquitos. The interior trench and pit edge angles are in poor condition and badly corroded (see Photograph 55). All of the dynamos are in poor condition and badly corroded (see Photograph 56).
