RESOLUTION NO. 18-088

A RESOLUTION OF THE CITY COMMISSION OF THE CITY OF KEY WEST, FLORIDA, REQUESTING THAT THE HISTORIC ARCHITECTURAL REVIEW COMMISSION (HARC) REVIEW THE DETERMINATION OF THE CHIEF BUILDING OFFICIAL REGARDING THE DEMOLITION OF CERTAIN STRUCTURES AT THE HISTORIC DIESEL ENERGY PLANT AT 100 ANGELA STREET/GERALDINE STREET, AND MAKE RECOMMENDATIONS TO THE CITY COMMISSION; PROVIDING FOR AN EFFECTIVE DATE

# Structural Condition Assessment Key West Diesel Plant Key West, Florida

Re: Structural Condition Assessment  
Key West Diesel Plant  
Key West, Florida

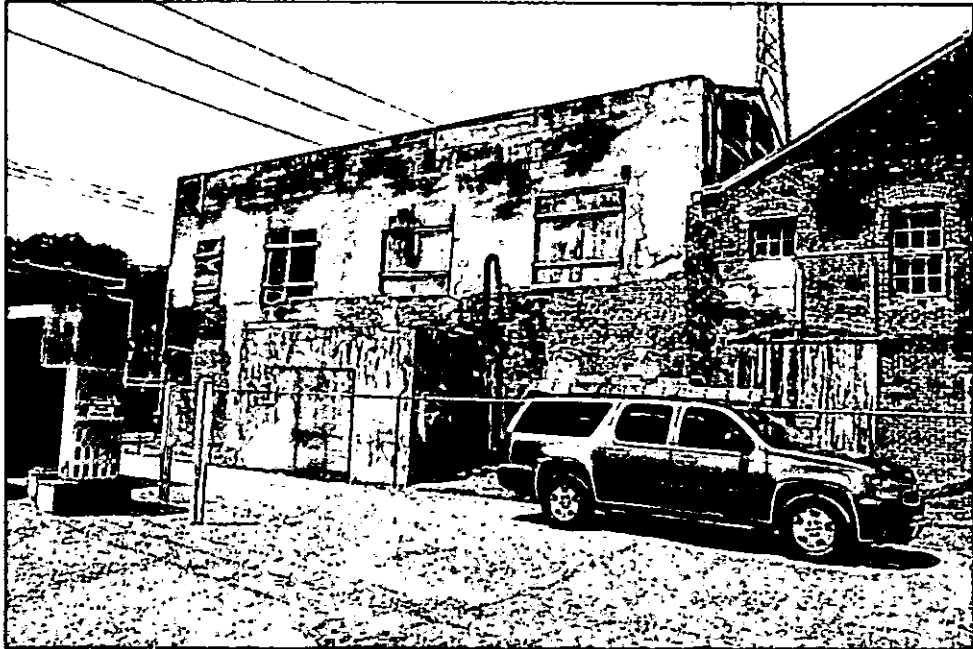
PHOTOGRAPH 5 (BUILDING IV AND V)

The abandoned Diesel Plant consists of four (4) connected one-story, buildings with the three (3) eastern buildings housing four (4) electric dynamos and the southwestern building having a lower roof that probably housed a shop and support spaces. The northernmost eastern building (Building I) houses one (1) dynamo and consists of a high new pre-engineered wood truss framed roof with plywood sheathing and metal roofing supported by perimeter multi-wythe brick walls and interior steel beams and columns (see Photographs 1 and 2). The easternmost center building (Building II) houses two (2) dynamos and consists of metal roofing on plywood sheathing, on wood joists and beams supported by heavy timber trusses and steel beams and columns that support crane beams (see Photographs 3 and 4). The heavy timber roof trusses are supported by perimeter multi-wythe brick walls. The southernmost eastern building (Building IV) houses one (1) dynamo and consists of metal roofing on wood sheathing on wood joists and beams supported by heavy timber trusses, and perimeter low multi-wythe brick walls and upper concrete walls (see Photographs 5 and 6).

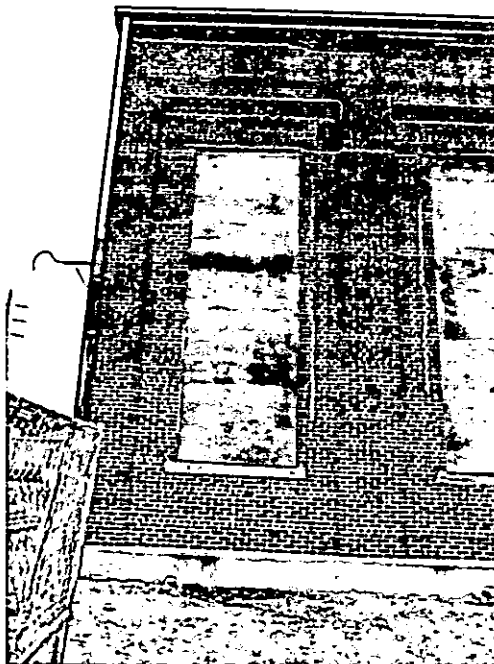
PHOTOGRAPH 17 (BUILDING I)

The exterior masonry walls are in good condition but there are numerous cracks, corroded embedments, deteriorated mortar, corroded lintels, deteriorated face brick, brick cracks with vegetation and random cracks in the concrete water table (see Photographs 17, 18, 19, 20, 21, 22 and 23). At the western return metal panel wall, there is a badly corroded angle purlin and a large column spall with corroded reinforcing and an area of missing metal wall panel (see Photographs 24, 25 and 26). The remaining metal panels are corroded and in poor condition (see Photograph 27).

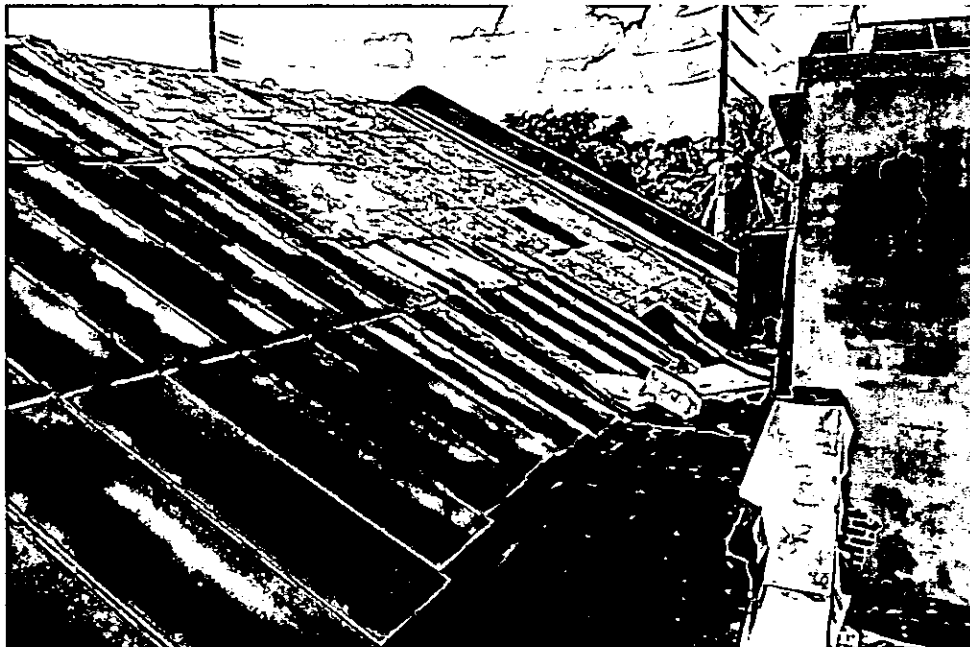
PHOTOGRAPH 28 (BUILDING II)

- II. The eastern center building (Building II) is in much worse condition than the Building I with metal roofing in extremely poor condition with large areas of missing metal roofing and large areas of deteriorated roof decking (see Photograph 28). The roof wood structure is in good condition as well as the steel structure with surficial corrosion except for several badly corroded columns and post bases with more than 20% material loss (see Photographs 29 and 30).

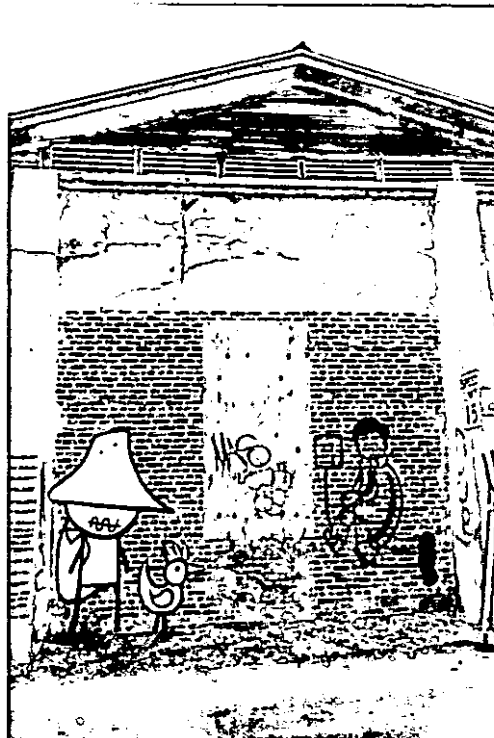
PHOTOGRAPH 48 (BUILDING III)

- III. The southwestern building (Building III) is in worse condition than Building I, but in better condition than the Building II and Building IV. The western metal roof is in good condition with several areas of corroded metal roofing and corroded roofing screws. The eastern metal roof is in poor condition with areas of missing roofing, extensive metal roofing deterioration and areas of deteriorated wood decking (see Photograph 46). The roof wood joists, beams, steel beams and columns are in good condition with surficial steel corrosion on the steel members and a deteriorated wood beam kicker (see Photograph 47). The slab on grade is cracked and uneven and the exterior high concrete has large areas of spalling concrete and a spalling concrete lintel (see Photographs 48 and 49). The exterior CMU and brick has several cracks, corroded embedments and delaminating stucco.
