# Structural Condition Assessment Key West Diesel Plant Key West, Florida

AES Project No. 316-048  
August 3, 2016

Re: Structural Condition Assessment  
Key West Diesel Plant  
Key West, Florida

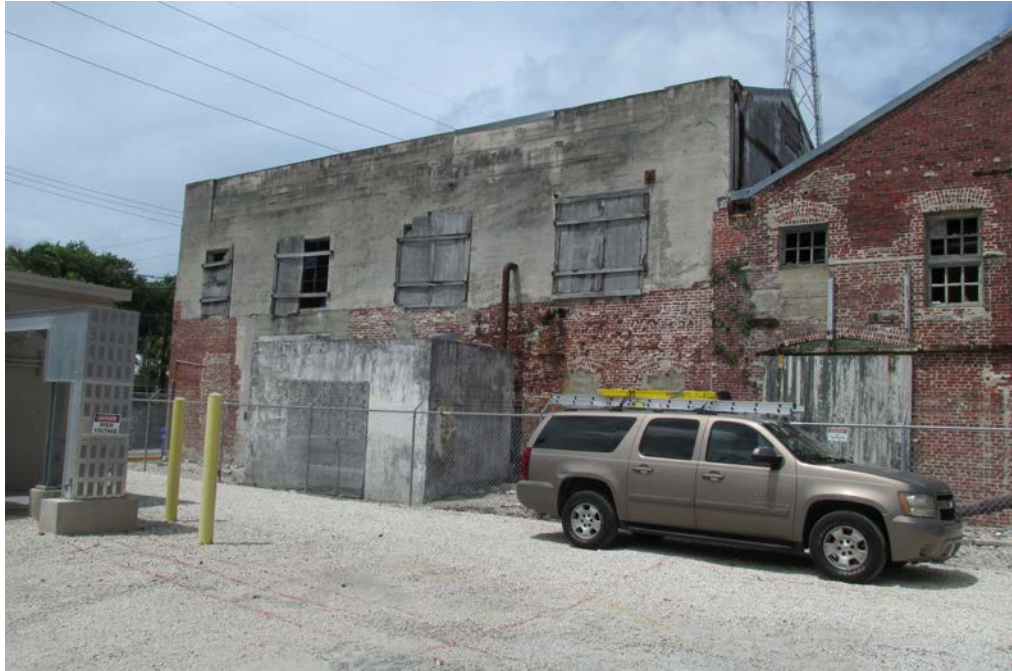
PHOTOGRAPH 5 (BUILDING IV AND V)

The abandoned Diesel Plant consists of four (4) connected one-story, buildings with the three (3) eastern buildings housing four (4) electric dynamos and the southwestern building having a lower roof that probably housed a shop and support spaces. The northernmost eastern building (Building I) houses one (1) dynamo and consists of a high new pre-engineered wood truss framed roof with plywood sheathing and metal roofing supported by perimeter multi-wythe brick walls and interior steel beams and columns (see Photographs 1 and 2). The easternmost center building (Building II) houses two (2) dynamos and consists of metal roofing on plywood sheathing, on wood joists and beams supported by heavy timber trusses and steel beams and columns that support crane beams (see Photographs 3 and 4). The heavy timber roof trusses are supported by perimeter multi-wythe brick walls. The southernmost eastern building (Building IV) houses one (1) dynamo and consists of metal roofing on wood sheathing on wood joists and beams supported by heavy timber trusses, and perimeter low multi-wythe brick walls and upper concrete walls (see Photographs 5 and 6).

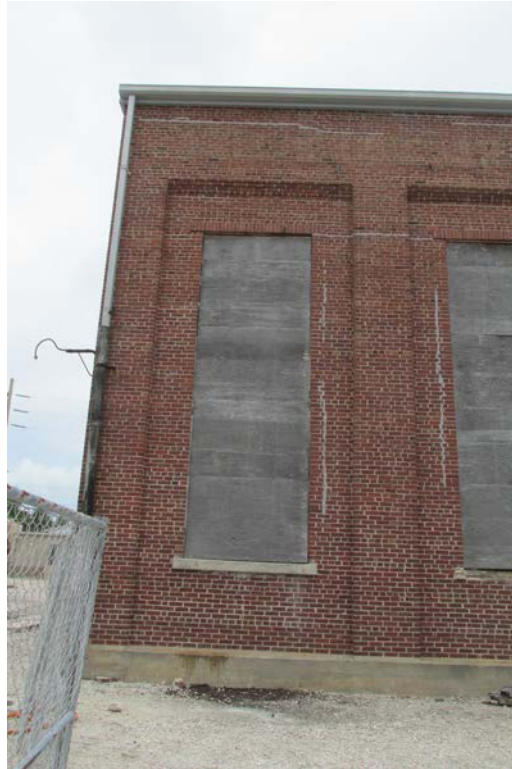
**PHOTOGRAPH 17 (BUILDING I)**

The exterior masonry walls are in good condition but there are numerous cracks, corroded embedments, deteriorated mortar, corroded lintels, deteriorated face brick, brick cracks with vegetation and random cracks in the concrete water table (see Photographs 17, 18, 19, 20, 21, 22 and 23). At the western return metal panel wall, there is a badly corroded angle purlin and a large column spall with corroded reinforcing and an area of missing metal wall panel (see Photographs 24, 25 and 26). The remaining metal panels are corroded and in poor condition (see Photograph 27).

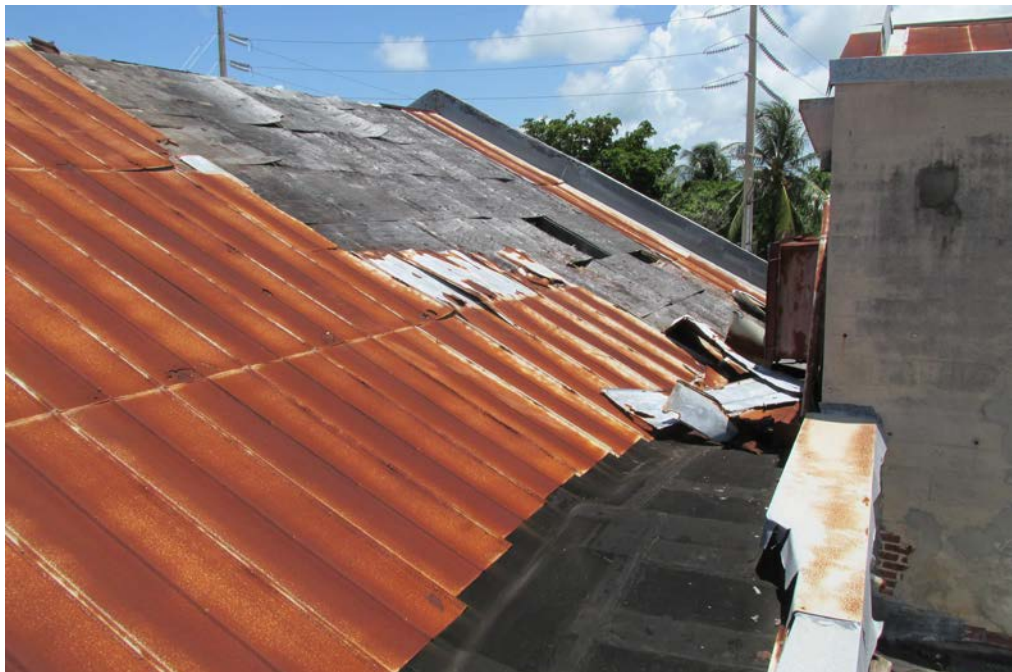
**PHOTOGRAPH 28 (BUILDING II)**

- II. The eastern center building (Building II) is in much worse condition than the Building I with metal roofing in extremely poor condition with large areas of missing metal roofing and large areas of deteriorated roof decking (see Photograph 28). The roof wood structure is in good condition as well as the steel structure with surficial corrosion except for several badly corroded columns and post bases with more than 20% material loss (see Photographs 29 and 30).

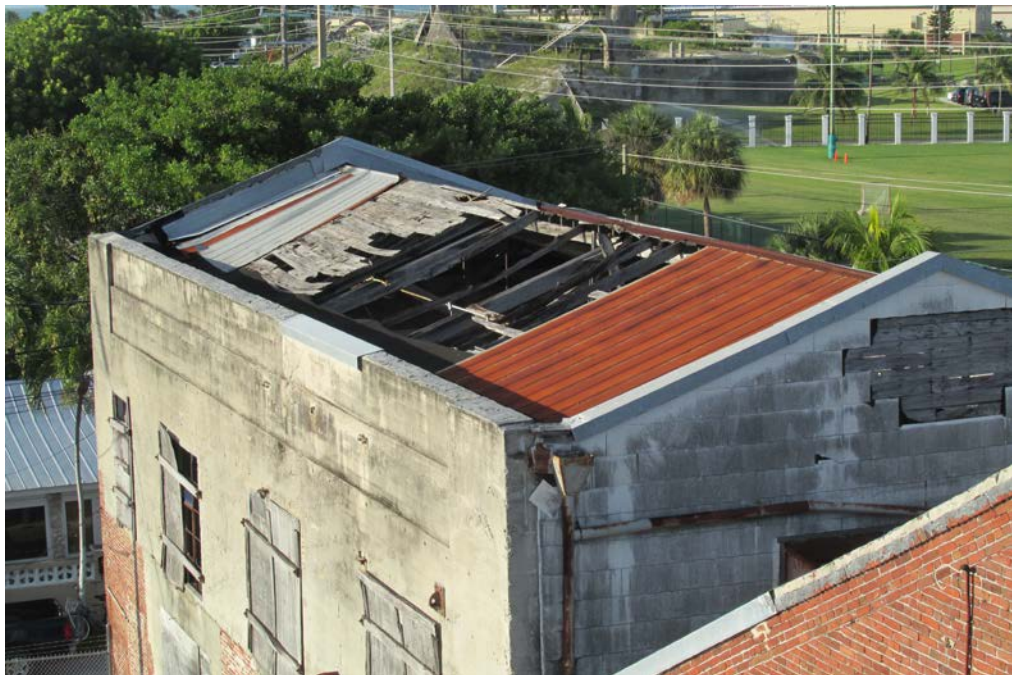
PHOTOGRAPH 40 (BUILDING IV)

- IV. The southernmost eastern building (Building IV) is in worse condition than Building II with a large area of missing metal roofing and wood sheathing, a deteriorated bottom roof truss chord and a wall opening with numerous loose and missing bricks with bricks falling (see Photographs 40, 41 and 42). The wood roof joists are in poor condition but the wood trusses appear in good condition. The steel structure is in good condition with surficial corrosion but many of the steel column bases are severely corroded with more than 20% material loss (see Photograph 43). The exterior masonry walls are in good condition but there are numerous cracks, corroded embedments, deteriorated mortar and loose and missing face brick. The upper concrete walls have large areas of honey combed concrete and an area of spalled concrete with corroded reinforcing (see Photographs 44 and 45).

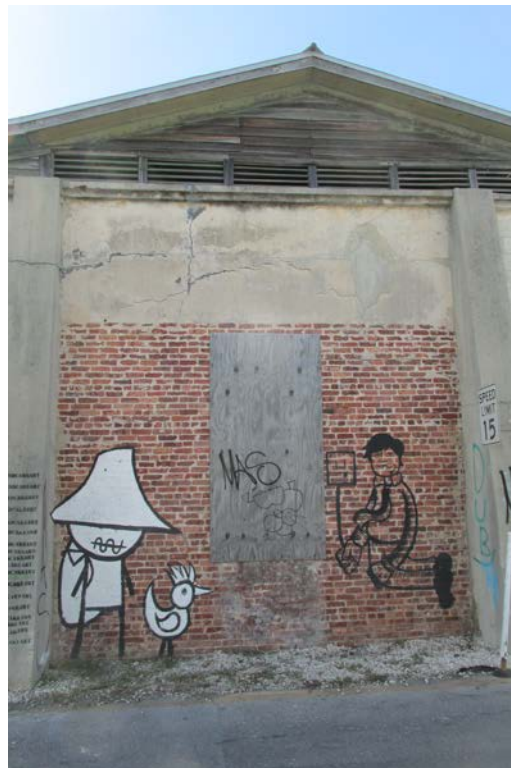
PHOTOGRAPH 48 (BUILDING III)

- III. The southwestern building (Building III) is in worse condition than Building I, but in better condition than the Building II and Building IV. The western metal roof is in good condition with several areas of corroded metal roofing and corroded roofing screws. The eastern metal roof is in poor condition with areas of missing roofing, extensive metal roofing deterioration and areas of deteriorated wood decking (see Photograph 46). The roof wood joists, beams, steel beams and columns are in good condition with surficial steel corrosion on the steel members and a deteriorated wood beam kicker (see Photograph 47). The slab on grade is cracked and uneven and the exterior high concrete has large areas of spalling concrete and a spalling concrete lintel (see Photographs 48 and 49). The exterior CMU and brick has several cracks, corroded embedments and delaminating stucco.

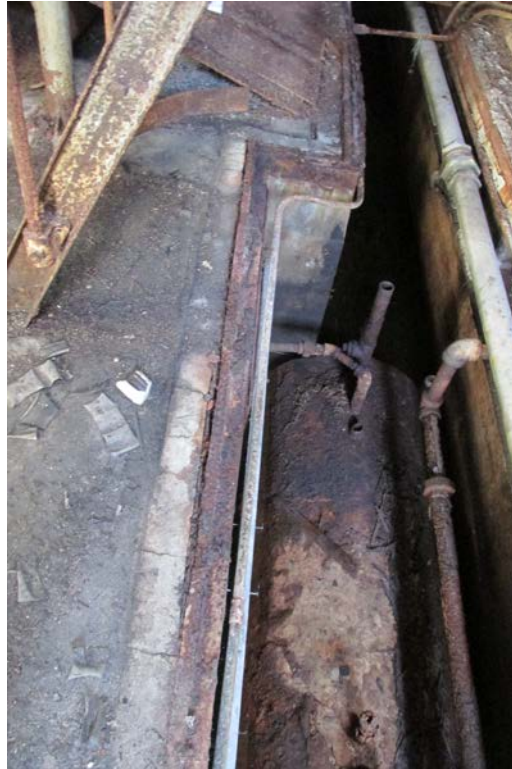
PHOTOGRAPH 55 (BUILDING III)

- V. The concrete exhaust building (Building V) is in good condition with corroded steel ladders; a badly corroded pipe support, a cracked housekeeping pad and a hairline crack in the roof parapet (see Photographs 50, 51, 52 and 53). The exterior pit and chute walls are in poor condition with cracked and spalling concrete with corroding reinforcing (see Photograph 54). All of the interior pits are full of water and breeding mosquitos. The interior trench and pit edge angles are in poor condition and badly corroded (see Photograph 55). All of the dynamos are in poor condition and badly corroded (see Photograph 56).
