Subject: Key West Garrison Bight Seawall Assessment

KEY WEST CITY MARINA AT GARRISON BIGHT
"CHARTER BOAT ROW" SEAWALL ASSESSMENT 2020

SUBMITTED: September 30, 2020

REVISED: October 9, 2020

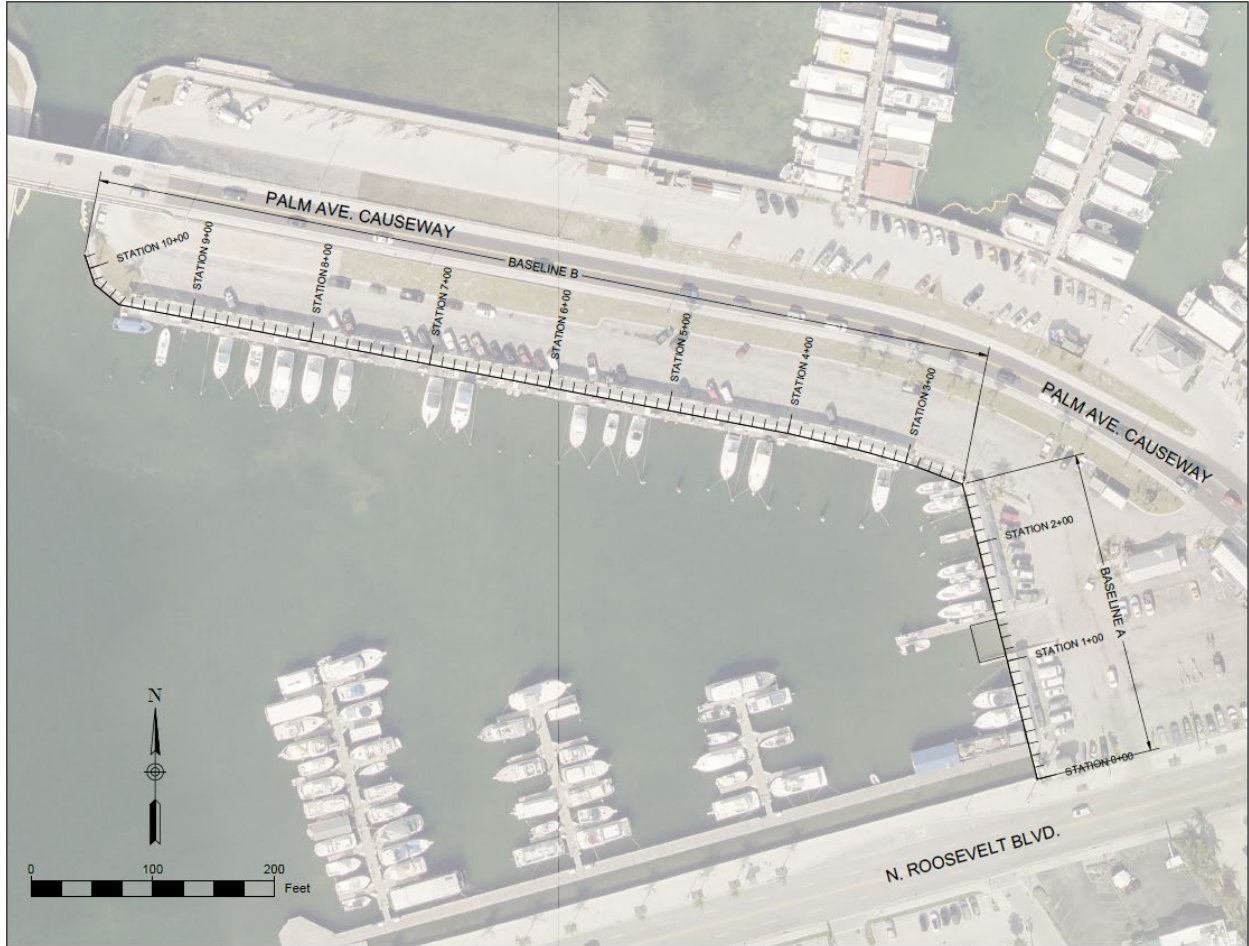
Figure 1: Inspection Stationing Layout for Cataloguing Deficiencies

The following exhibit shows how the inspection transect was configured and referenced to provide a synopsis of the wall conditions. Figure 1 shows how the divers marked the basin bottom from 0-feet to 1,010-feet, along the toe of the wall.

Tape measures were used to mark the site from 0+00 feet (at N Roosevelt Blvd.) to 10+10 feet (at the bridge crossing of Palm Avenue Causeway) by placing measurement tape along the mudline of the wall. Measurements were then taken as needed perpendicular to the tape-marker at the mudline up the wall to the points of interest so that each deficiency could be catalogued. The inspection consisted of a limited nondestructive structural assessment sufficient to determine the existing visual condition of the bulkhead. Tetra Tech staff were onsite to coordinate field work logistics and catalog structural deficiencies within the designated limits of inspection.

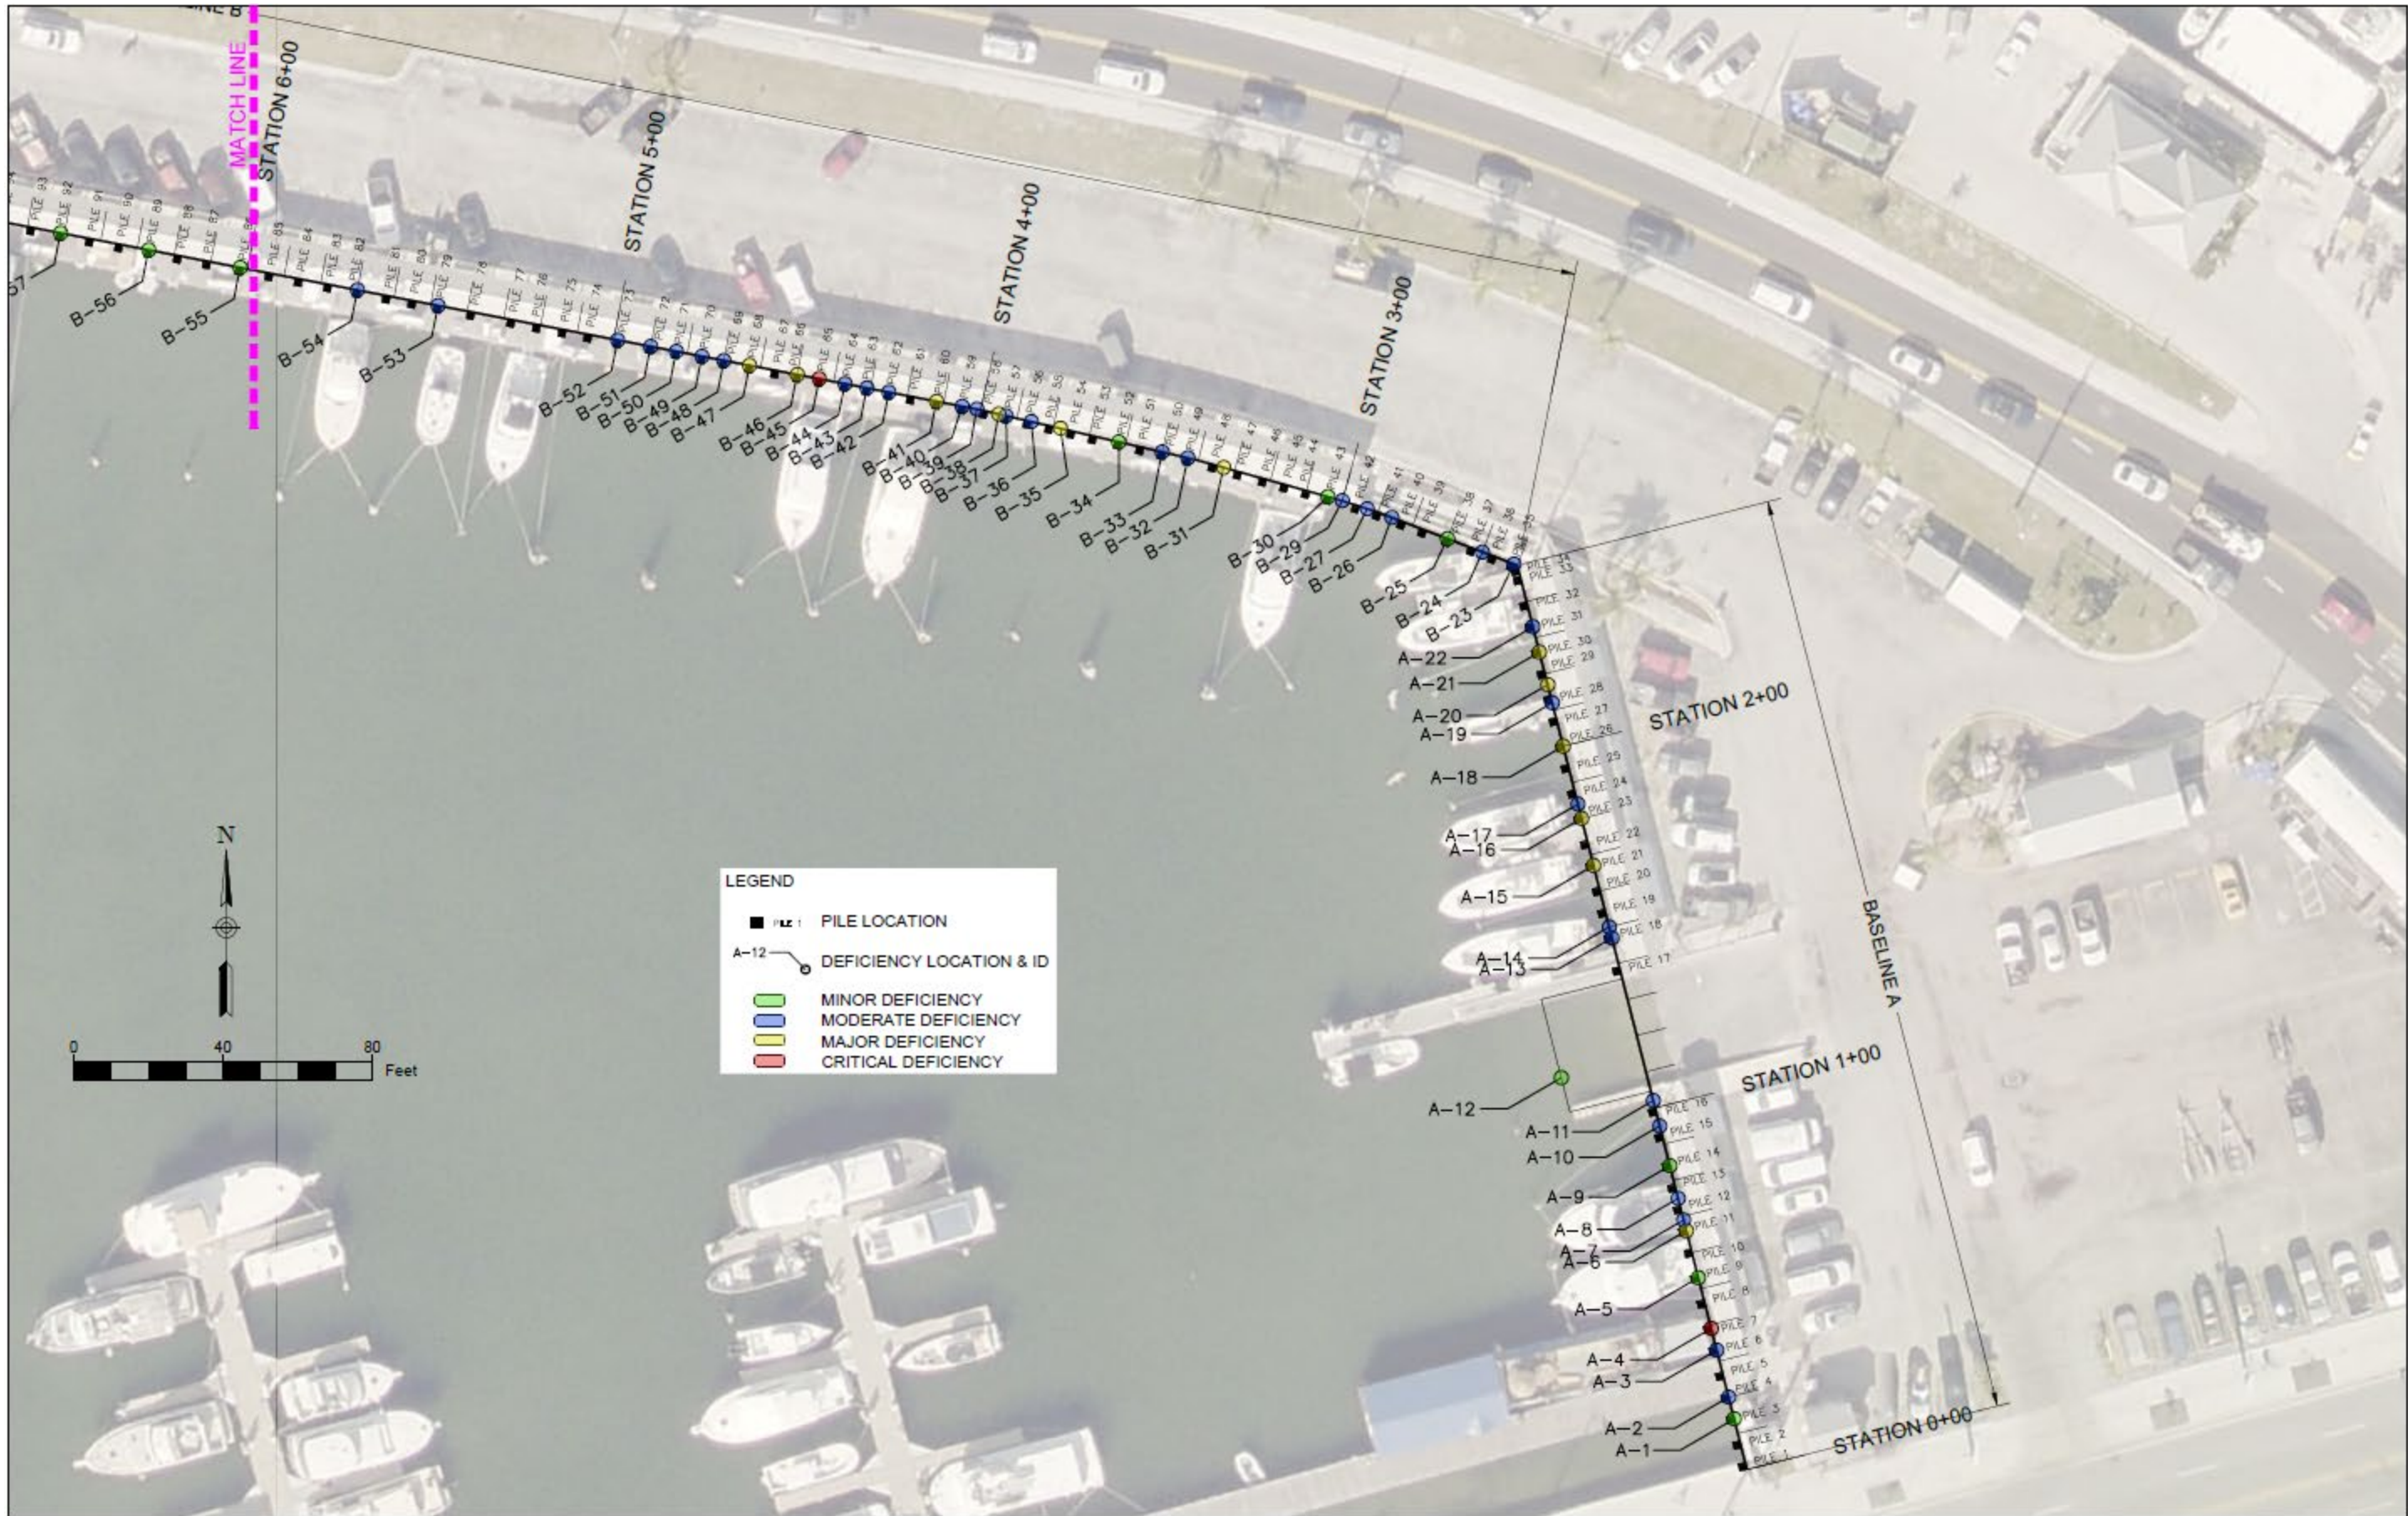
Figure 5: Deficiency Locations - Station 0+00 to Station 6+00

Deficiencies have been quantified/described in Table 2 and their general locations can be seen on Figure 5 and Figure 6. Each deficiency has been given a numerical value preceded by the Baseline (A or B). The “location/pile #” indicates the structural component for the deficiency being addressed (referenced to the nearest pile), followed by a station which generalizes the location along the inspection transect.

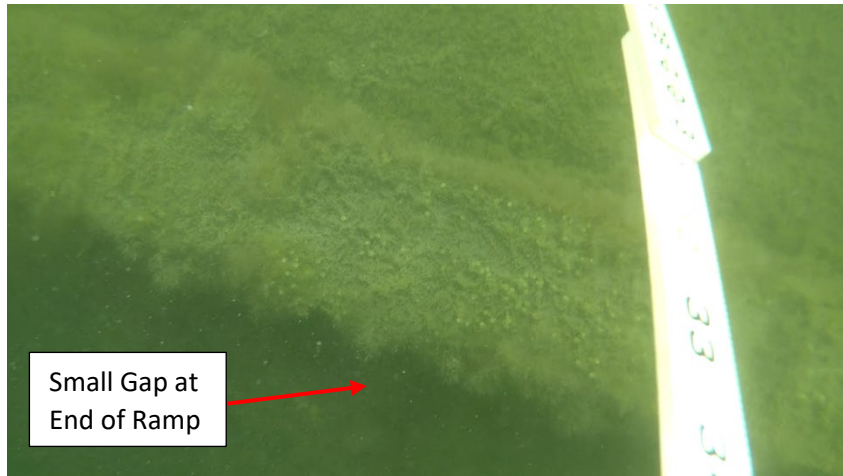
Deficiency A-12: Boat Ramp (Station 1+14)

A-10	Panel 15-16	0+95	Moderate	Horizontal cracking along full width of panel, above water line.
A-11	Panel 16-17	1+02	Moderate	Horizontal cracking along full width of panel, above water line.
A-12	Boat Ramp	1+14	Minor	Small void area, 4-6" penetration, below bottom of ramp footer - does not present an issue as there appears to be concrete overpour in this area.
A-13	Pile 18	1+47	Moderate	16" crack at top right wing of pile.
A-14	Panel 18-19	1+50	Moderate	Horizontal cracking along full width of panel, above water line.
A-15	Pile 21	1+67	Major	Top right wing of pile spalled/separated with cracking extending 32" from cap to below water at pile face.
A-16	Pile 23	1+80	Major	Top right wing/face of pile spalled/separated extending 28" from cap to below water.
A-17	Panel 24-25	1+84	Moderate	Horizontal cracking along full width of panel, above water line.
A-18	Pile 26	2+00	Major	Right-side face of pile has a large crack with some concrete separation extending 28" from cap to below water. Left-side face has also begun cracking, and there is honeycombing on the pile. The panel behind the pile is also starting to show vertical cracking adjacent to the pile.

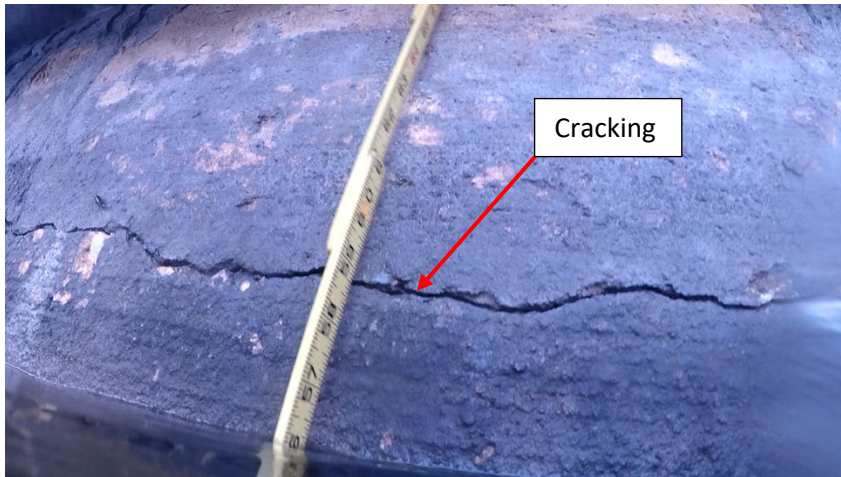
Deficiency A-20: Panel 28-29 (Station 2+17)_1 of 2

A-19	Panel 27-28	2+12	Moderate	Panel cracking next to Pile 28 (right side of pile), with cracks extending toward Pile 27.
A-20	Panel 28-29	2+17	Major	Horizontal cracking along full width of panel, above water line. Also, void/undermining below panel with 5" of penetration.
A-21	Pile 30	2+26	Major	Top right wing spalled/separated with multiple cracks on face of pile extending 38" from cap to below water.
A-22	Pile 31	2+33	Moderate	Cracks with some face spalling developing in front of both wings on face of pile extending 33" from cap to below water and rust staining.
B-23	Pile 35	2+51	Moderate	Cracks developing on face of pile, mostly right side, extending 28" from cap to below water.
B-24	Culvert Panel 36-37	2+60	Moderate	Multiple cracks developing above culvert opening with exposed aggregate around mouth of opening.
B-25	Pile 38	2+70	Minor	Crack beginning to develop on face of pile above water.

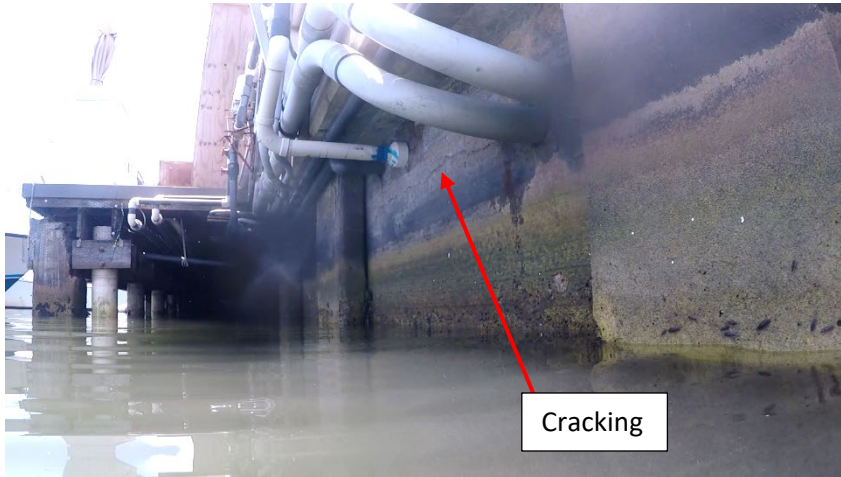
Deficiency B-27: Panel 41-42 (Station 2+93)

B-26	Panel 40-41	2+86	Moderate	Horizontal cracking along full width of panel, above water line, with additional cracks developing near Pile 40.
B-27	Panel 41-42	2+93	Moderate	Horizontal cracking beginning near pipe cutouts by Pile 41, extending along full width of panel, above water line.
B-28	Pile 42	2+96	Moderate	Cracks developing on face of pile extending 22" down from cap.
B-29	Panel 42-43	3+00	Moderate	Horizontal cracking along full width of panel, above water line.
B-30	Pile 43	3+04	Minor	Cracks beginning to form on face of pile with some rust staining.
B-31	Cap @ 47-48	3+33	Major	Spalled/broken-off chunk of concrete from cap with exposed rebar.
B-32	Pile/Cap 49	3+43	Moderate	Gap in concrete cap around top of pile with cracking developing along the cap.
B-33	Pile/Cap 50	3+50	Moderate	Cracking on front face of pile extending 23" down from cap. Also, 3 spalls/broken-off chunks, 6-12" wide, from cap at location of embedded reinforcement.

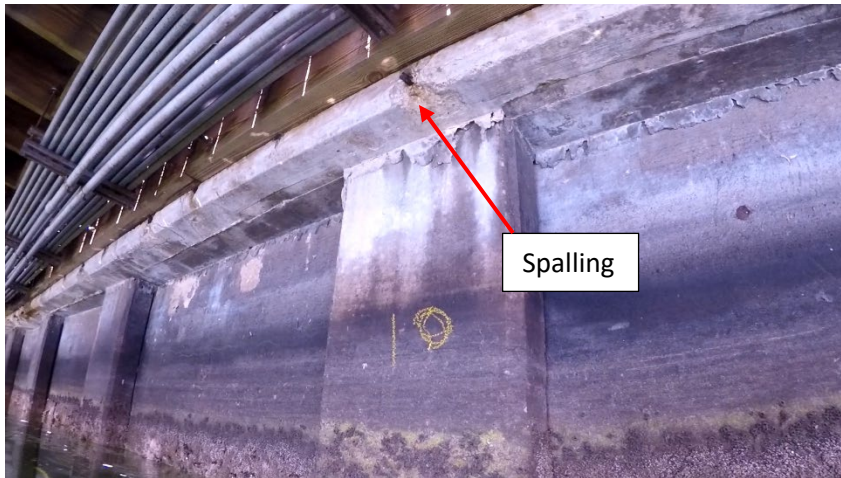
Deficiency B-34: Cap @52 (Station 3+62)

B-34	Cap @ 52	3+62	Minor	Small spall/broken edge of cap at location of embedded reinforcement.
B-35	Cap @ 54-55	3+78	Major	3 spalls/broken-off chunks, 10-12" wide, from cap at location of embedded reinforcement, with additional cracking occurring along the cap and at top of cap.
B-36	Pile/Cap 56	3+86	Moderate	Cracking on right wing of pile extending 21" down from cap. Also, 2 spalls/broken-off chunks, 6" wide, from cap at location of embedded reinforcement.
B-37	Pile 57	3+93	Moderate	Cracking with initial separation at right wing of pile extending 29" down from cap to below water.
B-38	Cap @ 57-58	3+95	Major	40" long section of spalled concrete from the cap with exposed rebar around locations of embedded reinforcement, with hairline cracking at top of cap.
B-39	Cap @ 58-59	4+01	Moderate	2 spalls/broken-off chunks, 8-16" wide, from cap at location of embedded reinforcement.
B-40	Pile 59	4+05	Moderate	Cracking with initial separation at right wing of pile extending 24" down from cap to below water.

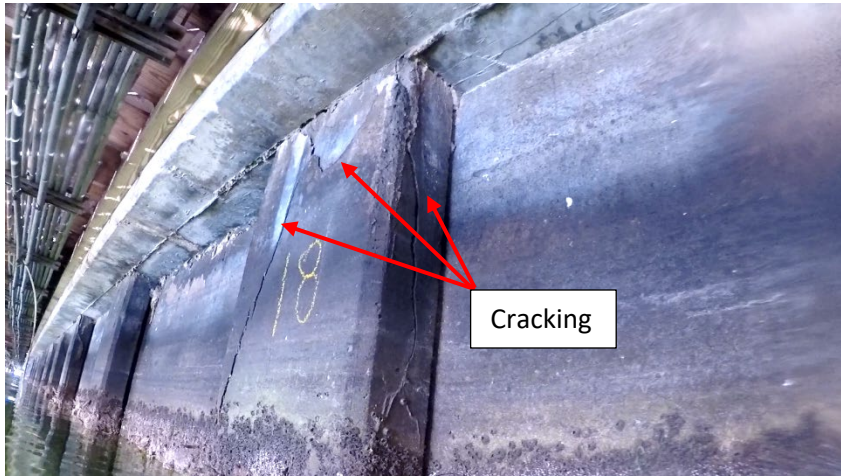
Deficiency B-41: Pile 60 (Station 4+12)

Baseline / Deficiency ID	Location / Pile #	Approx. Station Center	Deficiency Type	Description
B-41	Pile 60	4+12	Major	Cracking along both wings and face with impending spalls, extending 28" down from cap to water.
B-42	Pile 62	4+25	Moderate	Cracking at right wing extending 24" down from cap.
B-43	Pile 63	4+31	Moderate	Cracking at right wing extending 24" down from cap with additional cracks on the face of the pile.
B-44	Pile 64	4+37	Moderate	Cracking at both wings extending 18" down from cap with additional cracks/spalls on the face of the pile.
B-45	Pile 65	4+44	Critical	Heavy cracking/impending spall of right wing extending down the full pile, fully spalled sections of pile at left wing with exposed/corroded rebar, and spalled/missing concrete toward mudline at pile-panel interface with 6-10" of penetration behind pile.
B-46	Pile 66	4+50	Major	Heavy cracking/impending spalling of both wings at front face of pile, extending 36" down from cap to below water.

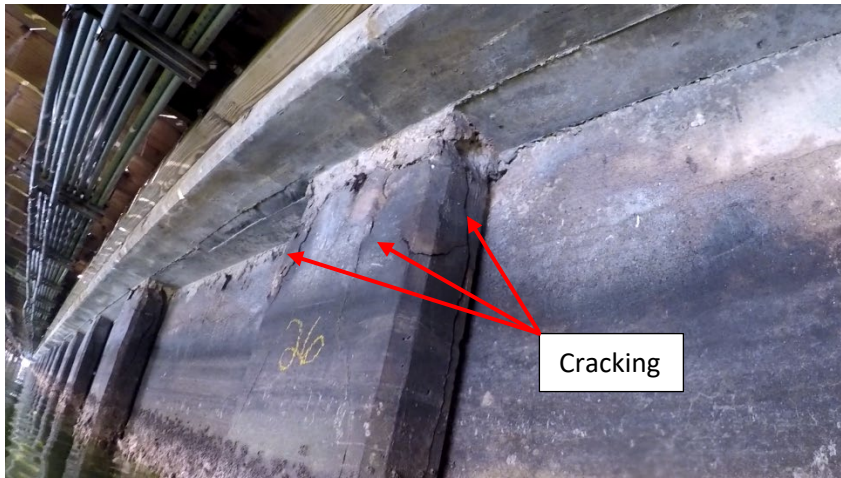
Deficiency B-47: Pile 68 (Station 4+63)

B-47	Pile 68	4+63	Major	Cracking at both wings and face of pile extending 24" down from cap and spalled/missing sections of concrete along left wing.
B-48	Pile 69	4+70	Moderate	Cracking at left wing and face of pile with impending concrete spalling, extending 27" down from cap.
B-49	Pile 70	4+76	Moderate	Cracking at left wing of pile extending 26" down from cap, and some cracking beginning to develop toward right face of pile.
B-50	Pile/Cap 71	4+83	Moderate	Various cracks along face and wings of pile extending 17-24" down from cap with signs of impending spalls. Also, approx. 24"x24" section of honeycombing at bottom of cap with apparent gaps between cap and pile.
B-51	Pile 72	4+90	Moderate	Various cracks at right wing and face of pile extending 25" down from cap to water.
B-52	Pile 73	4+99	Moderate	Spalled/missing concrete at top right wing of pile approx. 3"x7", with seeming separation between the pile and cap.

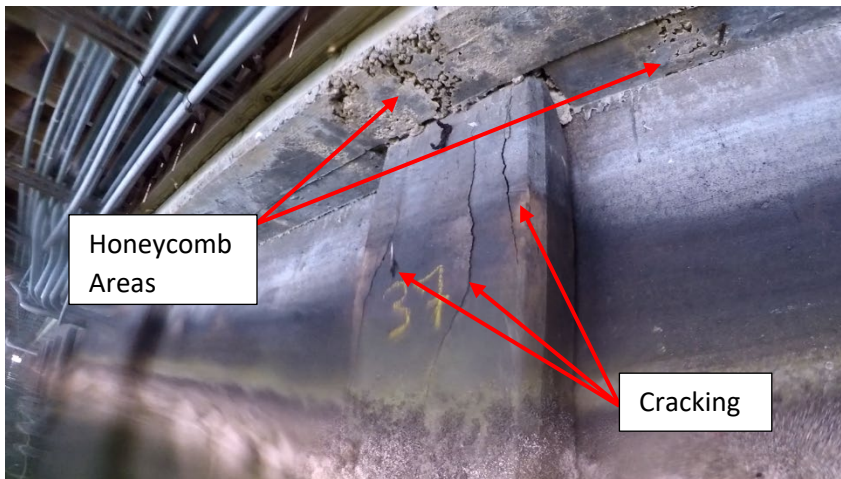
Deficiency B-53: Pile/Cap 79 (Station 5+48)

B-53	Pile/Cap 79	5+48	Moderate	Various cracks along face of pile extending 27" down from cap, and various locations of honeycombing underneath the cap. Also some cracking visible at top of cap.
B-54	Pile 82	5+70	Moderate	Cracking on right wing and face of pile extending 20" down from cap.
B-55	Pile 86	6+02	Minor	Cracks beginning to develop on right wing of pile.
B-56	Pile 89	6+27	Minor	Cracks beginning to develop on wings and face of pile.
B-57	Pile 92	6+51	Minor	Cracks developing on pile extending 26" down from cap.
B-58	Cap @ 95	6+76	Moderate	2"x6" cavity in cap next to Pile 95 with 2-4" penetration.
B-59	Pile 96	6+82	Minor	Cracks developing on pile extending 24" down from cap.
B-60	Pile 97	6+90	Moderate	Cracking on right wing and face of pile extending 27" down from cap.
B-61	Pile 98	6+99	Moderate	Cracking on face of pile extending 23" down from cap with concrete separation, and additional cracking on wings.

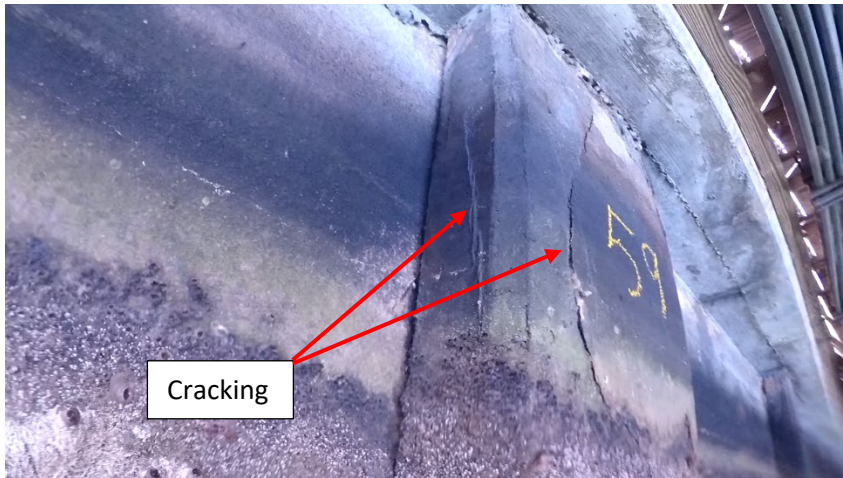
Deficiency B-63: Pile 101 (Station 7+22)

B-62	Pile 100	7+15	Major	Large crack with concrete separation of right wing of pile extending 23" down from cap.
B-63	Pile 101	7+22	Moderate	Cracking developing on face of pile extending 24" down from cap.
B-64	Panels 103-110	7+38 to 7+96	Major	Voids/undermining beneath panels along approximately 58-ft section with 4-10" of penetration.
B-65	Pile 103	7+38	Major	Large cracks with concrete separation on face and left wing of pile extending 22" down from cap.
B-66	Pile 104	7+47	Moderate	Cracking on face and right wing of pile extending 24" down from cap.
B-67	Pile 105	7+55	Major	Large cracks with concrete separation on left wing of pile extending 30" down from cap, and cracks beginning to form on face by right wing of pile.
B-68	Pile 106	7+63	Moderate	Cracking on face of pile extending 24" down from cap with impending spall of concrete cover.
B-69	Pile/Cap 107	7+71	Moderate	Cracking on face of pile extending 17" down from cap with impending spall of concrete cover. Some hairline cracking also visible at top of cap.

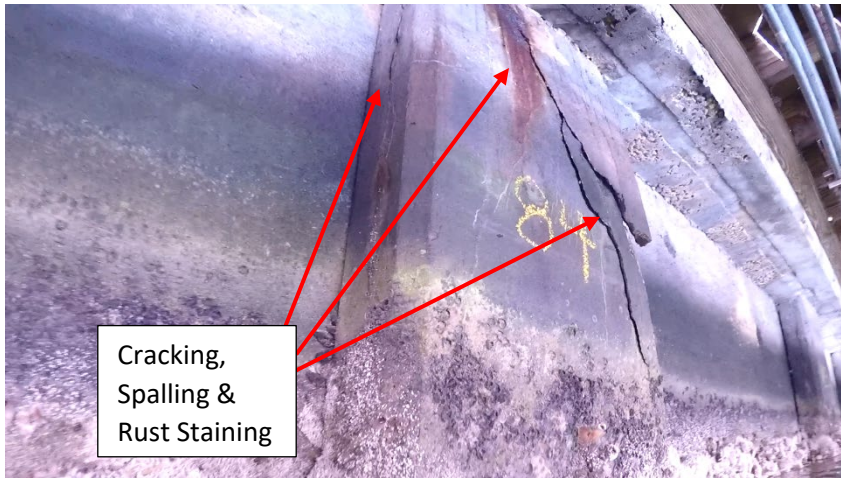
Deficiency B-84: Panel 124-125 (Station 9+10)

Cracking,
Spalling &
Rust Staining

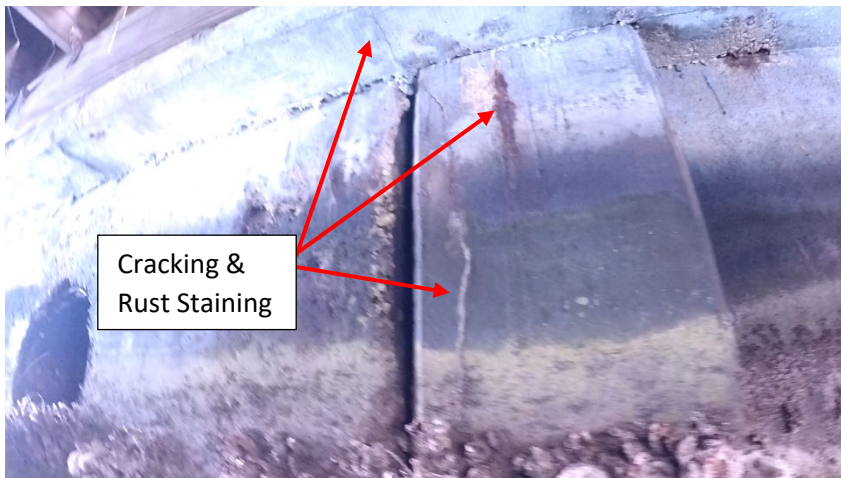
Deficiency B-86: Pile 127 (Station 9+31)

Cracking &
Rust Staining

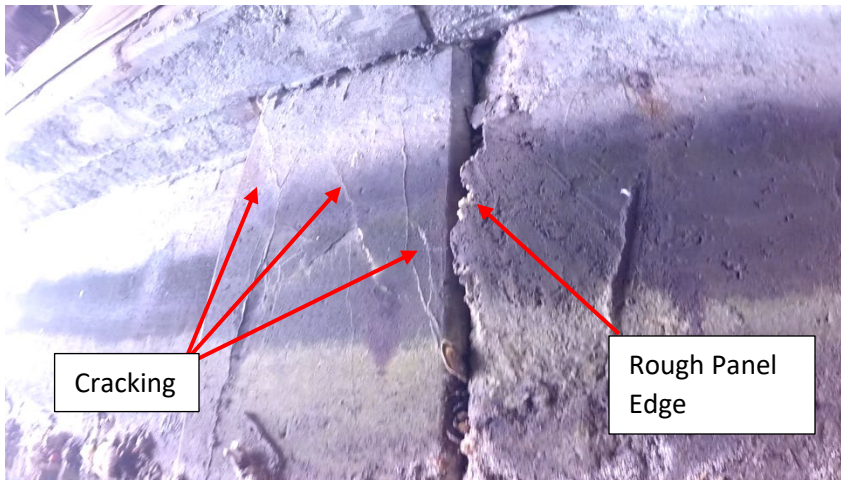
Deficiency B-88: Culvert Panel 128-129 (Station 9+43)

Cracking

Rough Panel Edge

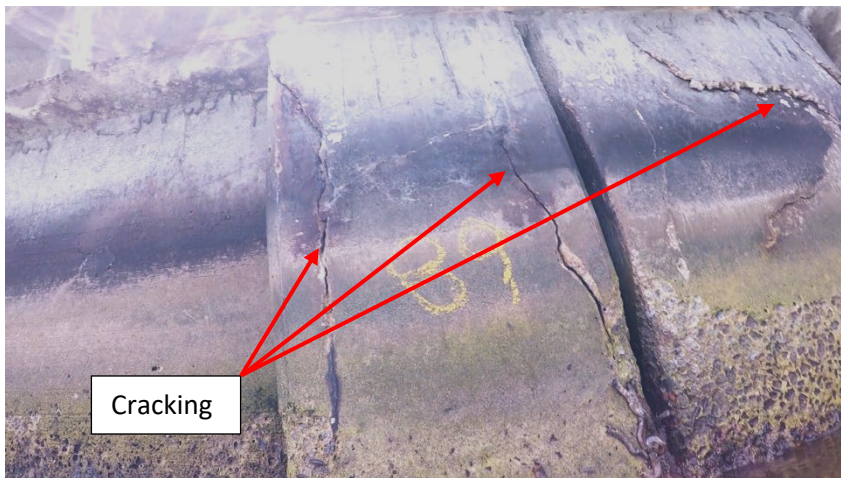
Deficiency B-90: Pile 130 (Station 9+55)

Cracking
