CITY OF KEY WEST

PROJECT: GR1503 / SEAWALL REPAIR & REPLACEMENT OPTIONS

SEPTEMBER 2015

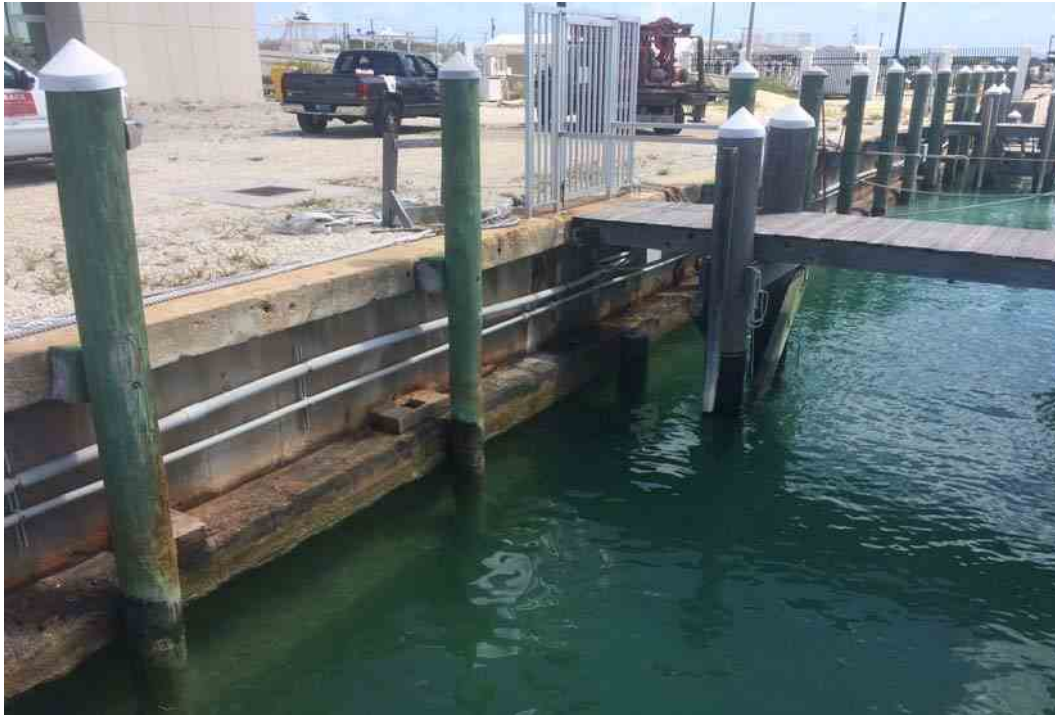
1) Typical View of Existing Seawall

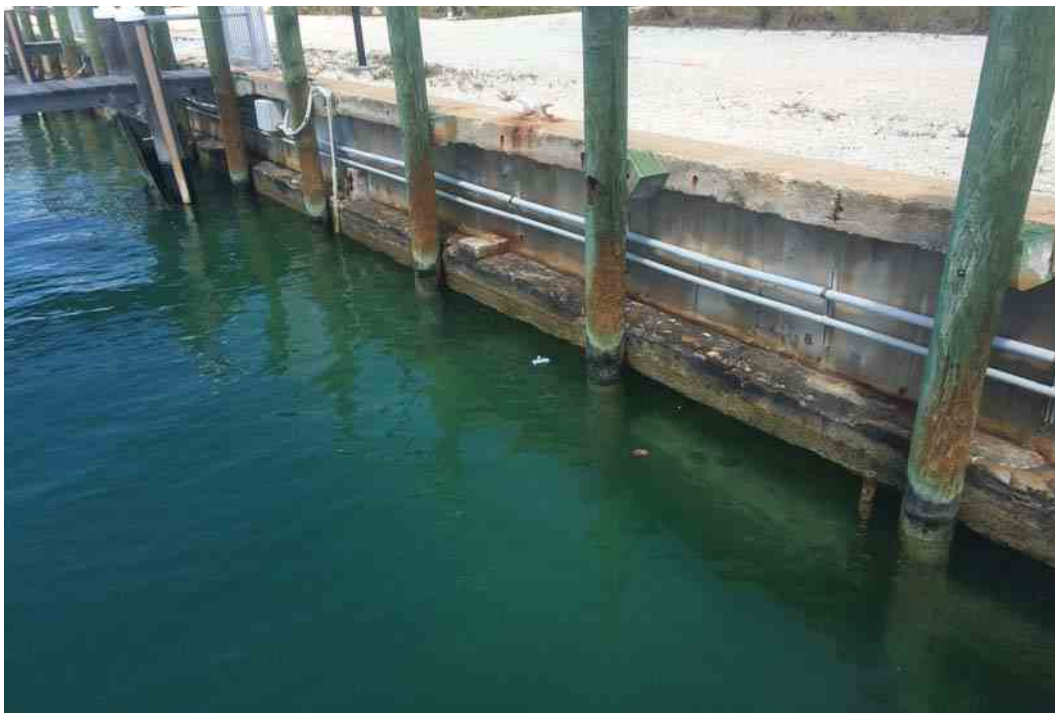
2) Typical View of Existing Seawall

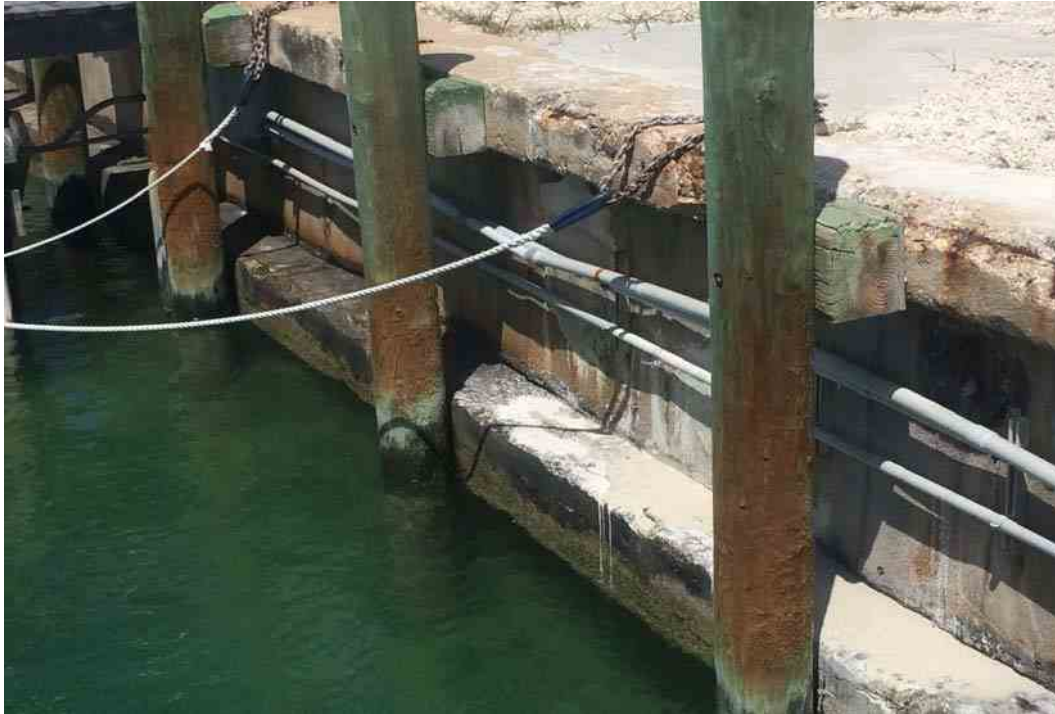
5) Close-Up View of Seawall Front
