STAFF REPORT

RE: 255 Trumbo Road (application # TP2022-0003)

FROM: Karen DeMaria, City of Key West Urban Forestry Manager

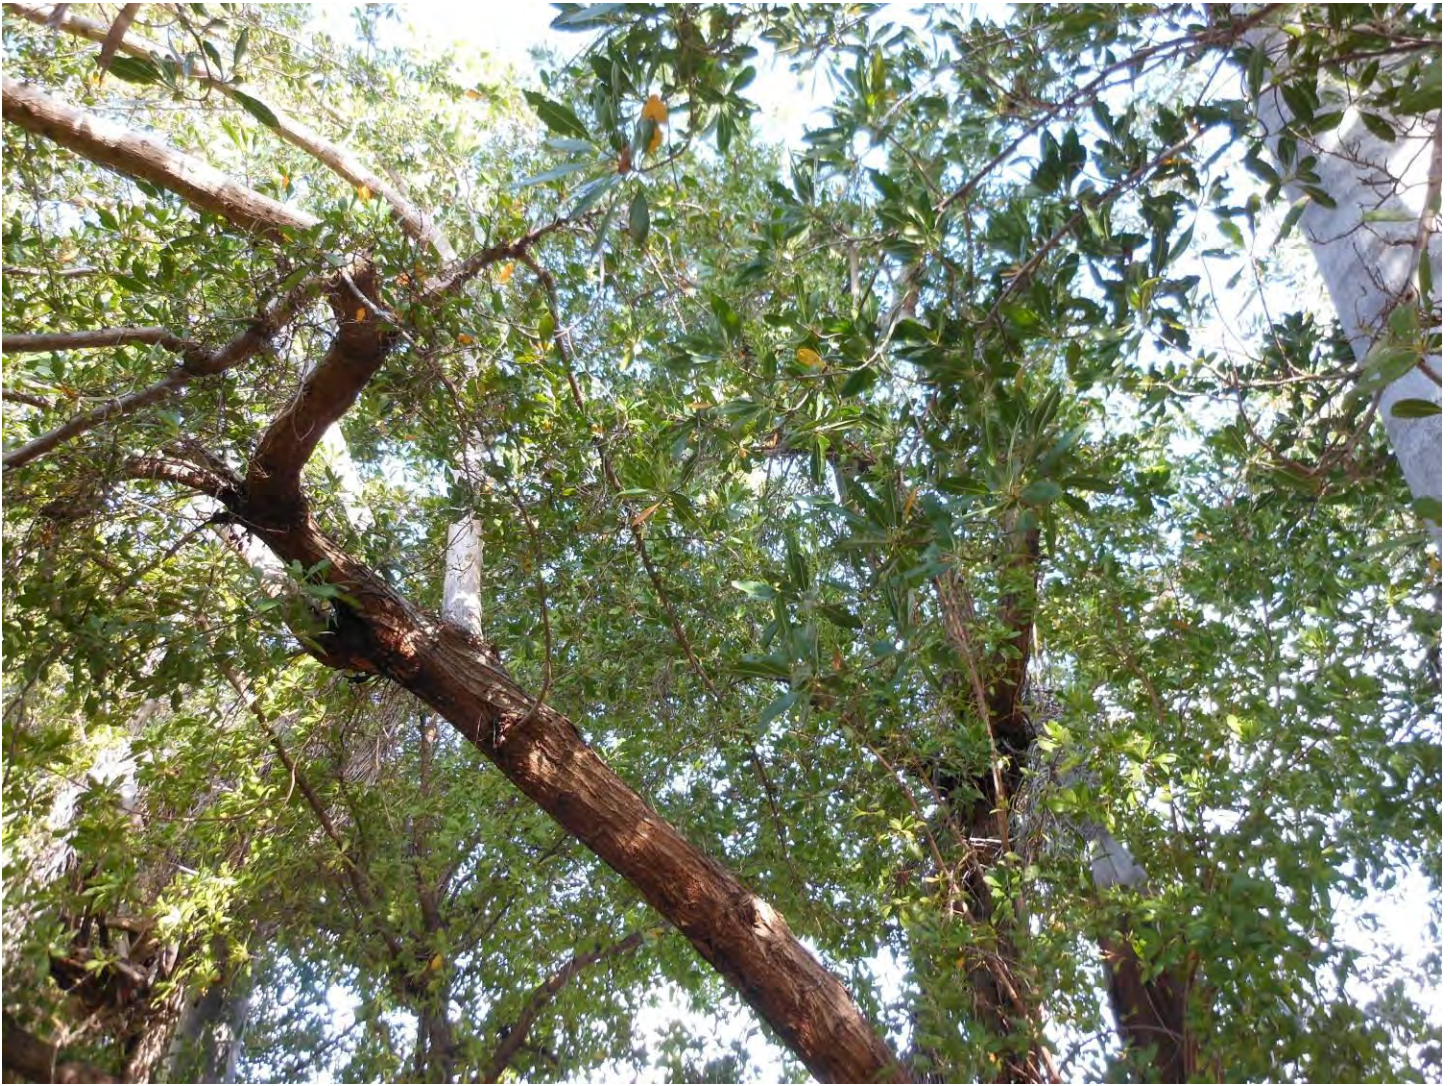
Tree #27-one photo of tree

Diameter: 12"

Condition: 50% (fair to poor)

Value x Diameter = 9.1 replacement caliper inches
