STAFF REPORT

RE: 1315 Olivia Street (permit application # T17-8334)

FROM: Karen DeMaria, City of Key West Urban Forestry Manager

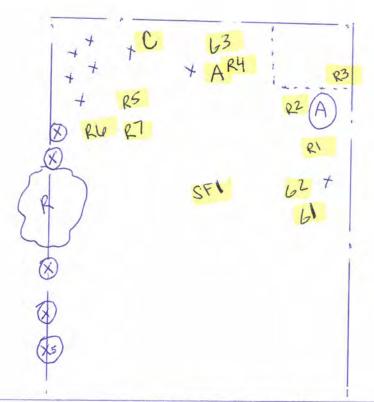
1315	Olivia	Street		
	2/24/17		KKD/	Plain NTS

R1 = 1.4"	No Transplant
R2 = 2.2"	No transplut
R3= 3.5"	No transplant
R4 = 2.8"	No transplant
RS = 1.5"	Transplant?
R6= 1.5"	Transplant?
R7 = 2.5"	Transplant?
61 = 2.2"	No transplant
	Transplant?
63= 3.8"	
SF1=3.8"	No transplant Transplant?
C = 8.2"	No transplant
A = 2.2"	Transplaint?

Key: x = Christmas Palus (NOT Regulated) (R) = Royal Poinciana (to remain) (X) = Christmas Palus (to remain) (A) = Avocado (to remain)

C = Cherry Tree (to remove) A = Avocado (to remove) SF = Strangler Fig (to remove) G = Gumbo Limbos (to remove)
