## Cynthia's Blue Palms

City of Key West Tree Commission

February 22, 2017

Purpose: Following are my findings of evaluation concerning 1 Sapodilla trees, 2 Royal Poinciana trees, 2 Washingtonia palms and 2 Mahogany trees located at 3717 Eagle Avenue, Key West, Florida. I have been retained by owner Peter Batty, Jr. This application is being submitted as this is a new home purchase for Mr. Batty to include reconstruction and extensive landscaping. Trees can be seen from Eagle Avenue (photo 1).

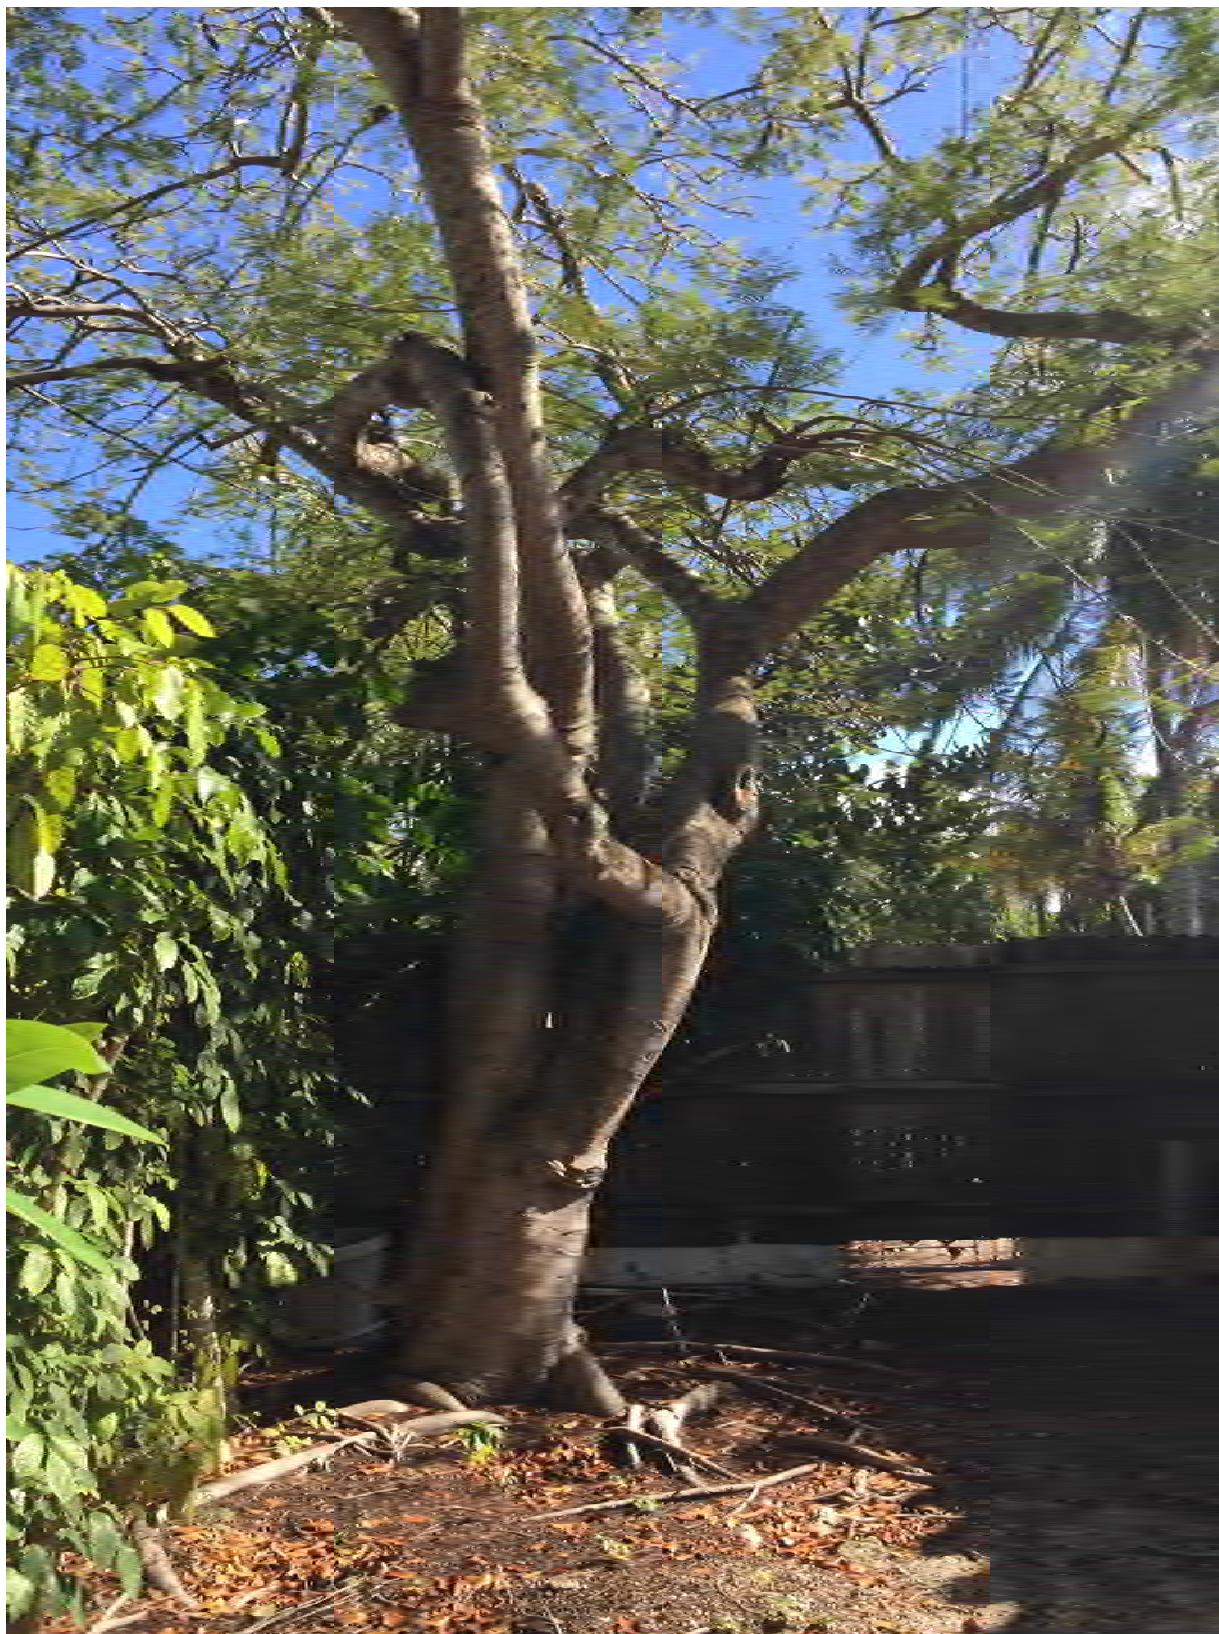
2b

**Royal Poinciana**, *Delonix regia*, tree number **1**, located directly behind and abutting concrete wall at the southeast side yard (photos 2,2b). The tree is approximately 25.5" diameter measured at approximately 5' above grade. Canopy spread is approximately 18'x20'. Condition is very poor and failure likely. Photographs depict main codominance at approximately 3.5' above grade with severely included bark (photos 2c,3,4,5). Southside base of tree has an area of decay with wound wood evident hence, suspect continual internal decay (photo 6). Branching from codominate stems further depicts included bark with decay (photos 7,8,9,). Scaffolding criss-crossing branches are also evident throughout the canopy (photos 9,10,11). The next three photos show a small tree codominance failure (photos 12,13,14). Since failure of this tree is likely, I recommend removal.
