# Structural Condition Assessment Key West Diesel Plant Key West, Florida

AES Project No. 316-048  
August 3, 2016

Re: Structural Condition Assessment  
Key West Diesel Plant  
Key West, Florida

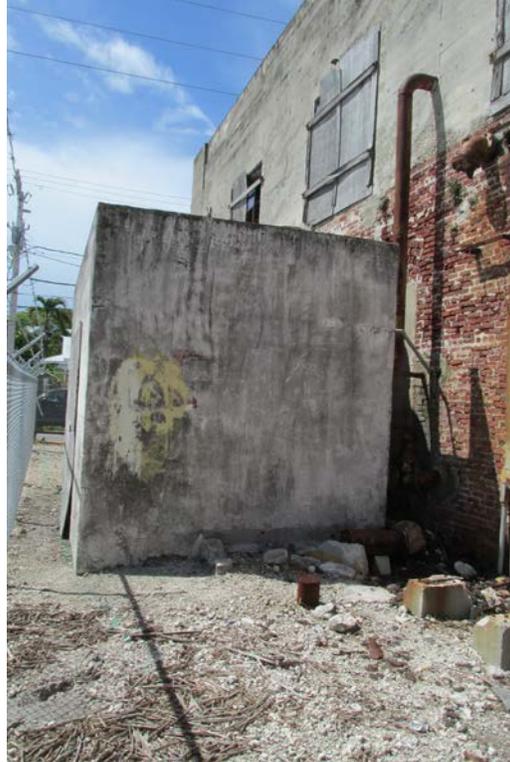
**PHOTOGRAPH 7 (BUILDING V)**

Below the roof structure is a gantry crane supported by a steel crane beam and steel columns independent of the perimeter brick walls. To the east of this building is an exterior concrete exhaust structure (Building V), which consists of a concrete roof slab with concrete parapets supported by concrete walls (see Photographs 7 and 8). The southwestern building (Building III) consists of metal roofing on wood sheathing on wood joists, and beams supported by interior steel beams and columns and perimeter multi-wythe brick walls, CMU walls and concrete walls (see Photographs 9 and 10).

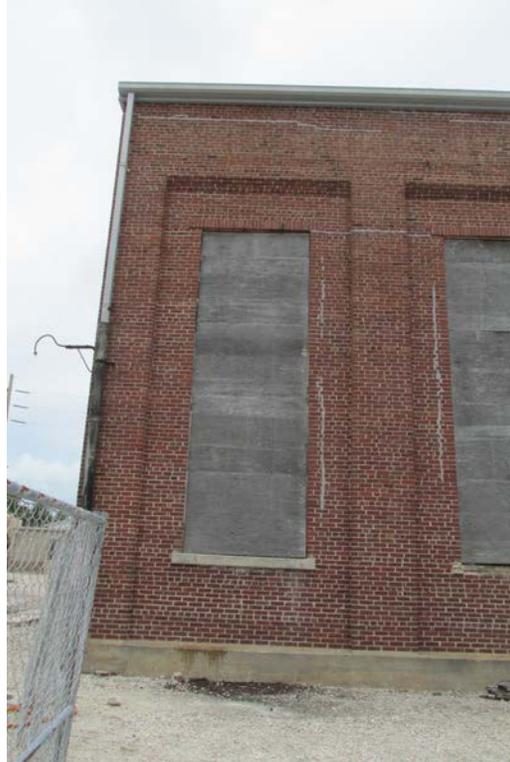
**PHOTOGRAPH 17 (BUILDING I)**

The exterior masonry walls are in good condition but there are numerous cracks, corroded embedments, deteriorated mortar, corroded lintels, deteriorated face brick, brick cracks with vegetation and random cracks in the concrete water table (see Photographs 17, 18, 19, 20, 21, 22 and 23). At the western return metal panel wall, there is a badly corroded angle purlin and a large column spall with corroded reinforcing and an area of missing metal wall panel (see Photographs 24, 25 and 26). The remaining metal panels are corroded and in poor condition (see Photograph 27).

Building I is in good condition with the exterior masonry requiring repair and several window lintels requiring replacement. The steel structure is in good condition with surficial corrosion except for one (1) column that needs reinforcement due to excessive corrosion at its base. All of the steel needs to be cleaned of corrosion and coated with a corrosion inhibiting coating. The slab on grade is cracked and uneven and is due for replacement. The exterior masonry requires repointing and all of the corroded embedments and steel lintels need to be cleaned of corrosion and coated with a corrosion inhibiting coating. The deteriorated face brick needs to be removed and replaced and the vegetation in the wall cracks needs to be removed and the cracks repointed. At the western return metal panel wall, the badly corroded angle purlin needs replacement as well as the wall metal panels. The concrete spall in this wall also requires repair.

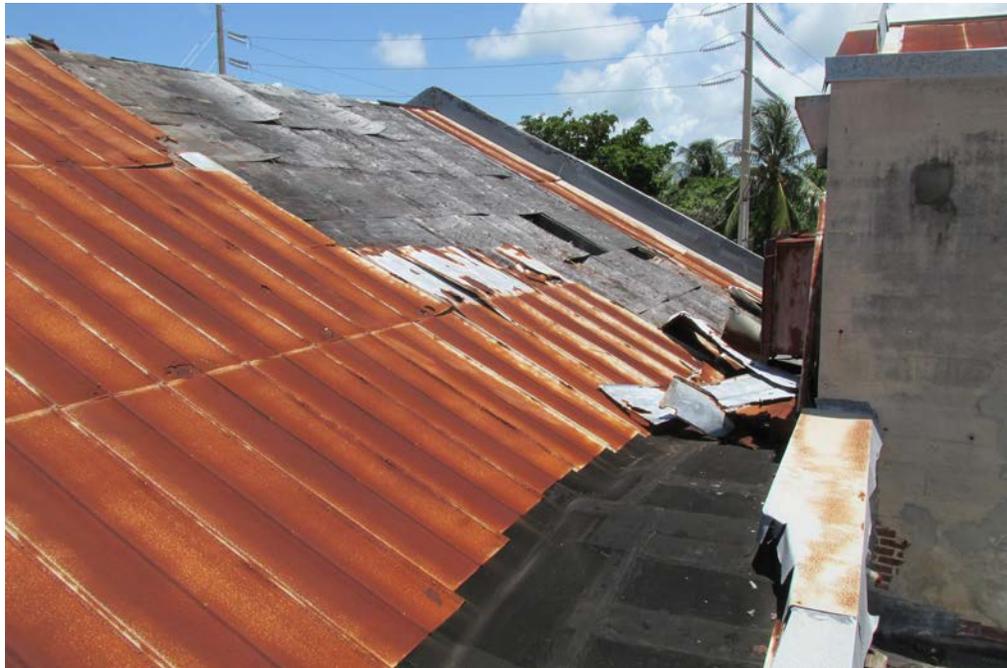
PHOTOGRAPH 28 (BUILDING II)

- II. The eastern center building (Building II) is in much worse condition than the Building I with metal roofing in extremely poor condition with large areas of missing metal roofing and large areas of deteriorated roof decking (see Photograph 28). The roof wood structure is in good condition as well as the steel structure with surficial corrosion except for several badly corroded columns and post bases with more than 20% material loss (see Photographs 29 and 30).

The remainder of the buildings are in worse condition than Building I with Building IV being in the worst condition with a portion of missing roof. These buildings are stable but require new roofs with extensive roof sheathing replacement and some wood structure reinforcement and replacement. At the areas of missing and badly deteriorated roofing, these roofs could sustain significant damage in a severe wind event losing the remainder of their roofing and sheathing. In general, the steel structure is in good condition with surficial corrosion but several columns will need reinforcement due to excessive corrosion at their bases. All of the steel needs to be cleaned of corrosion and coated with a corrosion inhibiting coating. At Building IV, the wall opening with numerous loose and missing bricks and falling bricks needs to be shored or repaired immediately to prevent further deterioration of the wall. The exterior masonry walls are in good condition except for the northwest corner of Building II where there is a large area of missing brick that needs to be rebuilt. The remaining walls need to be repointed, deteriorated face brick removed and replaced and the vegetation in the wall cracks removed and the cracks repointed. Like Building I, all of the corroded embedments and steel lintels need to be cleaned of corrosion and coated with a corrosion inhibiting coating. In many of the arched brick openings, brick has been infilled with no lintel installed. This infill brick is being held in place by the mortar alone and in areas is cracking. This infill brick needs to be removed or steel lintels installed to support it. At Building II, the concrete platform is in poor condition with large spalls and the concrete carbonated to the reinforcing with the concrete containing high levels of chlorides. If it is the owner's desire to rehabilitate this platform when the concrete is repaired, it should be treated with a penetrating corrosion inhibitor or an active cathodic protection system installed. Due to the thickness of the platform walls, both will be expensive, therefore strong consideration should be taken for demolishing this platform. The exterior concrete walls and pits, except for Building V, are in poor condition requiring extensive repair. Like the Building II concrete platform, the concrete contains high levels of chlorides and once repaired, the walls should be treated with a penetrating corrosion inhibitor or an active cathodic protection system installed, and the exterior concrete coated with a penetrating sealer. The exterior pits and chutes are abandoned and should be cleaned of debris, the top of the deteriorated walls demolished to 8" below grade and filled with clean fill or stone. All of the interior trench and pit edge angles are in poor condition and badly corroded. All of the dynamo pits are full of water and breeding mosquitos. When the deteriorated dynamos are removed, the pits need to be pumped empty of water. The pits and trenches need to be dewatered, cleared of debris with the edge angles removed, and the pits and trenches filled with clean fill or stone with a concrete slab on grade placed, drilled and adhesived into the pit and trench walls level with the surrounding concrete slabs on grade. If any of the dynamos are kept for display, their pits should be pumped empty of water and filled and capped as described above.

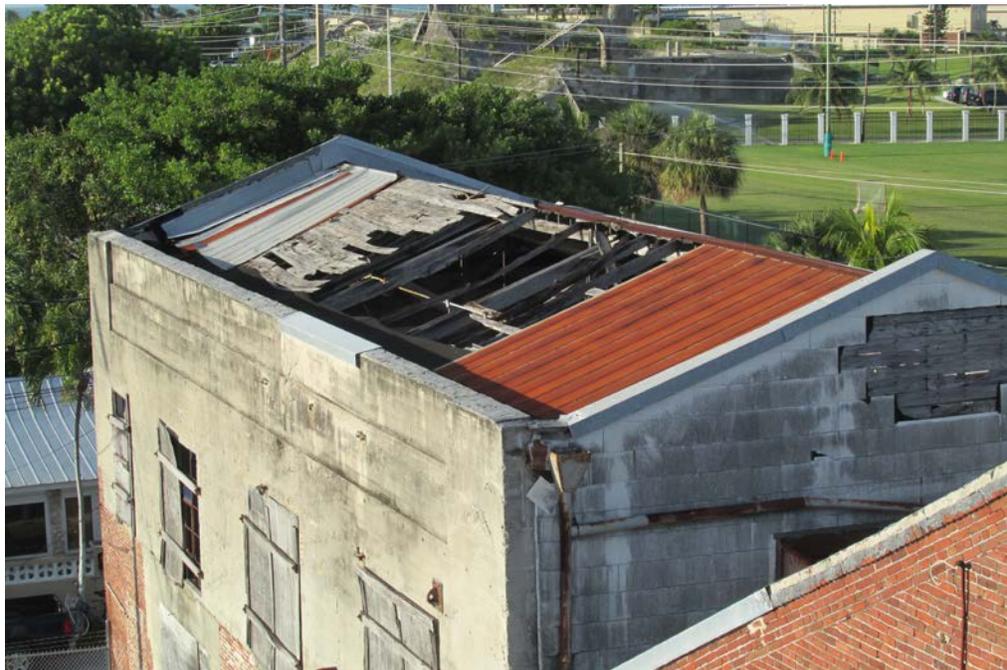
PHOTOGRAPH 40 (BUILDING IV)

- IV. The southernmost eastern building (Building IV) is in worse condition than Building II with a large area of missing metal roofing and wood sheathing, a deteriorated bottom roof truss chord and a wall opening with numerous loose and missing bricks with bricks falling (see Photographs 40, 41 and 42). The wood roof joists are in poor condition but the wood trusses appear in good condition. The steel structure is in good condition with surficial corrosion but many of the steel column bases are severely corroded with more than 20% material loss (see Photograph 43). The exterior masonry walls are in good condition but there are numerous cracks, corroded embedments, deteriorated mortar and loose and missing face brick. The upper concrete walls have large areas of honey combed concrete and an area of spalled concrete with corroded reinforcing (see Photographs 44 and 45).

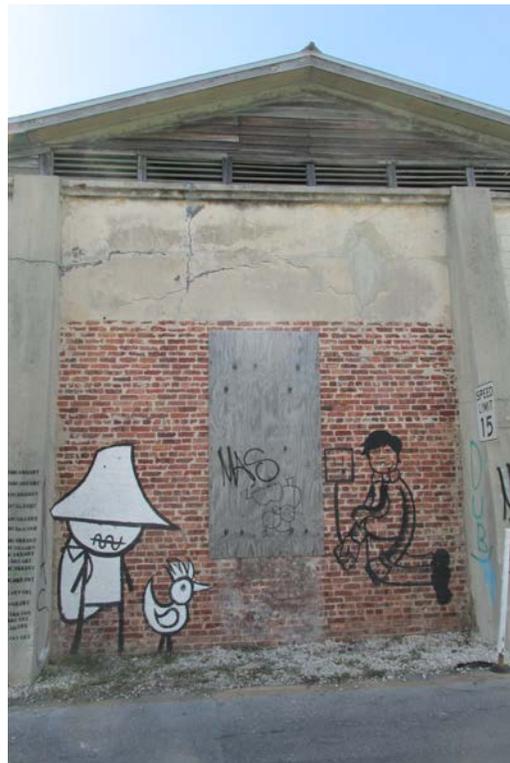
PHOTOGRAPH 48 (BUILDING III)

- III. The southwestern building (Building III) is in worse condition than Building I, but in better condition than the Building II and Building IV. The western metal roof is in good condition with several areas of corroded metal roofing and corroded roofing screws. The eastern metal roof is in poor condition with areas of missing roofing, extensive metal roofing deterioration and areas of deteriorated wood decking (see Photograph 46). The roof wood joists, beams, steel beams and columns are in good condition with surficial steel corrosion on the steel members and a deteriorated wood beam kicker (see Photograph 47). The slab on grade is cracked and uneven and the exterior high concrete has large areas of spalling concrete and a spalling concrete lintel (see Photographs 48 and 49). The exterior CMU and brick has several cracks, corroded embedments and delaminating stucco.

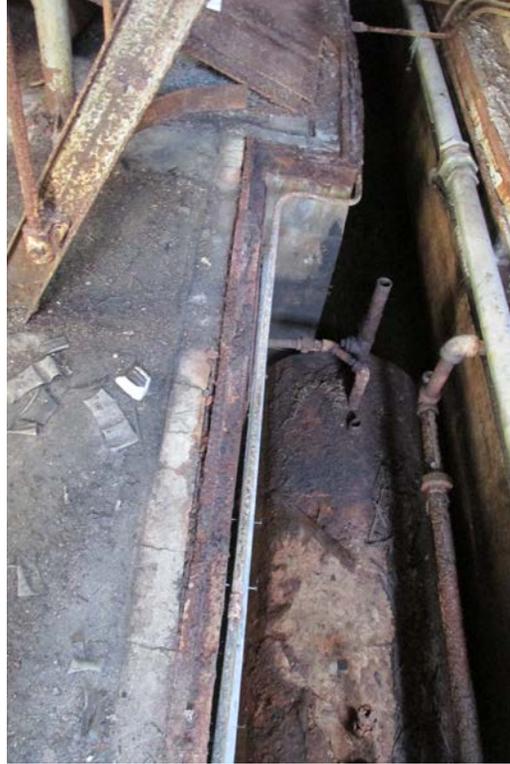
PHOTOGRAPH 55 (BUILDING III)

- V. The concrete exhaust building (Building V) is in good condition with corroded steel ladders; a badly corroded pipe support, a cracked housekeeping pad and a hairline crack in the roof parapet (see Photographs 50, 51, 52 and 53). The exterior pit and chute walls are in poor condition with cracked and spalling concrete with corroding reinforcing (see Photograph 54). All of the interior pits are full of water and breeding mosquitos. The interior trench and pit edge angles are in poor condition and badly corroded (see Photograph 55). All of the dynamos are in poor condition and badly corroded (see Photograph 56).
