STAFF REPORT

DATE: August 1, 2017

RE: 1300 Atlantic Boulevard (C.B. Harvey Rest Beach Park) (permit application # T17-8522)

FROM: Karen DeMaria, City of Key West Urban Forestry Manager

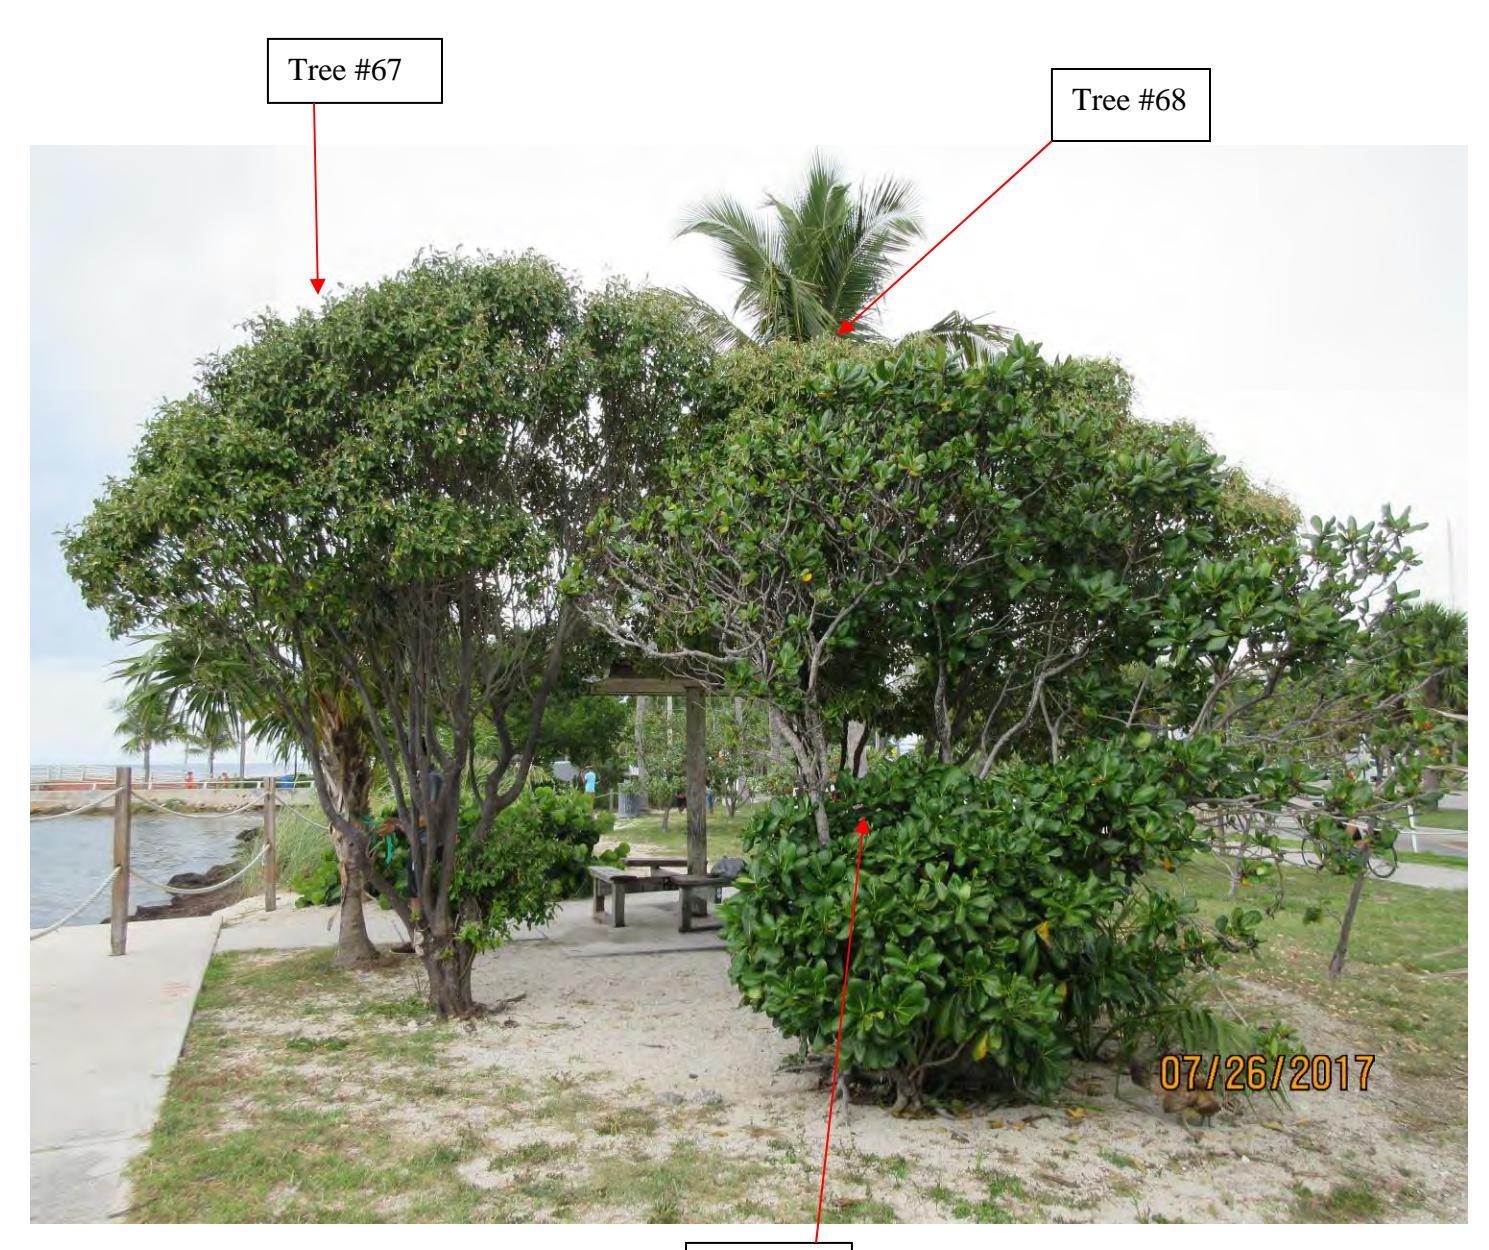
Tree #66

Diameter: 8.5" Location: 90% Species: 100% (on protected tree list) Condition: 70% (fair, sprawling tree) Total Average Value = 86% Value x Diameter = 7.3 replacement caliper inches

It appears that this tree is on the edge of the work area. It is not known at this time whether the tree can successfully be transplanted. Tree Species: Bay Cedar (Suriana maritima) Tree #48:
