CITY OF KEY WEST

POST-HURRICANE IRMA
SEAWALL CONDITION ASSESSMENT
AQUARIUM BASIN SEAWALL

**Subject: Post-Hurricane Irma Condition Assessment
Key West Aquarium Basin Seawall**

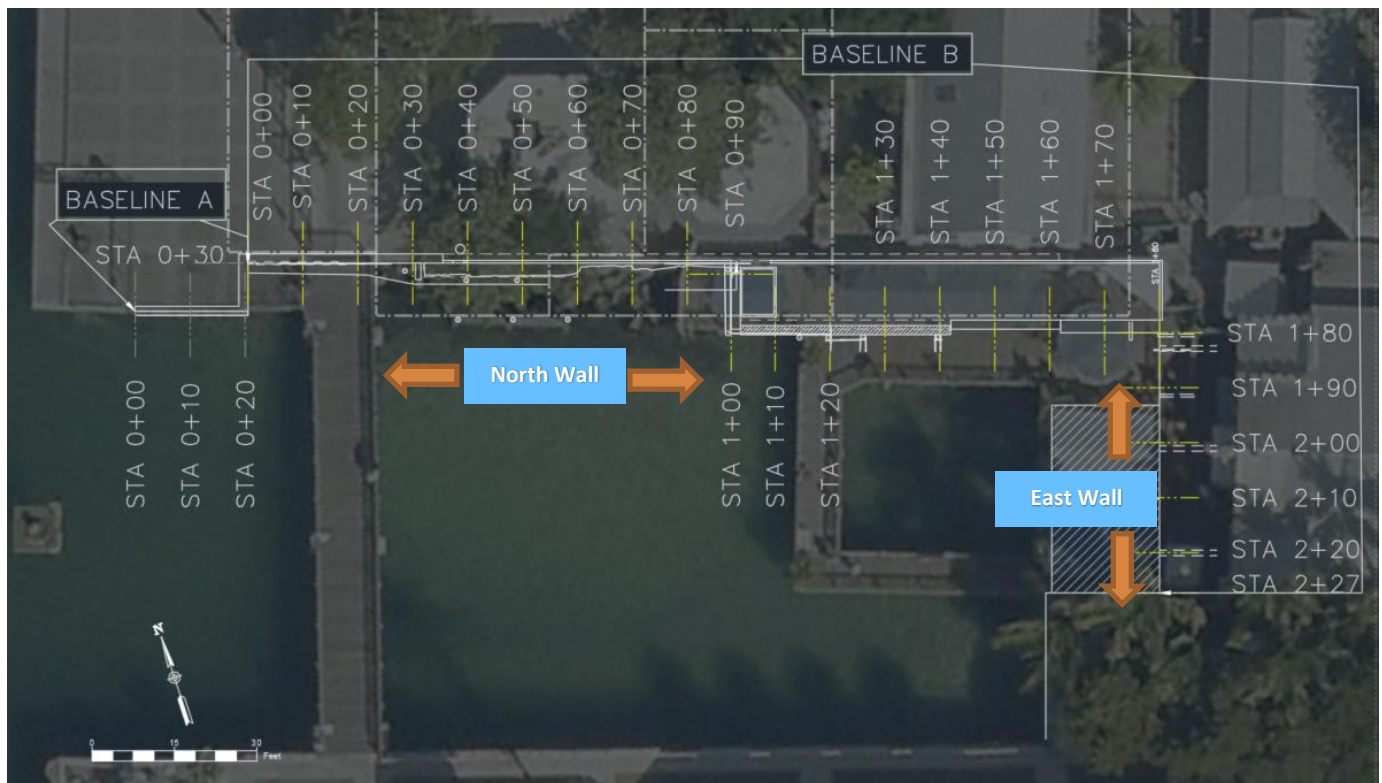
Figure 1: Survey Stationing Layout for Cataloging Deficiencies

The following exhibit is intended to show how the inspection transect was configured and referenced to provide a synopsis of the wall conditions. Figure 1 shows how the engineer delineated the stationing with two baselines from 0-feet to 30-feet for Baseline A, and from 0-feet to 227-feet for Baseline B along the top of the cap.

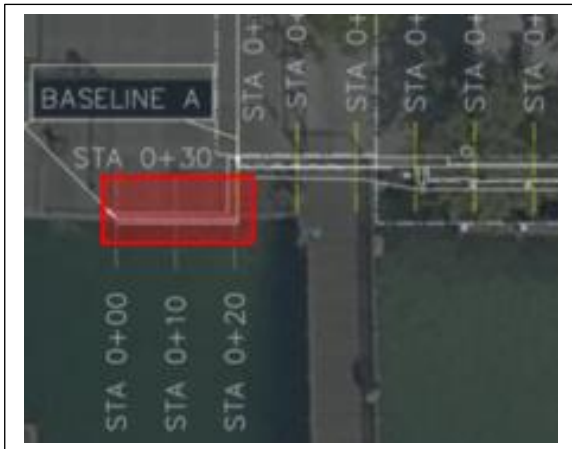
Figure 3: Plan view of Baseline A

Description	Baseline A (STA 0+00 to 30+00)
Condition Index	GOOD, no repairs required
Service Life	40-50 years
Age of Structure	10-15 Years
