ORDER TO REPAIR, ALTER, OR IMPROVE BUILDINGS

Structural Condition Assessment Key West Diesel Plant Key West, Florida

AES Project No. 316-048
August 3, 2016

Re: Structural Condition Assessment
Key West Diesel Plant
Key West, Florida

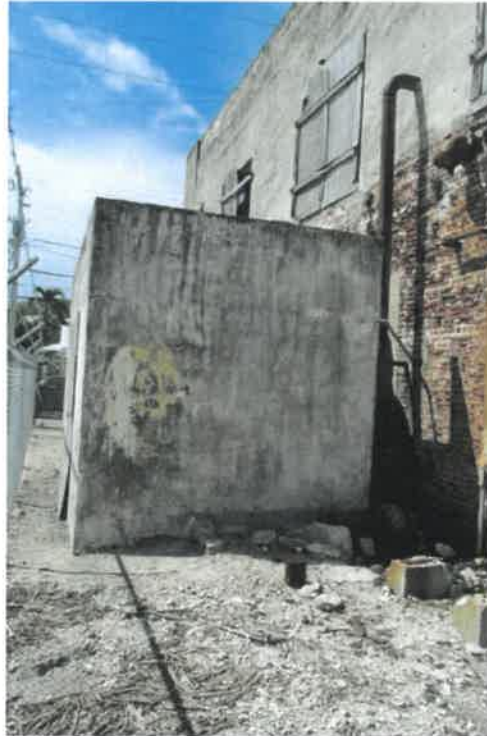
PHOTOGRAPH 7 (BUILDING V)

Below the roof structure is a gantry crane supported by a steel crane beam and steel columns independent of the perimeter brick walls. To the east of this building is an exterior concrete exhaust structure (Building V), which consists of a concrete roof slab with concrete parapets supported by concrete walls (see Photographs 7 and 8). The southwestern building (Building III) consists of metal roofing on wood sheathing on wood joists, and beams supported by interior steel beams and columns and perimeter multi-wythe brick walls, CMU walls and concrete walls (see Photographs 9 and 10).

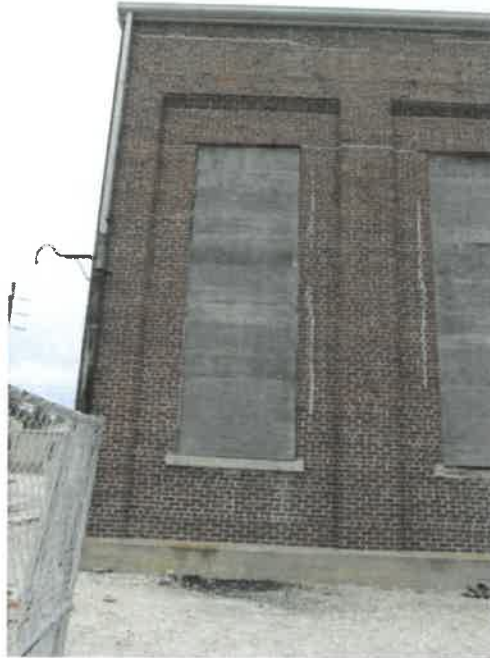
PHOTOGRAPH 17 (BUILDING I)

The exterior masonry walls are in good condition but there are numerous cracks, corroded embedments, deteriorated mortar, corroded lintels, deteriorated face brick, brick cracks with vegetation and random cracks in the concrete water table (see Photographs 17, 18, 19, 20, 21, 22 and 23). At the western return metal panel wall, there is a badly corroded angle purlin and a large column spall with corroded reinforcing and an area of missing metal wall panel (see Photographs 24, 25 and 26). The remaining metal panels are corroded and in poor condition (see Photograph 27).

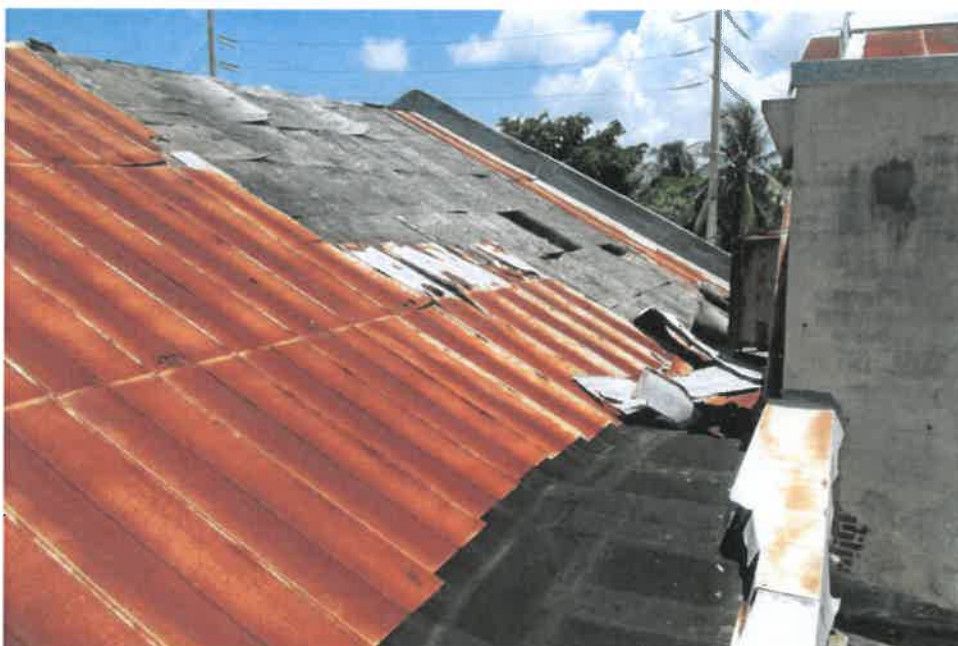
PHOTOGRAPH 28 (BUILDING II)

- II. The eastern center building (Building II) is in much worse condition than the Building I with metal roofing in extremely poor condition with large areas of missing metal roofing and large areas of deteriorated roof decking (see Photograph 28). The roof wood structure is in good condition as well as the steel structure with surficial corrosion except for several badly corroded columns and post bases with more than 20% material loss (see Photographs 29 and 30).

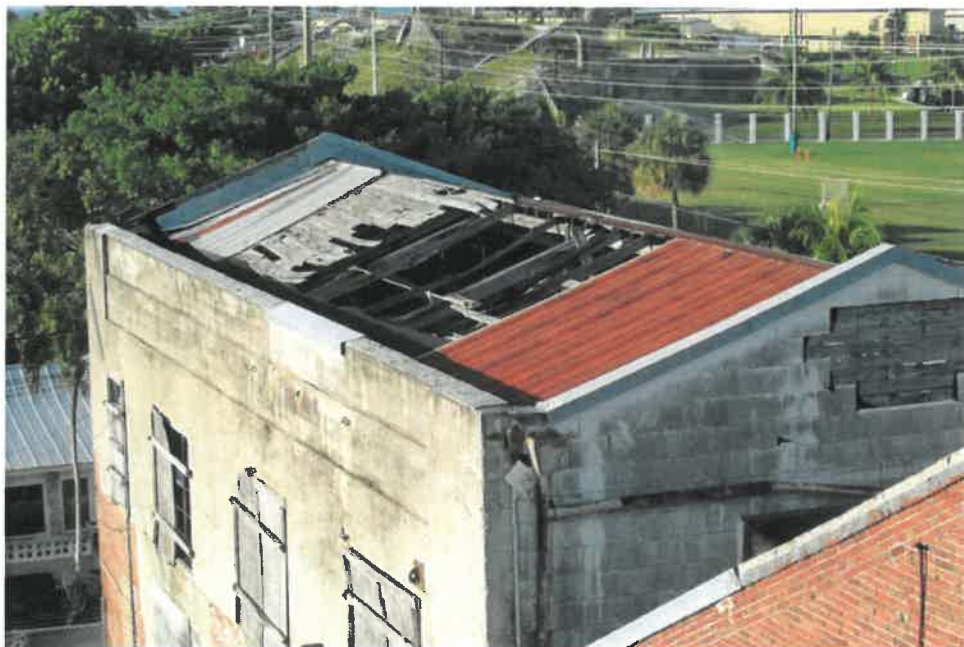
PHOTOGRAPH 40 (BUILDING IV)

- IV. The southernmost eastern building (Building IV) is in worse condition than Building II with a large area of missing metal roofing and wood sheathing, a deteriorated bottom roof truss chord and a wall opening with numerous loose and missing bricks with bricks falling (see Photographs 40, 41 and 42). The wood roof joists are in poor condition but the wood trusses appear in good condition. The steel structure is in good condition with surficial corrosion but many of the steel column bases are severely corroded with more than 20% material loss (see Photograph 43). The exterior masonry walls are in good condition but there are numerous cracks, corroded embedments, deteriorated mortar and loose and missing face brick. The upper concrete walls have large areas of honey combed concrete and an area of spalled concrete with corroded reinforcing (see Photographs 44 and 45).

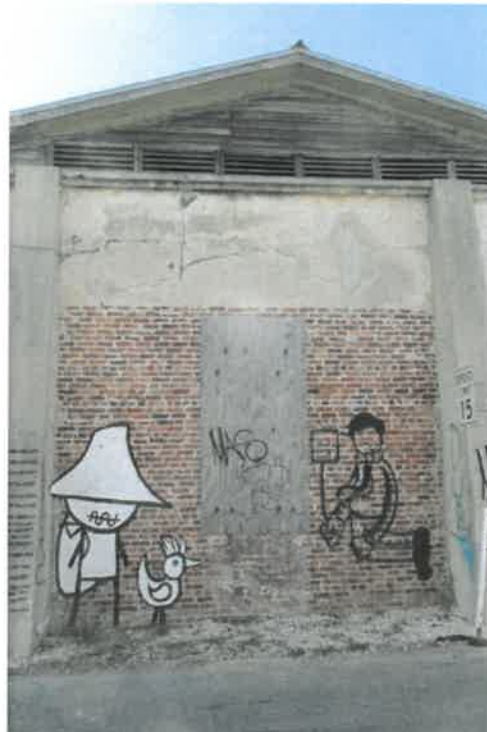
PHOTOGRAPH 48 (BUILDING III)

- III. The southwestern building (Building III) is in worse condition than Building I, but in better condition than the Building II and Building IV. The western metal roof is in good condition with several areas of corroded metal roofing and corroded roofing screws. The eastern metal roof is in poor condition with areas of missing roofing, extensive metal roofing deterioration and areas of deteriorated wood decking (see Photograph 46). The roof wood joists, beams, steel beams and columns are in good condition with surficial steel corrosion on the steel members and a deteriorated wood beam kicker (see Photograph 47). The slab on grade is cracked and uneven and the exterior high concrete has large areas of spalling concrete and a spalling concrete lintel (see Photographs 48 and 49). The exterior CMU and brick has several cracks, corroded embedments and delaminating stucco.

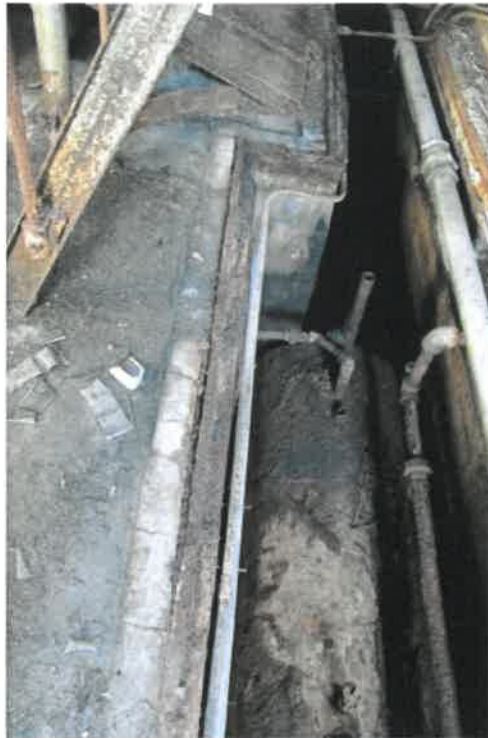
PHOTOGRAPH 55 (BUILDING III)

- V. The concrete exhaust building (Building V) is in good condition with corroded steel ladders; a badly corroded pipe support, a cracked housekeeping pad and a hairline crack in the roof parapet (see Photographs 50, 51, 52 and 53). The exterior pit and chute walls are in poor condition with cracked and spalling concrete with corroding reinforcing (see Photograph 54). All of the interior pits are full of water and breeding mosquitos. The interior trench and pit edge angles are in poor condition and badly corroded (see Photograph 55). All of the dynamos are in poor condition and badly corroded (see Photograph 56).
