STAFF REPORT

RE: **5220, 5224, 5228, & 5230 College Road**
(permit application # T2019-0135)

FROM: Karen DeMaria, City of Key West Urban Forestry Manager

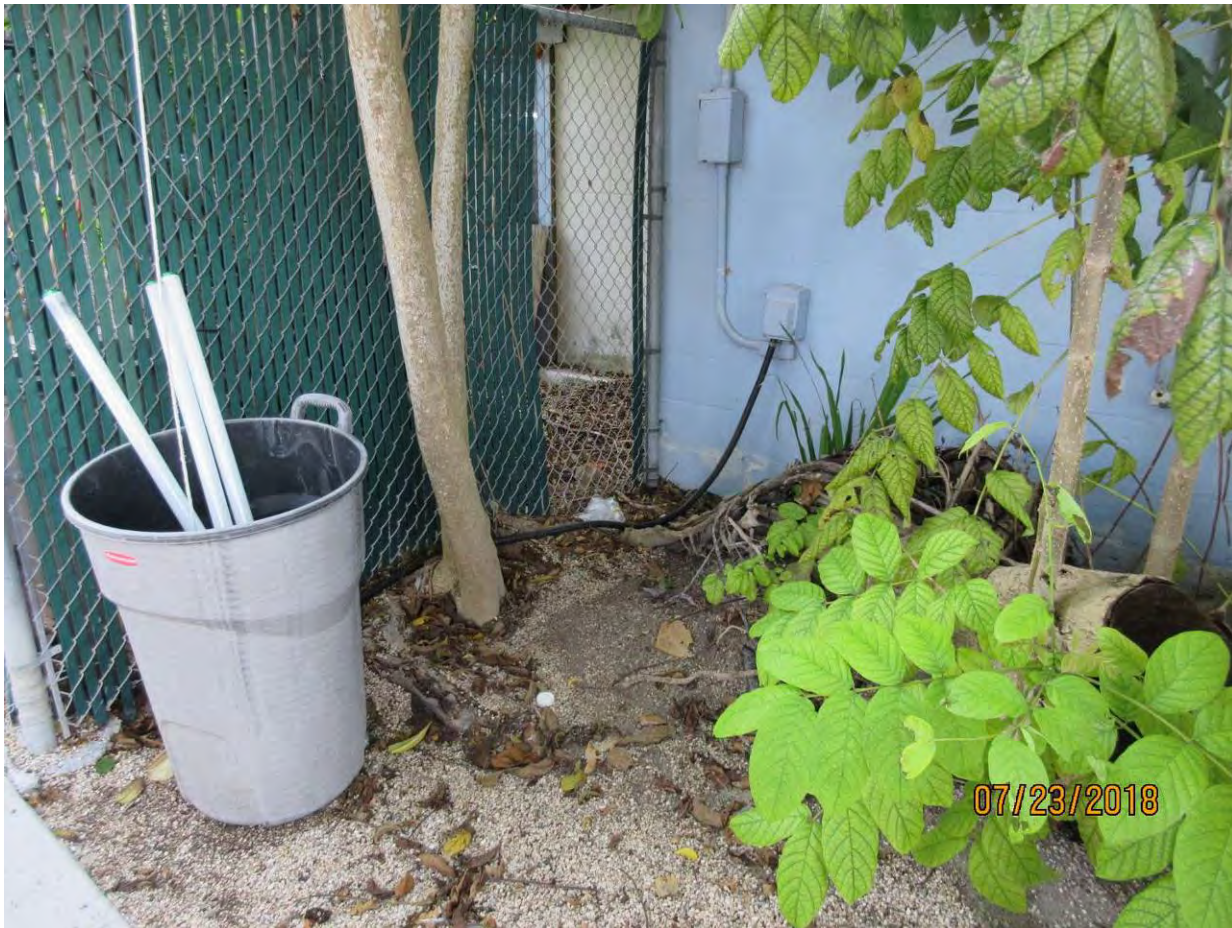
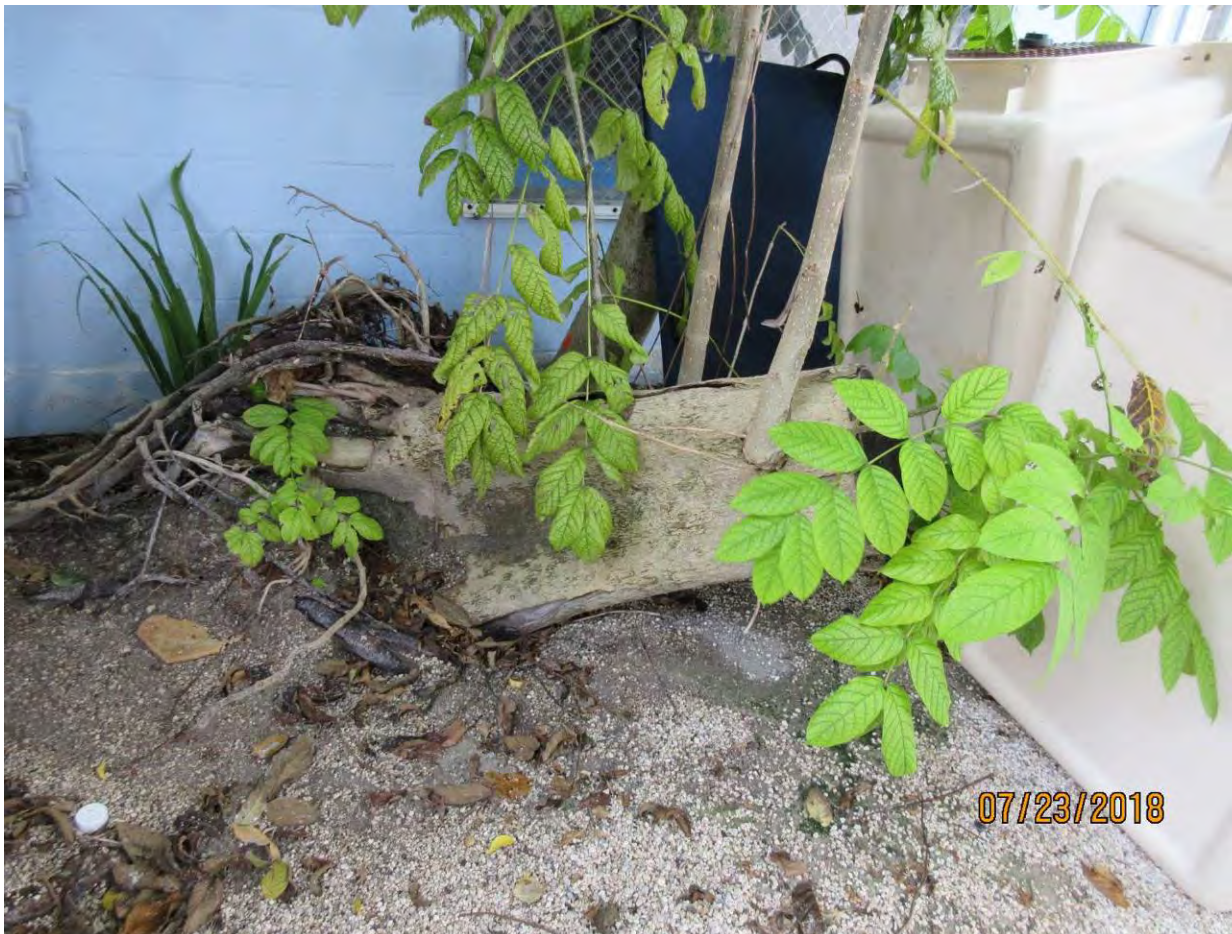
Tree
#36b

Tree #36b:

Diameter: 7.9" (double trunked)

Location: 60% (canopy impacted by adjacent tree)

Condition: 40% (codominant trunks, poor structure)

Value x Diameter = 3.9 replacement caliper inches

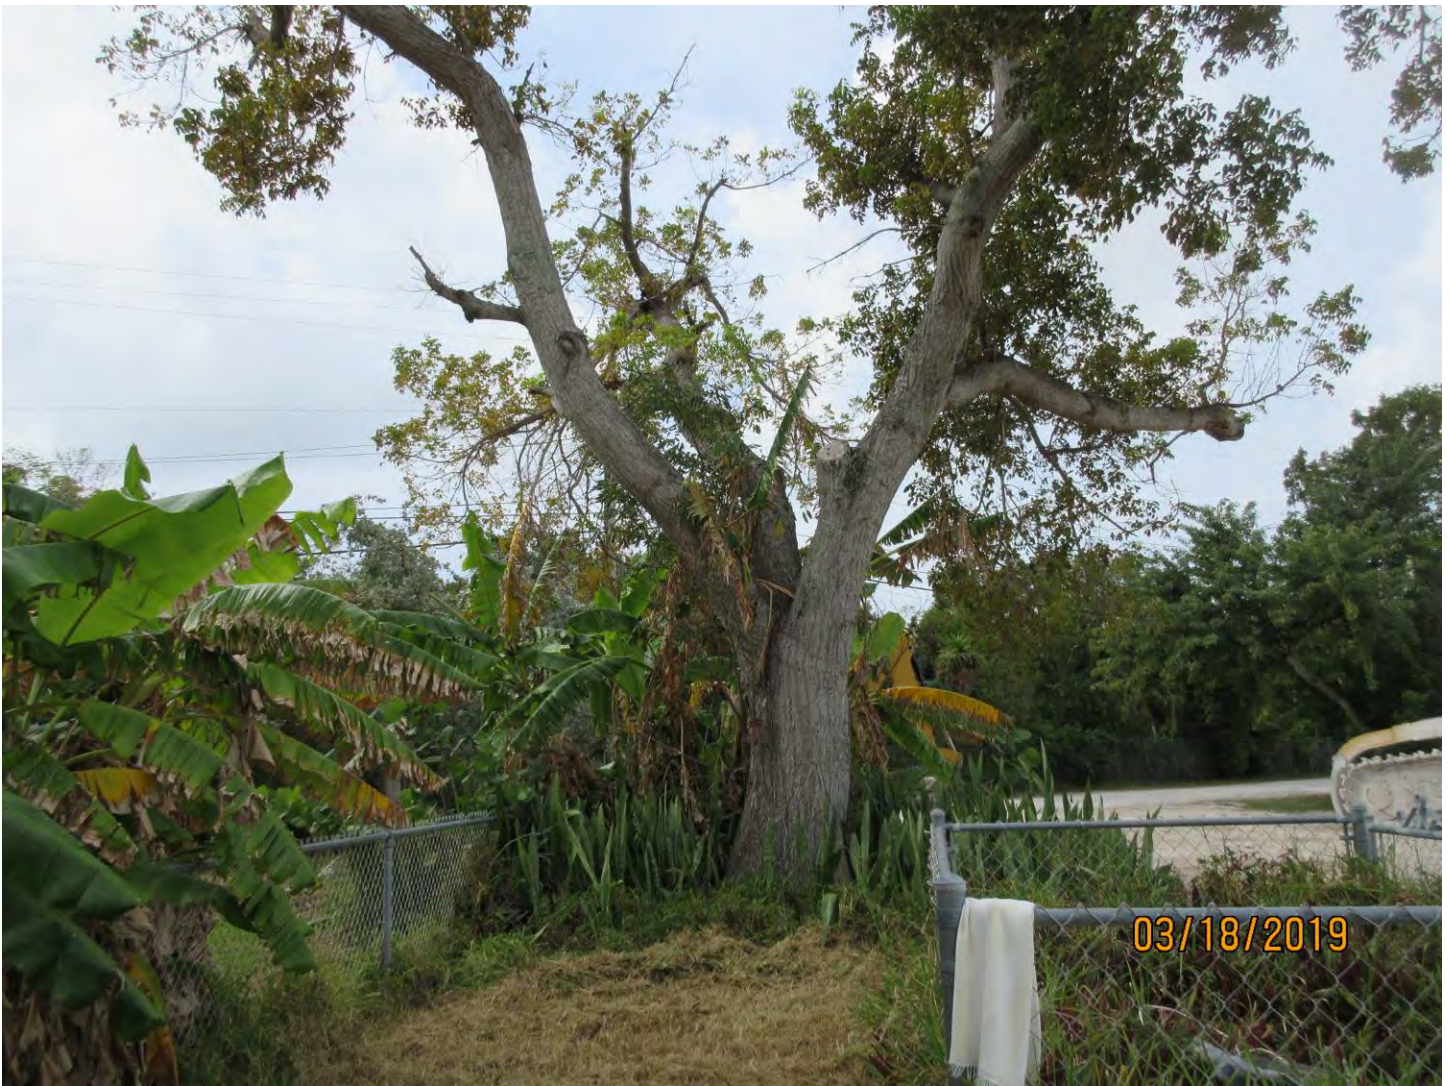
Diameter: 31.8"

Condition: 50% (fair, a lot of storm damage in canopy, decay, poor structure)

Value x Diameter = 24.1 replacement caliper inches
