## MEMORANDUM

DATE: April 5, 2019

RE: 2023 Flagler Avenue

FROM: Karen DeMaria, Urban Forestry Manager, City of Key West

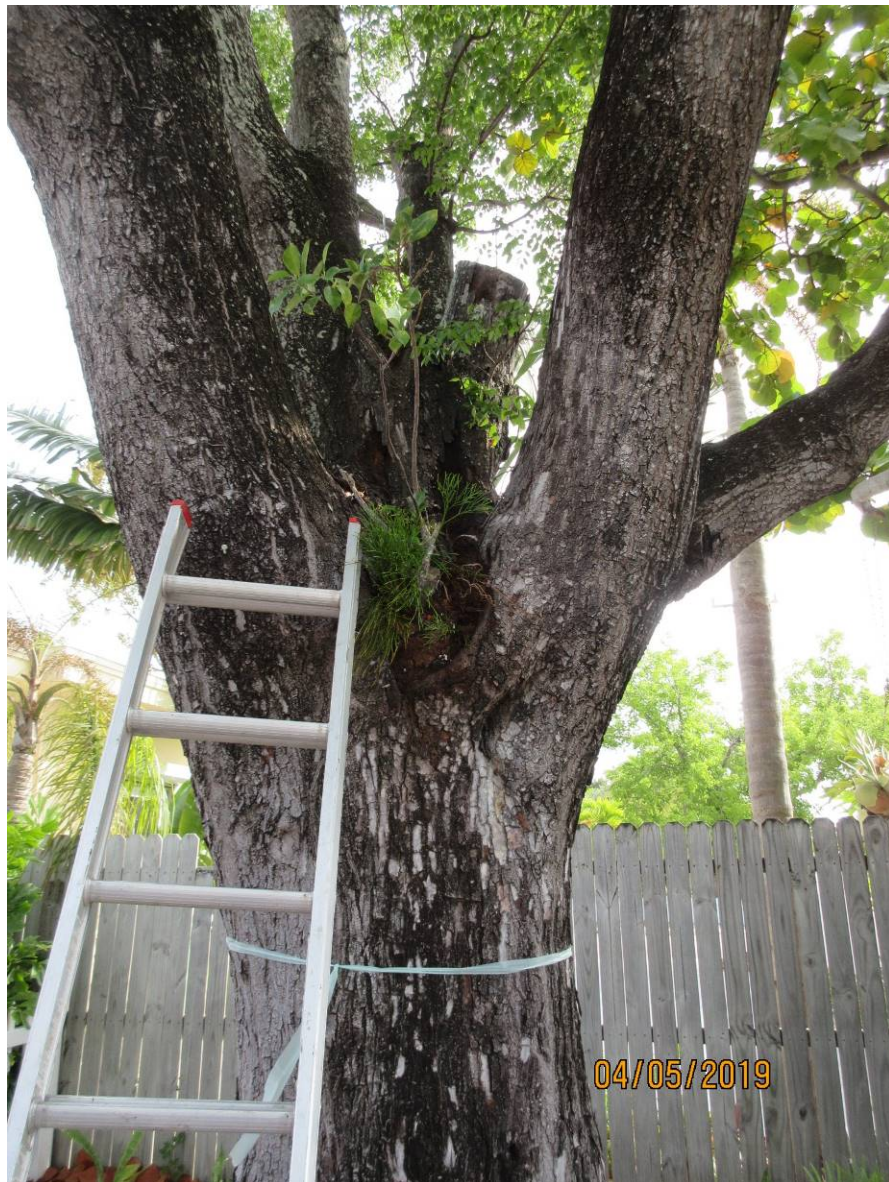
On April 5, 2019, the urban forester and the representative for the property, Kenneth King, did a core drill inspection of the crotch area of the mahogany tree. A 12" long drill bit was used to drill into several areas in the crotch to determine the depth of the decay. If the drill bit proceeds easily into the area, that indicates the presence of decay (Mahogany is a hard wooded tree).
