TASK ORDER 5-12 PORTS

ENGINEERING SERVICES FOR THE EVALUATION, TESTING AND STATEMENT OF WORK FOR MAINTENANCE AND REPAIRS OF THE NAVY MOLE ELECTRICAL DISTRIBUTION SYSTEM

The City of Key West (CITY) is working with the Navy to repair the existing electrical services on at the Mole Pier. The Navy has performed a visual inspection of the four (4) existing 13.8 kV to 480 V unit substations with corresponding switchgear that are used to provide shore power to ships berthed at the Mole Pier. The report identified that all electrical equipment is showing signs of significant deterioration due to the high salt environment. This equipment is further described in the design drawings (Exhibit A) navy drawings contract number N62427-03-C-0154 sheets E-1 through E-20A and as further described in field report dated February 2012 (Exhibit B)

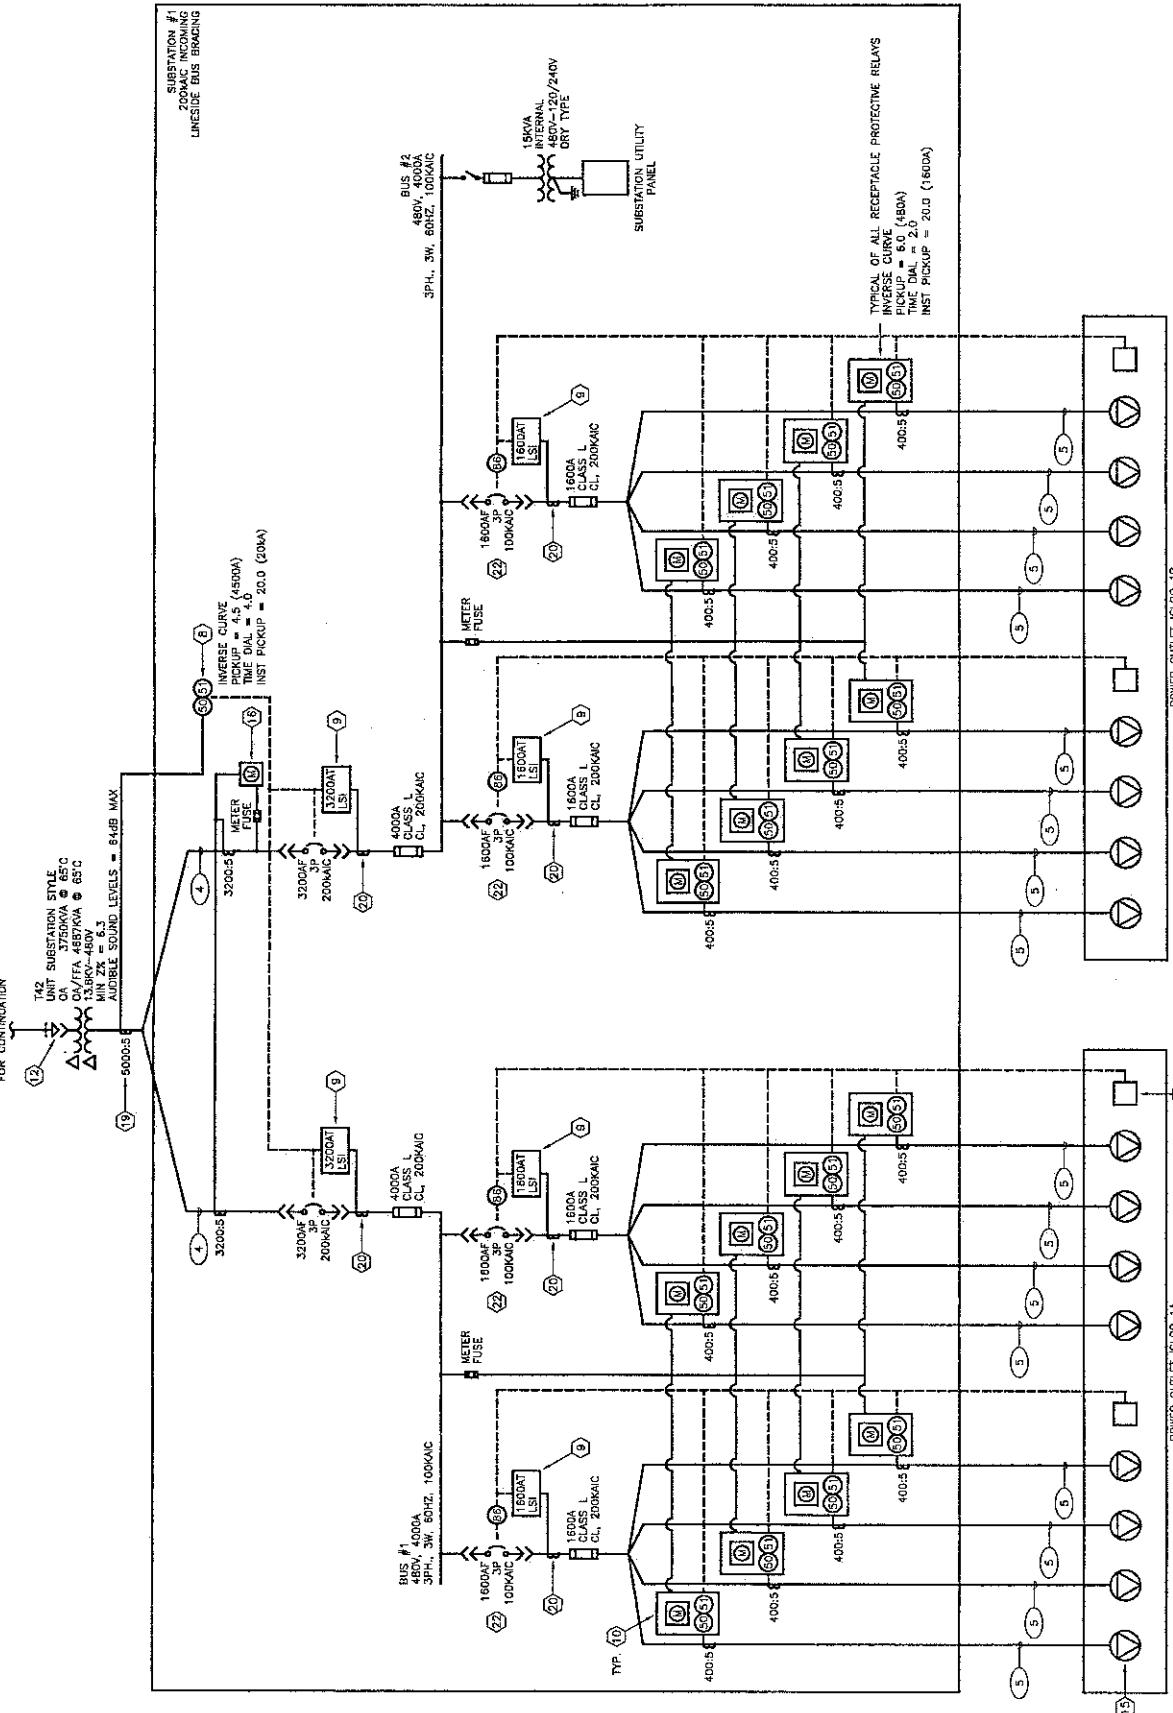
REFER TO DRAWING E-2 FOR KEYNOTES, FEEDER LEGEND, AND CT RATINGS

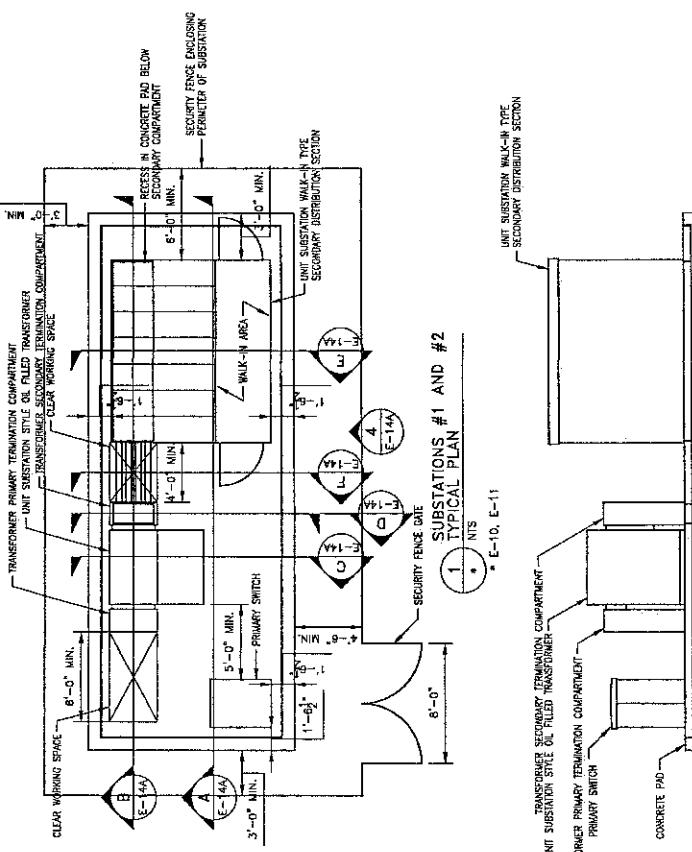
A SECTION
E-144 NS

PROVIDE ONE 1" AND SIXTEEN 4" SCH. 40 PVC CONDUITS BETWEEN RECESSES. USE THE 1" CONDUIT TO ROUTE THE CURRENT TRANSFORMER WIRING BETWEEN THE CURRENT TRANSFORMERS MOUNTED ON THE SECONDARY BUSINGS OF THE TRANSFORMER AND THE MAIN PROTECTIVE RELAY IN THE UNIT SUBSTATION SECONDARY DISTRIBUTION SECTION.

Diagram E SECTION shows a rectangular concrete pad with a central grid of circular rebar reinforcement. A callout labeled 'CONCRETE PAD' points to the overall structure, and another callout labeled '1' points to one of the circular rebar circles.

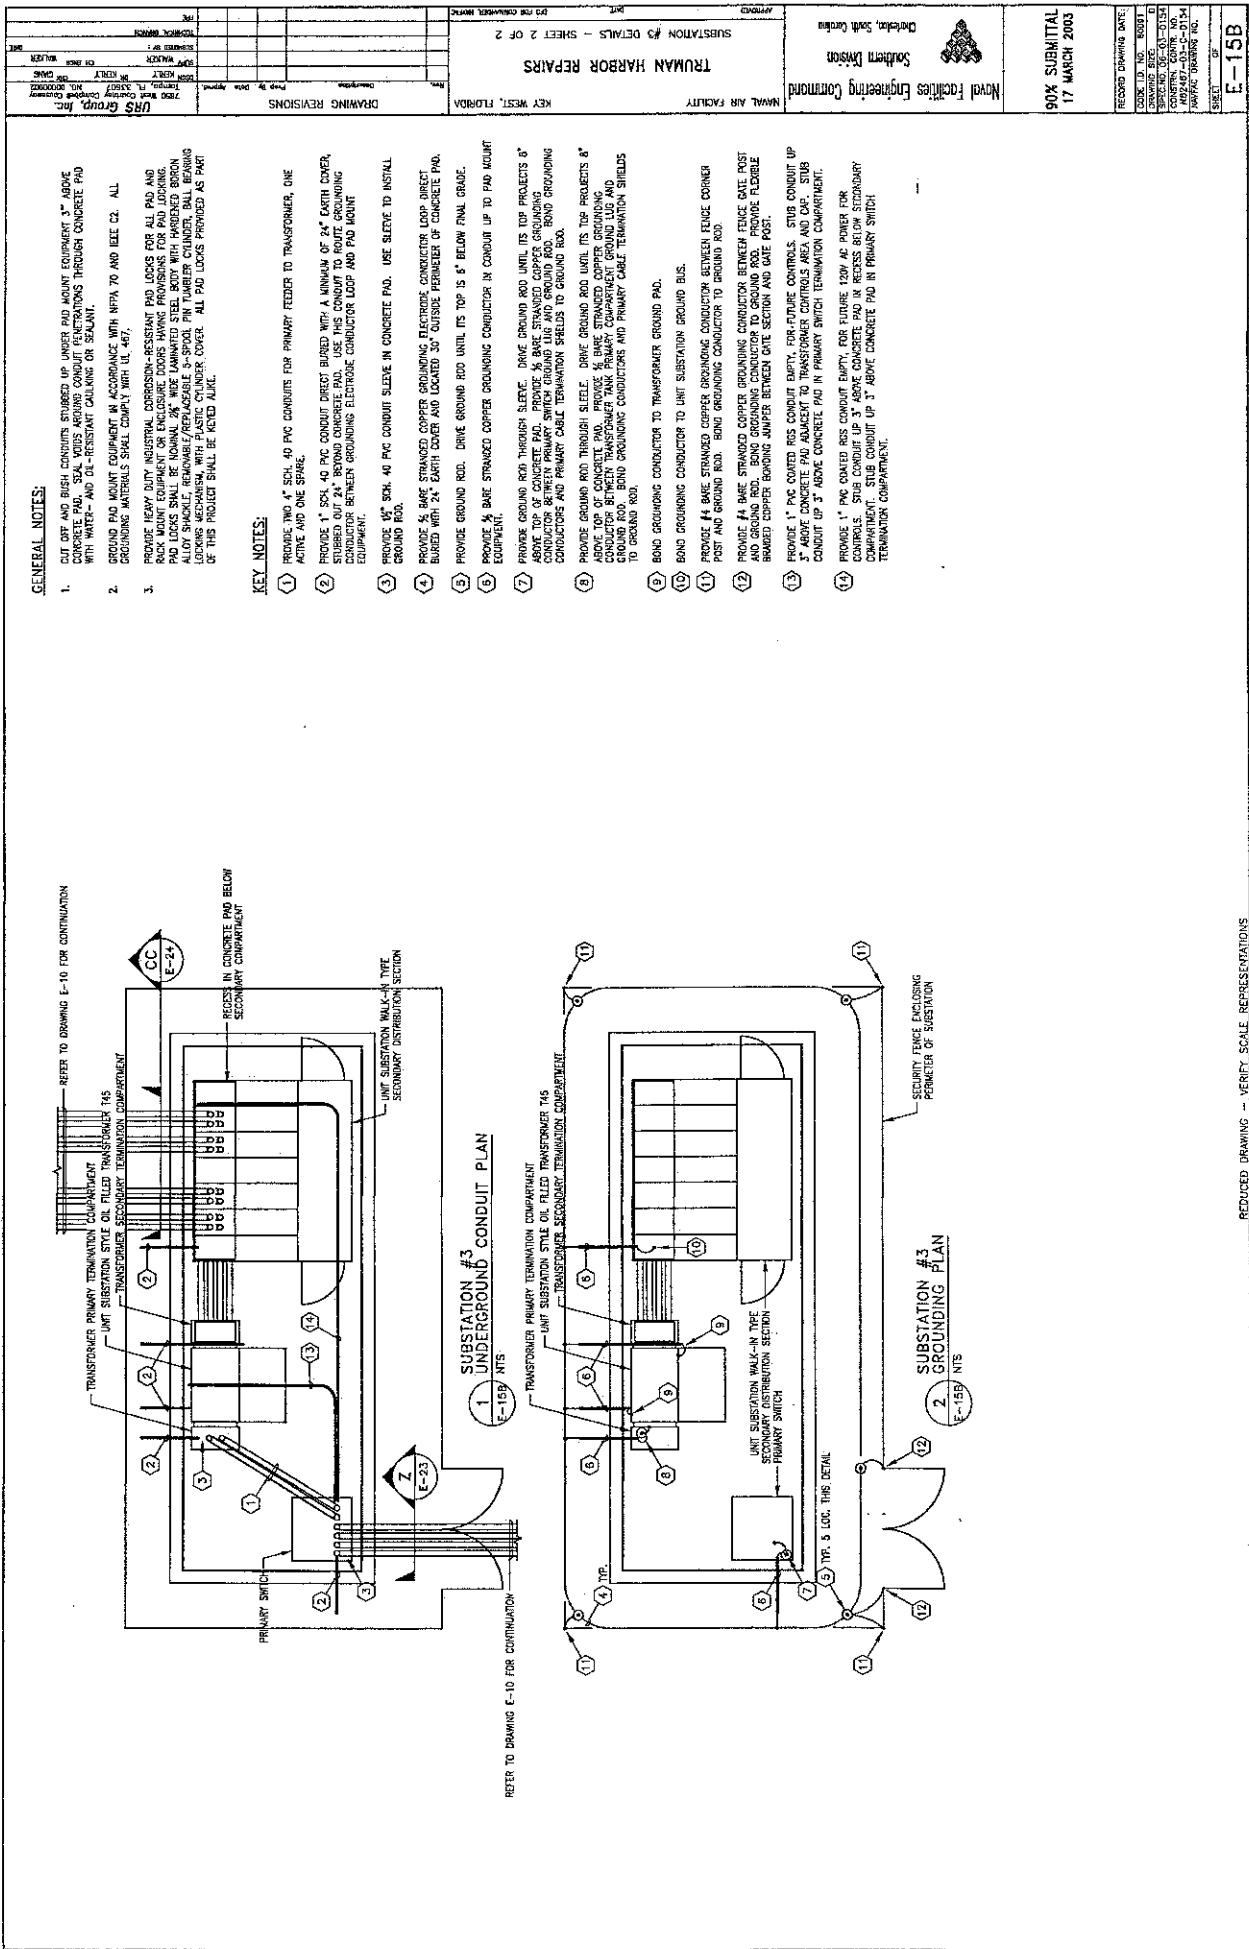
- CUT OFF AND BUSH CONDUITS STUBBED UP UNDER PAD MOUNT EQUIPMENT 5" ABOVE CONCRETE PAD. SEAL VENTS AGAINST CONDENSATION THROUGH CONCRETE PAD WITH WATER- AND OIL-RESISTANT CALMING OR SEALANT.
- GROUNDED PAD MOUNT EQUIPMENT IN ACCORDANCE WITH UL 457.
- PROVIDE HEAVY DUTY INDUSTRIAL CORROSION-RESISTANT PAD LOOPS FOR ALL PAD AND RACK EQUIPMENT OR ENCLOSURE COORDINATE HAVING GROUNDING CONDUCTOR LOOP DIRECTLY TO GROUND PAD. RACK EQUIPMENT SHALL BE PROVIDED WITH A GROUNDING CONDUCTOR WHICH IS CONNECTED TO THE GROUNDING BUS OF THE RACK. ALL PAD LOOPS PROVIDED AS PART OF THIS PROJECT SHALL BE KEPT ALIVE.

- PROVIDE GROUND ROD THRU SLEEVE. DRIVE GROUND ROD UNTIL ITS TOP PROJECTS 6". ABOVE TOP OF CONCRETE PAD. PROVIDE #6 BARE STRANDED COPPER GROUNDING CONDUCTOR BETWEEN SWITCHED WAY GROUNDING LUG AND GROUND ROD. BOND GROUNDING CONDUCTORS AND PRIMARY CABLE TERMINATION SHELLS TO GROUND ROD.
