THE CITY OF KEY WEST

SUBJECT: Six-month summary report on findings at the Stock Island Landfill

Staff has been tasked to assist the Sustainability Board with evaluating the Stock Island Landfill. To review environmental conditions, testing reports and current condition to determine highest and best use.

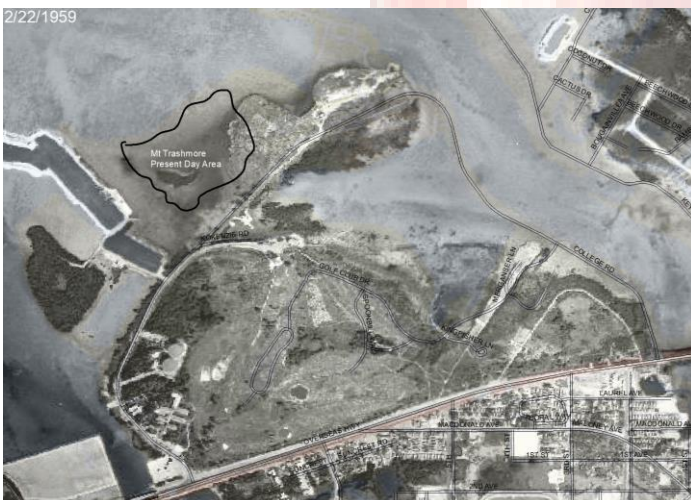
City of Key West dump site opened in the early 1930's. Aerials from 1959 show the current footprint of the landfill was water in 1959. It is believed that trenches were dug and fill was used as the base when it became a landfill began in the late 1960's.
