1316 ROYAL STREET
KEY WEST, FLORIDA

DRAWING NAME
TREE PROTECTION PLAN

LANDSCAPE PLAN

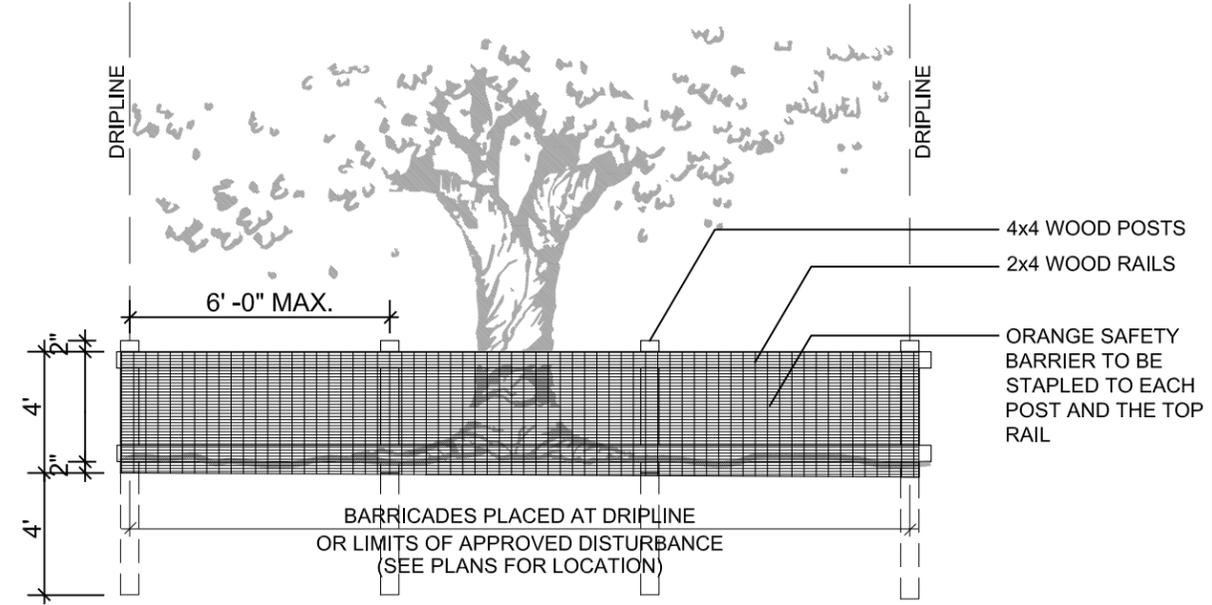
LEGEND

— TREE PROTECTION BARRIER

TREE PROTECTION AND PRESERVATION NOTES
