Staff Report for Item 11

Application Number: H16-01-0342

Address: #600 Eaton Street – Jones Fellowship Hall

Remove asphalt shingles and replace with metal v-crimp. Install modified bitumen roof on flat section.

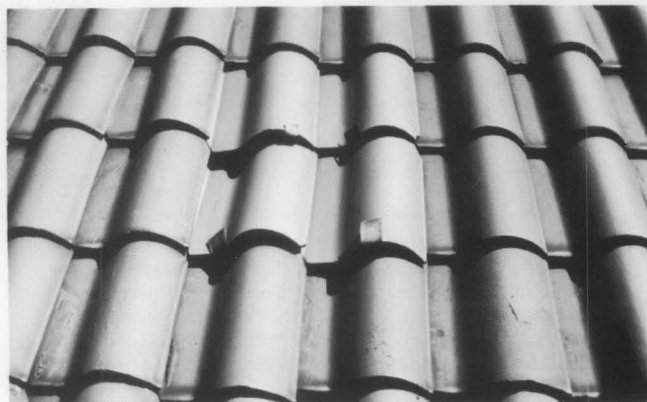
Repairs on this pantile roof were made with new tiles held in place with metal hangers. (Main Building, Ellis Island, New York)

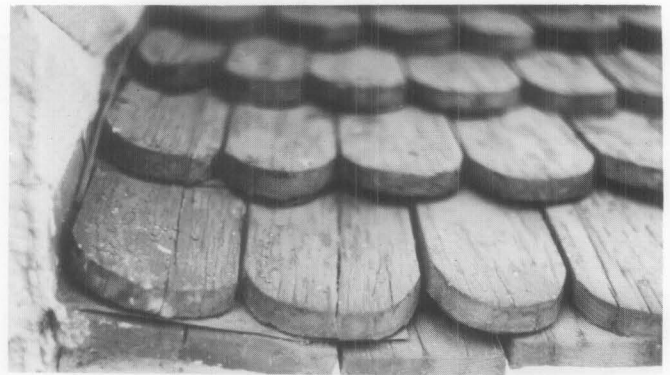
Replacement of particular historic details is important to the individual historic character of a roof, such as the treatment at the eaves of this rounded butt wood shingle roof. Also note that the surface of the roof was carefully sloped to drain water away from the side of the dormer. In the restoration, this function was augmented with the addition of carefully concealed modern metal flashing. (Mount Vernon, Virginia)

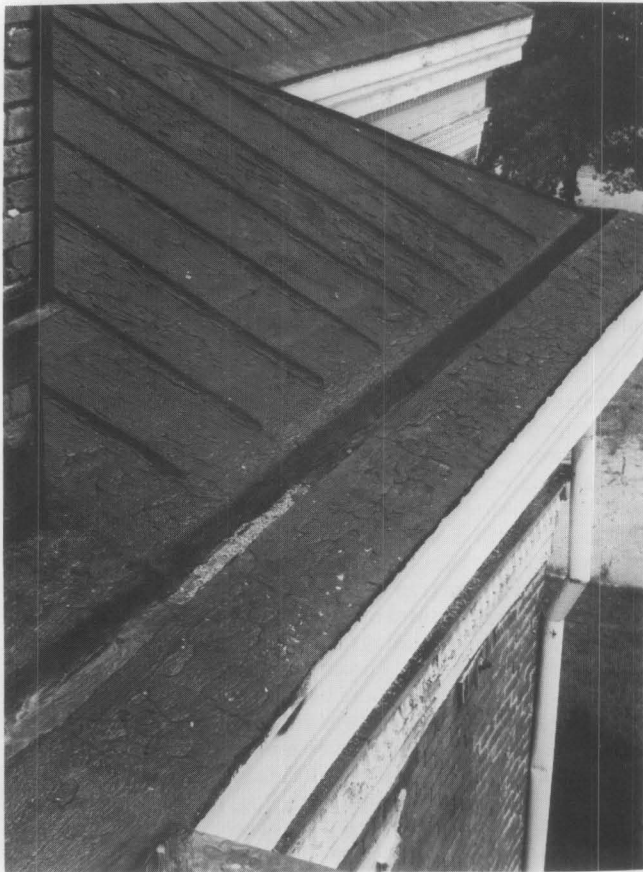
Repeated repair with asphalt, which cracks as it hardens, has created a blistered surface on this sheet-metal roof and built-in gutter, which will retain water. Repairs could be made by carefully heating and scraping the surface clean, repairing the holes in the metal with a flexible mastic compound or a metal patch, and coating the surface with a fibre paint. (Roane County Courthouse, Kingston, Tennessee, photo courtesy of Building Conservation Technology, Inc.)

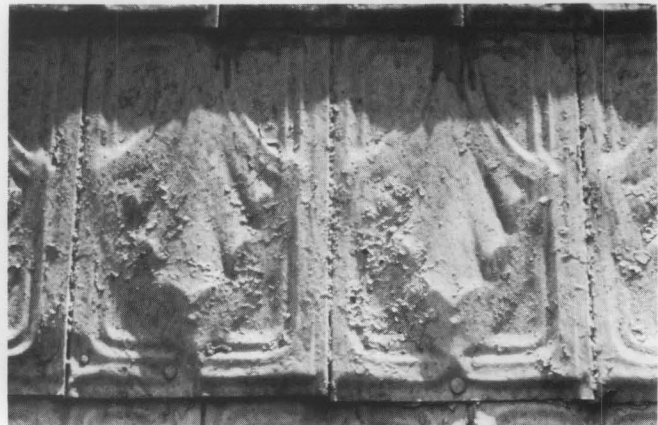
Tin shingles, commonly embossed to imitate wood or tile, or with a decorative design, were popular as an inexpensive, textured roofing material. These shingles $8\frac{3}{8}$ inch by $12\frac{1}{2}$ inch on the exposed surface) were designed with interlocking edges, but they have been repaired by surface nailing, which may cause future leakage. (Ballard House, Yorktown, Virginia, photo by Gordie Whittington, National Park Service)

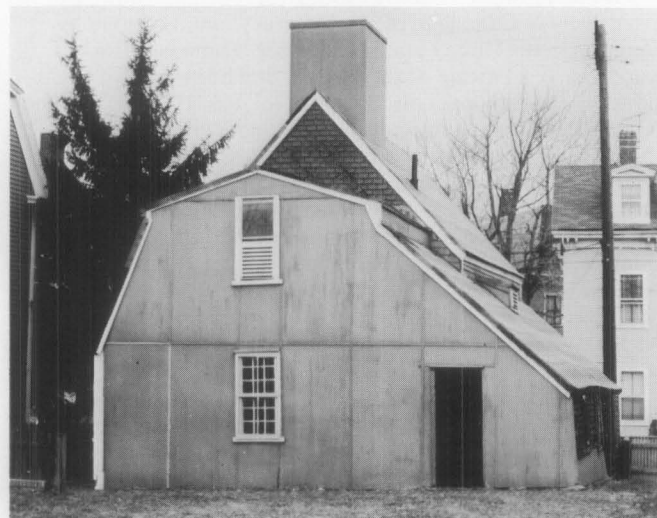
Temporary stabilization or "mothballing" with materials such as plywood and building paper can protect the roof of a project until it can be properly repaired or replaced. (Narbonne House, Salem, Massachusetts)

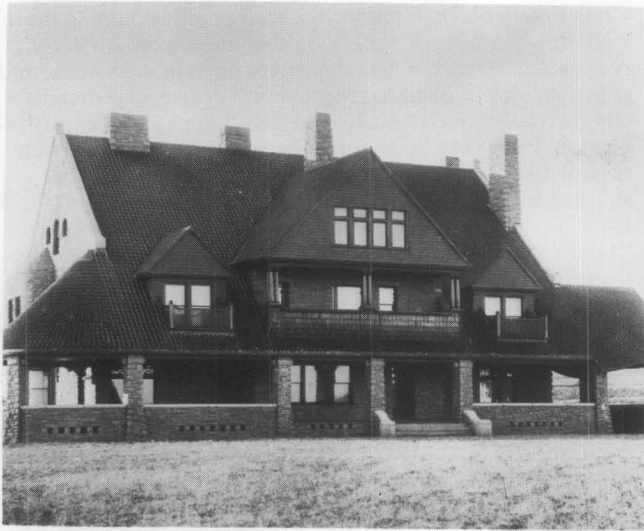
These two views of the same house demonstrate how the use of a substitute material can drastically affect the overall character of a structure. The textural interest of the original tile roof was lost with the use of asphalt shingles. Recent preservation efforts are replacing the tile roof. (Frank House, Kearney, Nebraska, photo courtesy of the Nebraska State Historical Society, Lincoln, Nebraska)

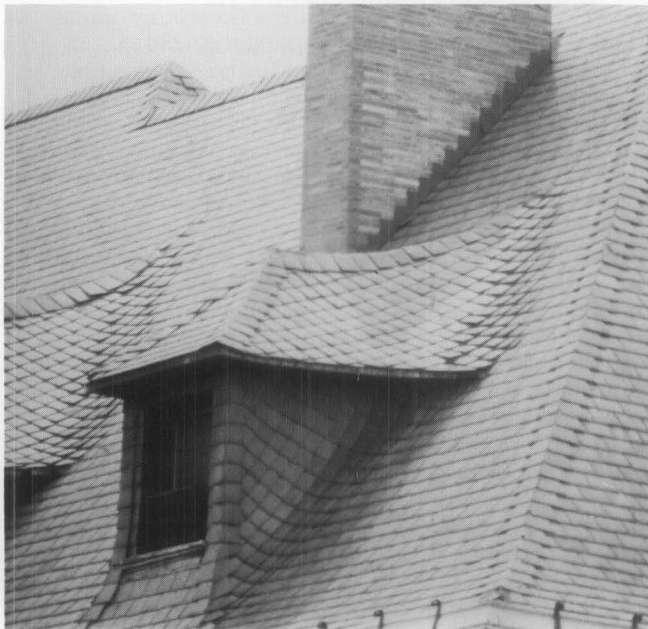
Because of the roof's visibility, the slate detailing around the dormers is important to the character of this structure. Note how the slates swirl from a horizontal pattern on the main roof to a diamond pattern on the dormer roofs and side walls. (18th and Que Streets, NW, Washington, D.C.)

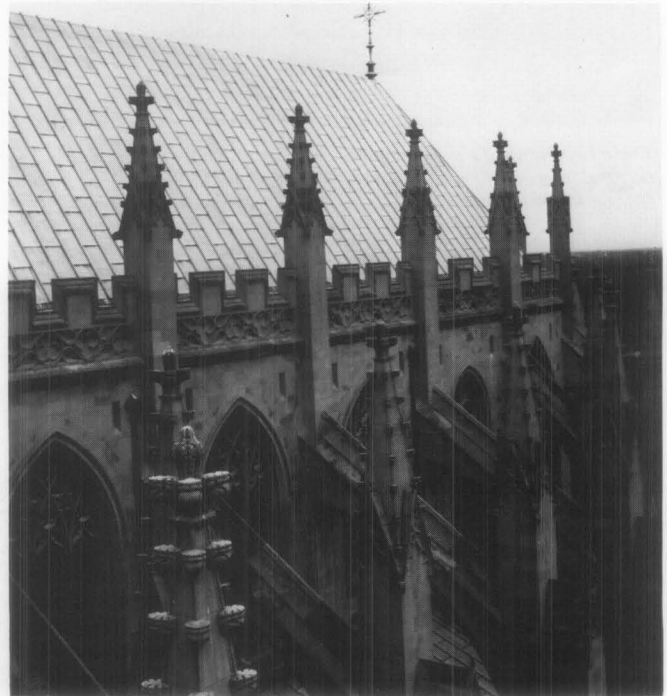
Good design and quality materials for the roof surface, fastenings, and flashing minimize roofing failures. This is essential on roofs such as on the National Cathedral where a thorough maintenance inspection and minor repairs cannot be done easily without special scaffolding. However, the success of the roof on any structure depends on frequent cleaning and repair of the gutter system. (Washington, D.C., photo courtesy of John Burns, A.I.A.)

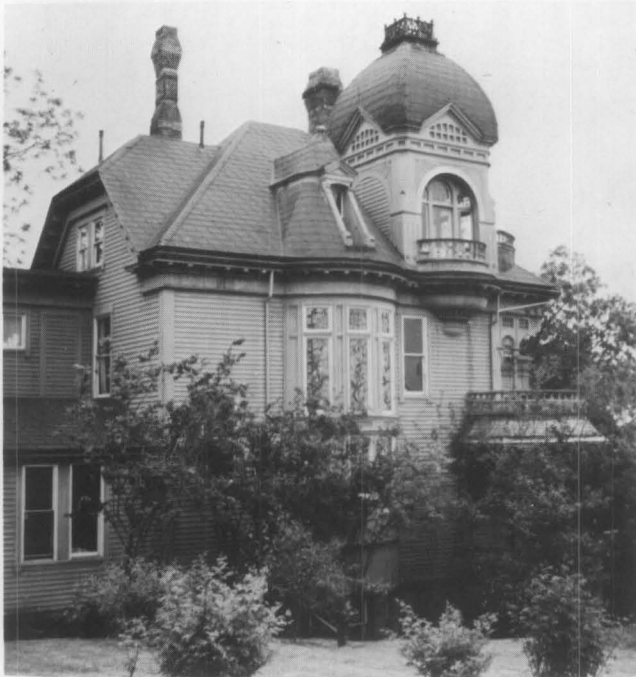
Special problems inherent in the design of an elaborate historic roof can be controlled through the use of good materials and regular maintenance. The shape and detailing are essential elements of the building's historic character, and should not be modified, despite the use of alternative surface materials. (Gamwell House, Bellingham, Washington)

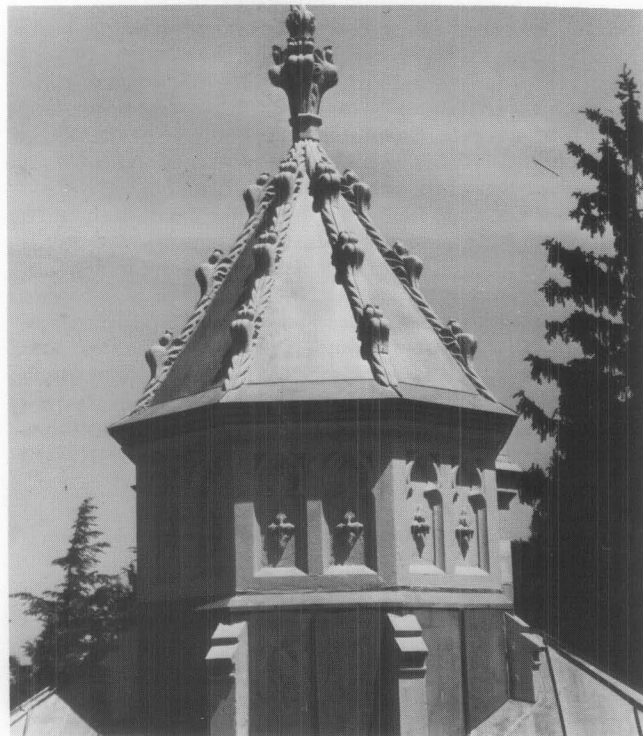
Decorative features such as cupolas require extra maintenance. The flashing is carefully detailed to promote run-off, and the wooden ribbing must be kept well-painted. This roof surface, which was originally tin plate, has been replaced with lead-coated copper for maintenance purposes. (Lyndhurst, Tarrytown, New York, photo courtesy of the National Trust for Historic Preservation)

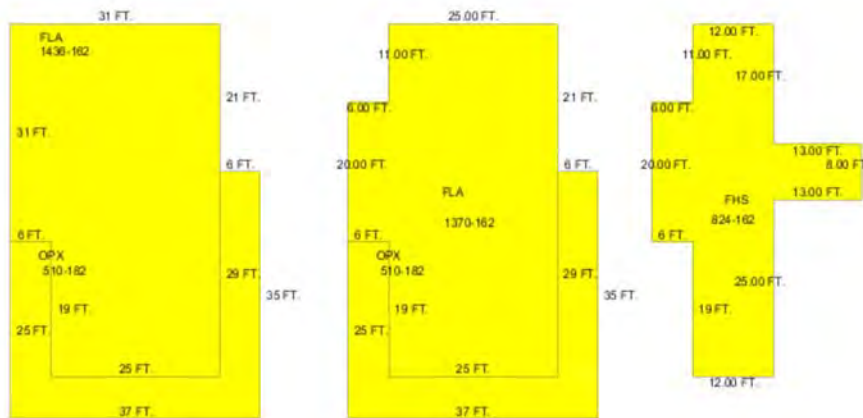
Nbr	Type	Ext Wall	# Stories	Year Built	Attic A/C	Basement %	Finished Basement %	Area
0	<u>FHS</u>	12:ABOVE AVERAGE WOOD	1	1993				824
1	<u>FLA</u>	12:ABOVE AVERAGE WOOD	1	1993	N N	0.00	0.00	1,436
2	<u>OPX</u>		1	1993	N N	0.00	0.00	510
3	<u>FLA</u>	12:ABOVE AVERAGE WOOD	1	1993	N N	0.00	0.00	1,370
4	<u>OPX</u>		1	1993	N N	0.00	0.00	510
