Historic Architectural Review Commission

Staff Report Item 7a

Application Number: H13-01-538

Address: #422 Front Street

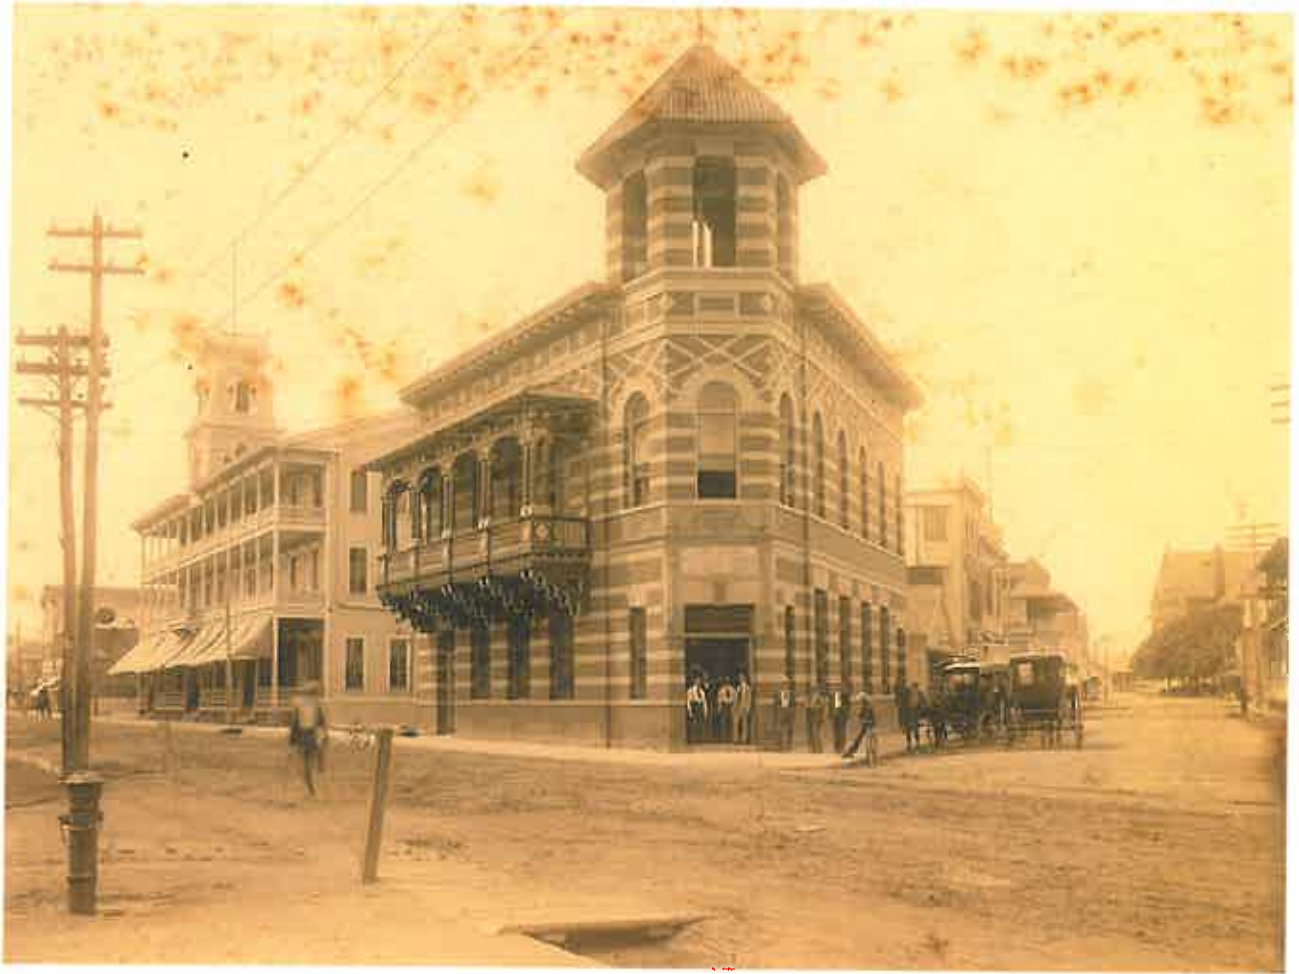
The opening of the First National Bank on Duval Street at the corner of Front in 1892. Photo from the Monroe County Library Collection

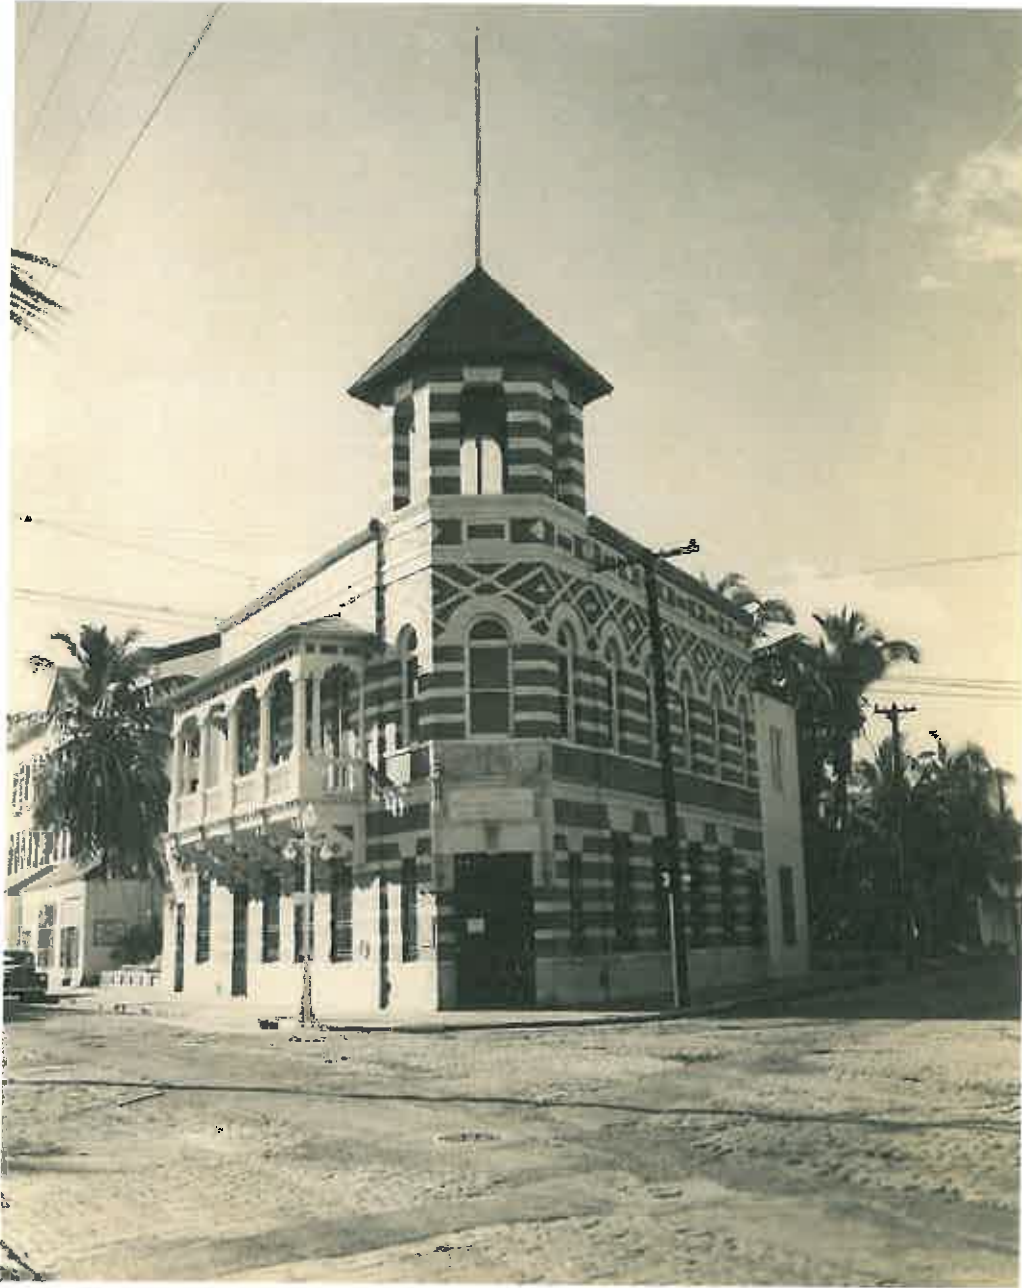
The First National Bank at Duval Street and Front Street C 1940. Key West Photo Service by Jeff Brodhead. From the DeWolfe and Wood Collection in the Otto Hirzel Scrapbook. Monroe County Library.

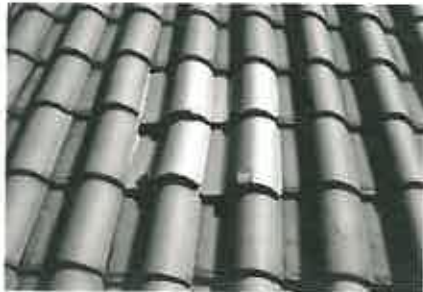
Repairs on this pantile roof were made with new tiles held in place with metal hangers. Photo: NPS files.

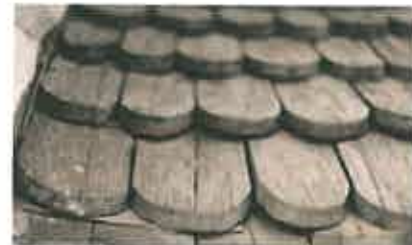
Replacement of particular historic details is important to the individual historic character of a roof, such as this rounded butt wood shingle roof. In the restoration, the drainage around a dormer was improved by the addition of carefully concealed modern metal flashing. Photo: NPS files.

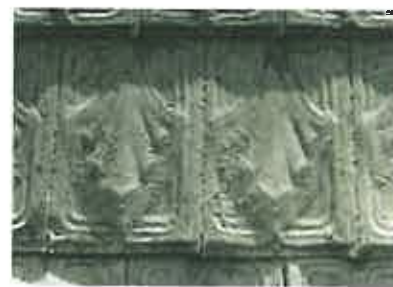
Tin shingles, commonly embossed to imitate wood or tile, or with a decorative design, were popular as an inexpensive, textured roofing material. Photo: NPS files.

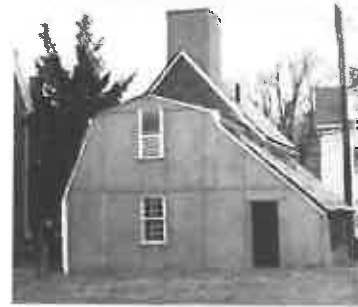
Temporary stabilization or "mothballing" with materials, such as plywood and building paper, can protect the roof of a project until it can be properly repaired or replaced. Photo: NPS files.

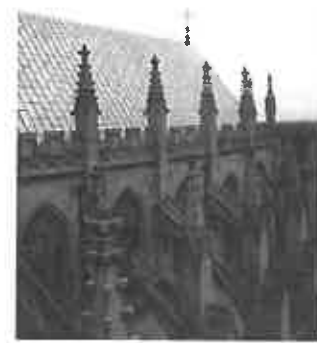
Good design and quality materials for the roof surface, fastenings, and flashing minimize failures. Photo: NPS files.

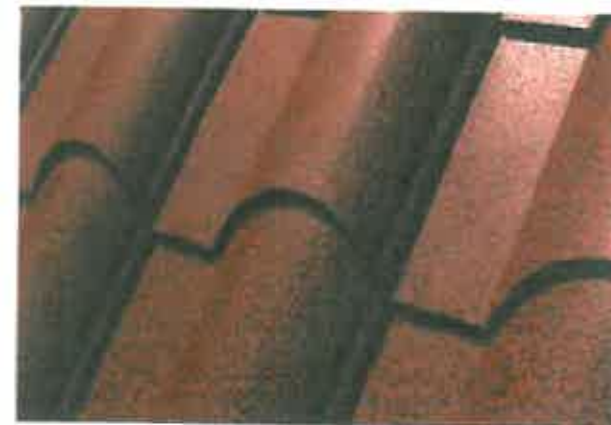
**NEW! 24 GAUGE
BARREL STYLE METAL TILE
MISSION RED SPLATTER
COAT PAINT SYSTEM**
