Staff Report

- 9a Rehabilitation of 814 Baptist lane and new one story addition. Elevate existing structure, replace stairs and enlarge front porch. Relocate existing accessory shed and site improvements- **#812-814 Baptist Lane/ #812-814 Patone Street- Ty Symroski (H12-01-189)**

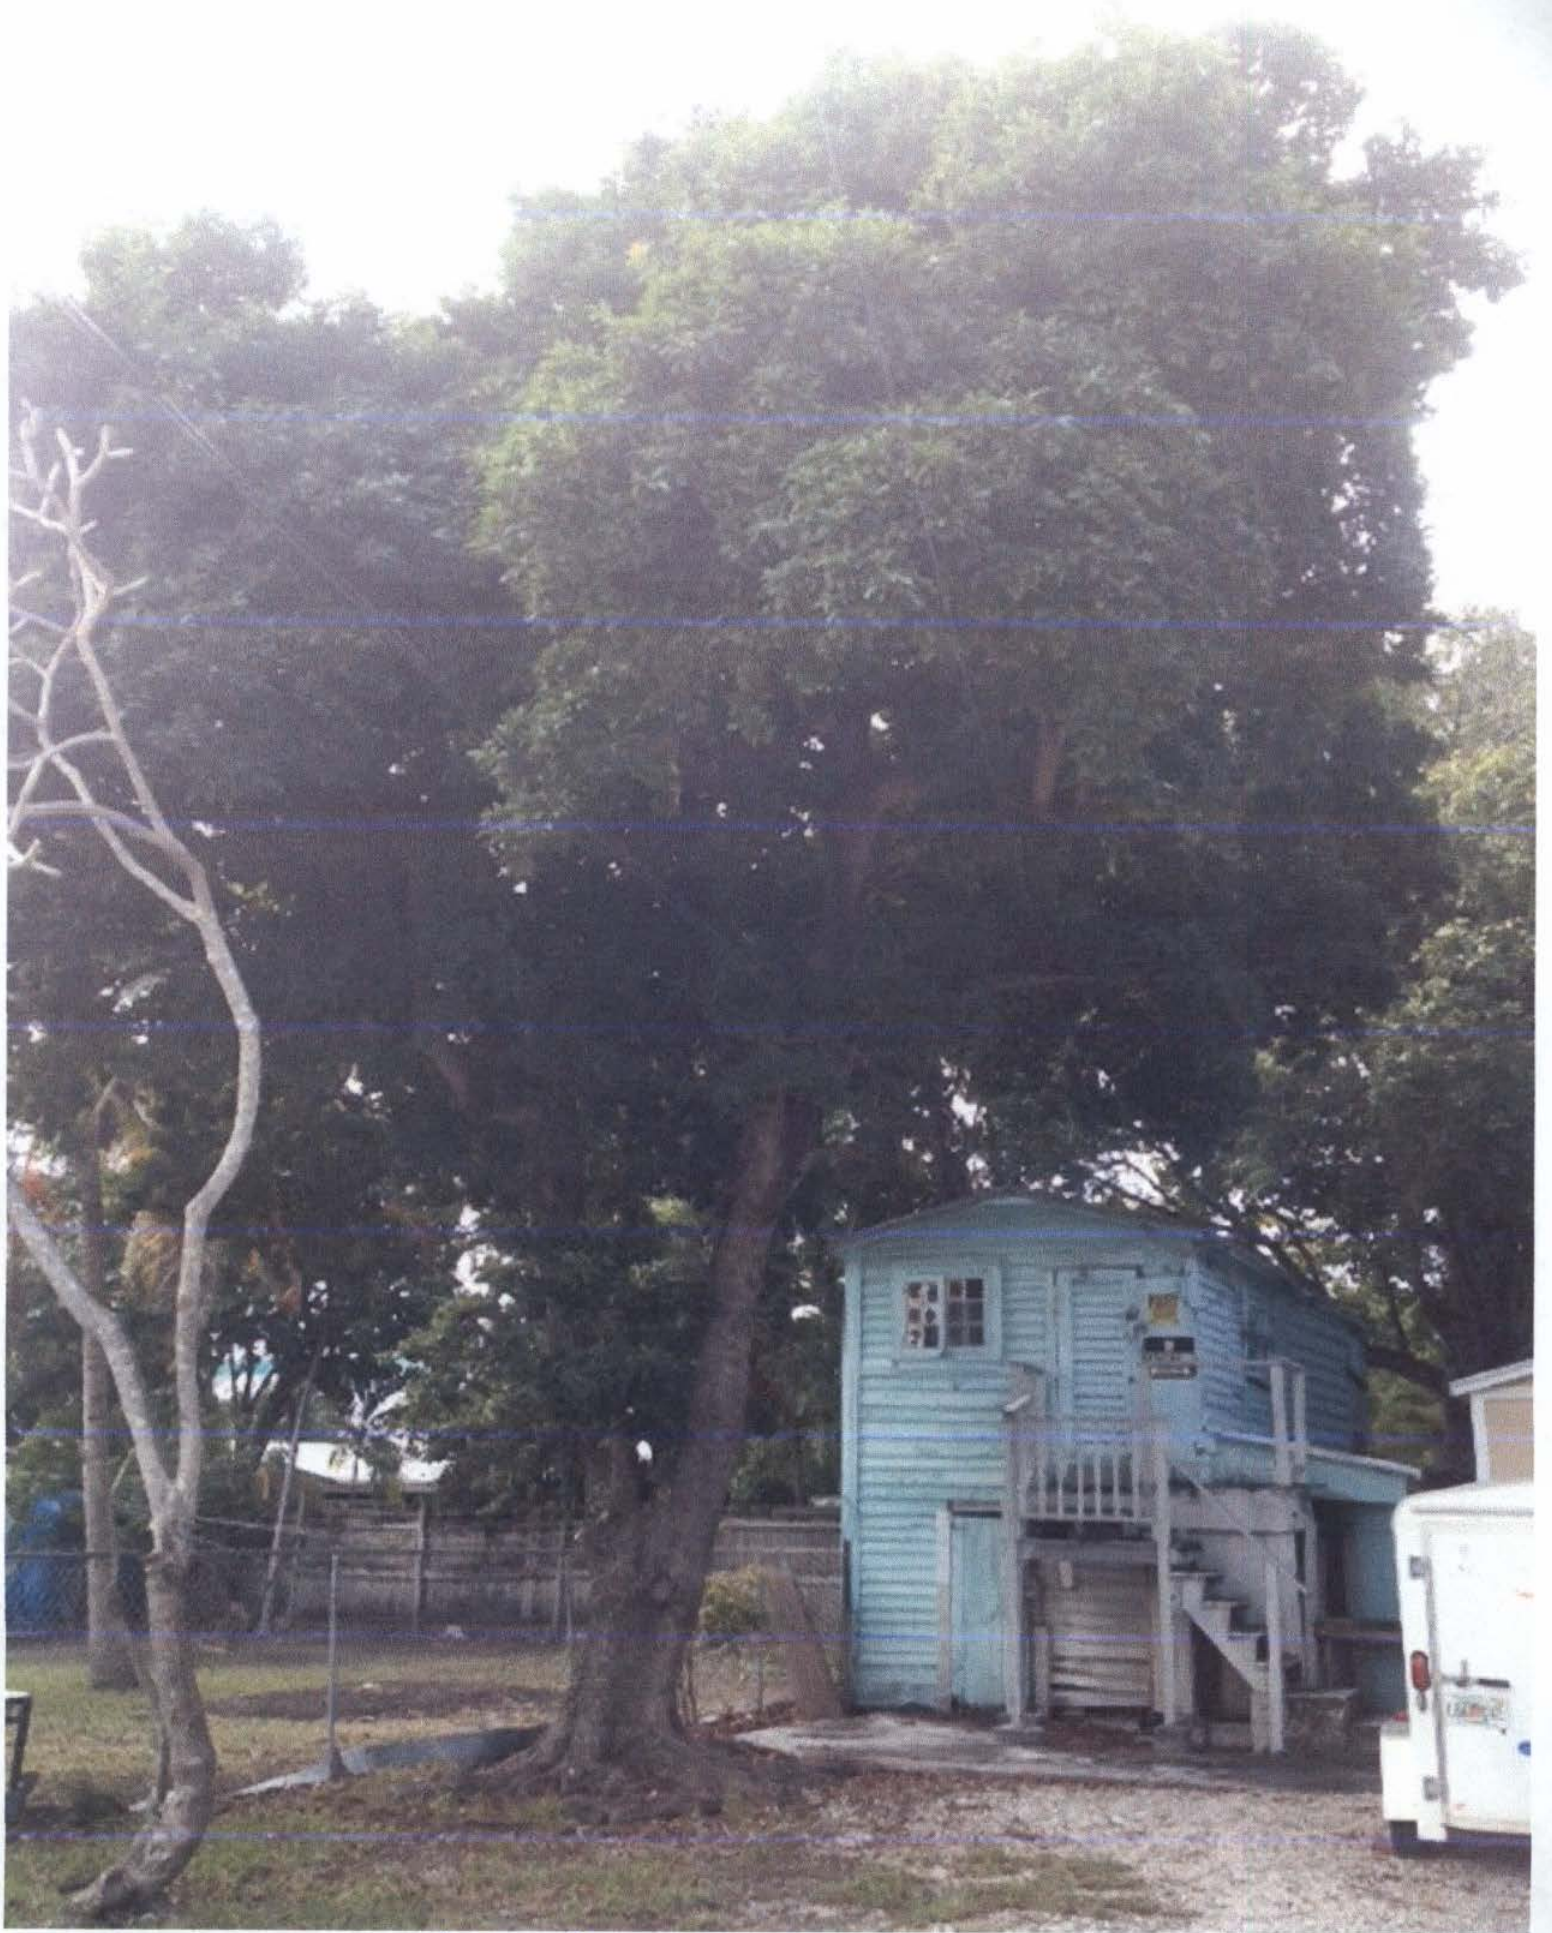
Sapodilla siel

The tree most impacted by construction is the Sapodilla at 24 $\frac{3}{4}$ " DBH, co-dominant at 4 $\frac{1}{2}$ ', approximately 40'x 60', and has prior extensive storm damage. It is growing at the center southernmost portion of the property, side yard, approximately 15'-18' feet from the face of the historic building. That building is located at the southwestern corner of the property. Construction vehicles will pass under the canopy (dripline) of this tree and breaking ground by means of augering holes for pilings. Above grade beams and cantilevering is proposed to lessen impact to root system. An ISA (International Society of Arboriculture) Certified Arborist will be on site during construction within the dripline.

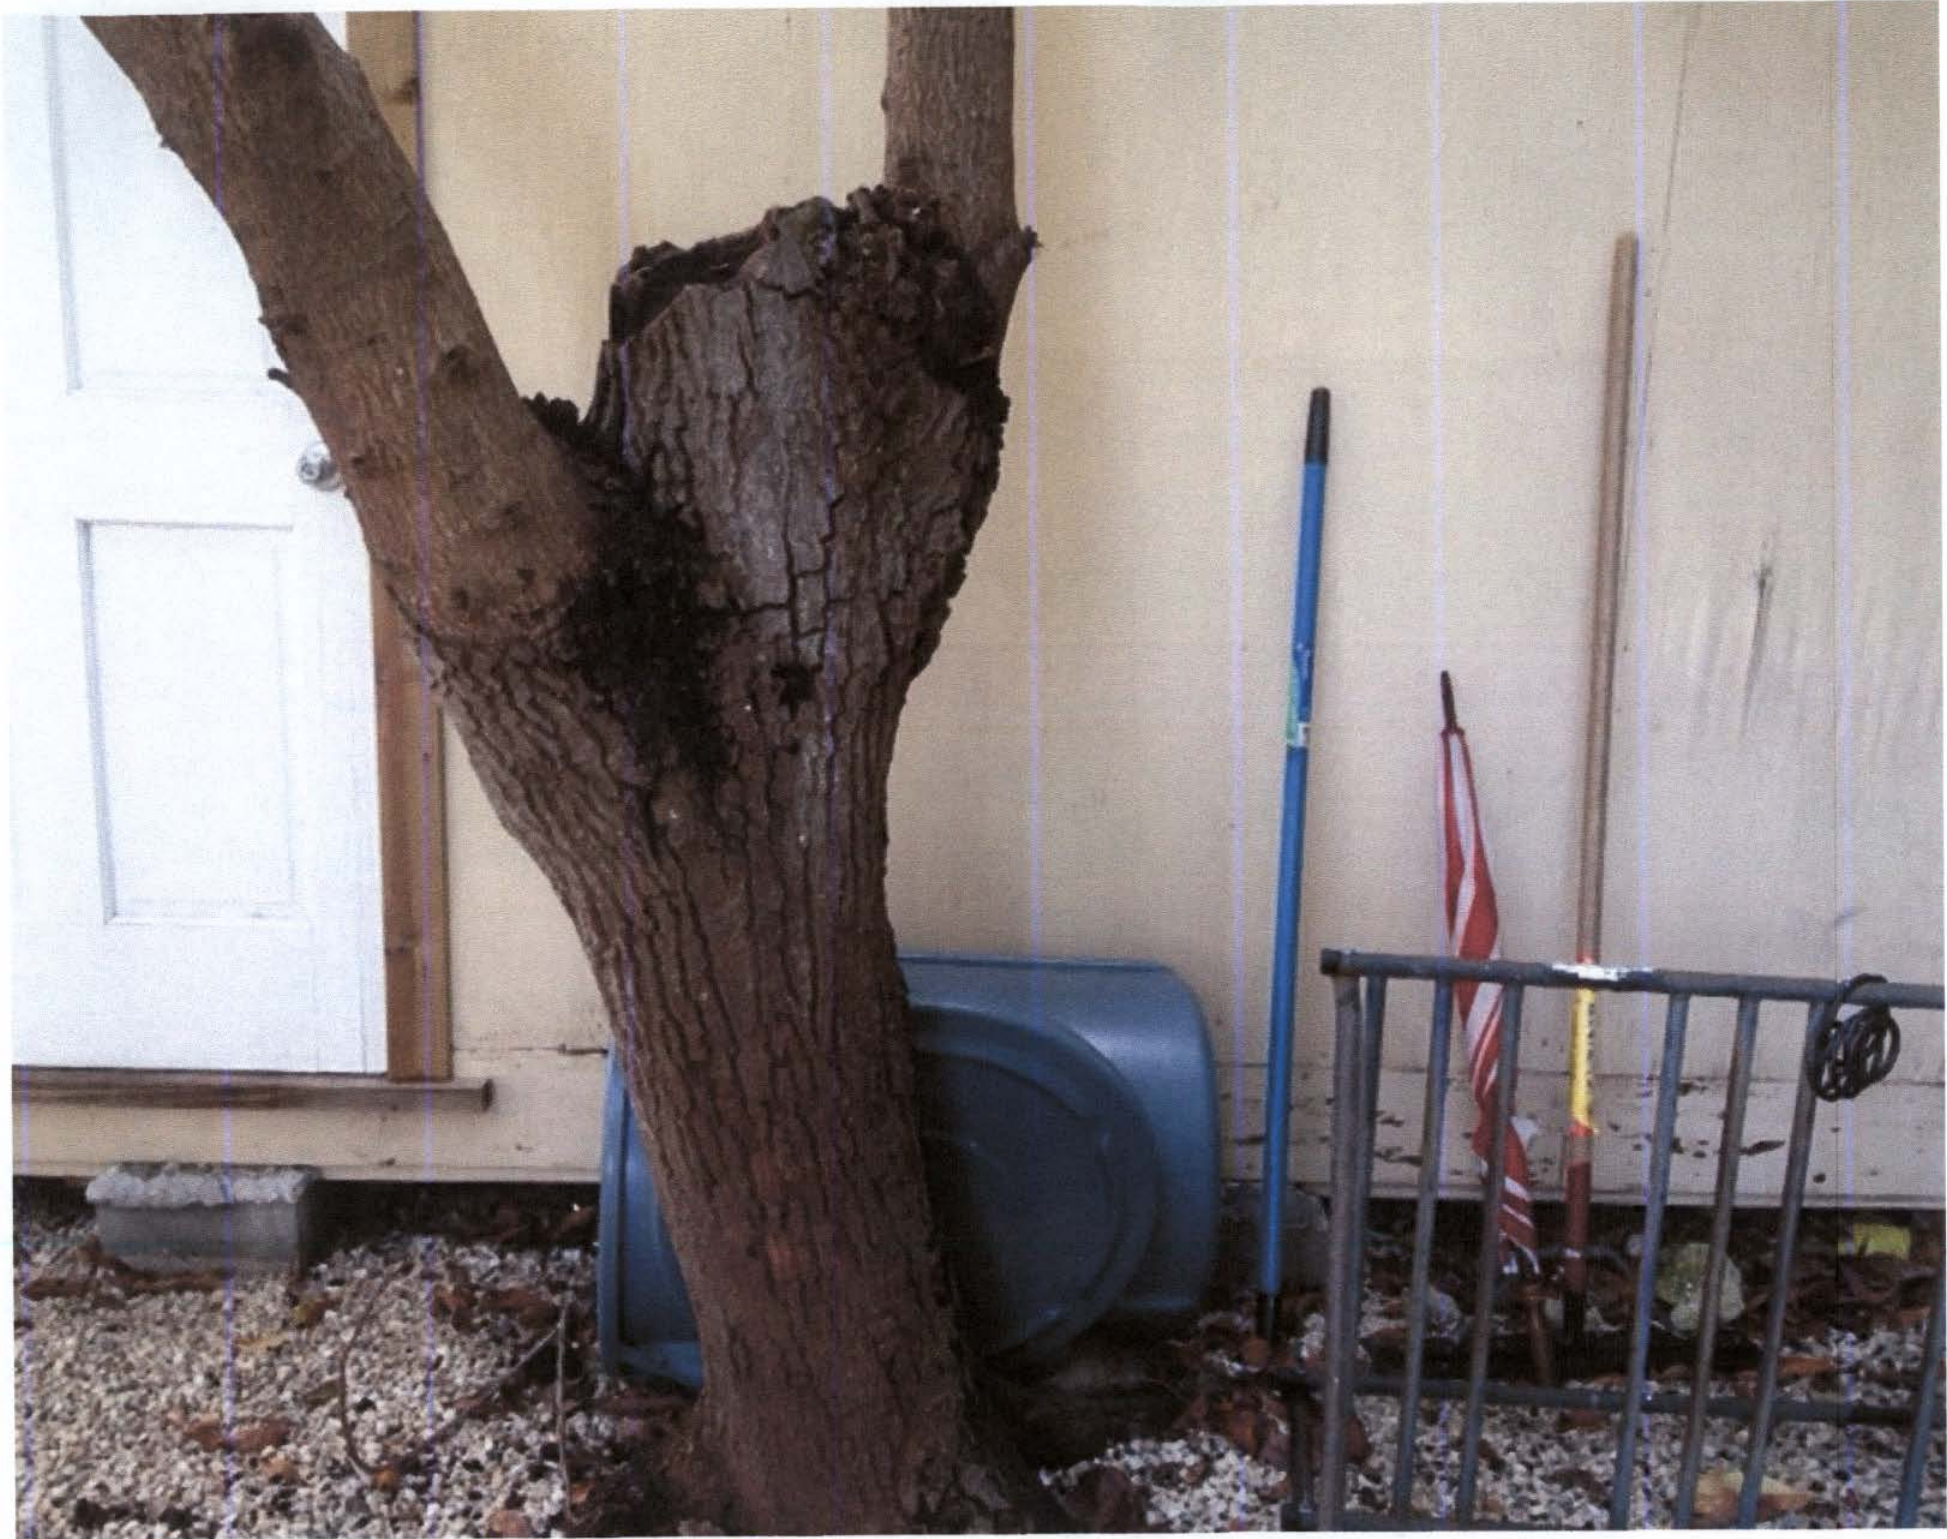
AVOCADO TO BE REMOVED

Renovation is proposed on an historic outbuilding at 812-814 Baptist Lane. On the property there are three historically significant trees; two are Sapodilla and one is a Spanish Lime. Their condition rating is fair. The Sapodilla closest to the historic building is most impacted by construction. Also on the site is an Avocado in poor condition which is to be removed.

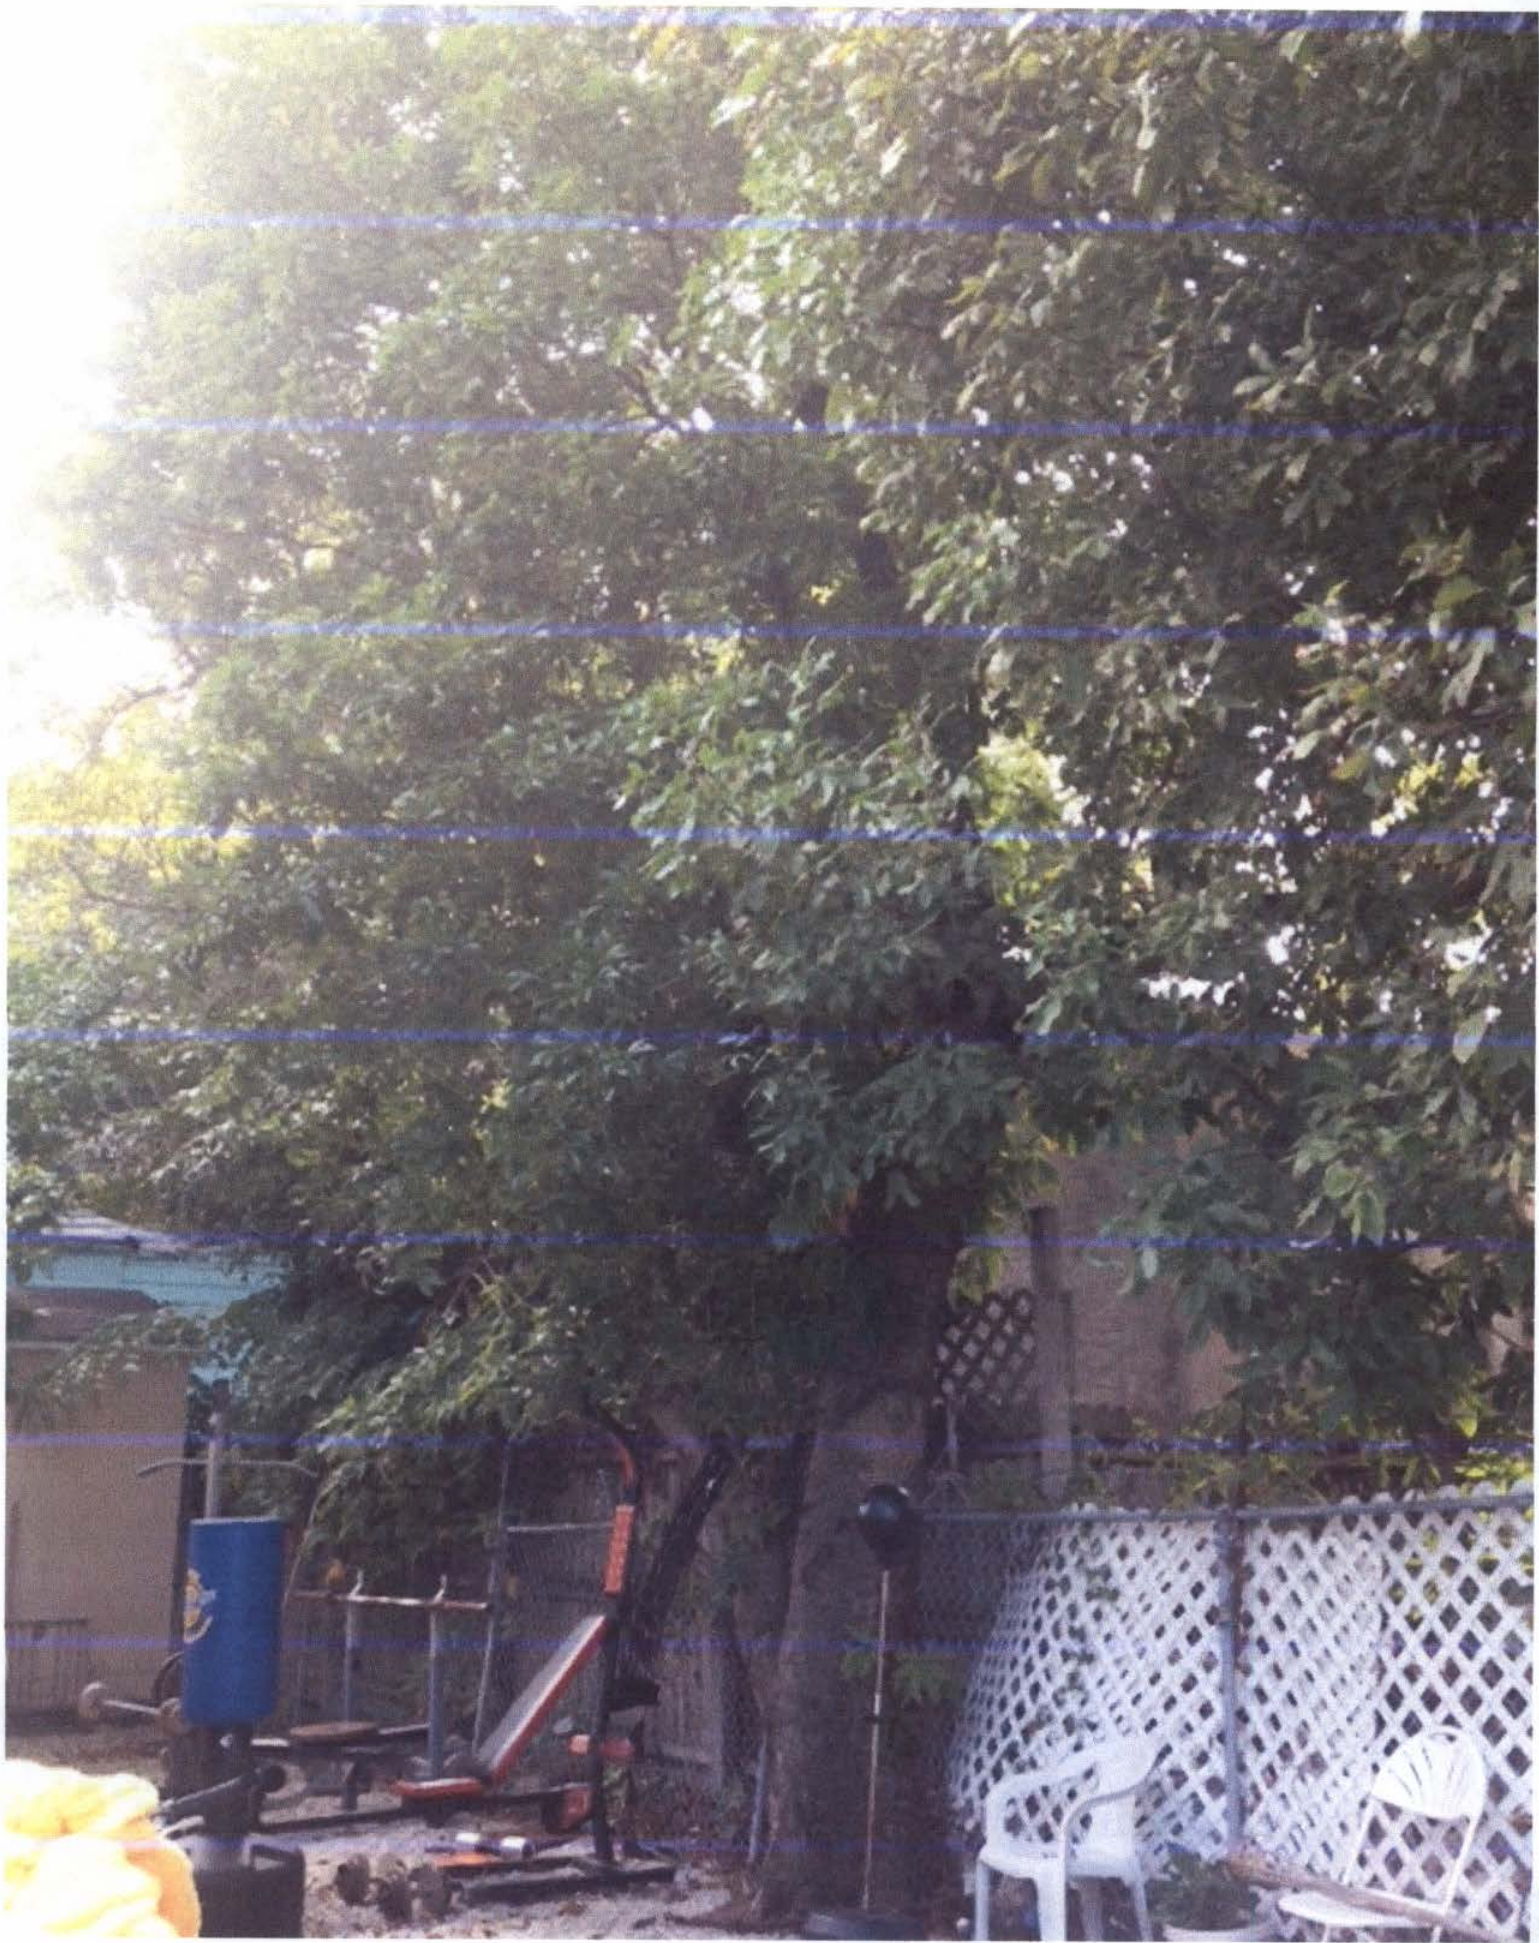
Sapodilla rear

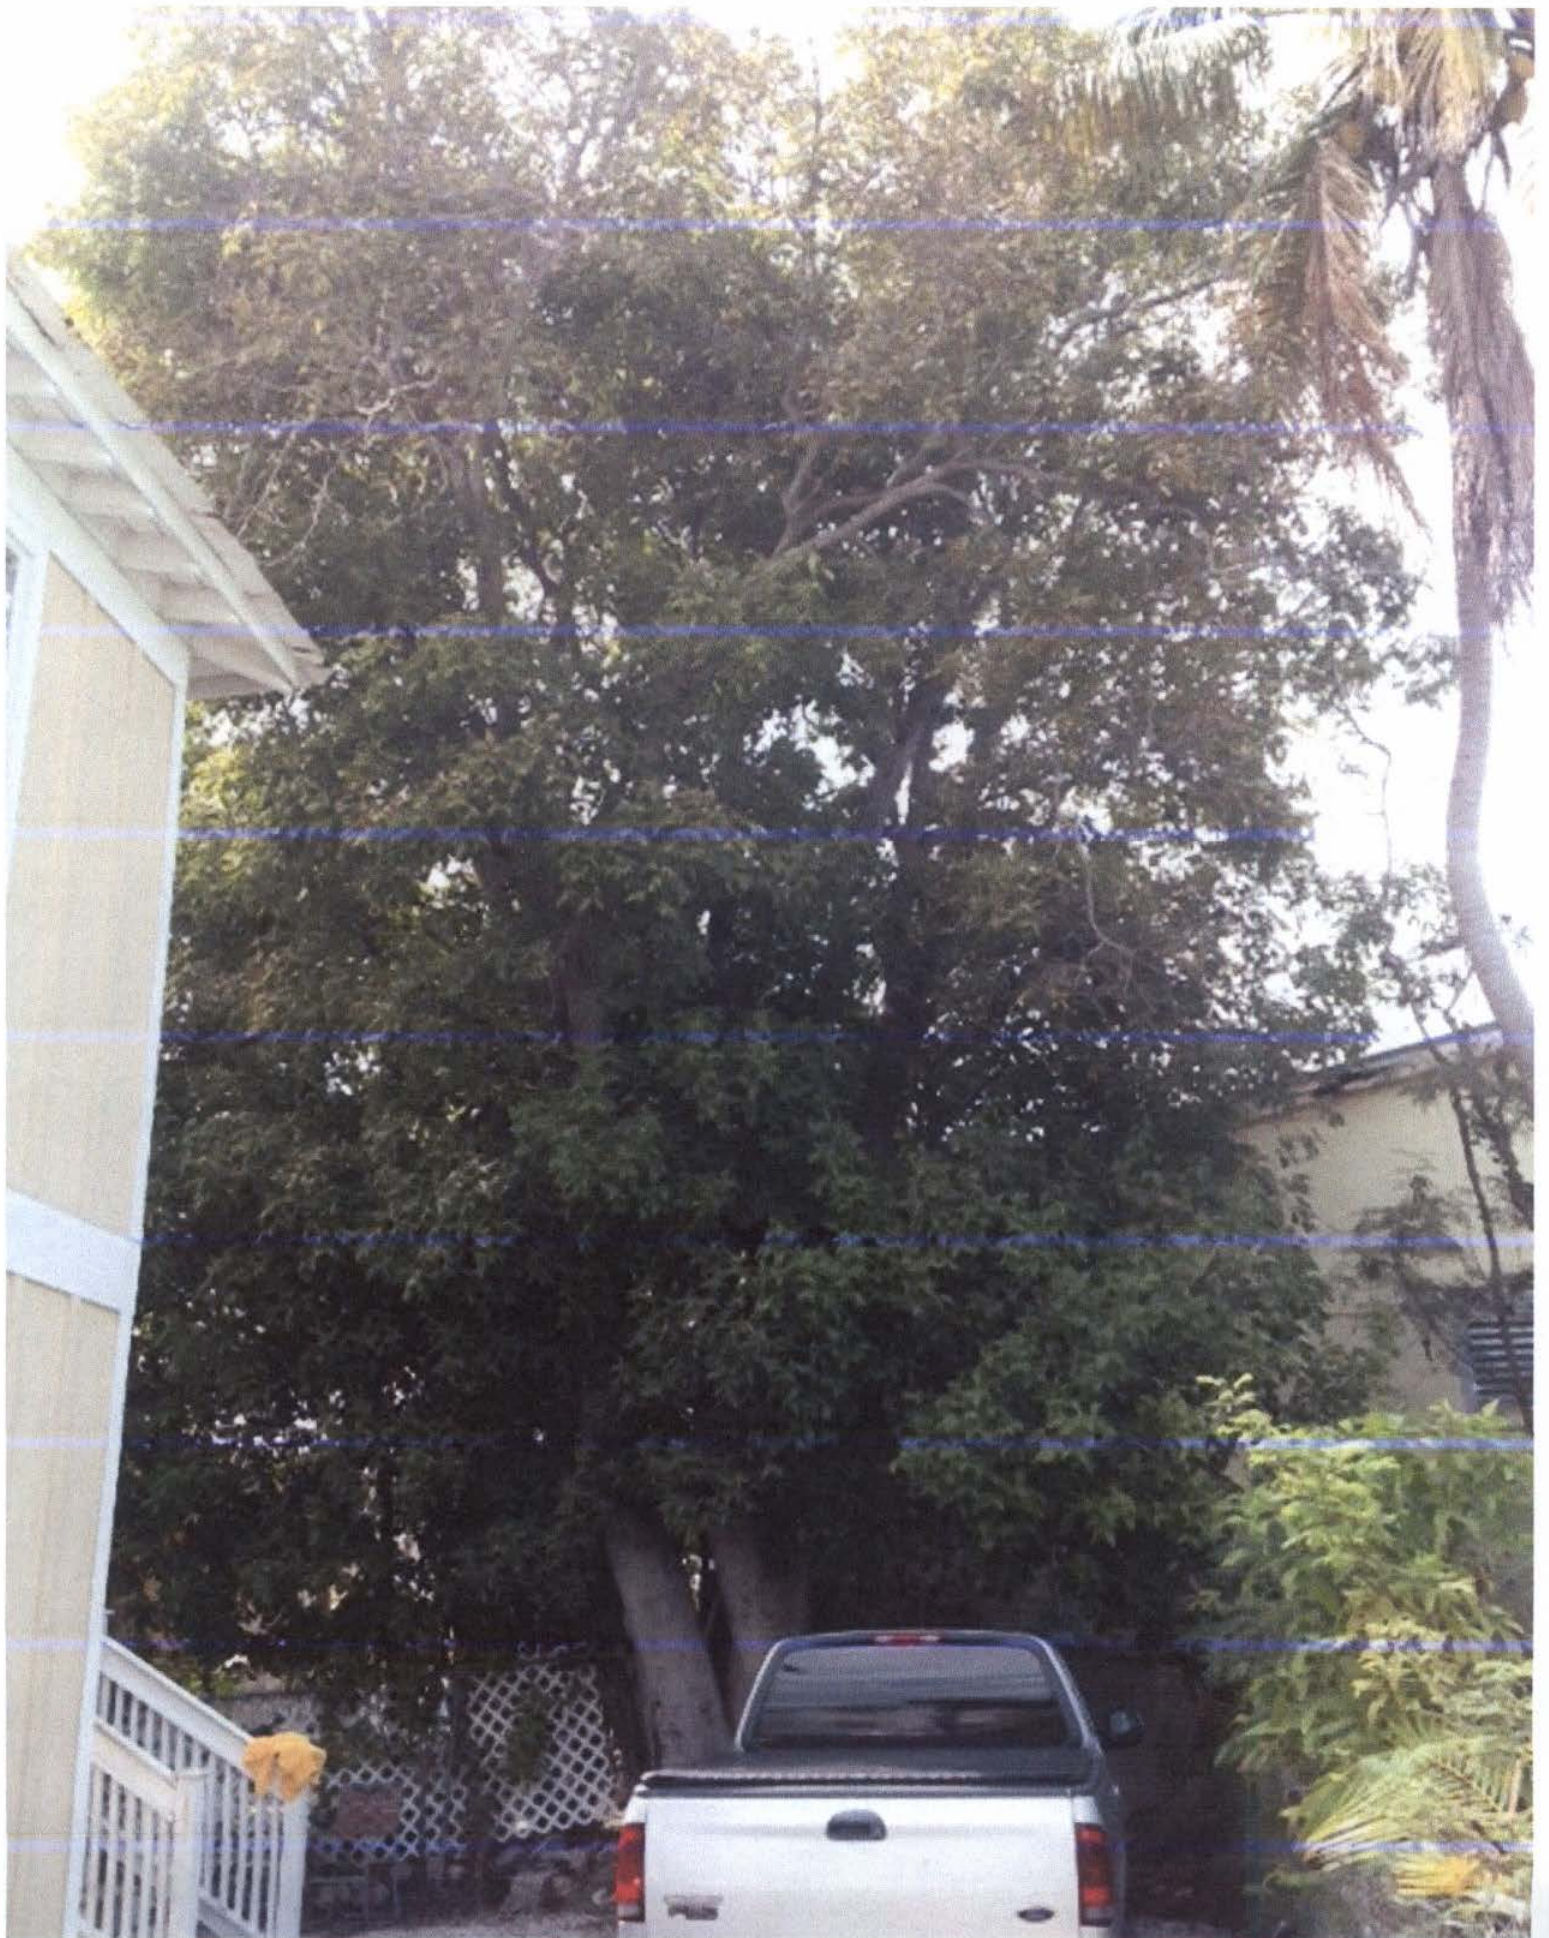
Spanish Lime rear
