## TREE COMMISSION TREE REMOVAL REPORT CITY of KEY WEST

PROPERTY: 701 Palm Ave

APPLICATION NUMBER: T2025-0144

REQUEST: Property owner is seeking removal of approx. 32 linear feet/240 square feet of mangroves behind city public restroom along seawall that parallels Palm Ave

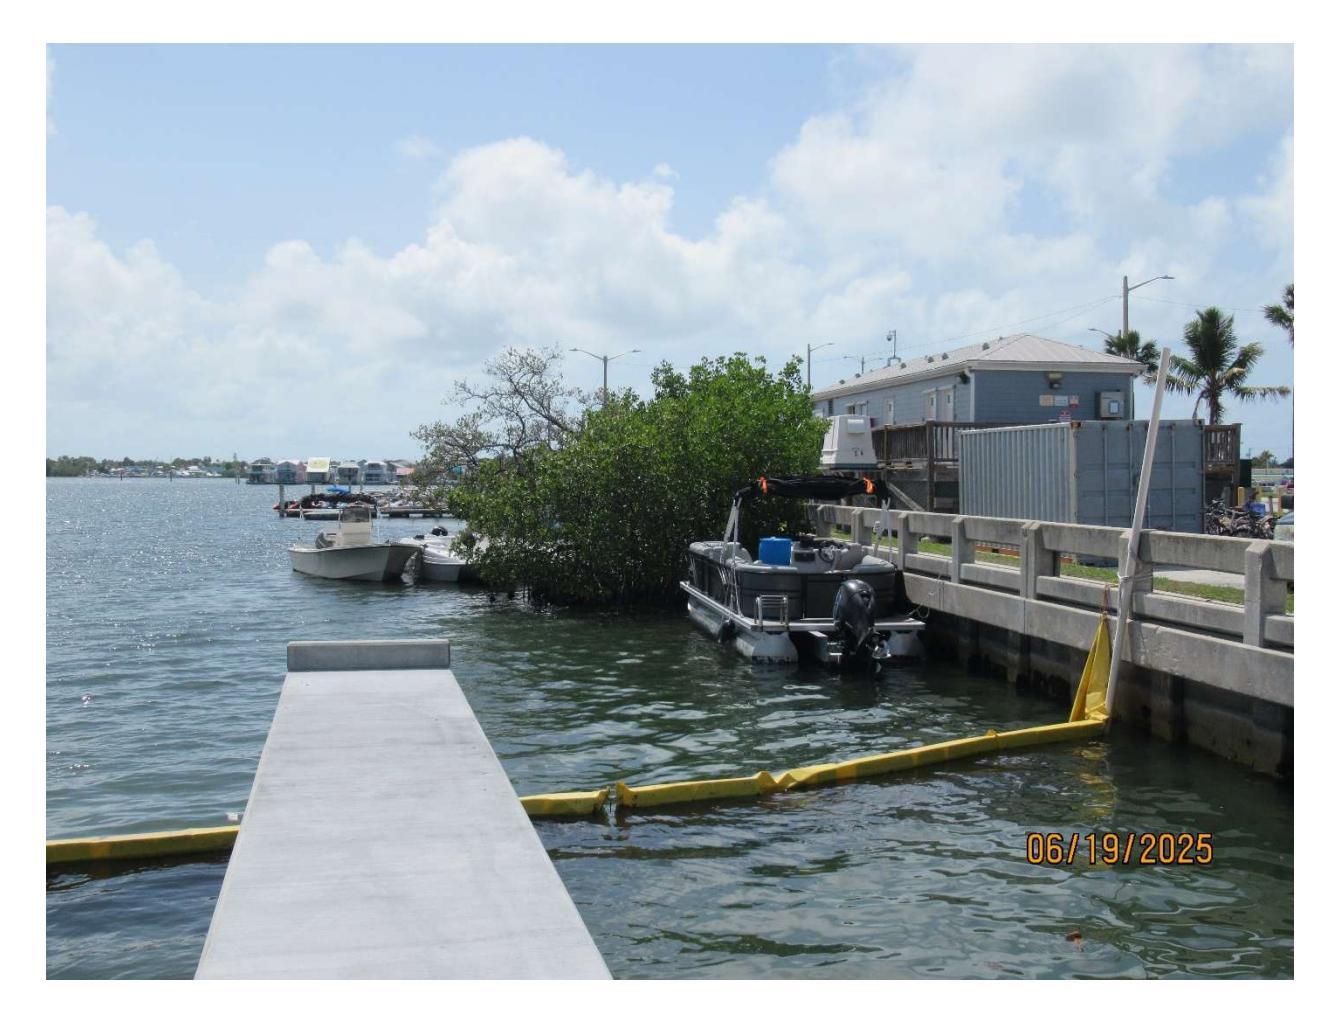
Photo shows mangrove view from Spencer's Boatyard facing East. The brach on the top left portion appears to be dead but closer inspection shows tiny micro sized leaves.

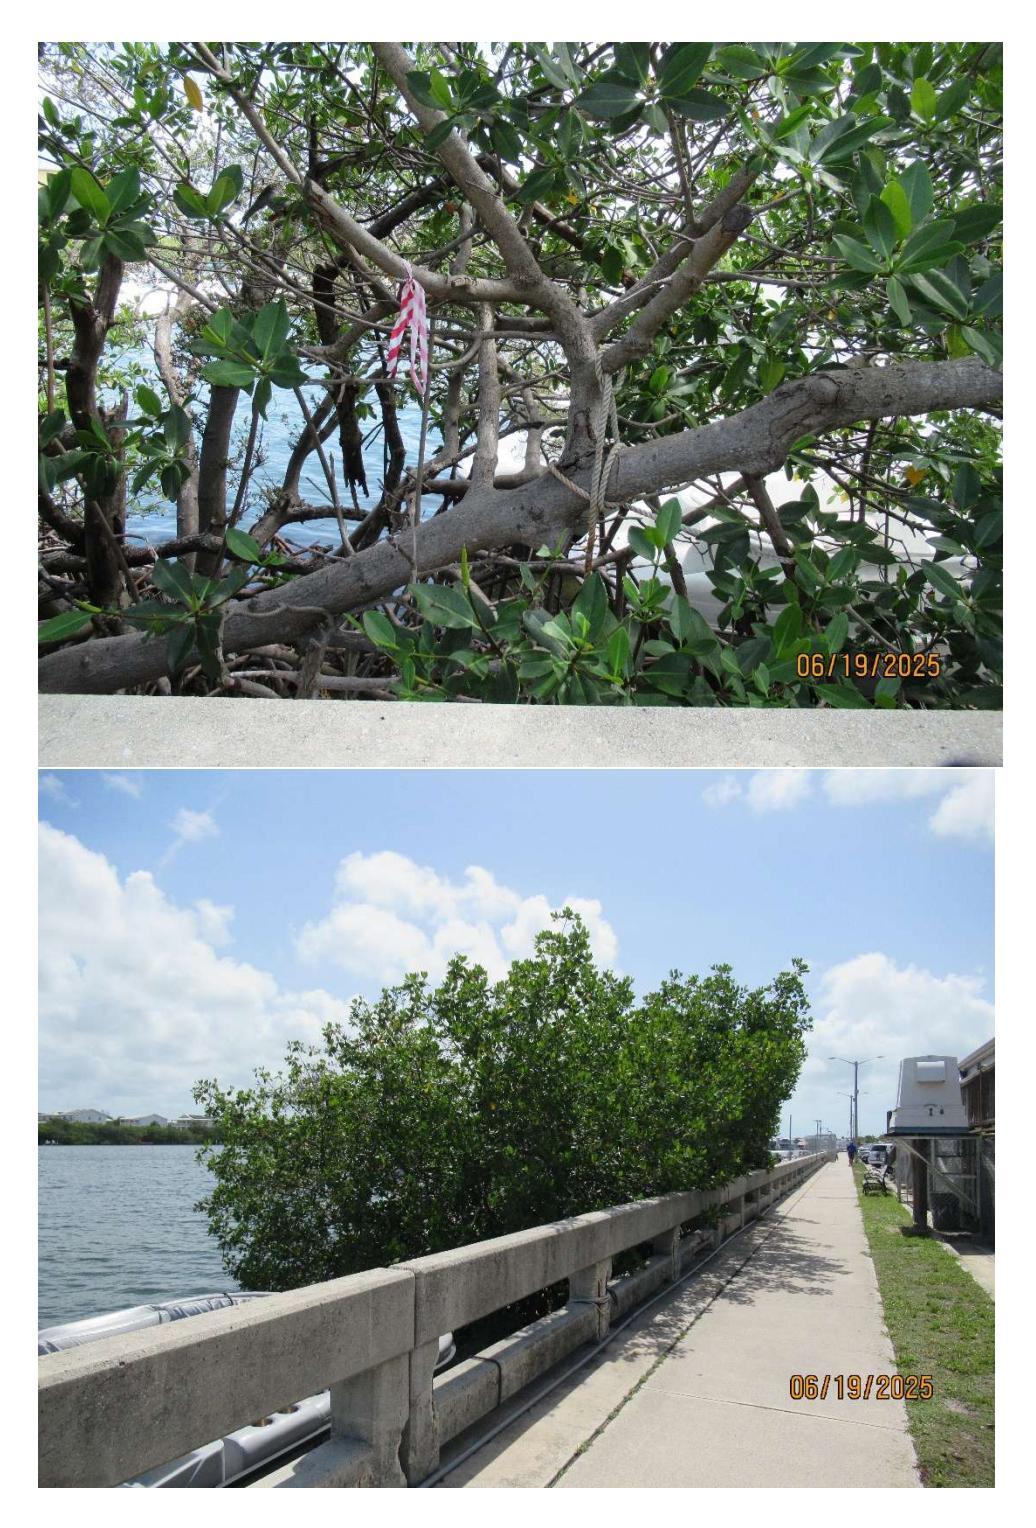
Close up of mangrove on top. View from sidewalk looking East.

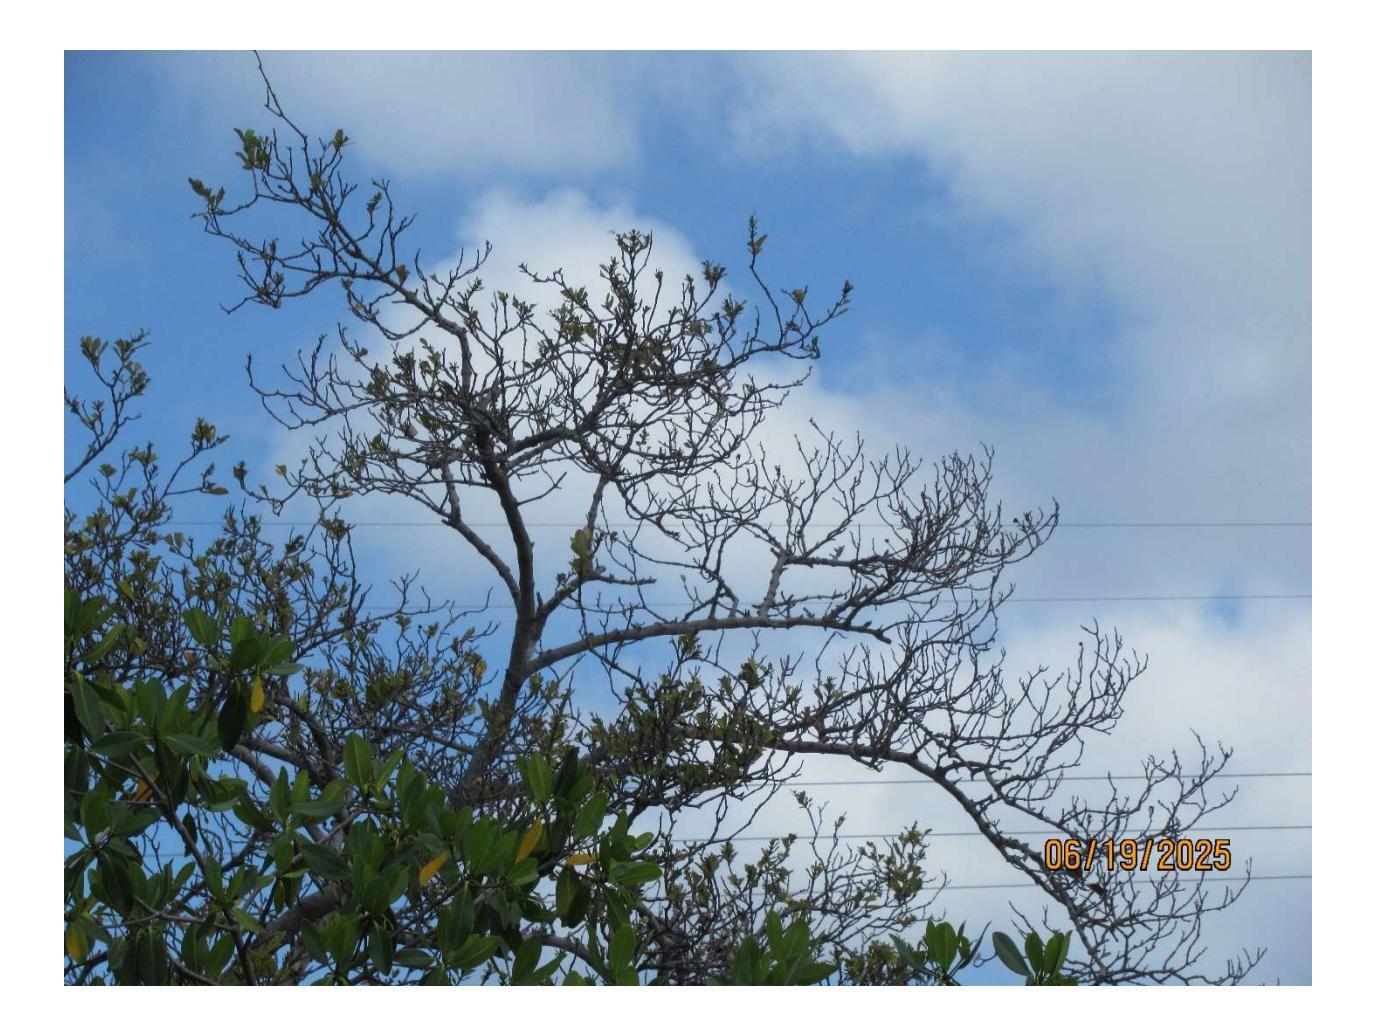
Large portion of cluster on the North edge of the mangroves appears to be stressed or shocked. Note the dwarf or micro sized leaves growing on what appear from far to be dead branches.

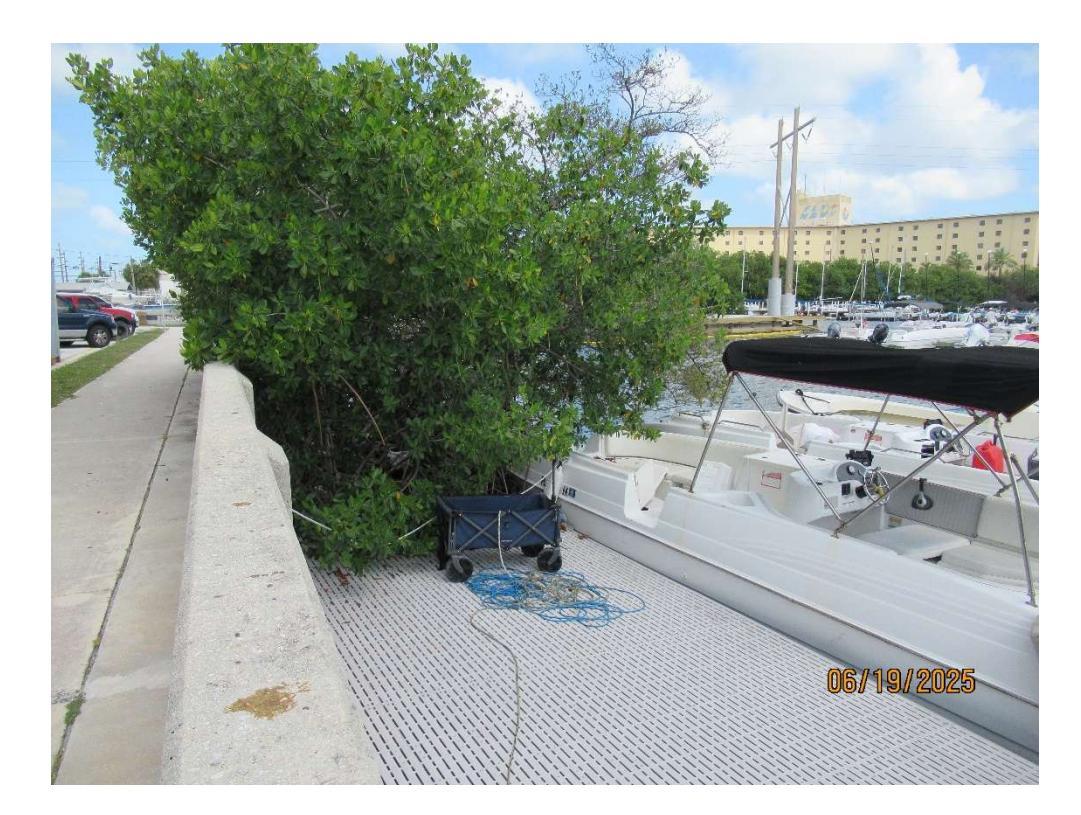
Mangroves views from the West.

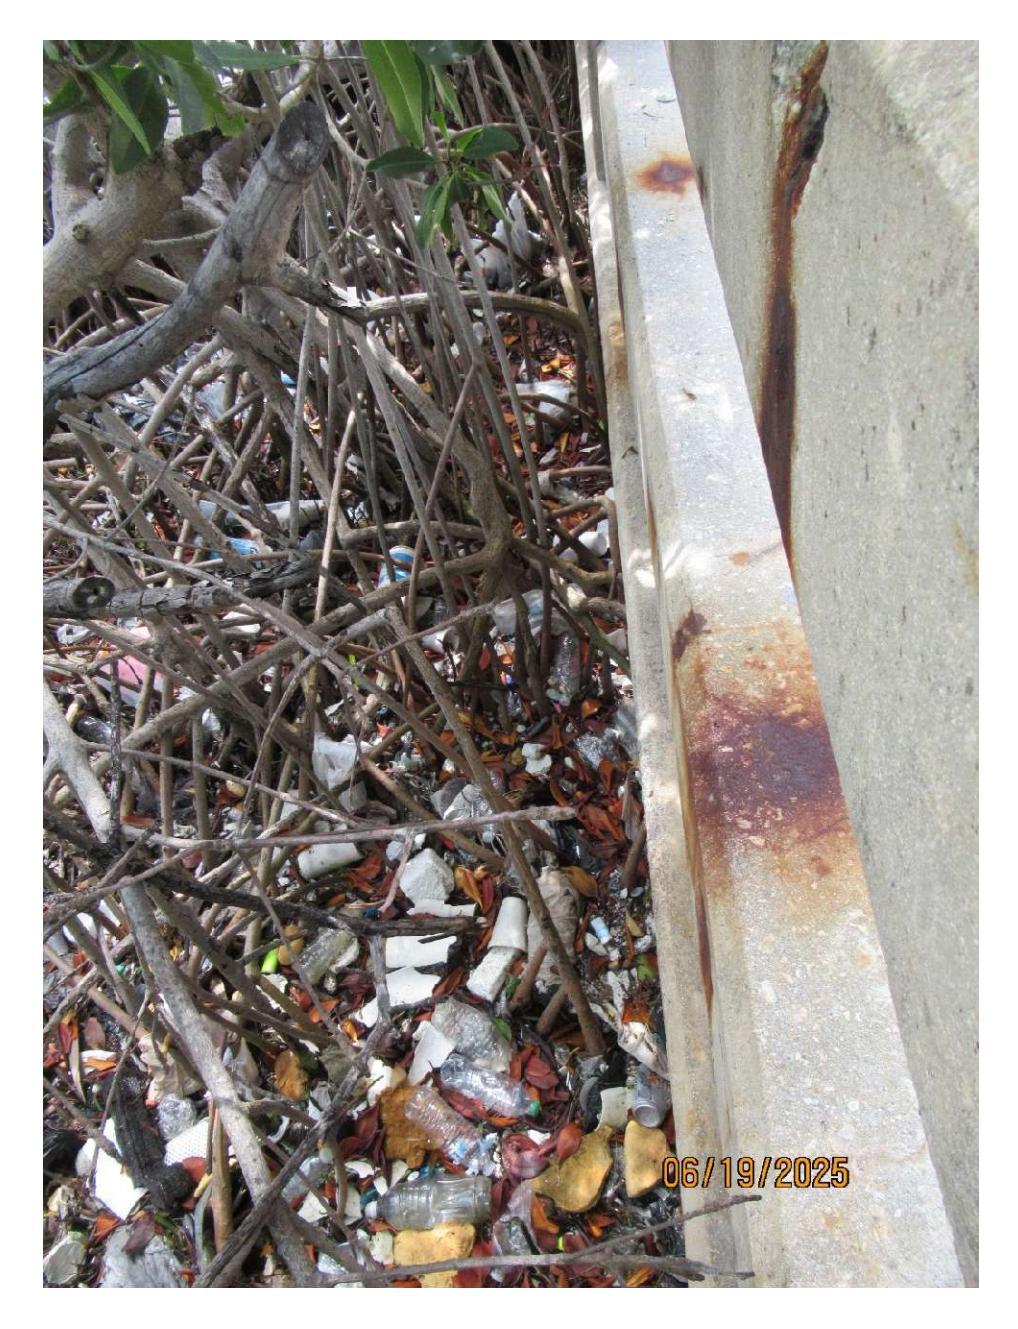
The most disturbing and truly unfortunate aspect of this situation is when you look down. This patch of mangroves is used as a trash bin. Some of this is captured naturally from tidal flow and wind, However I common sense tells me that due to the traffic that passes by these mangroves are simply being abused with litter. I can find no other explanation for this amount and type of trash.

RECOMMENDATION/NOTES: Normally mangroves help improve water quality and support our diverse ecosystem. Given the shocking amount of garbage held on this mangrove cluster one can logically imagine that this situation is contributing to poor water quality and harming the surrounding ecosystem. I'm not sure if the pros outweigh the cons in this circumstance.

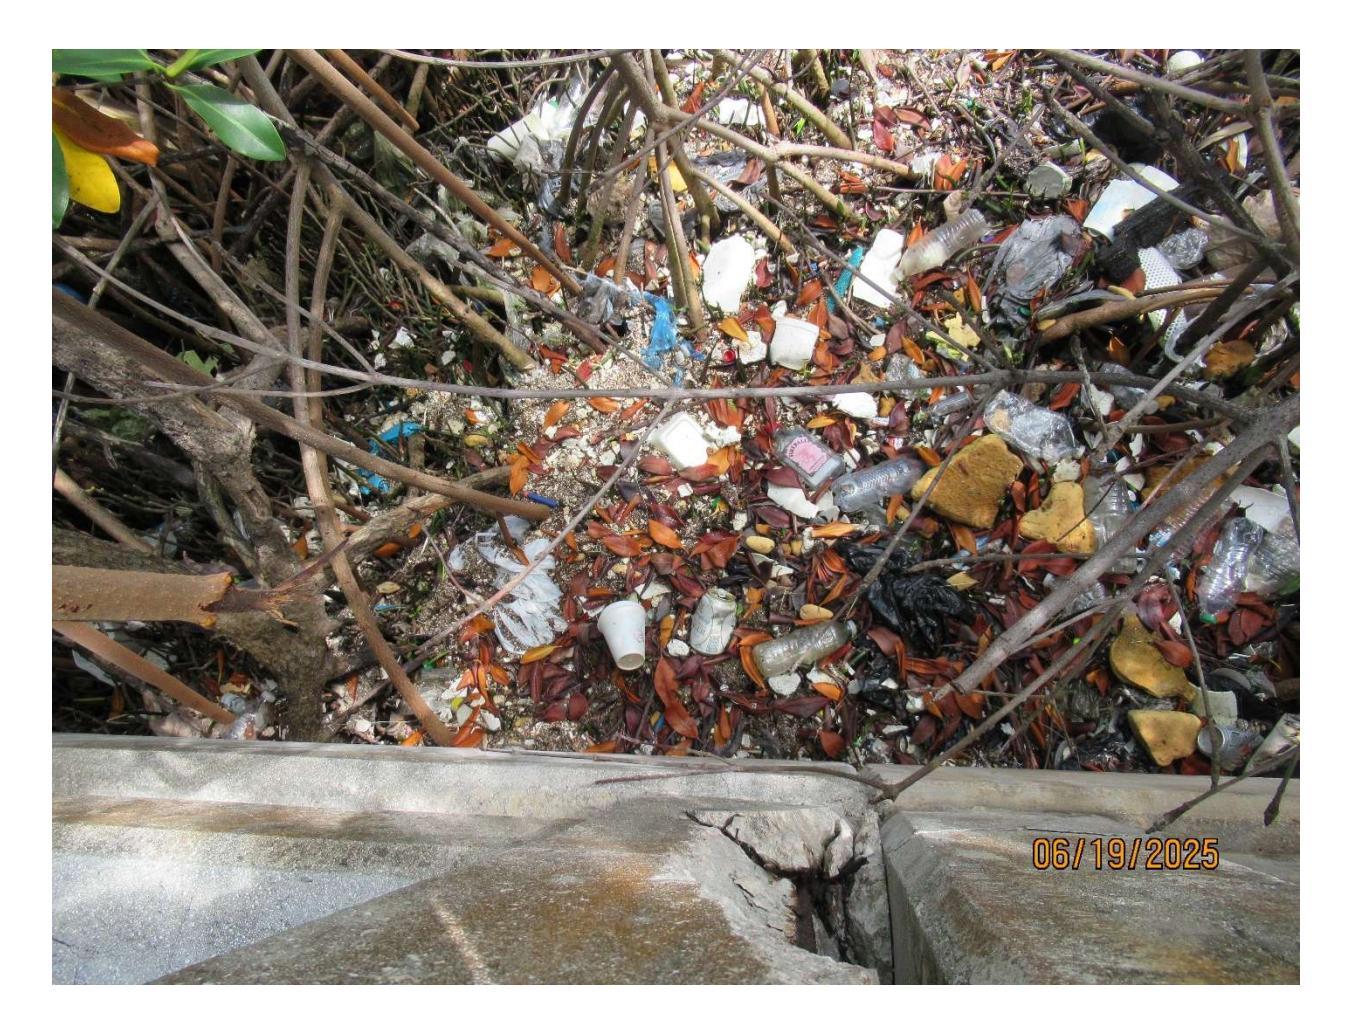
There is also a smell in this area that may be due to the trash, but I'm not sure.

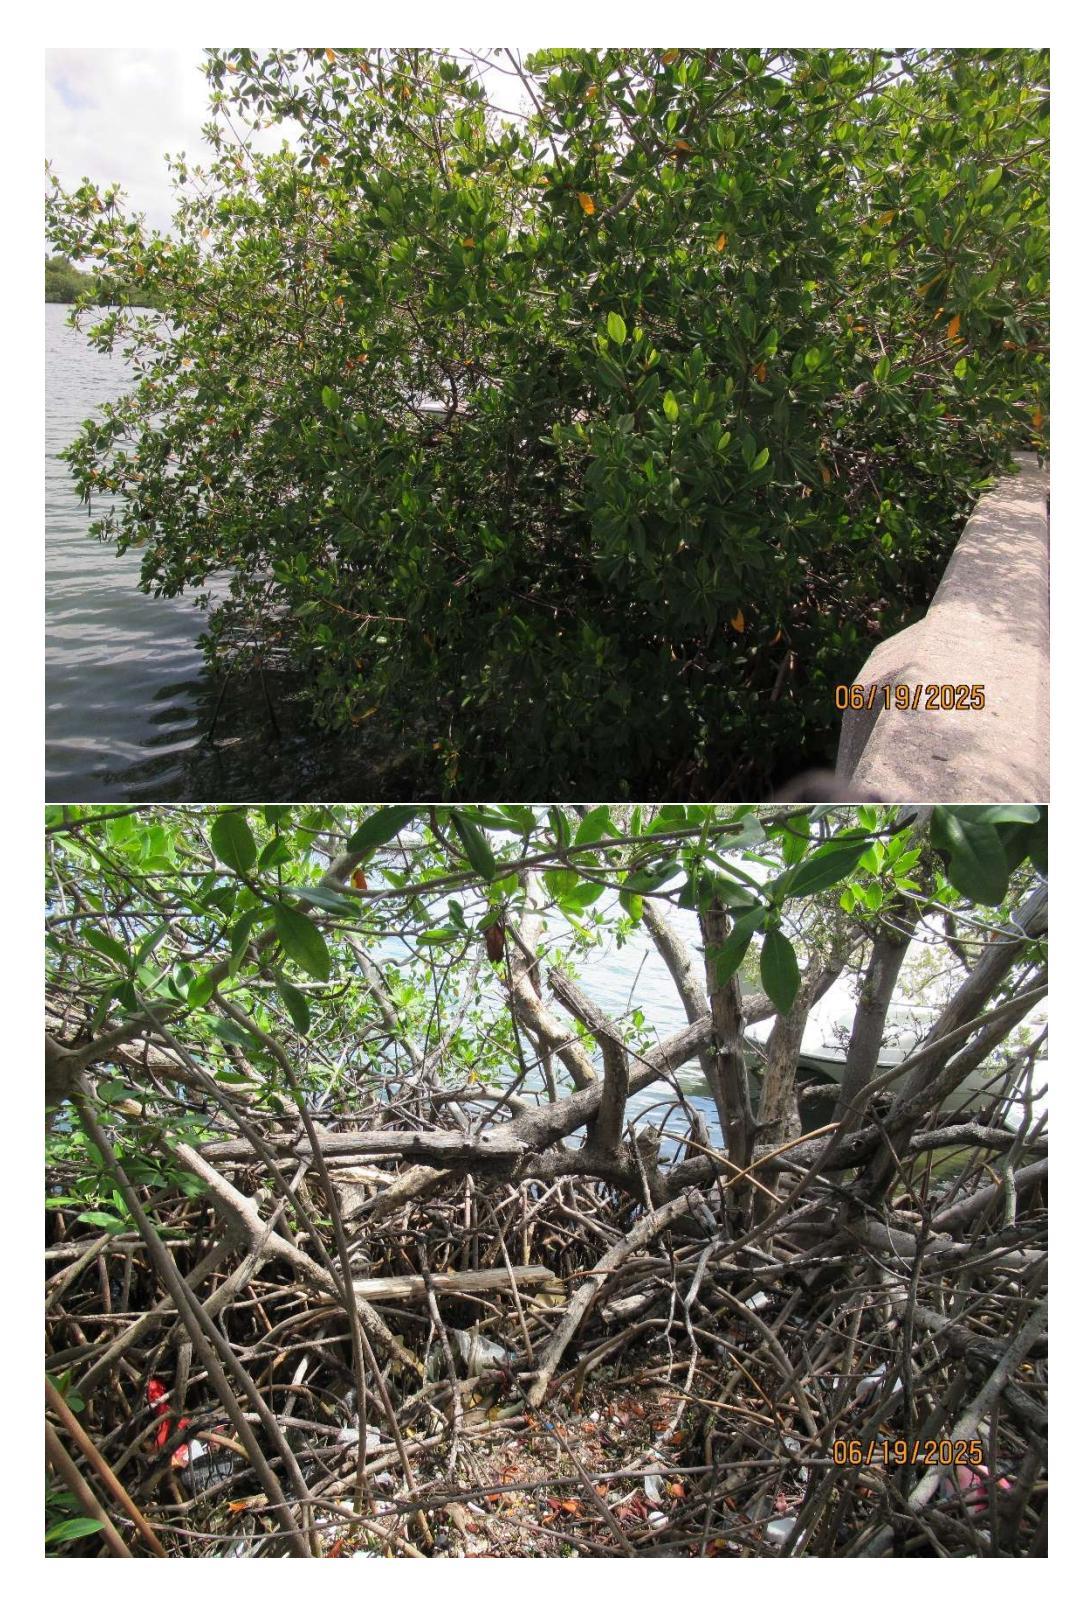
Top Photo: Close up of mangroves view from the East. Bottom photo: View of interior looking Northeast. Diameter: Approx. 240 Sq/ft or 54" diameter Condition: 40% (the tree is in poor health; part of it appears healthy but the overall assessment is a liability to the surrounding waters) Location: 80% (The tree is growing along a seawall that has a traffic pattern that lends itself to being viewed as a trash can.) Species: 100% Protected Tree Value: 73% Required Mitigation: 39 Caliper inches. (Property owner is willing to mitigate through a combination of planting native trees on his adjacent property and by donating to an organization that plants mangroves in the Florida Keys.)
