**Historic Architectural Review Commission  
Staff Report for Item 2**

**Address:** #1 Whitehead Street

Installation of aluminum impact doors with historic imagery and reconfiguration of front entry of the Key West Aquarium. New fountain at front.

Title:  
COVER SHEET  
SITE PLAN

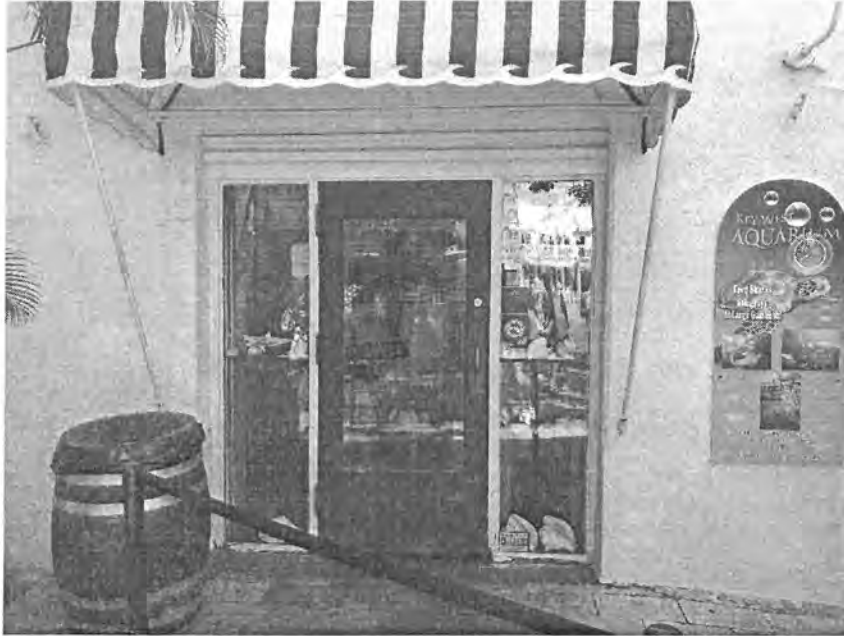
Current entry door of the Key West Aquarium. Ground level no impact windows white painted wood frame. Badly decayed from water and termites. Unable to spray or tent for insects because of contamination of fish tanks.

Would like to replace with a painted aluminum that will resist moisture and insects.

The frame will be aluminum the doors would be glass.

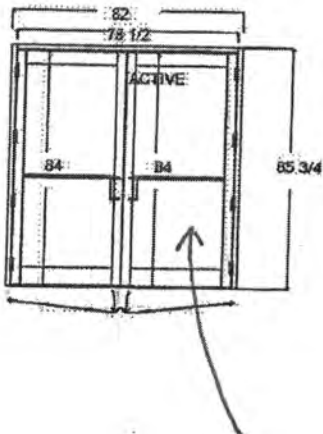
### Door 1: SUMMIT MEDIUM STILE 6070:

New door for customers with ADA access

1. Glass to be: 9/16 GREY CLEAR .120 HS
2. Finish to be: BRONZE:ANODIZED
3. 4 1/2" X 4" Butt Hinges
4. 3pt Locking Mechanism (Active leaf)
5. 2pt Locking Mechanism (Inactive leaf)
6. Key Cylinder
7. Thumb turn
8. 10" Offset tubular pull and tubular push bar
9. WIDTH INCREASED UP TO 96"
10. Overhead concealed door closer, Adjustable
11. Overhead concealed door closer, Adjustable
12. THRESHOLD TYPE: BUMPER
