9 Revised plans as per Commission request. Two proposals, proposal 1 step back new chimney, proposal 2 no built back of chimney and installation of wood siding- Code Compliance Case - #730 Southard Street - Adele V. Stones (H11-01-655)

Barletta Residence

Proposal 1

#730 Southard Street- Code Case- Chimney reconstruction

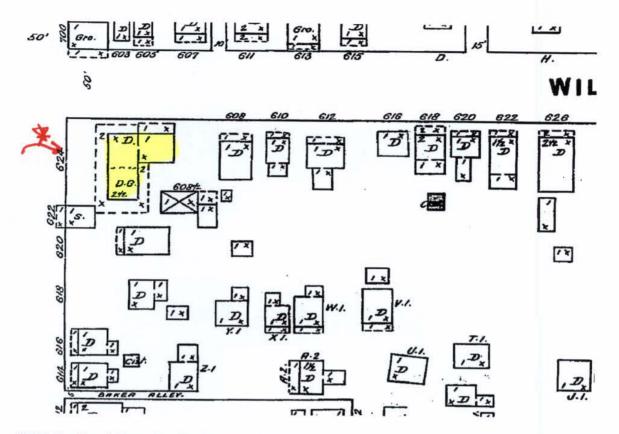
#730 Southard Street Sanborn map 1892 copy

Torregrosa stated that nevertheless staff found a similar footprint on the same location on the 1892 Sanborn map. Ms. Torregrosa stated that the house is on a corner lot and has a widows' walk that was depicted for the first time in the 1912 Sanborn map. Ms. Torregrosa stated that the house used to have an exposed brick chimney on the south. Ms. Torregrosa stated that according to the applicant the brick chimney was in poor condition. Ms. Torregrosa added that on a submitted letter the applicant also states that the architect of the project was always contemplating the reconstruction of the chimney but that he was not aware of the requirement of a demolition approval for the external chimney. Ms. Torregrosa stated that this historic chimney was a character defining element of the house. Ms. Torregrosa stated that the structure had some vegetation but was structurally stable when the project received approval from the Commission. Ms. Torregrosa stated that there are not many historic exterior brick chimneys still standing at present time. Ms. Torregrosa stated that the demolition of this character defining element is an irreparable lost; once a historic structure is demolished there is no replacement for it. Ms. Torregrosa stated that it is staff understanding that the existing structure presents characteristics and gives information which is contrary to criteria 1, 3, 5, 6, 8 and 9. It is staff opinion that the after the fact request for demolition is in conflict with the Code of Ordinance Section 102-218- Demolitions in the historic district. Ms. Torregrosa stated that it is staff recommendation to this Commission to deny the request. Ms. Torregrosa stated that it is the responsibility of this Commission to make a determination if the historic chimney qualified for demolition in accordance with Chapter 102 of the LDR's. Ms. Torregrosa concluded by stating that the removal of the historic chimney is an irreparable lost.

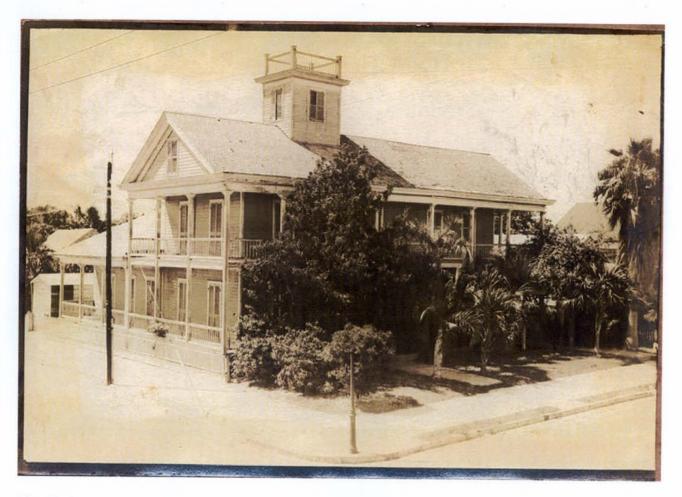
The Heritage House Collection, donated by the Campbell, Poirier and Pound families. The house at 730 Southard Street in the 1930s. From a collection of photographs taken or collected during the 1930s by the WPA workers in Key West.

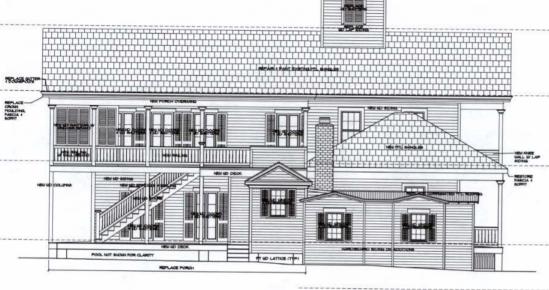
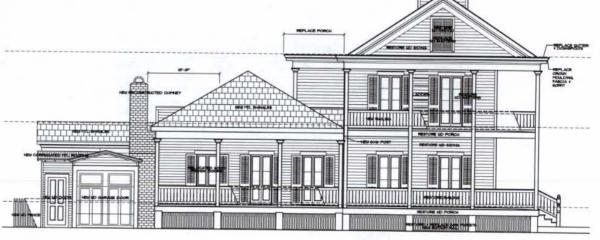
Proposal 1 attached pursuant to H11-01-1757 approving construction of new chimney with two conditions: (i) use of approved historic brick, and (ii) chimney "stepped back" from building.

William St Side Elevation

William St Elevation

The new proposed chimney will be wider than the historic and the conditionally approved one as depicted on the William Street elevation. A second proposal of no built back is also submitted in this packet. This option was suggested by one of the Commissioners during deliberations on the January 11, 2012 HARC meeting.

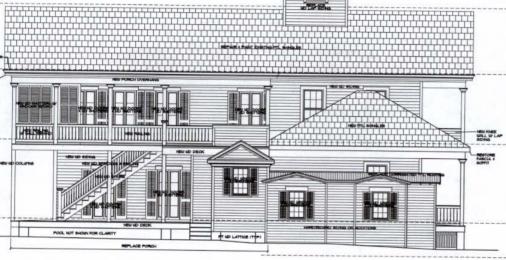
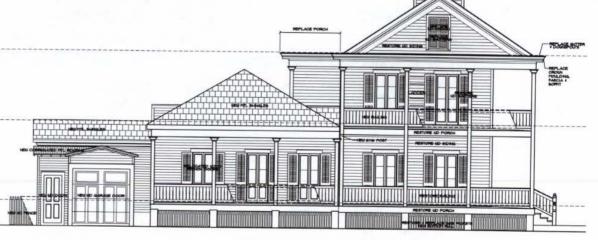
If the Board denies approval for Proposal 1 depicting the chimney incorporating the Board's conditions, Applicant presents Proposal 2 and requests that the Board rescind approval H11-01-1757 and approve placement of wood siding in the location of the former chimney opening, no replacement chimney to be constructed. The wood siding would be installed at the 5' x7' opening of the former chimney, to match original siding on the house.

William St Side Elevation

William St Elevation

Staff wants to analyze the second proposal of no built back. According to the applicant Building Code and Fire Code were not going to be met if the historic chimney was operable, the original intent that was presented to this Commission. The plans approved by this Commission for the restoration of the house included the existing historic chimney with the extended flue. This extension was proposed because the original chimney finished under the eave of the house, an operable chimney will not meet actual codes on such situation. After the January 11, 2012 meeting architect met with staff and explained that he needed the proposed configuration in order to comply with codes and manufacturer's specifications and that the historic chimney did not have the configuration required.

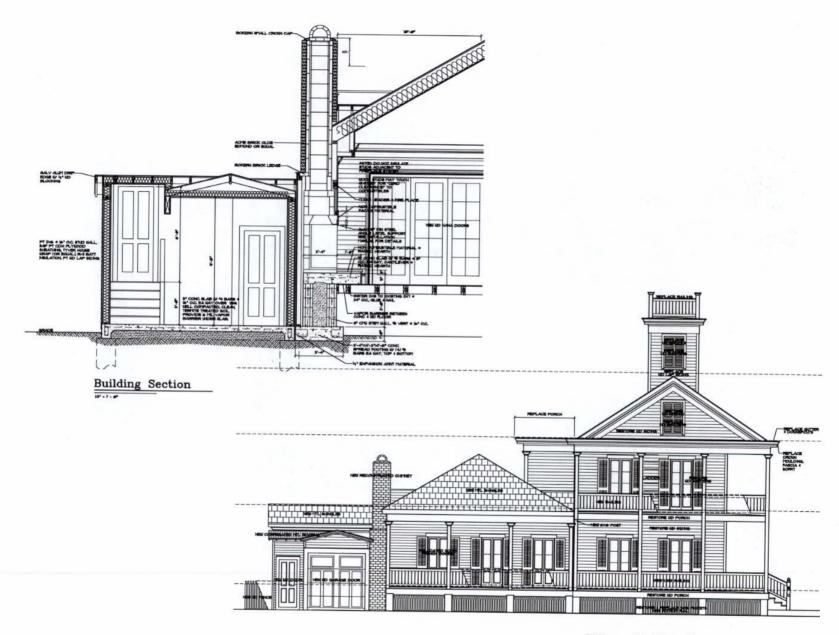
Plans Approved with Condition On January 11, 2012

William St Elevation

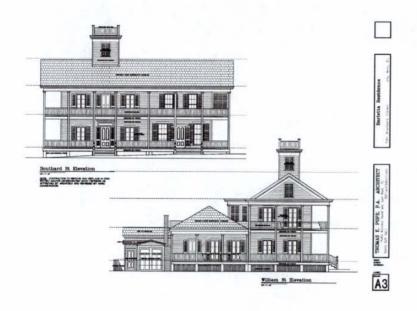
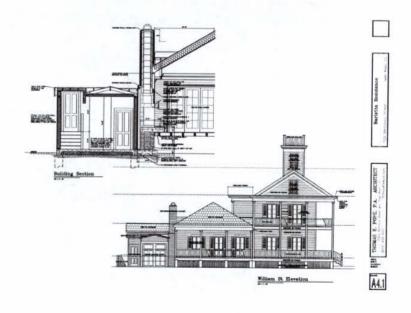
Plans approved by HARC

New submitted plans

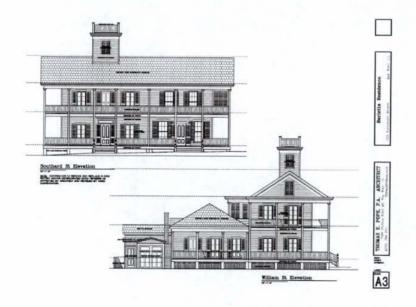
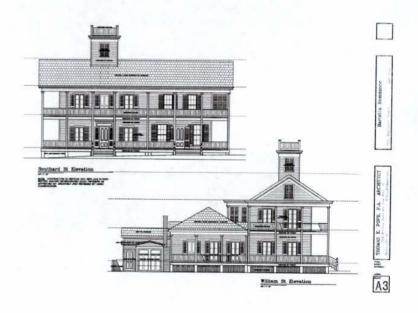
■Elevation plan approved by HARC

Elevation plan submitted as part of the Planning board variance request

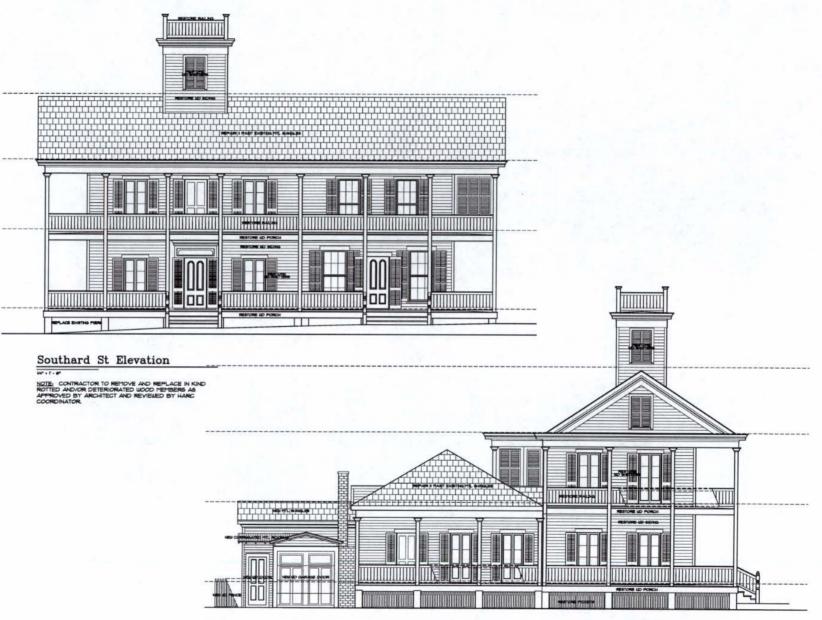
William St Elevation

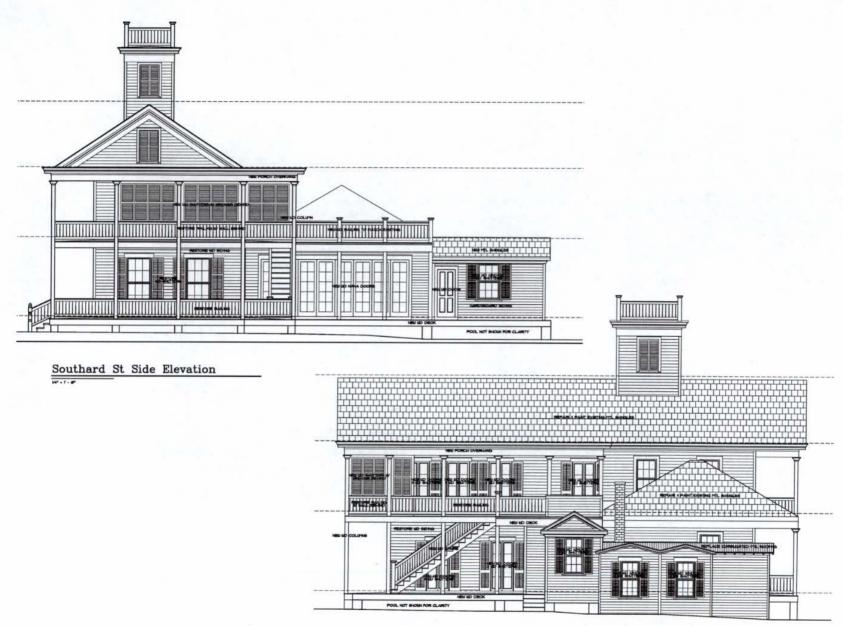
William St Side Elevation
