**Historic Architectural Review Commission  
Staff Report for Item 5**

**Application Number:** H18-03-0018

**Address:** #911 Watson/ #1010-1012 Olivia Streets

**Description of Work**

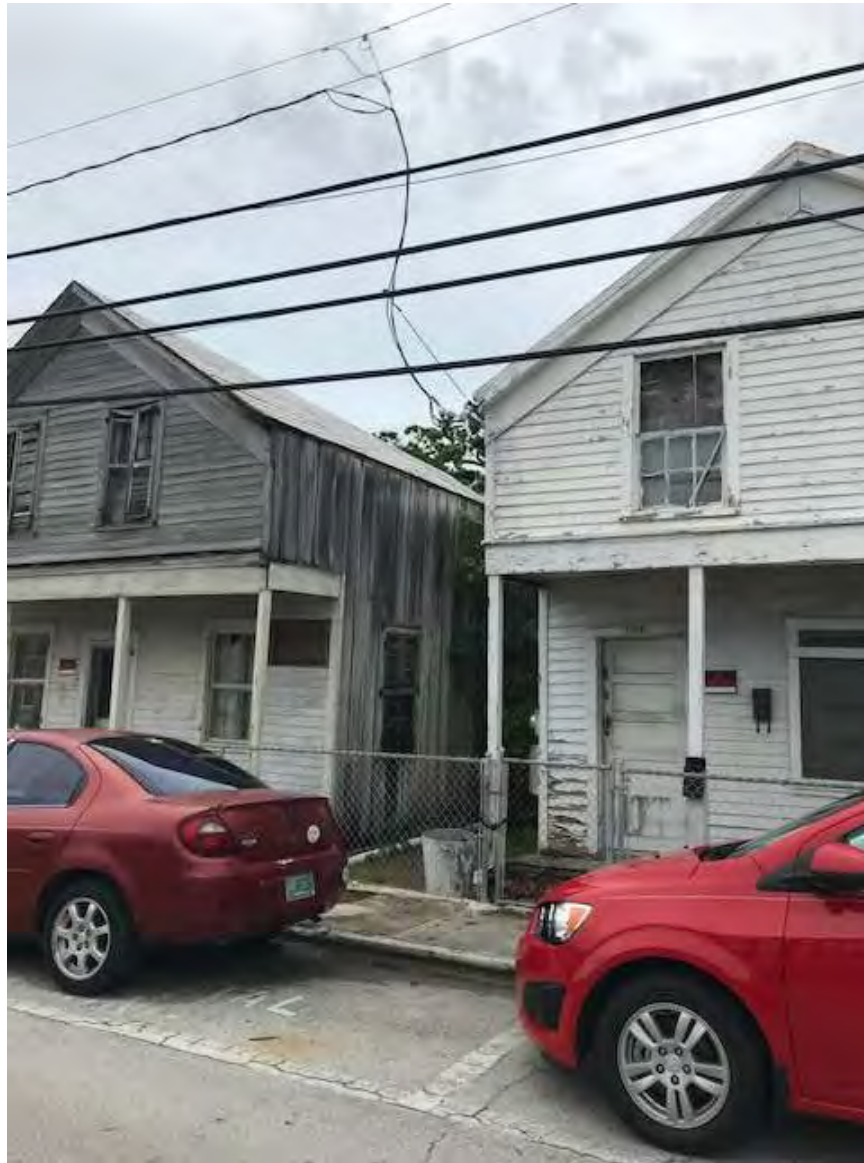
1012 Olivia Street to the left side of the picture. Proposed skylight will be visible from Olivia Street.

The proposed rehabilitation and stabilization of the historic houses on Olivia Street are consistent with all cited guidelines, with the exception of the proposed skylights. The restoration of both houses is necessary, as it will stop the neglect state of these very historic structures. The proposed approach for windows and doors will also comply with specific guidelines for such elements. It is staff's opinion that the revised plans are consistent with the cited guidelines and with the Secretary of the Interior's Standards for Rehabilitation, still staff is concern with the proposed design for the two houses is the proposed skylights are contrary to the cited guidelines as they will be visible from Olivia Street.

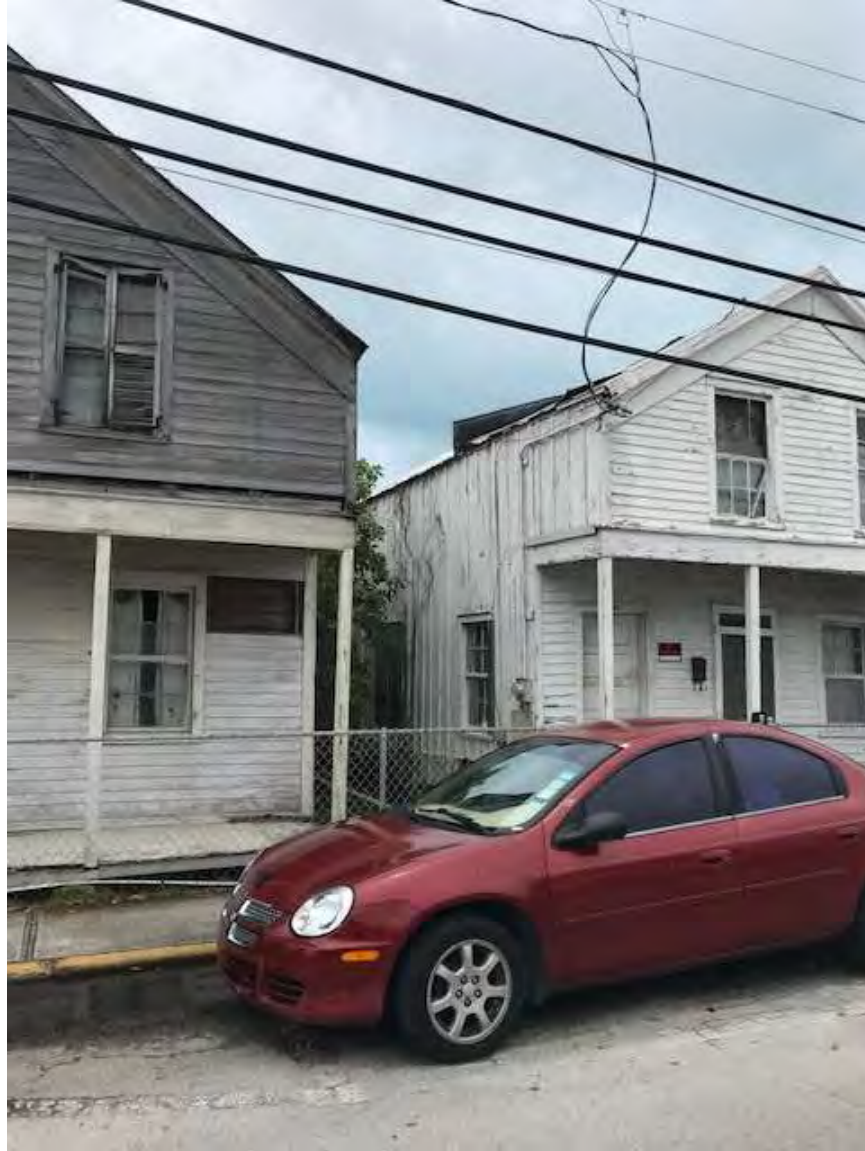
1010 Olivia Street right side of the photograph. Proposed skylight will be visible from Olivia Street.

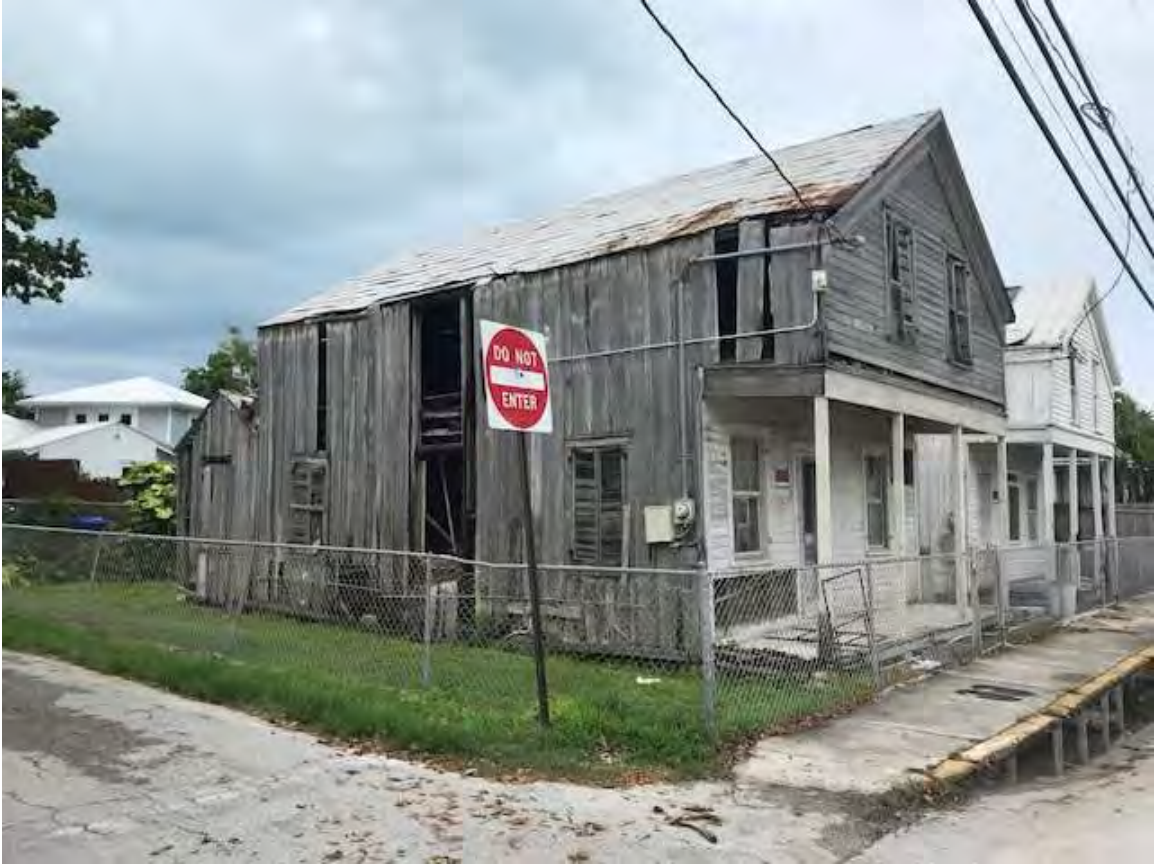
1012 Olivia Street current condition.

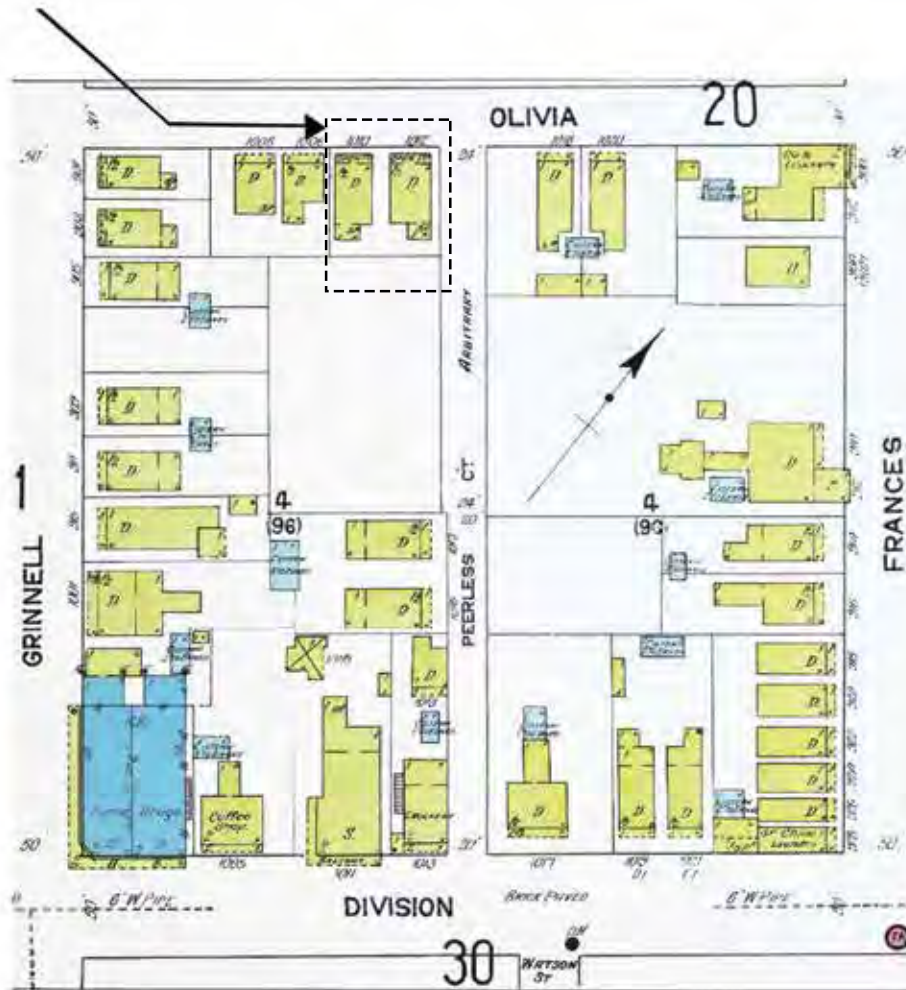
# 1912 SANBORN MAP

The 1912 Sanborn Map introduces a new street to the northeast side of 1012 Olivia Street. Peerless Court parallels Grinnell and Frances dividing the land between the two streets.

The additional notations to 1010 and 1012 Olivia Street indicate that the porches on the Olivia street side of the houses are open on the 1st floor. It is also noted that stove pipes are found in the small 1 story structures on the back of the houses.

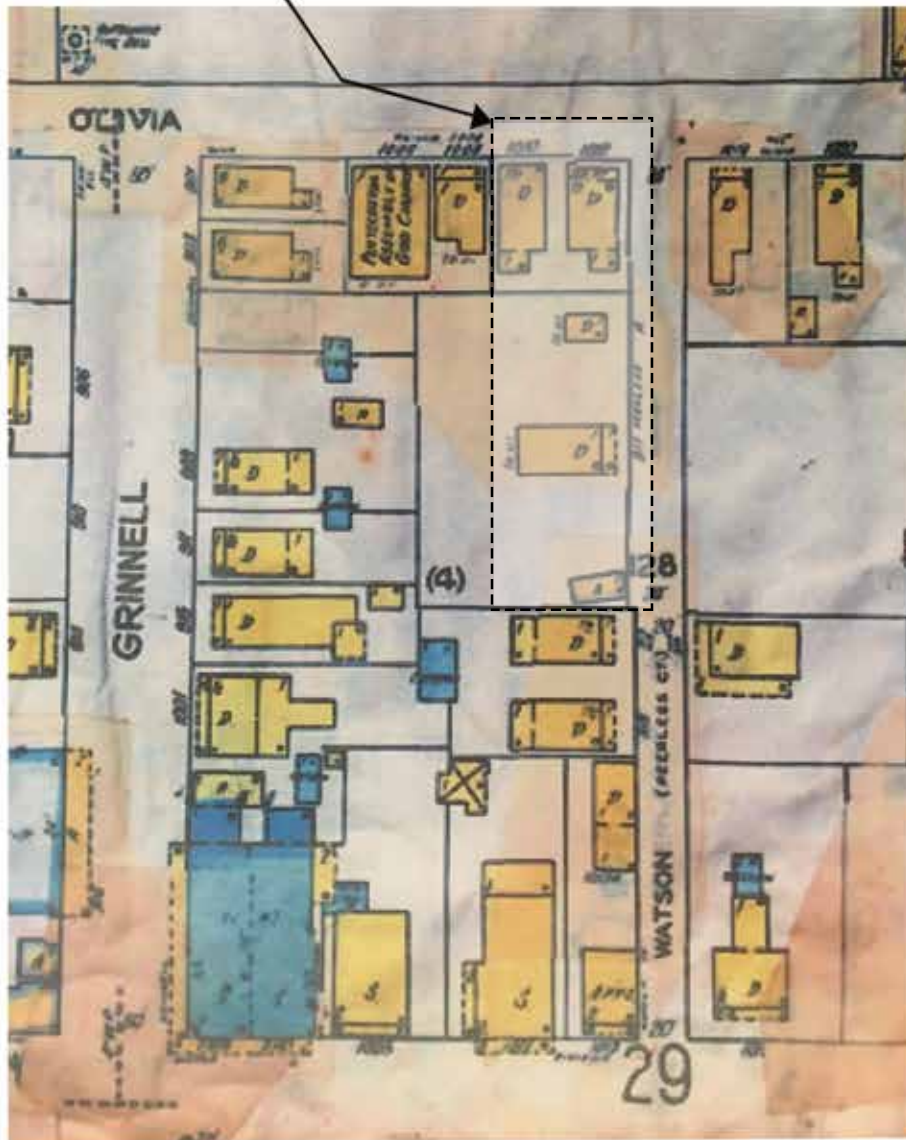
# 1948 SANBORN MAP

The 1948 Sanborn map indicates several changes to the neighborhood surrounding 1010 and 1012 Olivia though their descriptions remain consistent with the former 1926 map. Peerless Court has been renamed Watson Street. The construction of 3 new structures appear on the formerly vacant lot now referred to as 911 Watson Street. The new construction consists of 2 single family dwellings, both having 1 story and tin or slate roofs. The larger dwelling located on the middle of the lot is also indicated to have a 1 story porch. The third structure located on the southeastern corner of the lot is described to be a single story private garage with a shingle roof.

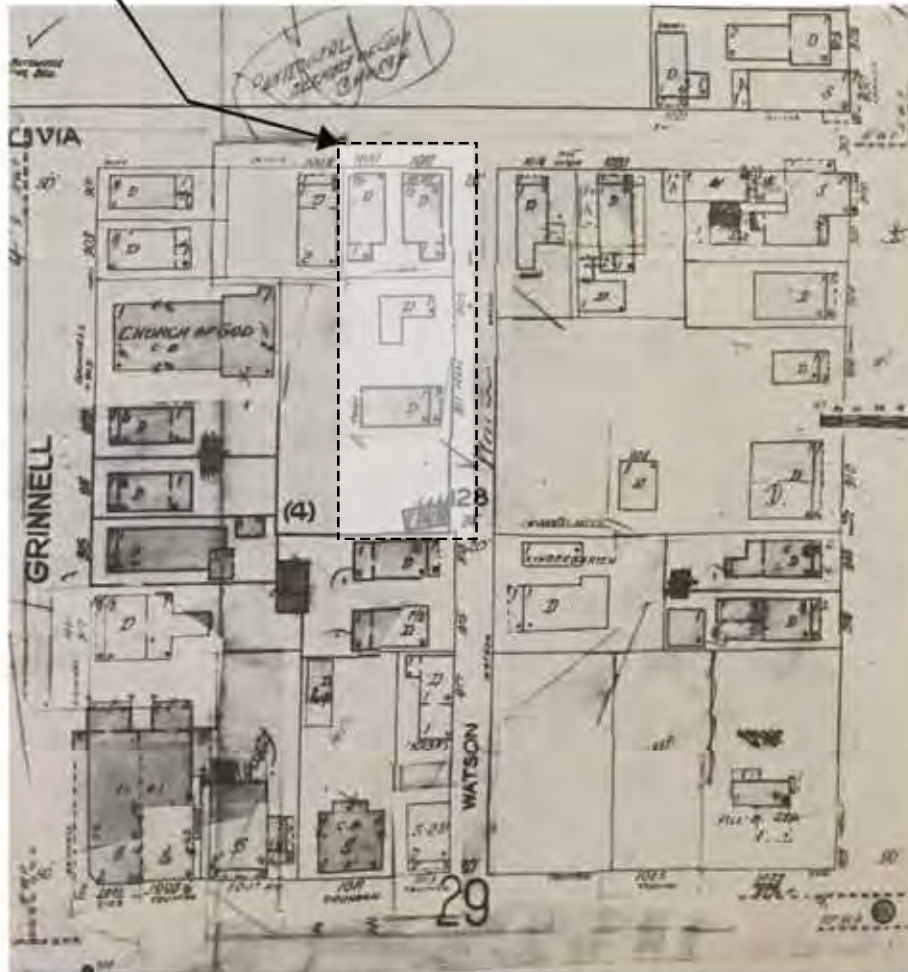
# 1962 SANBORN MAP

The 1962 Sanborn map shows the addition of a tin or slate roof to 1010 Olivia Street. The Watson Street location shows an addition to the structure located at the north side of the lot now being referred to as 905 Watson Street. The private garage on the southeastern corner of the lot appears to have been removed from the 1962 edition of the map, ie based on the pencil marks.

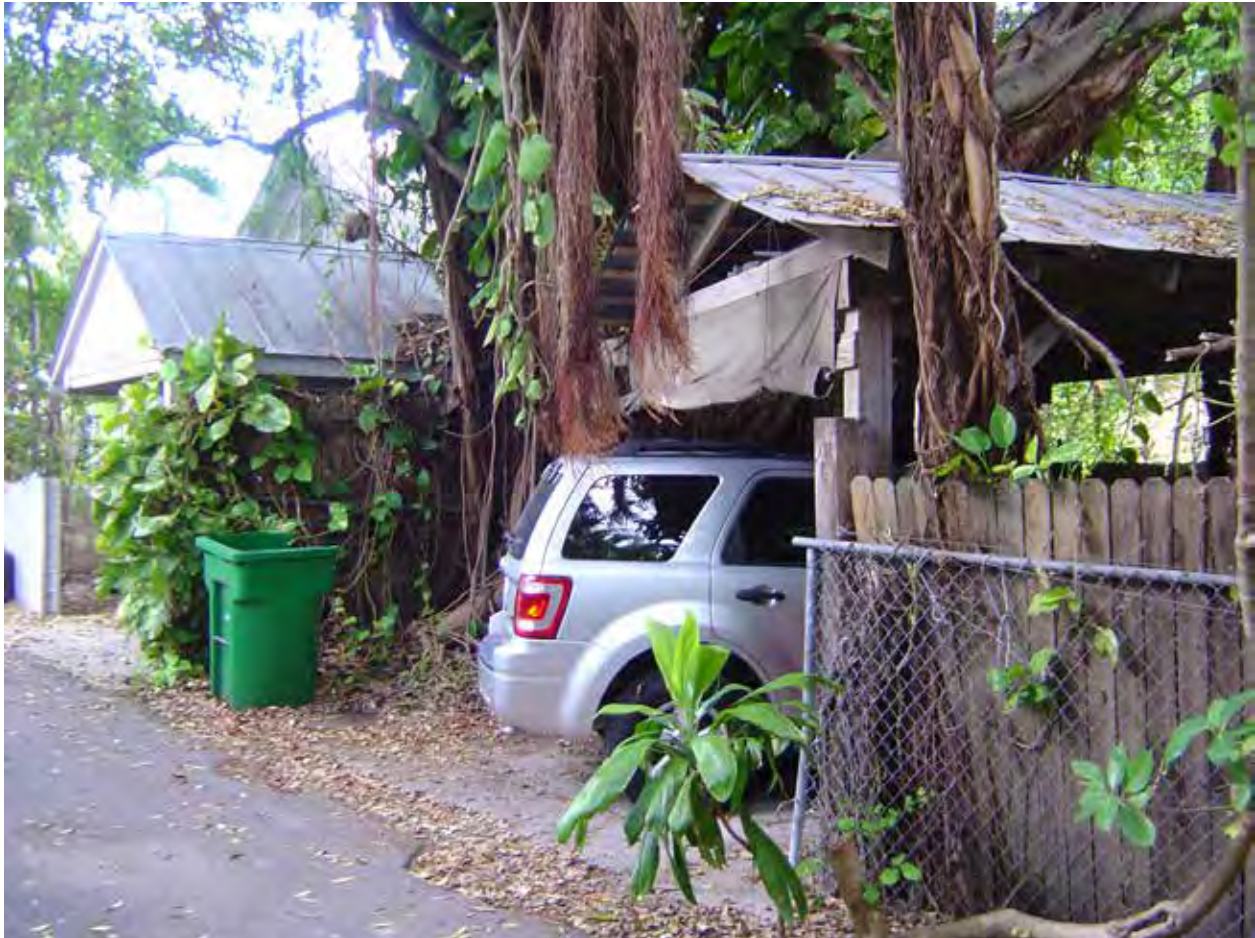
Carport structure visible in the 2010 (revised) survey by Isand Surveying Inc. The carport was removed to accommodate the addition designed by Matthew Stratton Architecture.

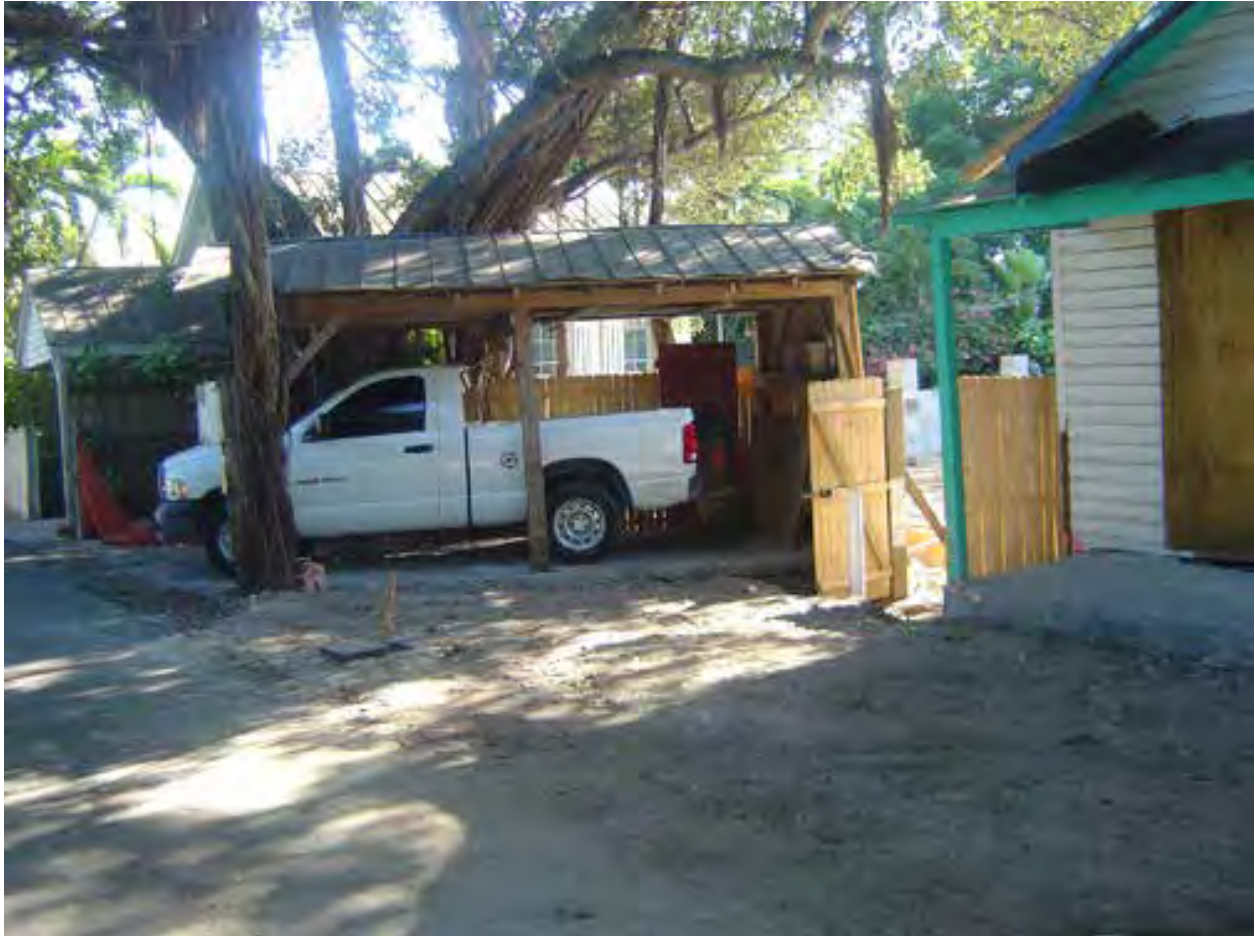
Carport structure visible in the 2010 (revised) survey by Island Surveying Inc. The carport was removed to accommodate the addition designed by Matthew Stratton Architecture.

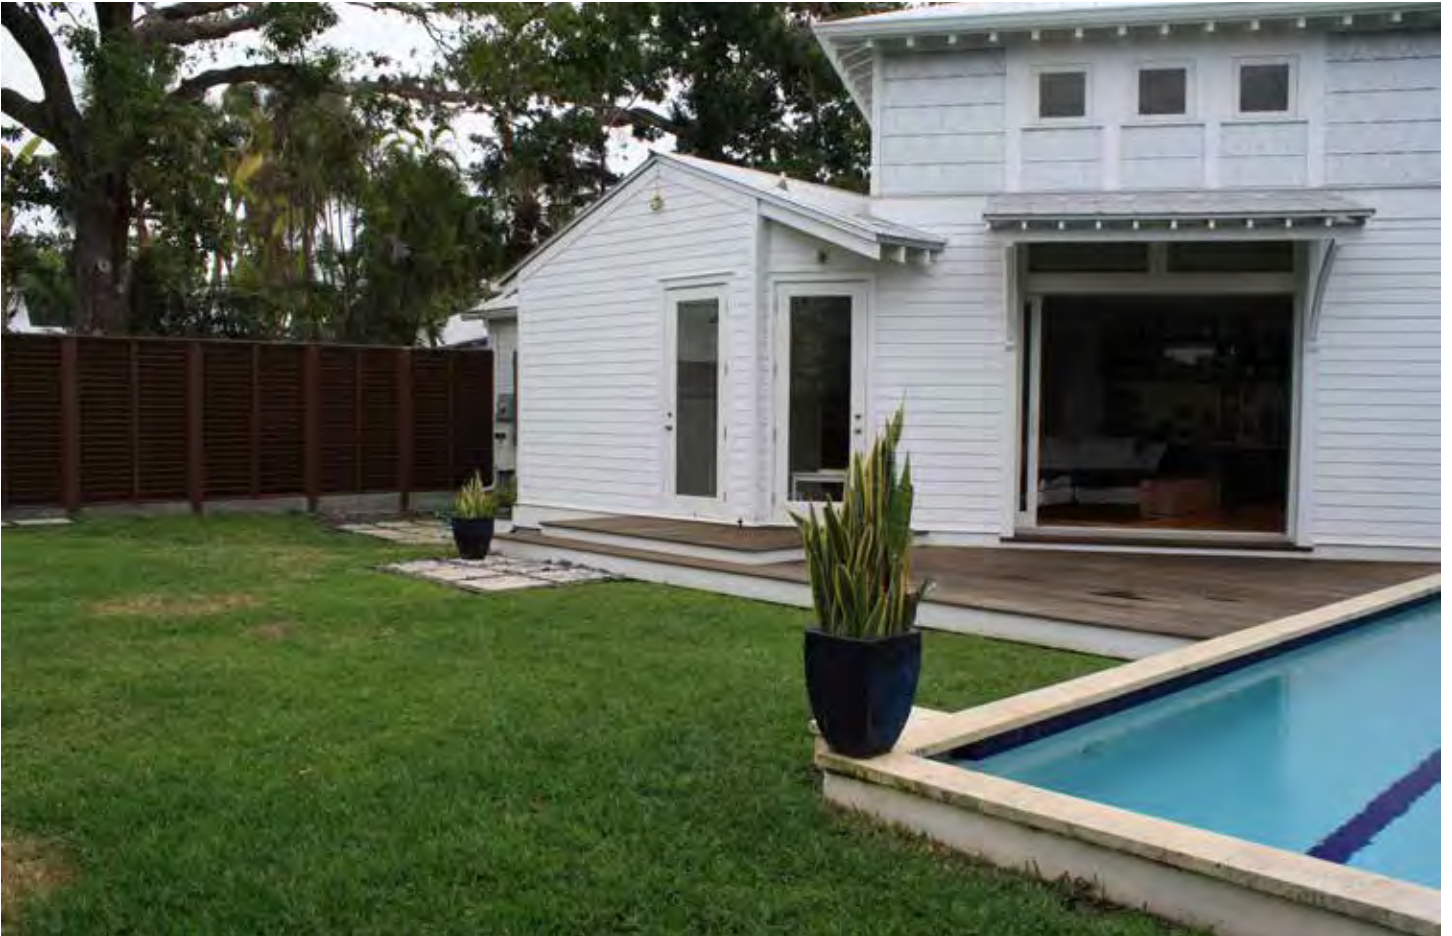
View of existing house from rear yard. The smaller portion of the structure in the center of the image will be the starting point for the proposed addition.

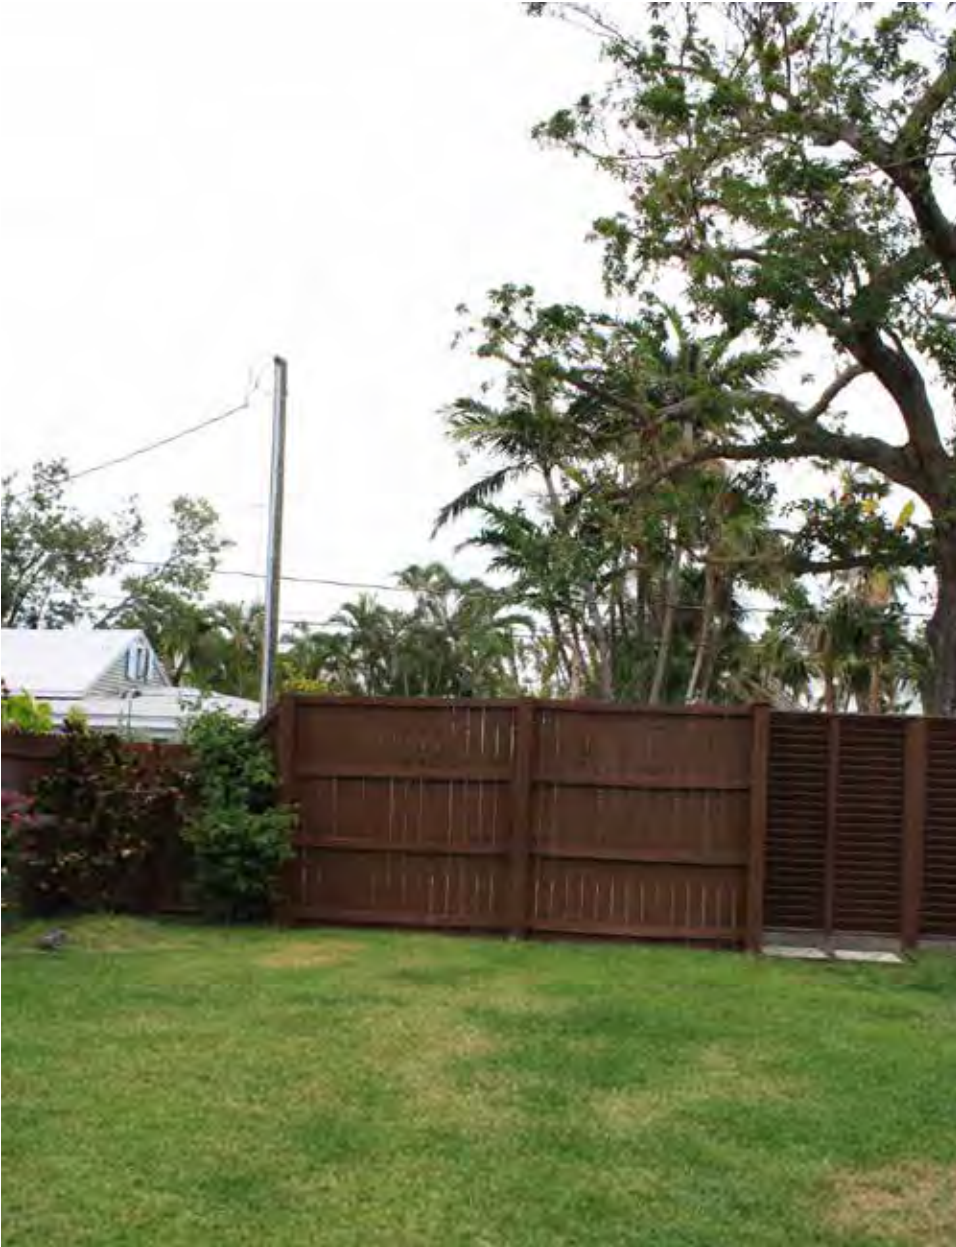
The existing board fence will be removed for construction phase. The plants to the left of the image will be replanted in the proposed garden wall extension corner planter.

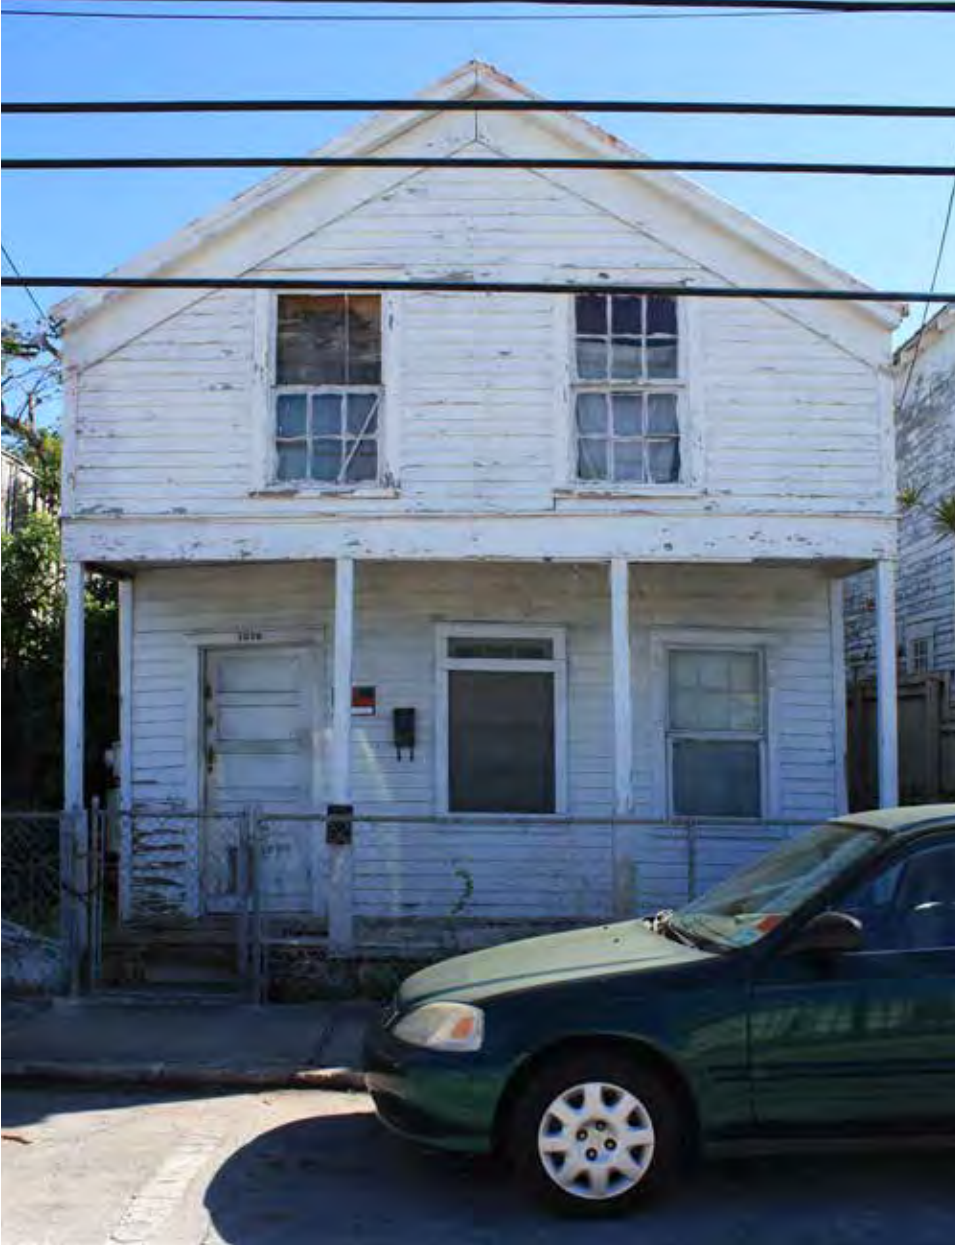
Front Façade

The front façade and porch will be restored.

The existing door will be replaced with a new 4 panel wood door with wood screen door.

The existing windows will be removed and replaced with new 6/6 painted wood double hung windows, with new operable wood louvered shutters. The restored building will be painted white with white trim.

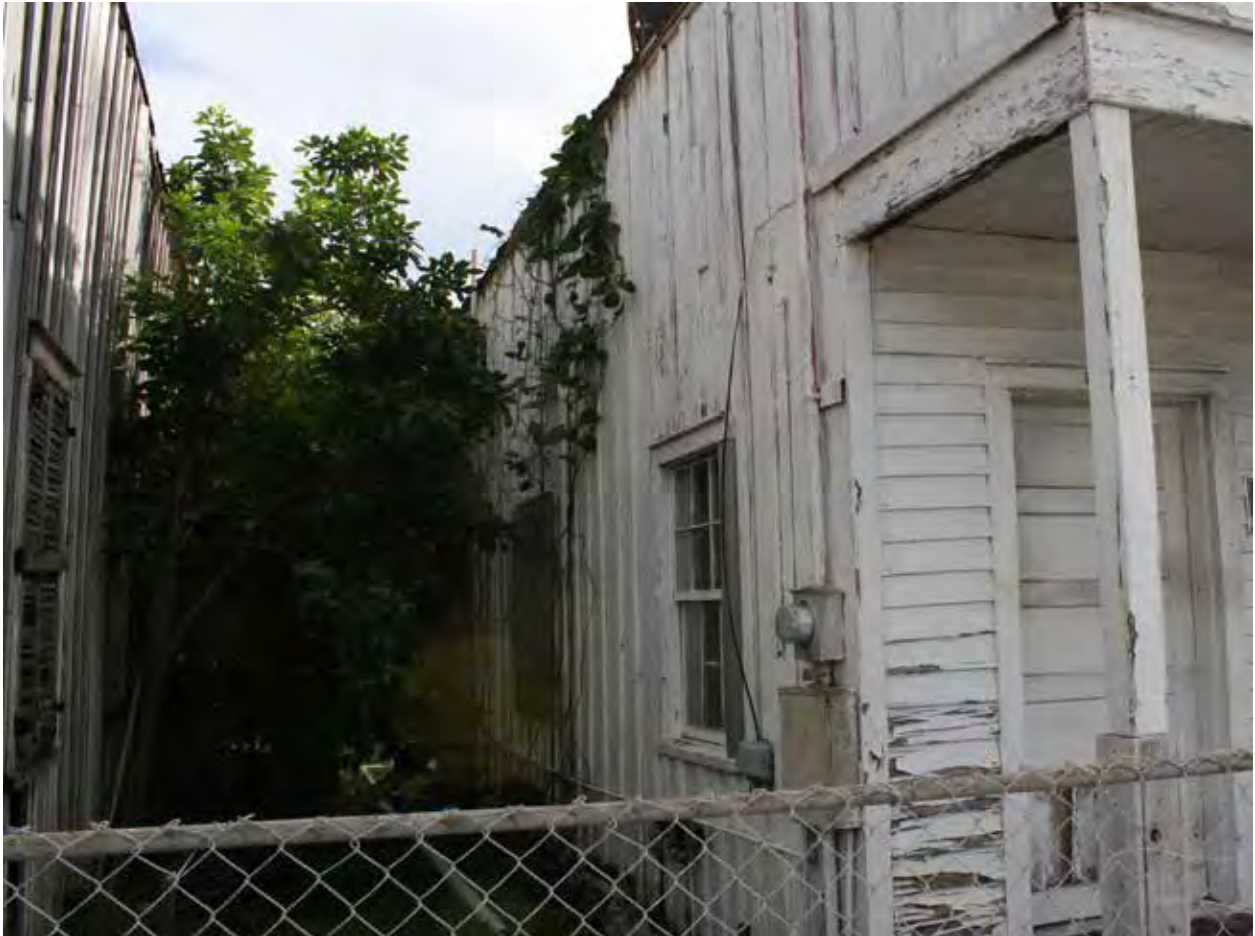
Side and Rear Façades

Board and batten siding will be restored with all windows and doors replaced. The space between 1010 and 1012 will be replanted with decorative native species to create privacy screening between the lower units.

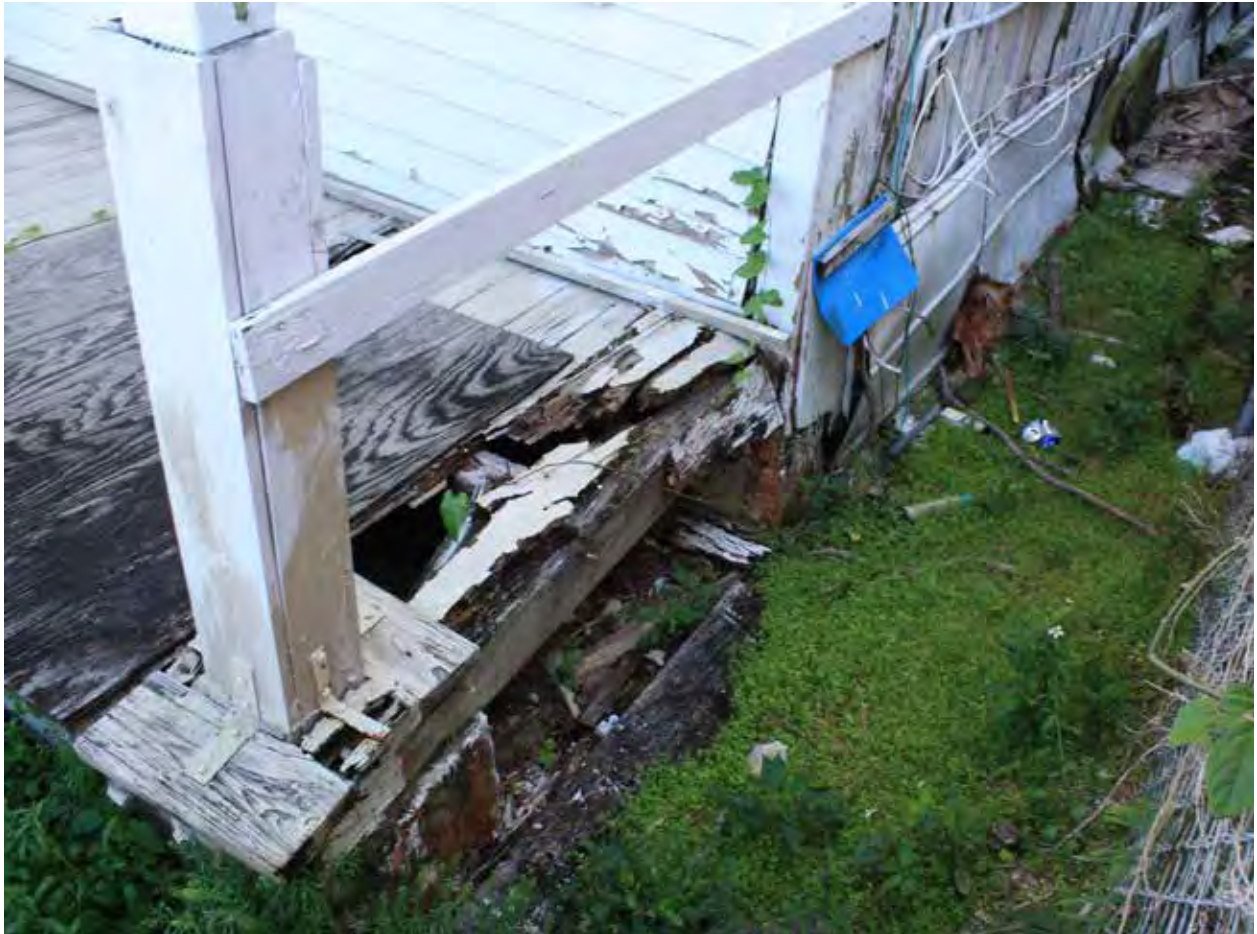
Front porch will be replaced with a new front porch with painted wood tongue in groove decking and painted wood columns.

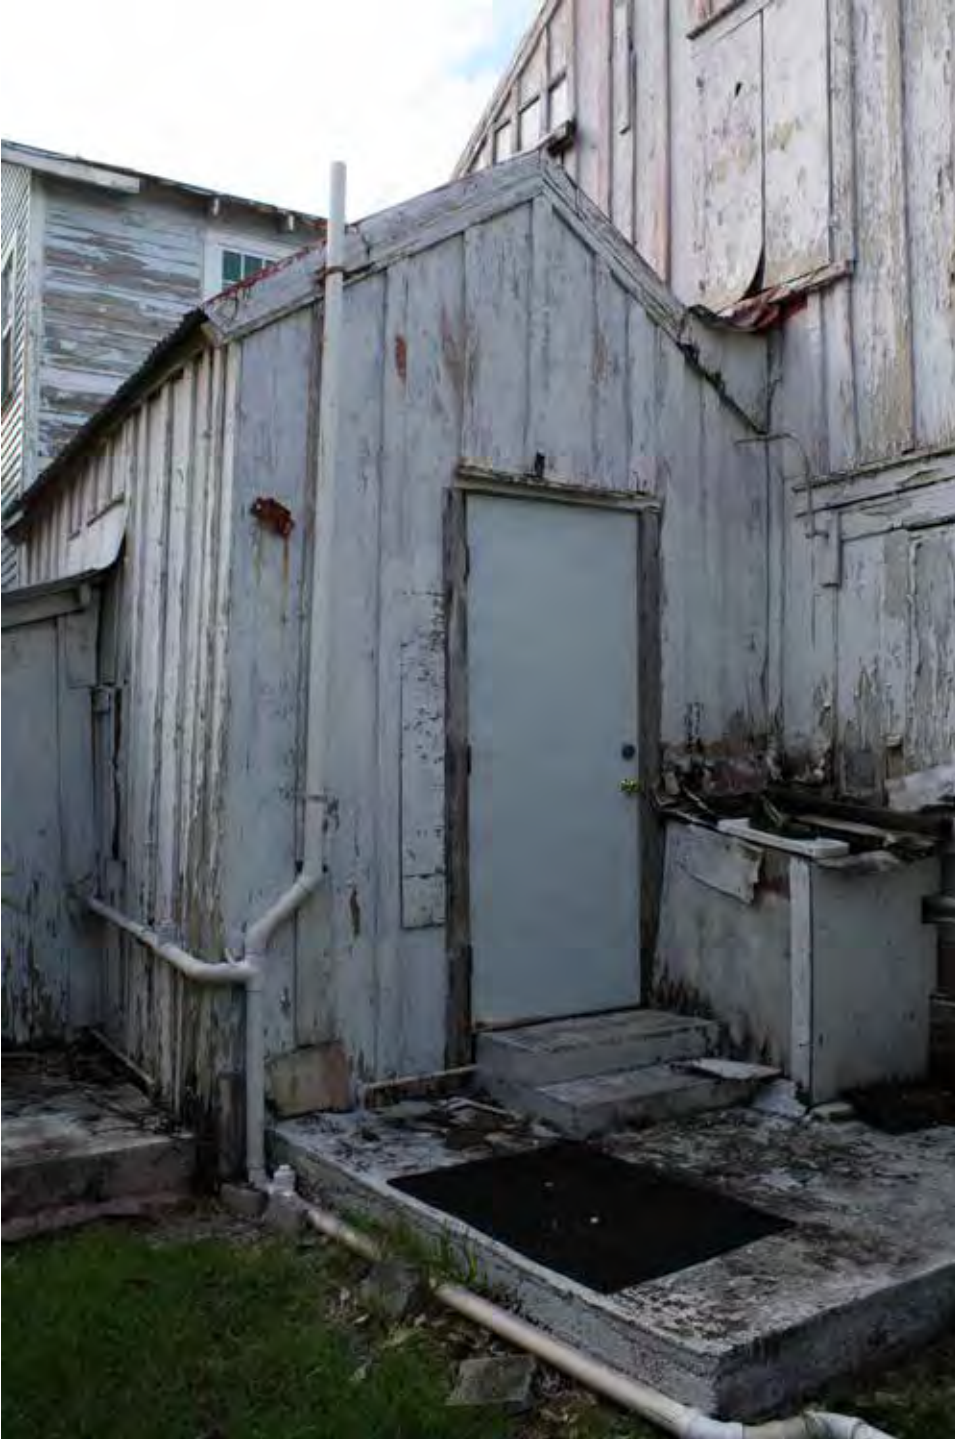
One story structure on the rear of the house will be restored and incorporated into the first floor unit.

The existing windows will be removed and replaced with new 6/6 painted wood double hung windows, with new operable wood louvered shutters. The existing door will be replaced with a new 4 panel wood door with wood screen door.

Existing concrete slab will be cleaned and refinished.

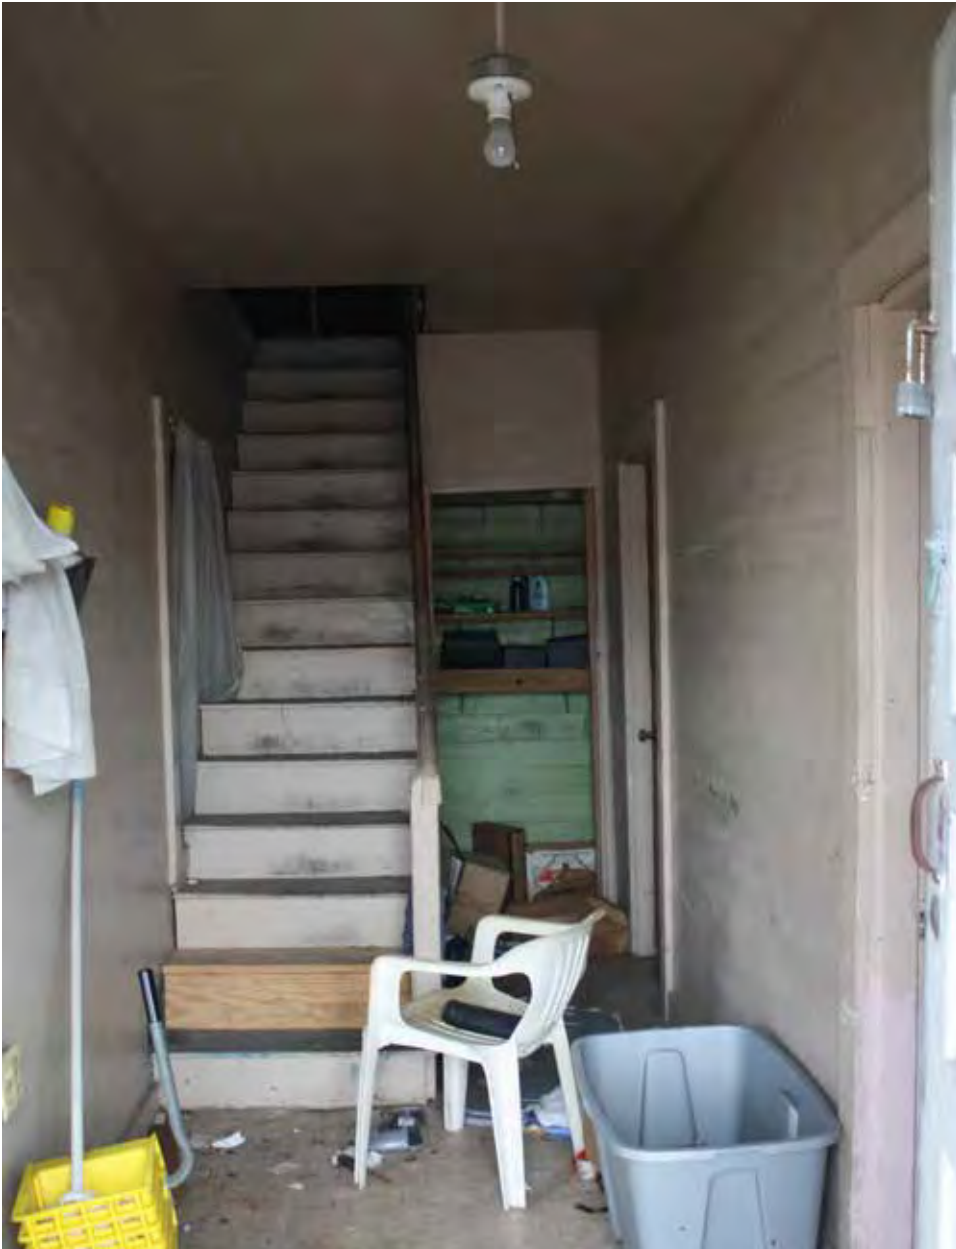
Existing stairs will be removed.  
The existing first floor interior will  
remain intact where possible.

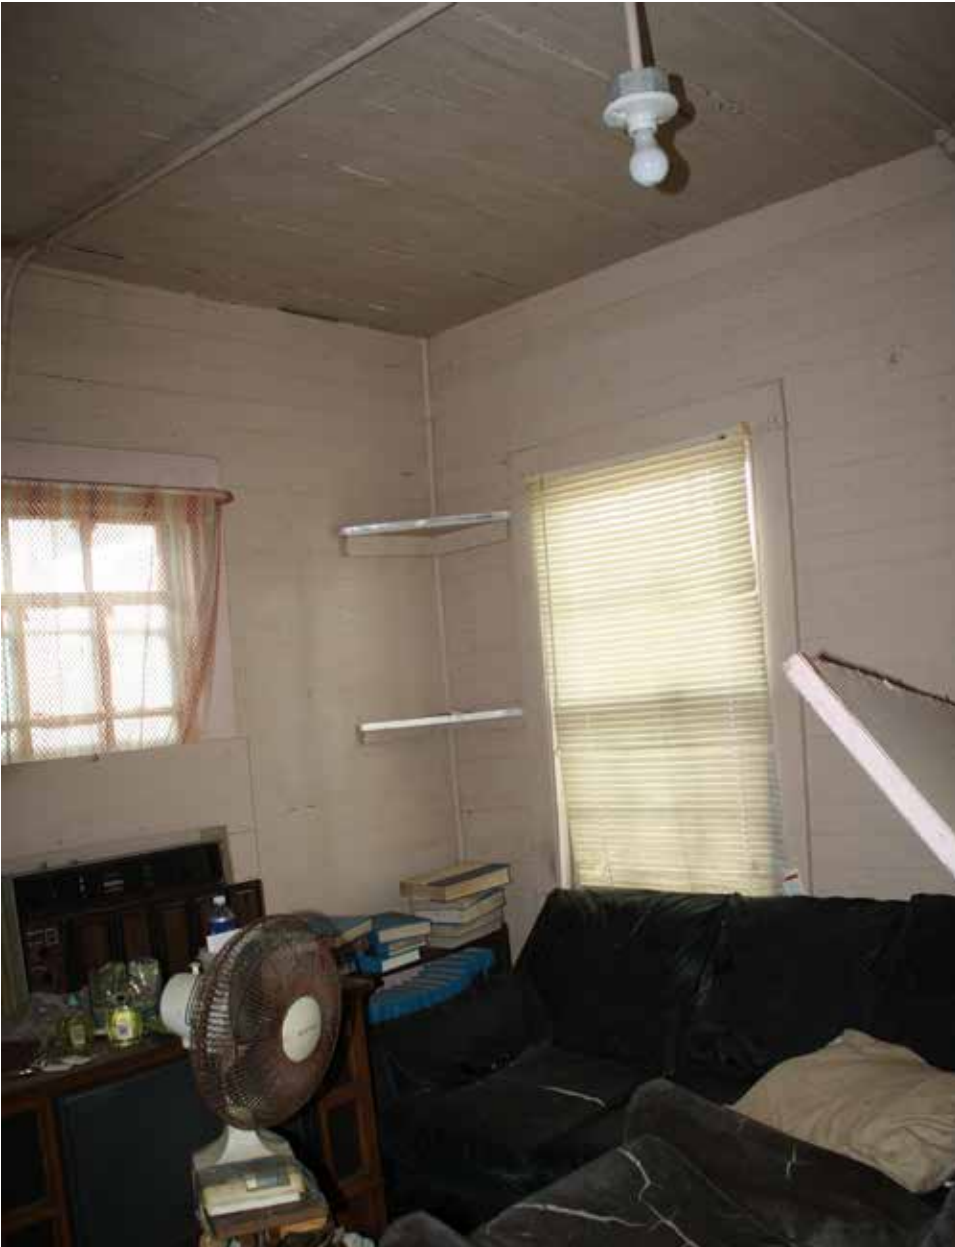
Existing tongue and groove walls and ceiling will remain intact and be restored or be reused/repurposed where ever possible.

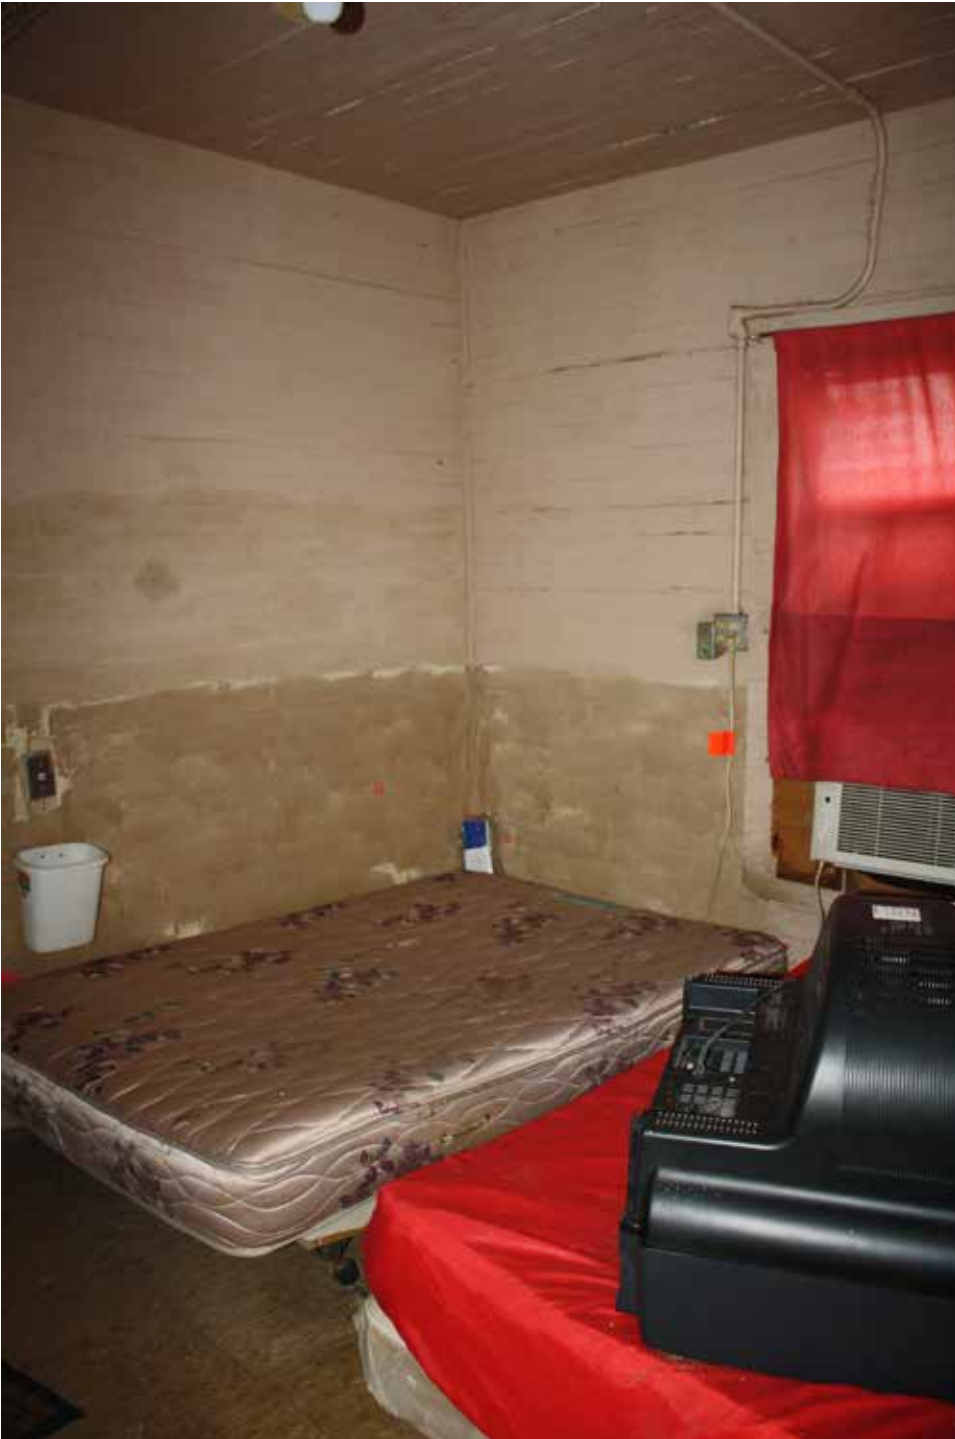
Existing tongue and groove walls and ceiling will remain intact and be restored or be reused/repurposed where ever possible.

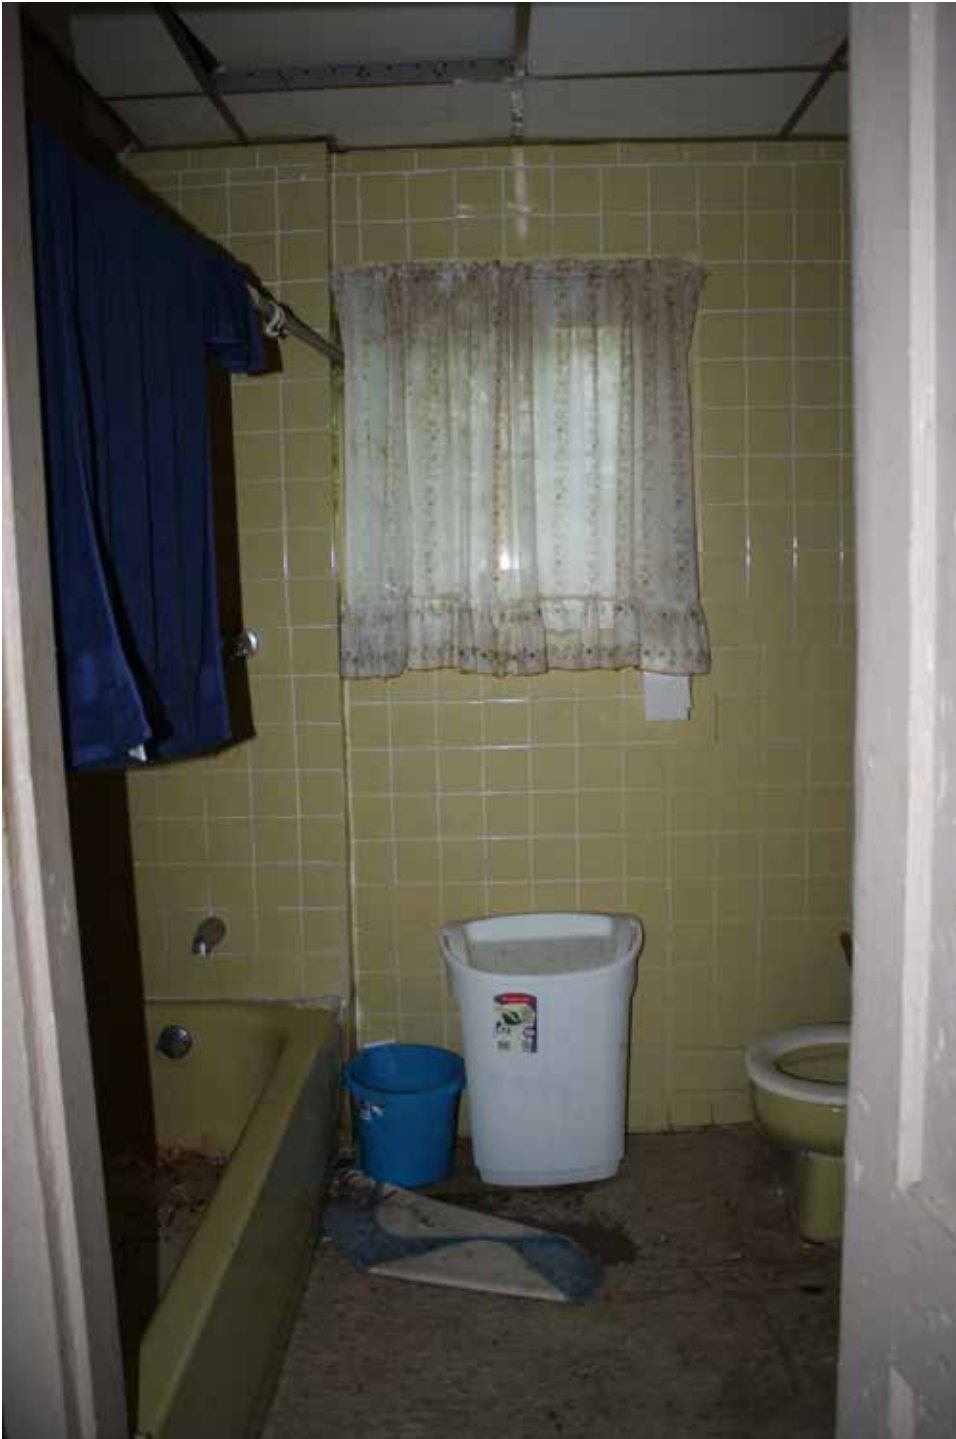
Existing bathroom will be demolished and replaced.

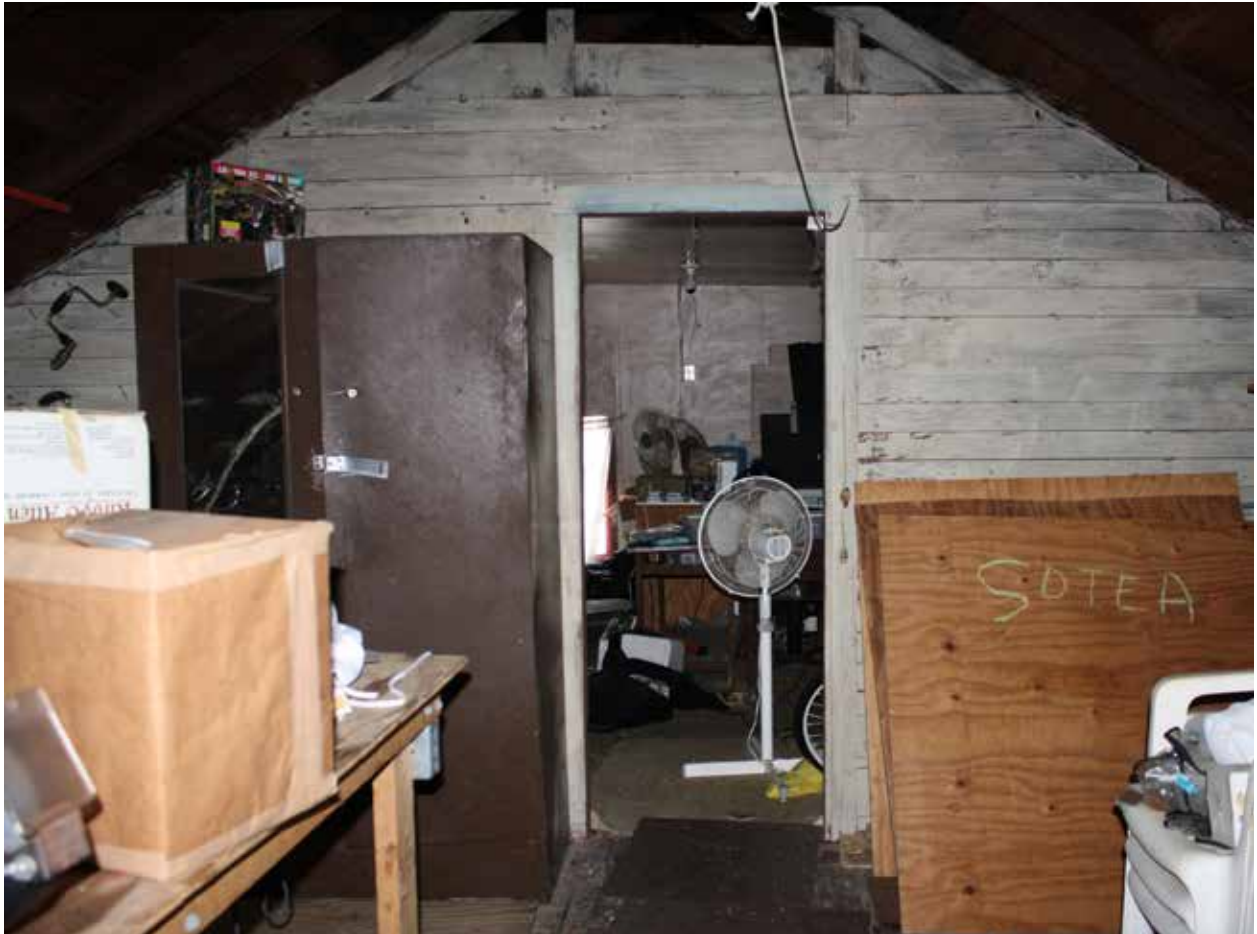
Existing central interior wall will be removed.
