**Historic Architectural Review Commission  
Staff Report for Item 5**

**Application Number:** H18-03-0018

**Address:** #911 Watson/ #1010-1012 Olivia Streets

**Description of Work**

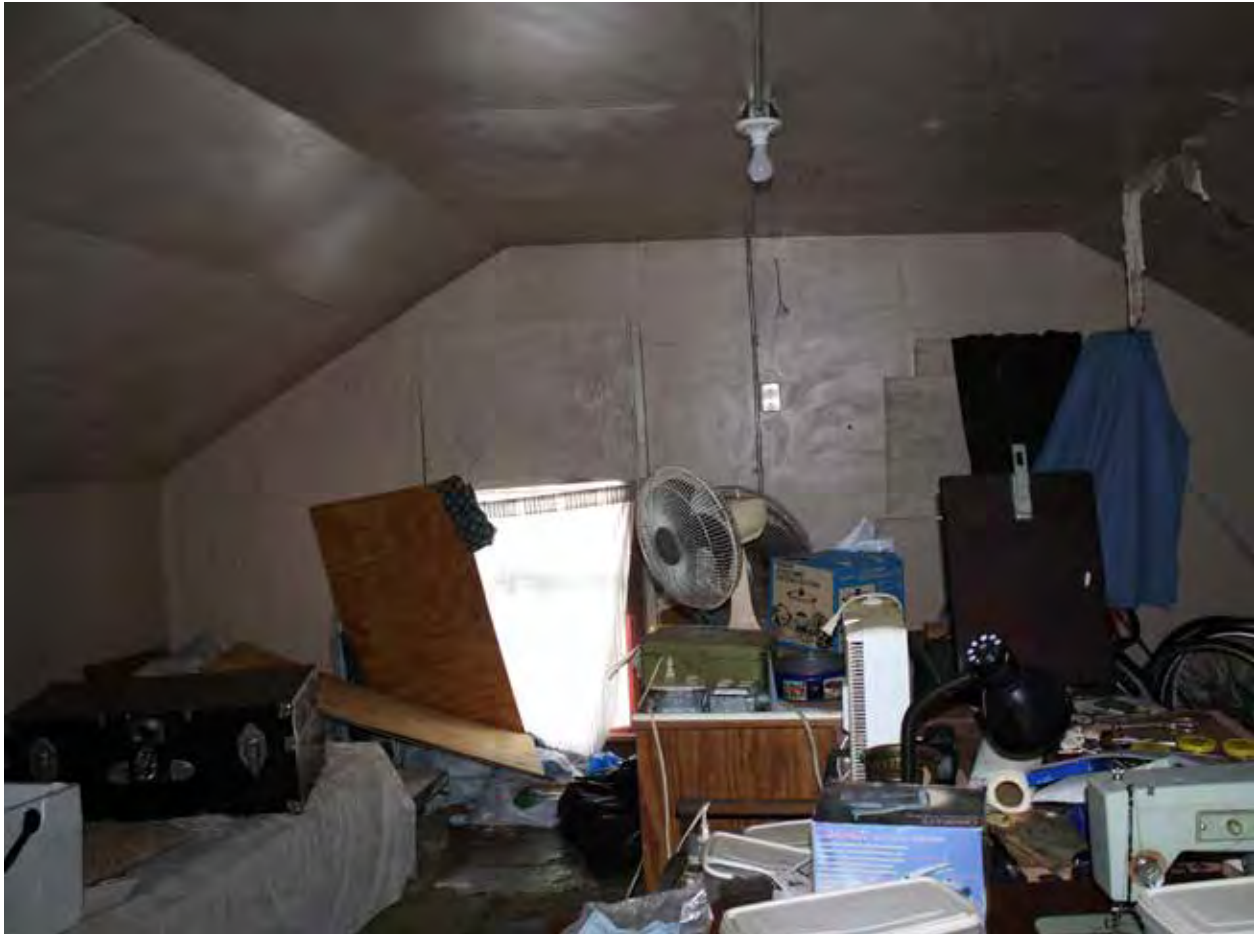
Existing plywood ceiling and walls will be removed as part of proposed renovation.

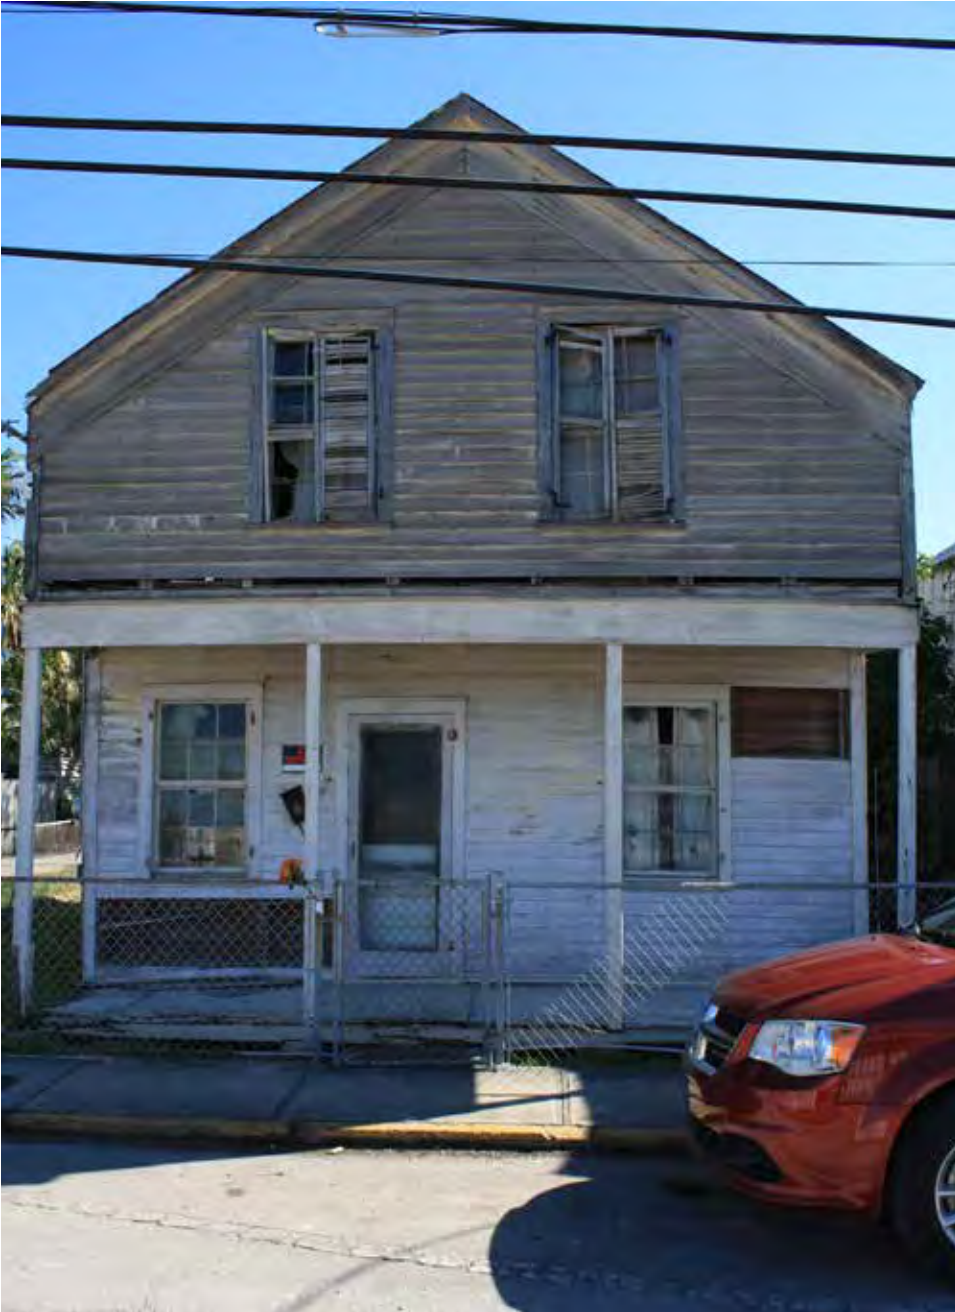
Front Façade

The front façade and porch will be restored.

The existing door will be replaced with a new 4 panel wood door with wood screen door.

The existing windows will be removed and replaced with new 6/6 painted wood double hung windows, with new operable wood louvered shutters. The restored building will be painted white with white trim.

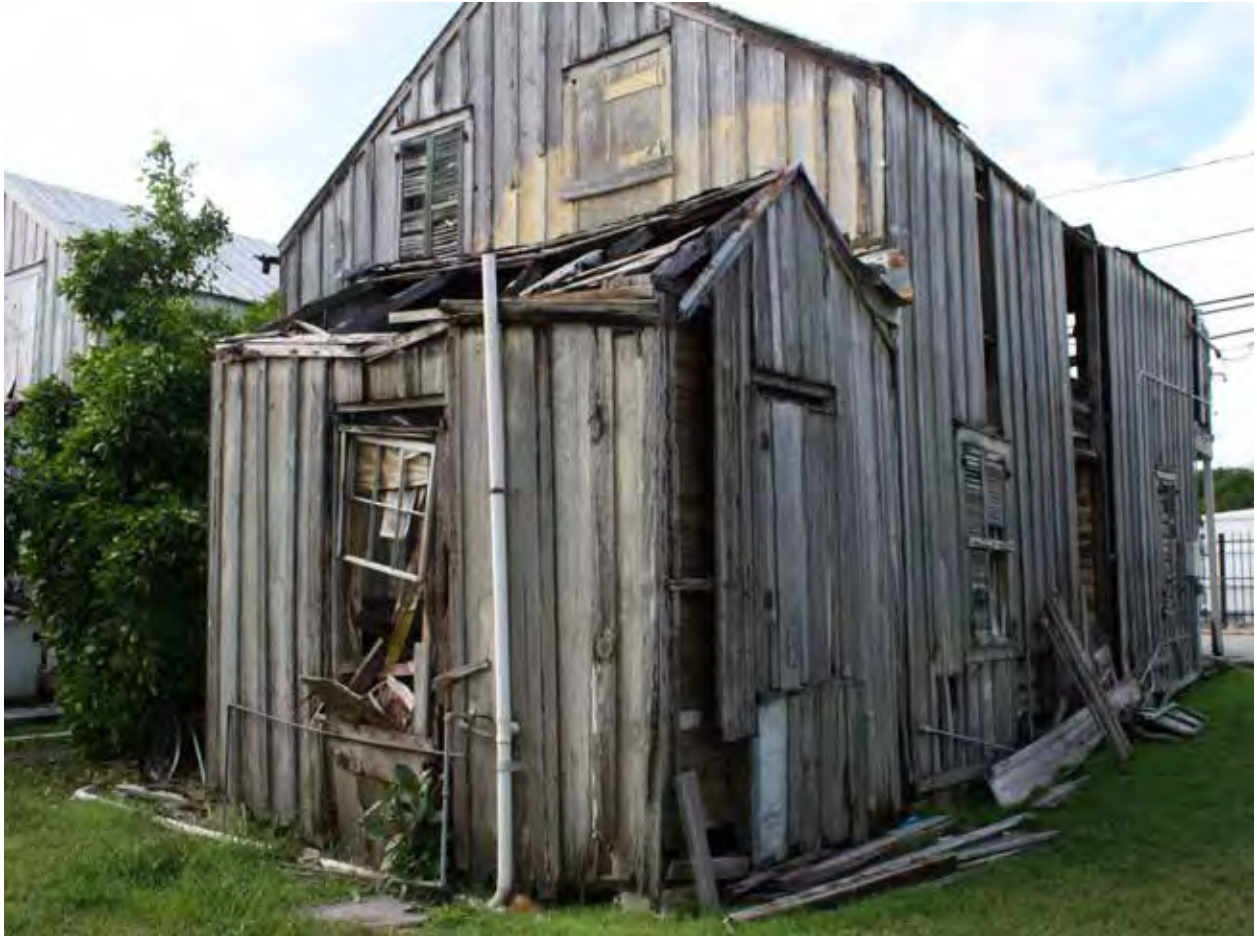
One story structure on the rear of the house will be restored and incorporated into the first floor unit.

The existing windows will be removed and replaced with new 6/6 painted wood double hung windows, with new operable wood louvered shutters. The existing wood board and batten siding will be restored or replaced with new wood board and batten siding and painted white.

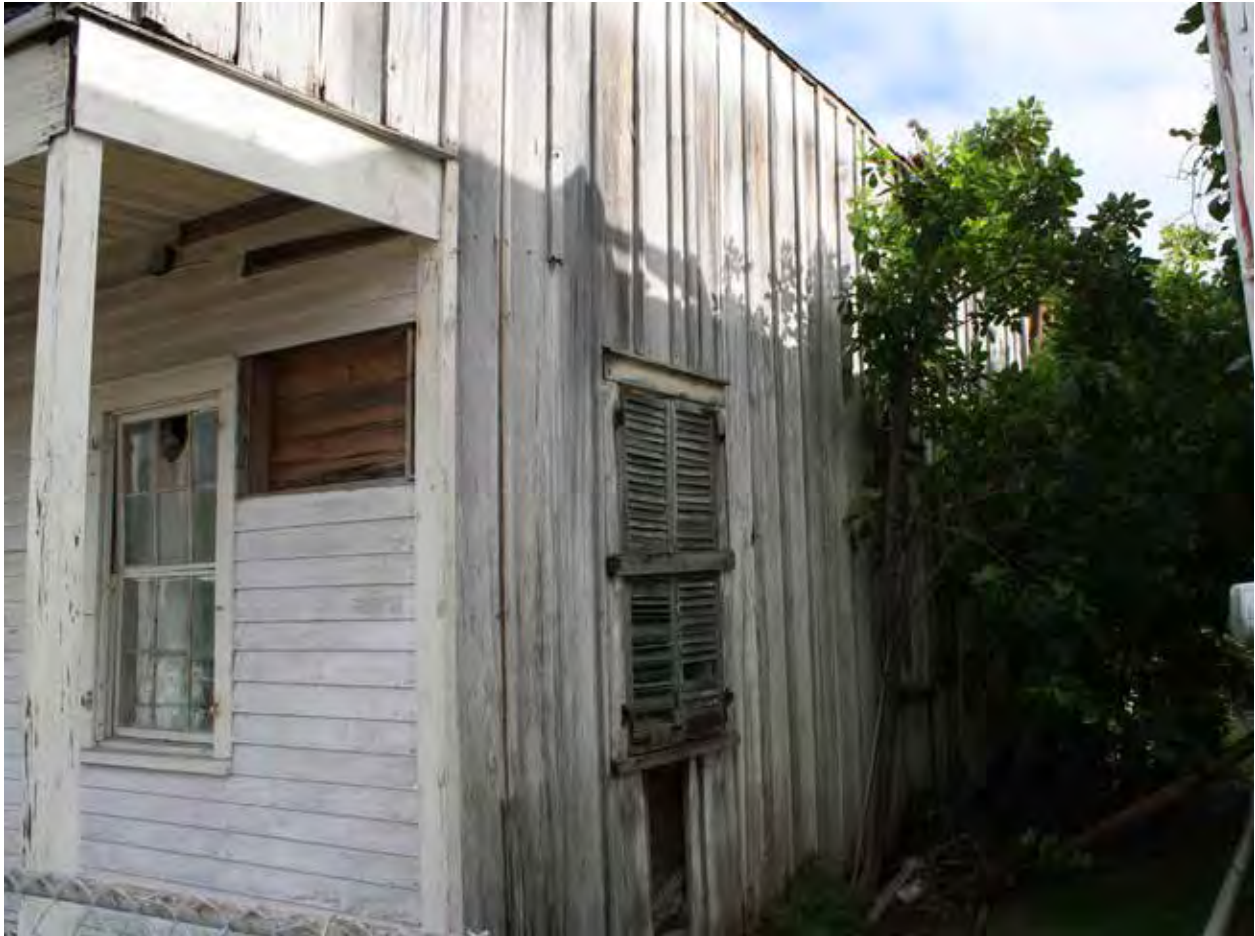
Side and Rear Façades

Board and batten siding will be restored with all windows and doors replaced. The space between 1010 and 1012 will be replanted with decorative native species to create privacy screening between the lower units.

The existing windows will be removed and replaced with new 6/6 painted wood double hung windows, with new operable wood louvered shutters.

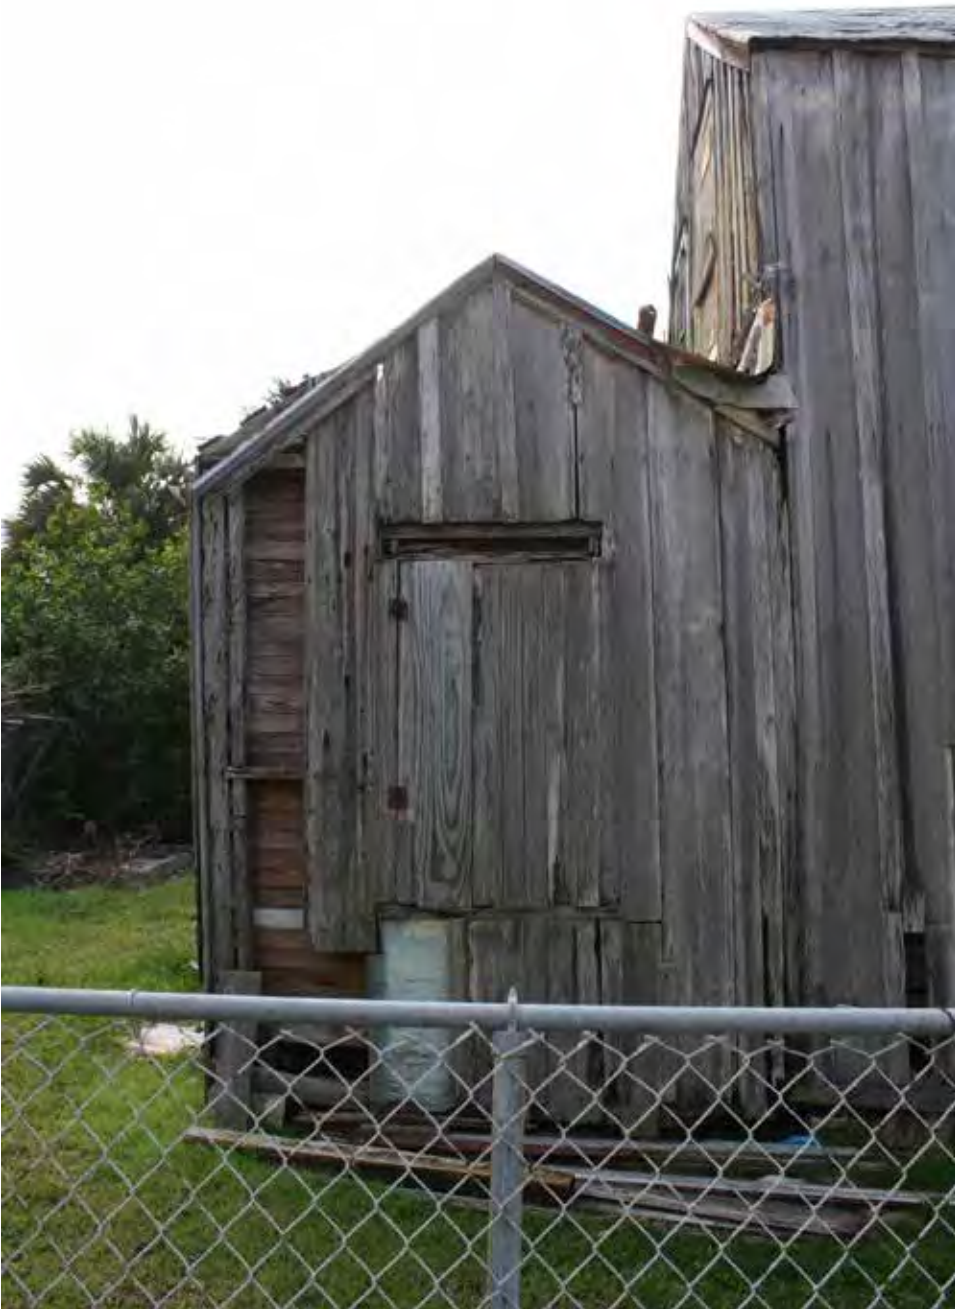
## Side and Rear Façades

Board and batten siding will be restored with all windows and doors replaced. The space between 1010 and 1012 will be replanted with decorative native species to create privacy screening between the lower units.

The existing windows will be removed and replaced with new 6/6 painted wood double hung windows, with new operable wood louvered shutters.

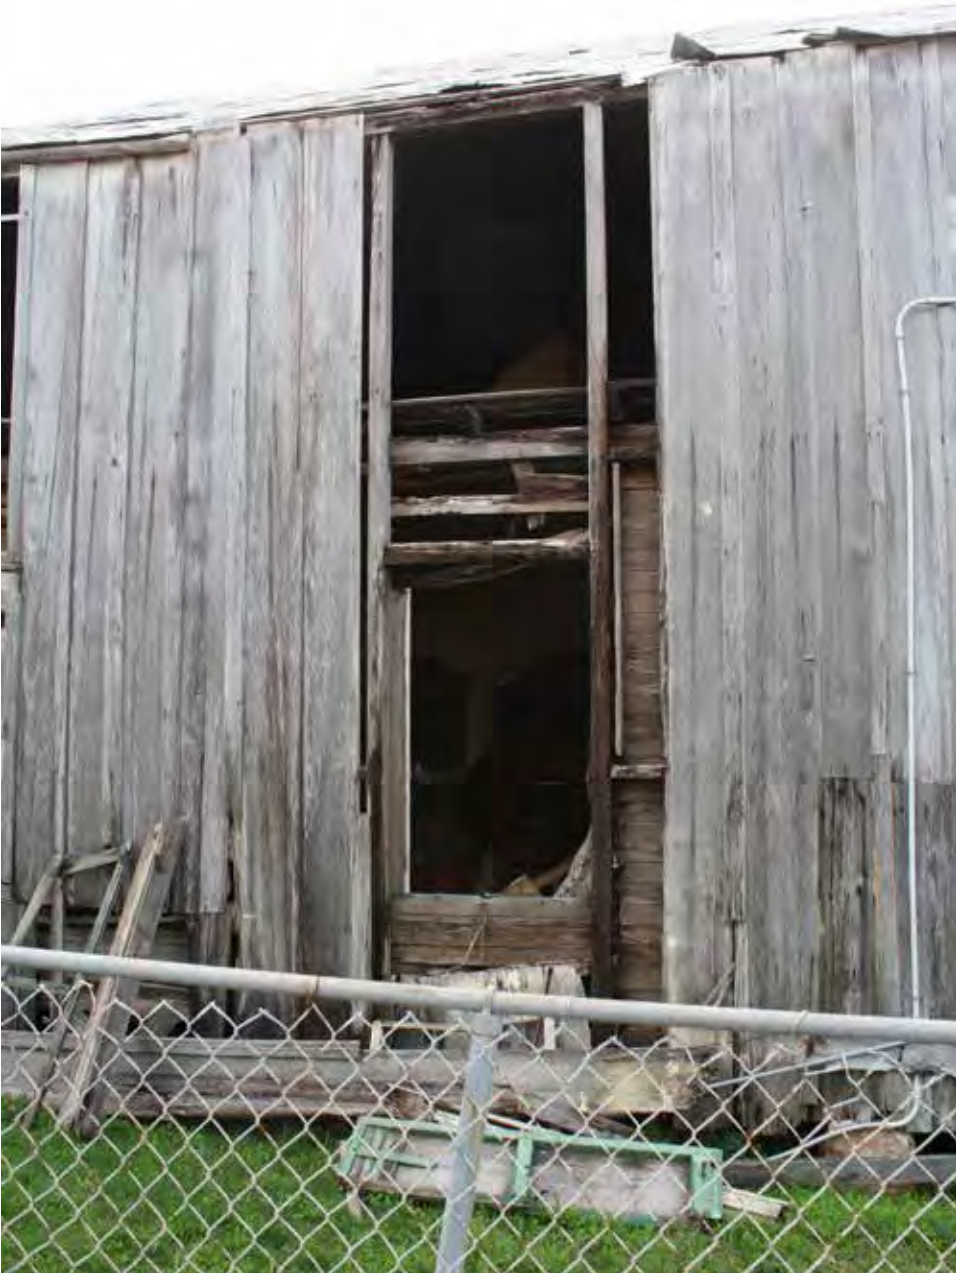
Side and rear façades

1012 will be rebuilt to replicate its historic appearance. The board and batten siding will be restored and painted white with white trim.

The existing windows will be removed and replaced with new 6/6 painted wood double hung windows, with new operable wood louvered shutters.

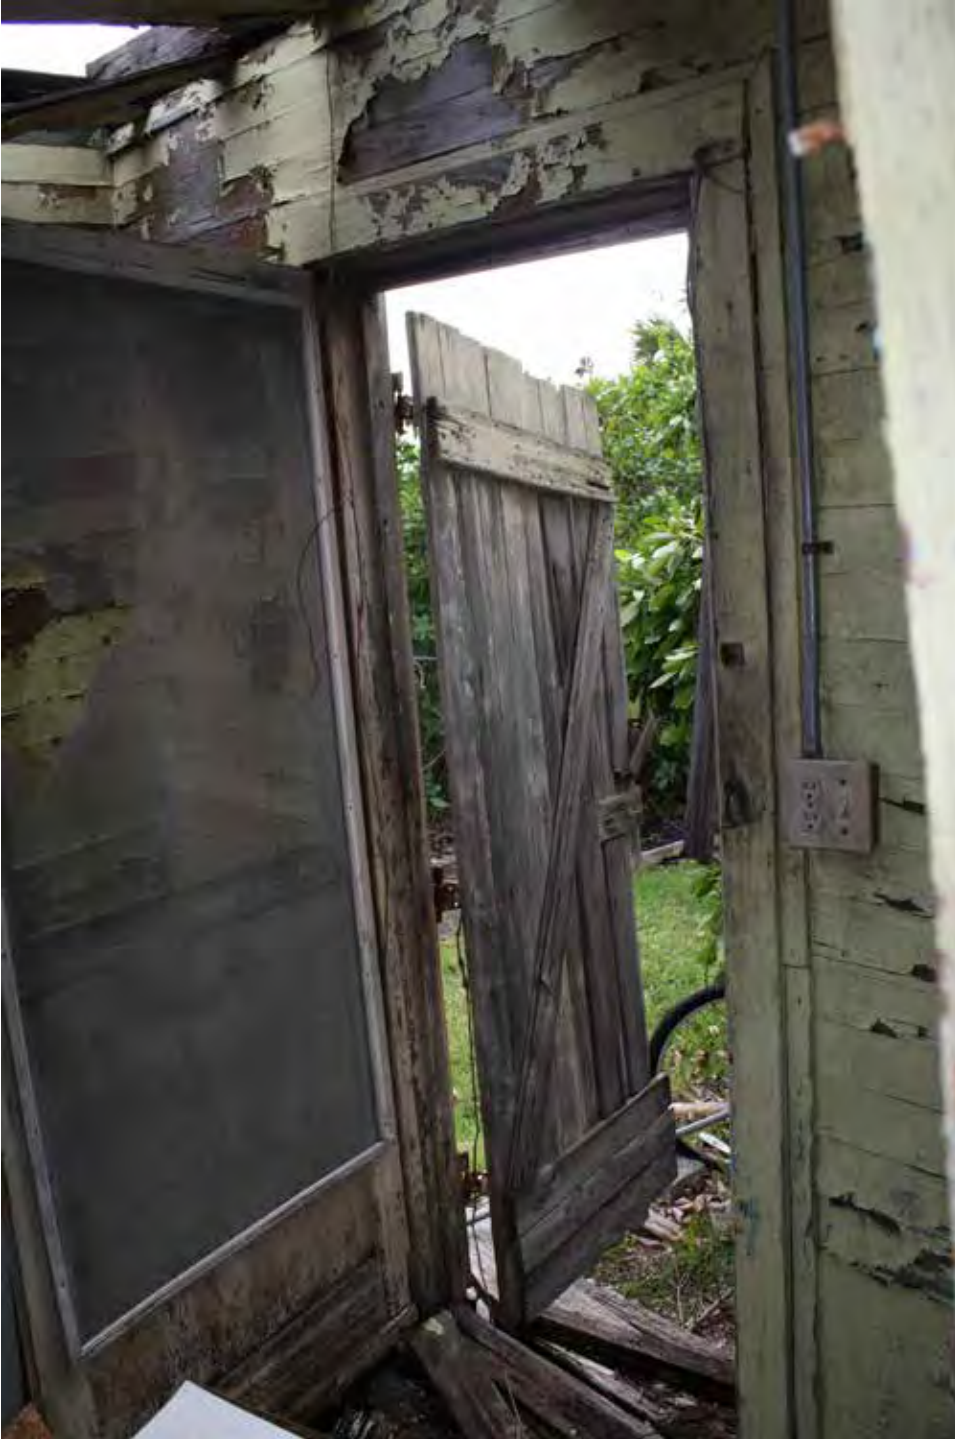
The existing door will be replaced with a new 4 panel wood door with wood screen door.

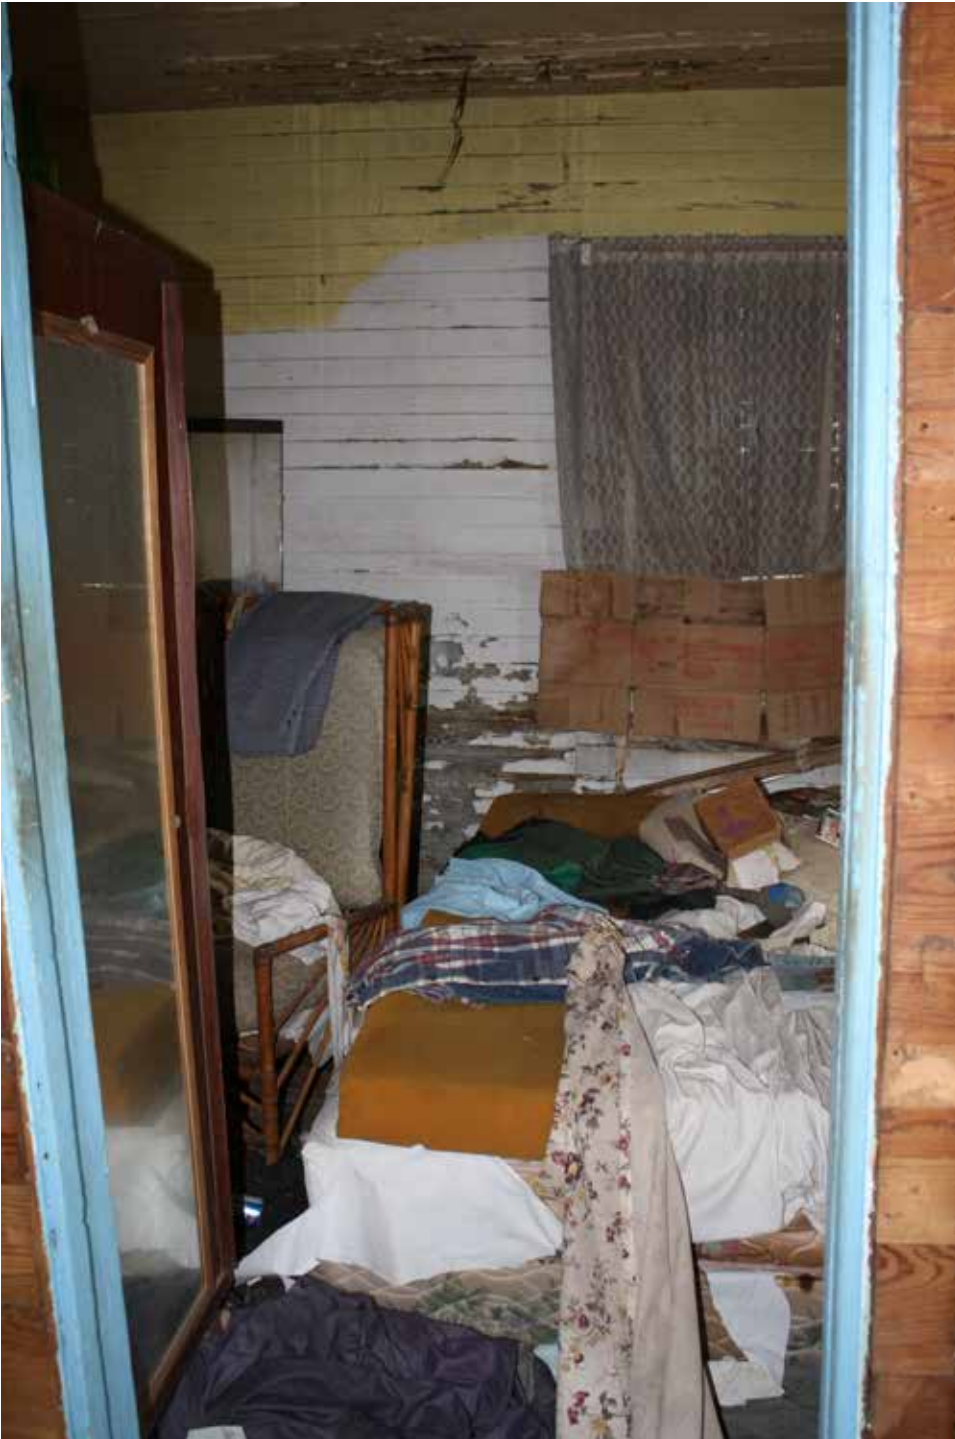
Existing tongue and groove walls and ceiling will remain intact and be restored or be reused/repurposed where ever possible.

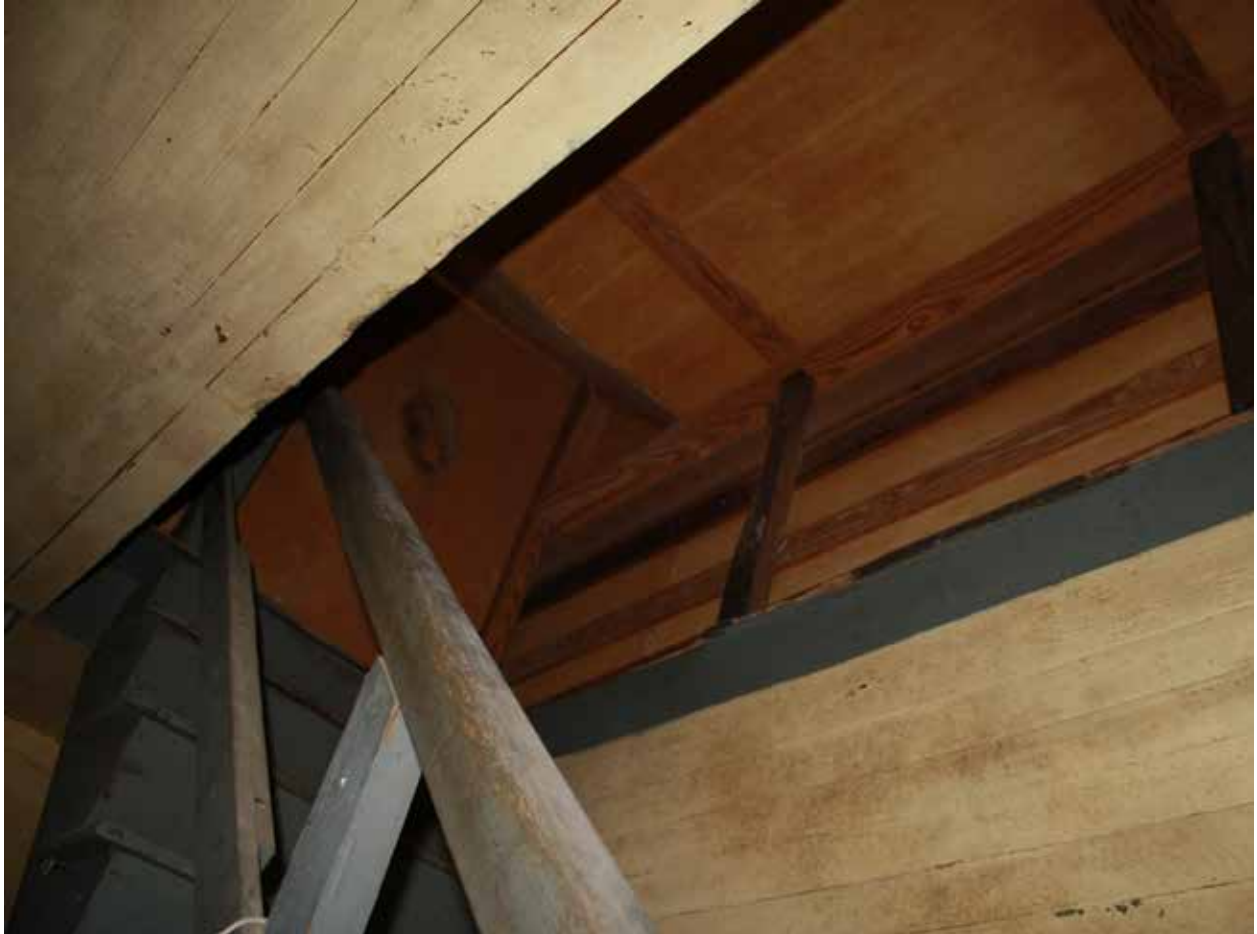
Existing tongue and groove walls and ceiling will remain intact and be restored or be reused/repurposed where ever possible.

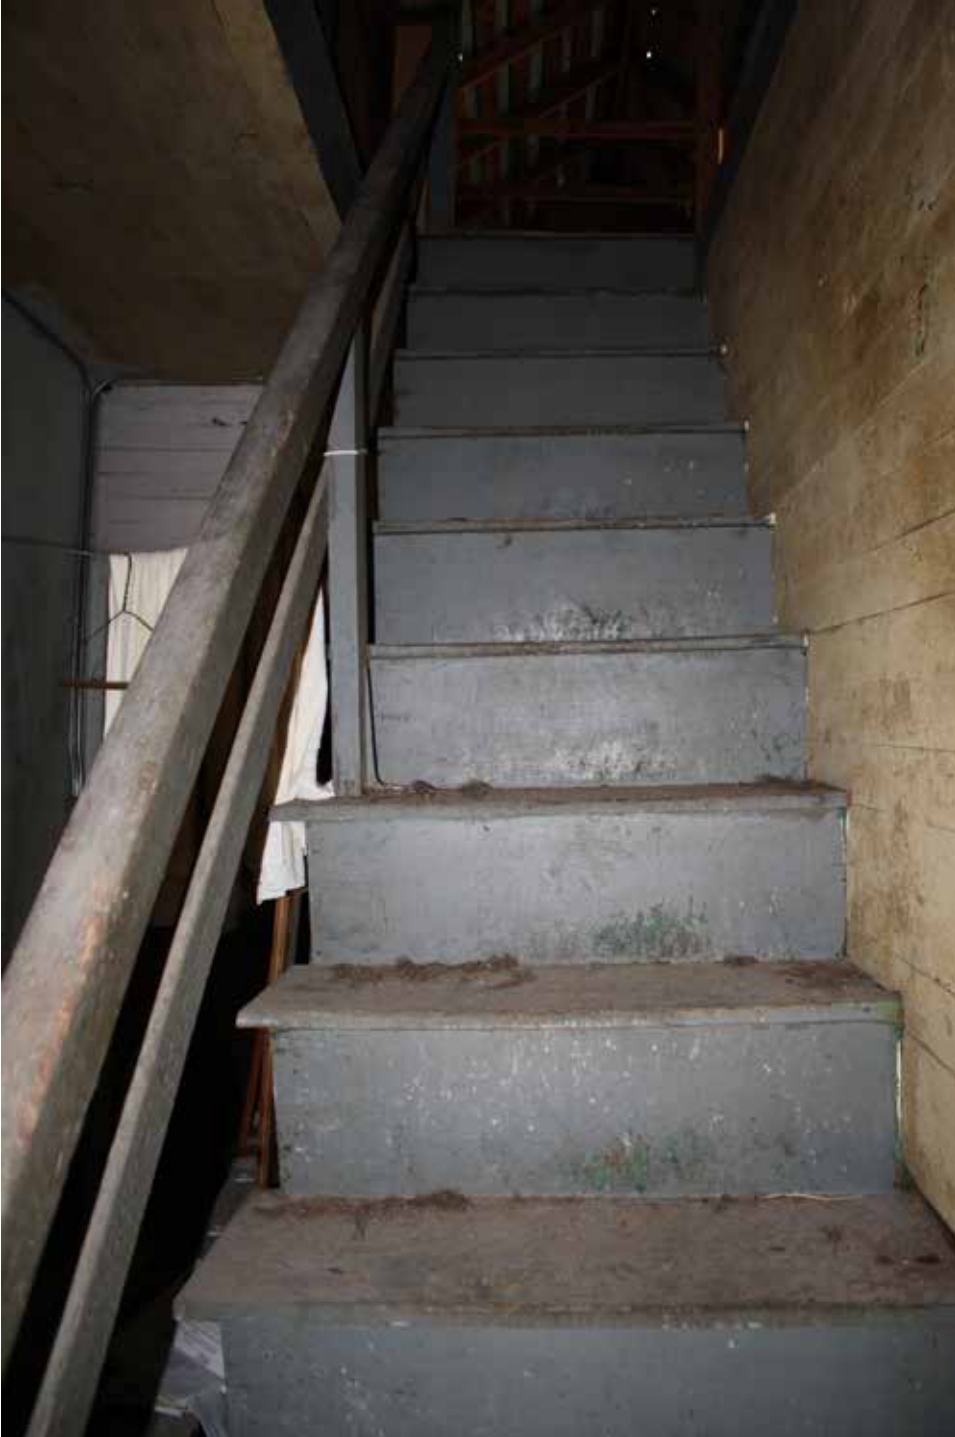
Existing stairs will be removed.  
The existing first floor interior  
will remain intact where ever  
possible.

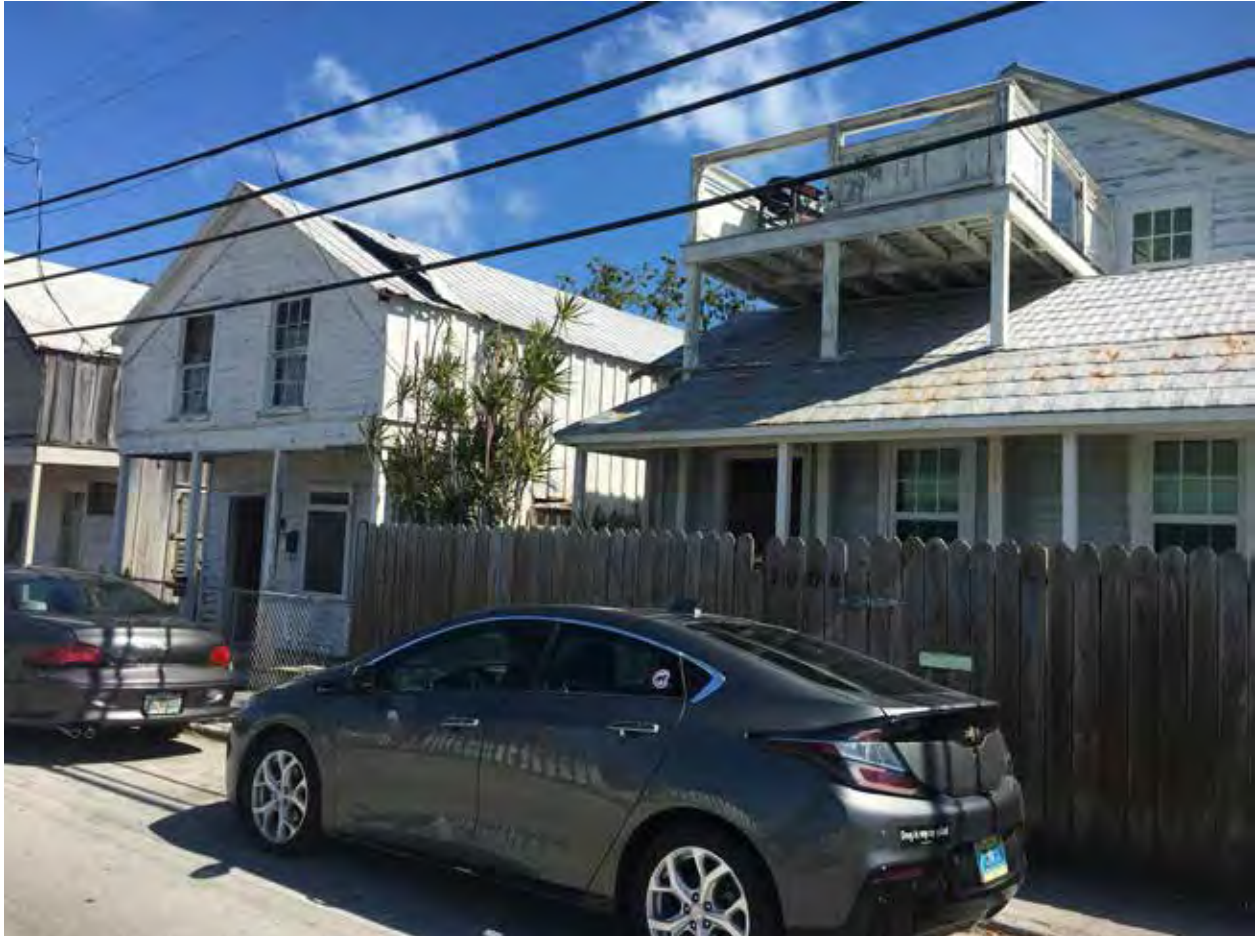
1008 Olivia Street

One and two story wood frame house with second floor deck built on roof of one story structure.

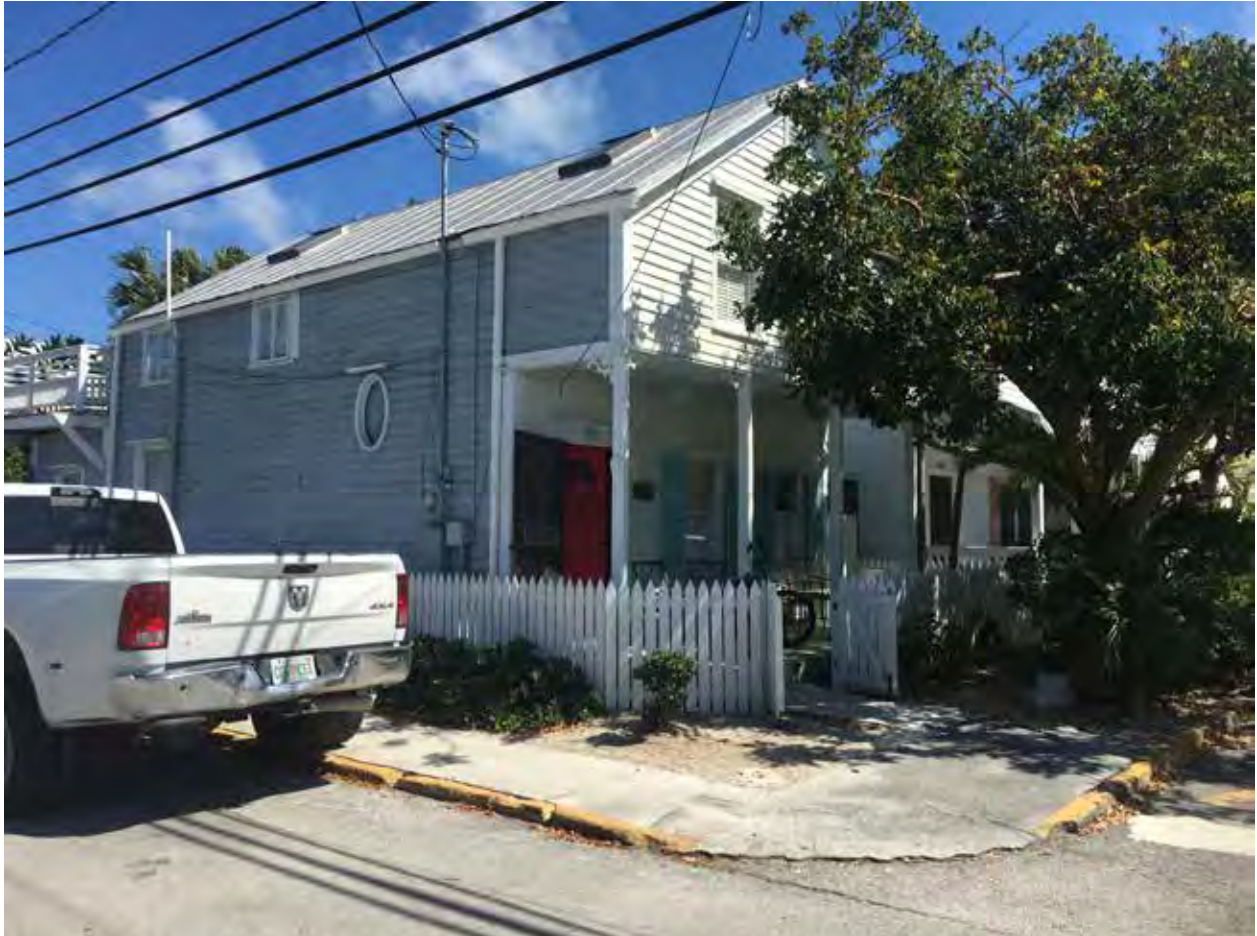
901 Grinnell Street

Two story wood frame house, also first appearing on the 1892 Sanborn Map. 901 Grinnell is structurally and stylistically very similar to 1010 and 1012 Olivia.

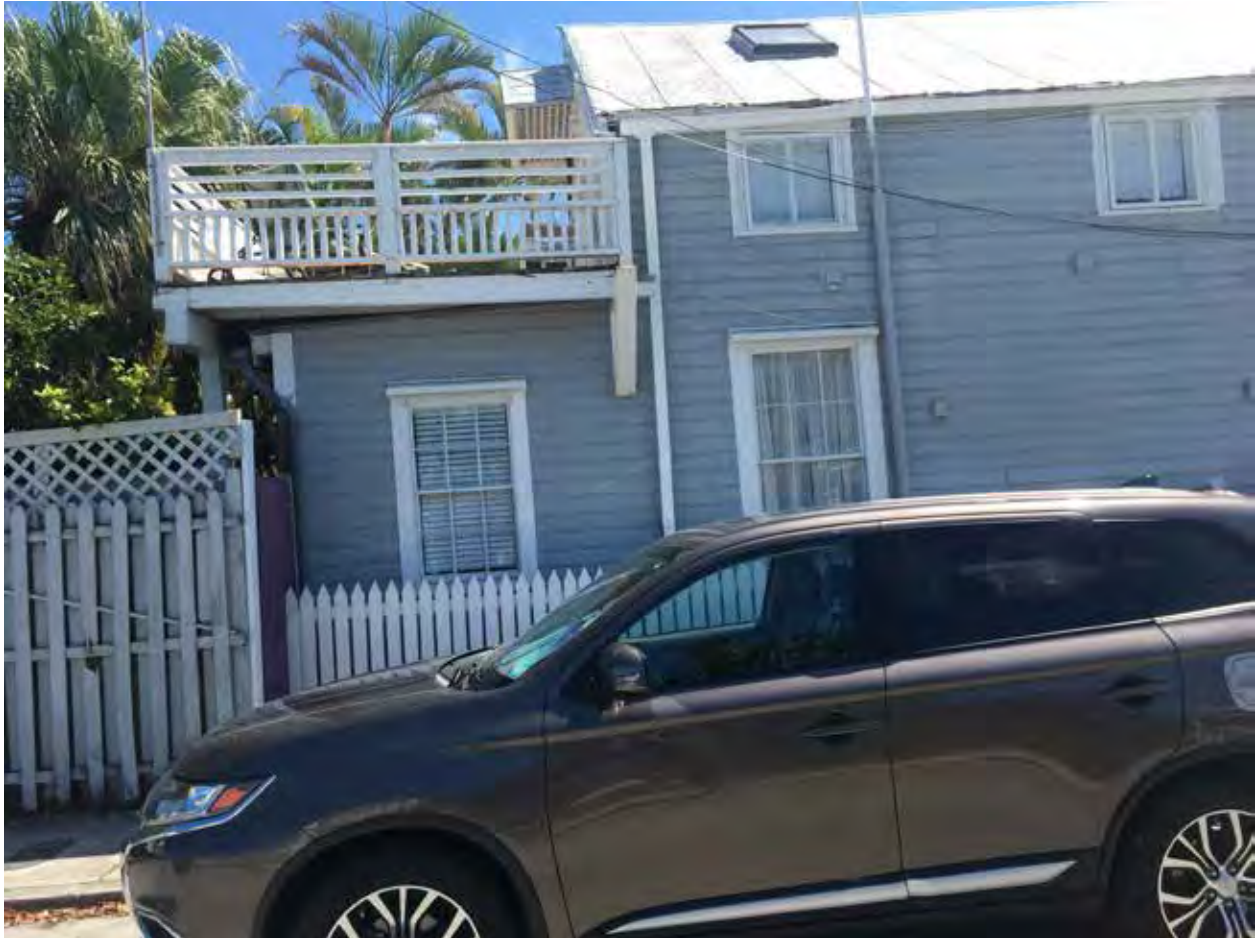
901 Grinnell Street

Second floor deck built on top  
of existing one story structure  
on rear of house.
