Historic Architectural Review Commission Staff Report for Item 8

Address: #1316 Royal Street/1319 William Street

Major Development Plan – Construction of six new single-family residences.

1316 ROYAL STREET
KEY WEST, FL
NEW RESIDENTIAL PROJECT

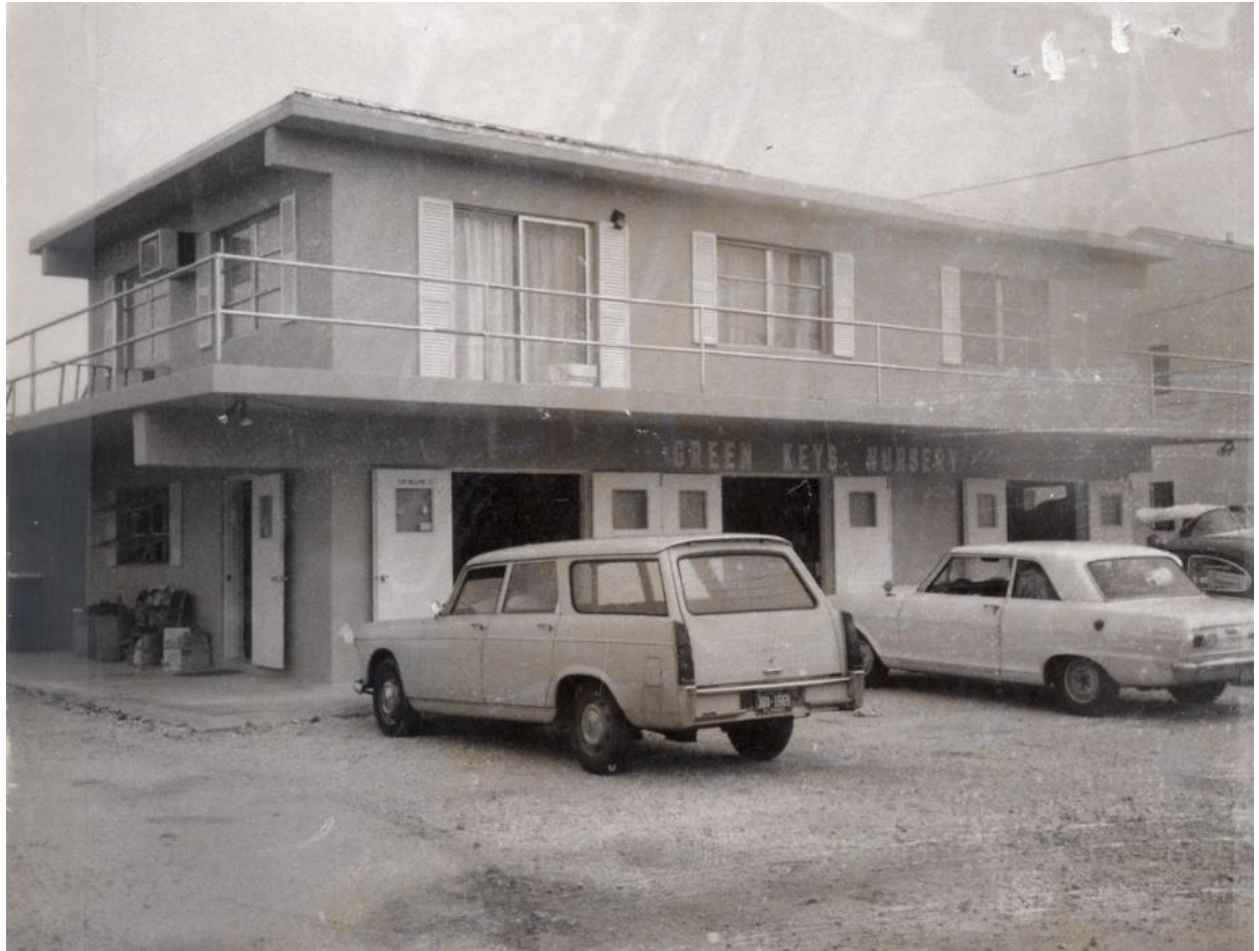
Historic photo from 1965 showing the two-story structure at 1319 William Street.
