**TREE COMMISSION TREE REMOVAL REPORT
CITY of KEY WEST**

PROPERTY: 1526 Washington St ROW

APPLICATION NUMBER: T2025-0220

REQUEST: The applicant is requesting removal of (1) Tamarind Tree

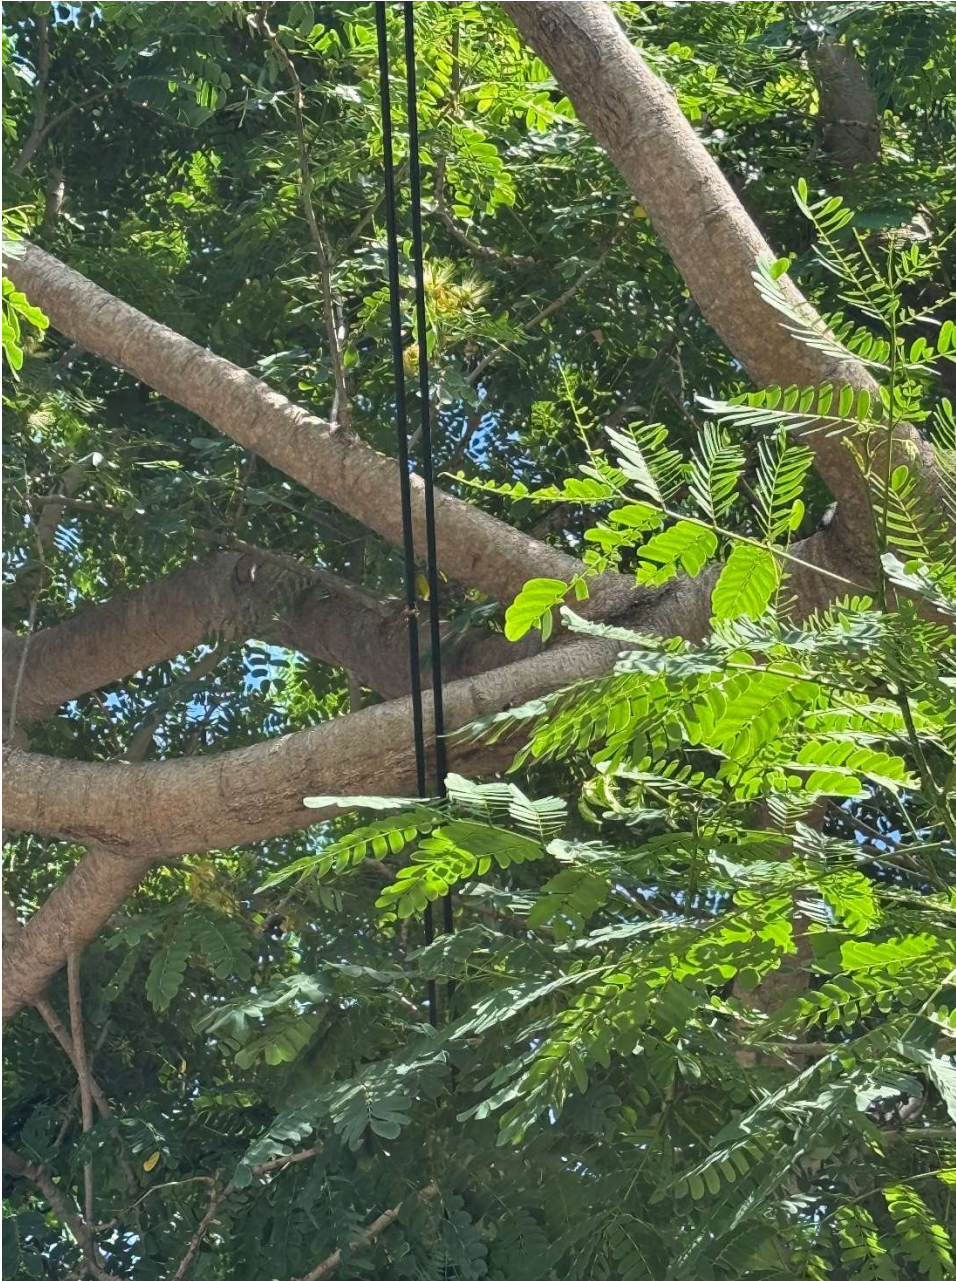
Tree is leaning on communication lines.

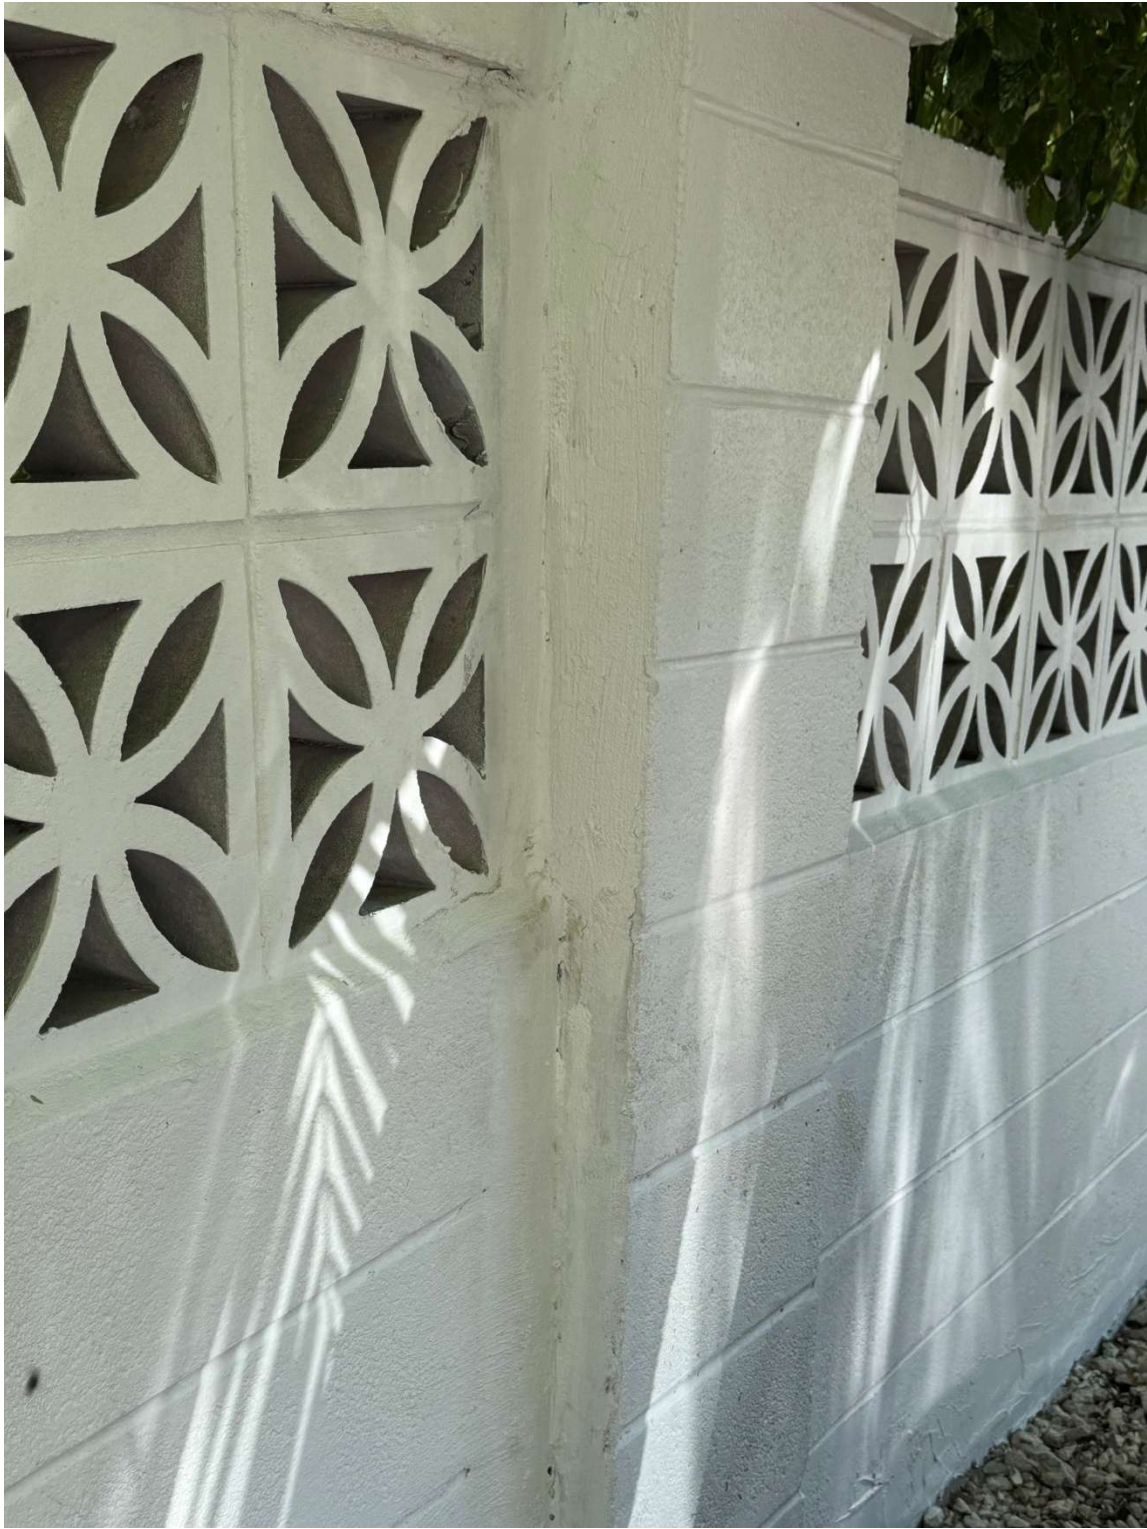
Tree's roots have caused significant structural damage to the concrete wall.

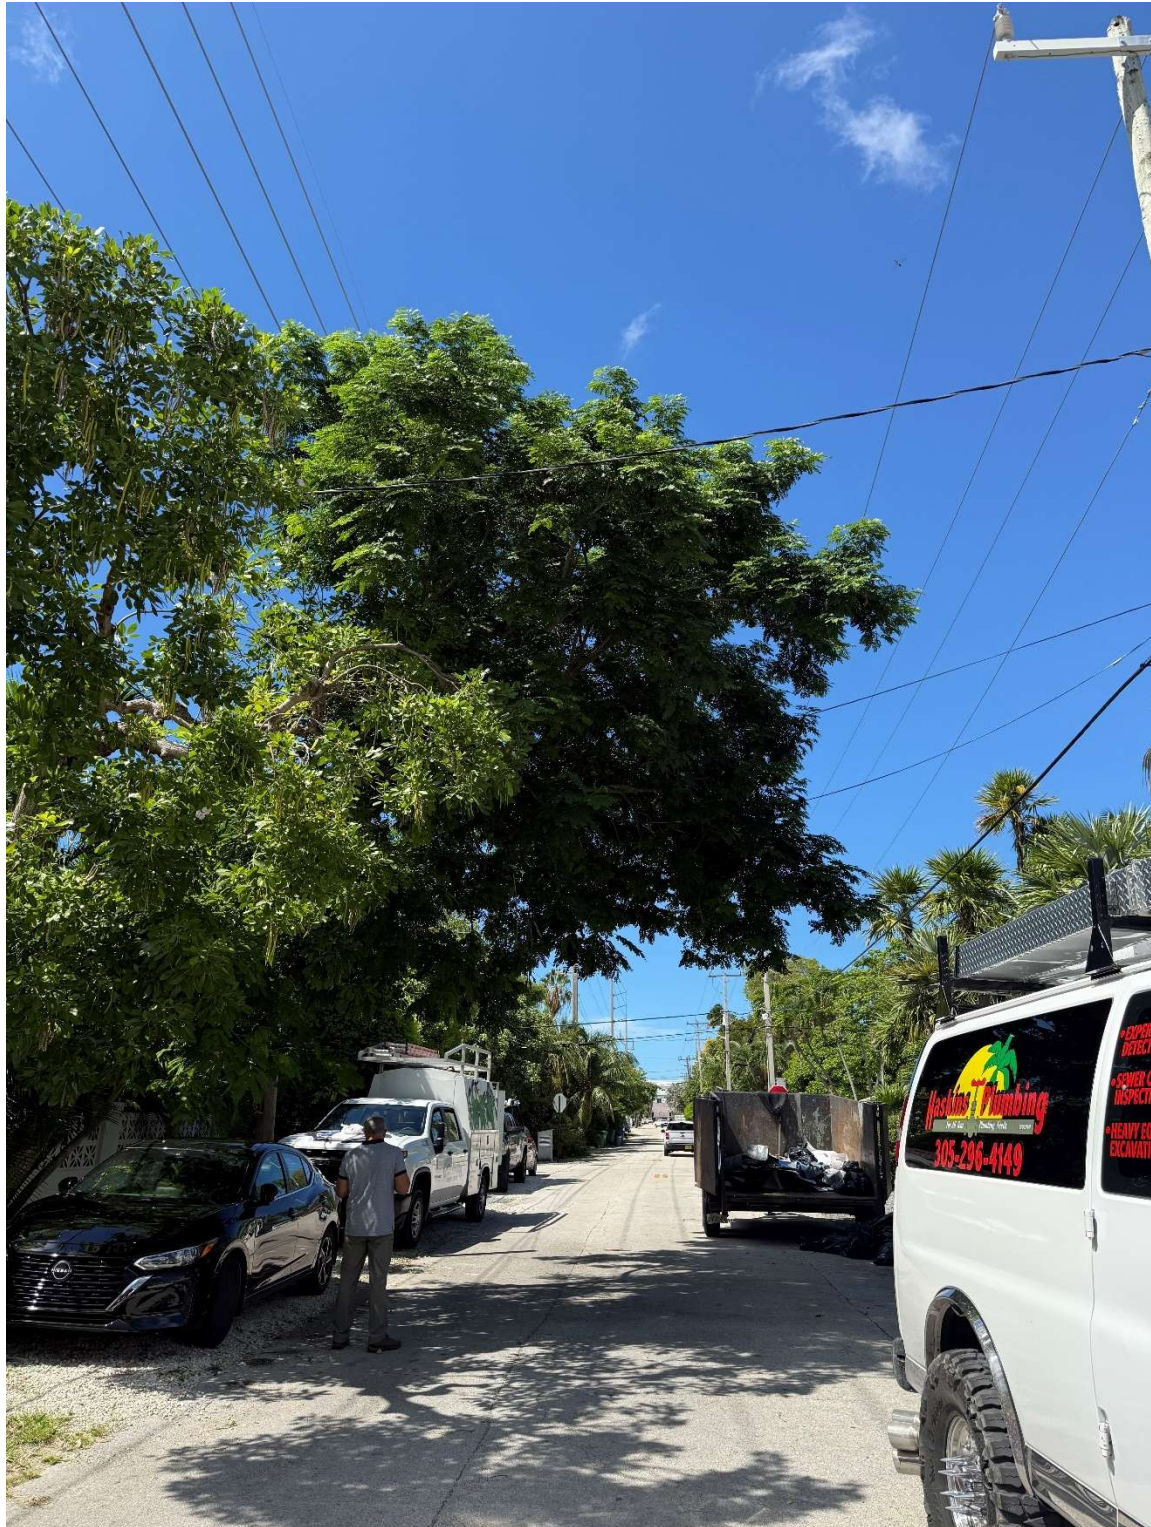
Tree's canopy is severely unbalanced.

NOTES: Due to the severely unbalanced canopy and lack of mitigation options, the tree is considered a hazard tree. This street is highly traveled by vehicles and pedestrian traffic.

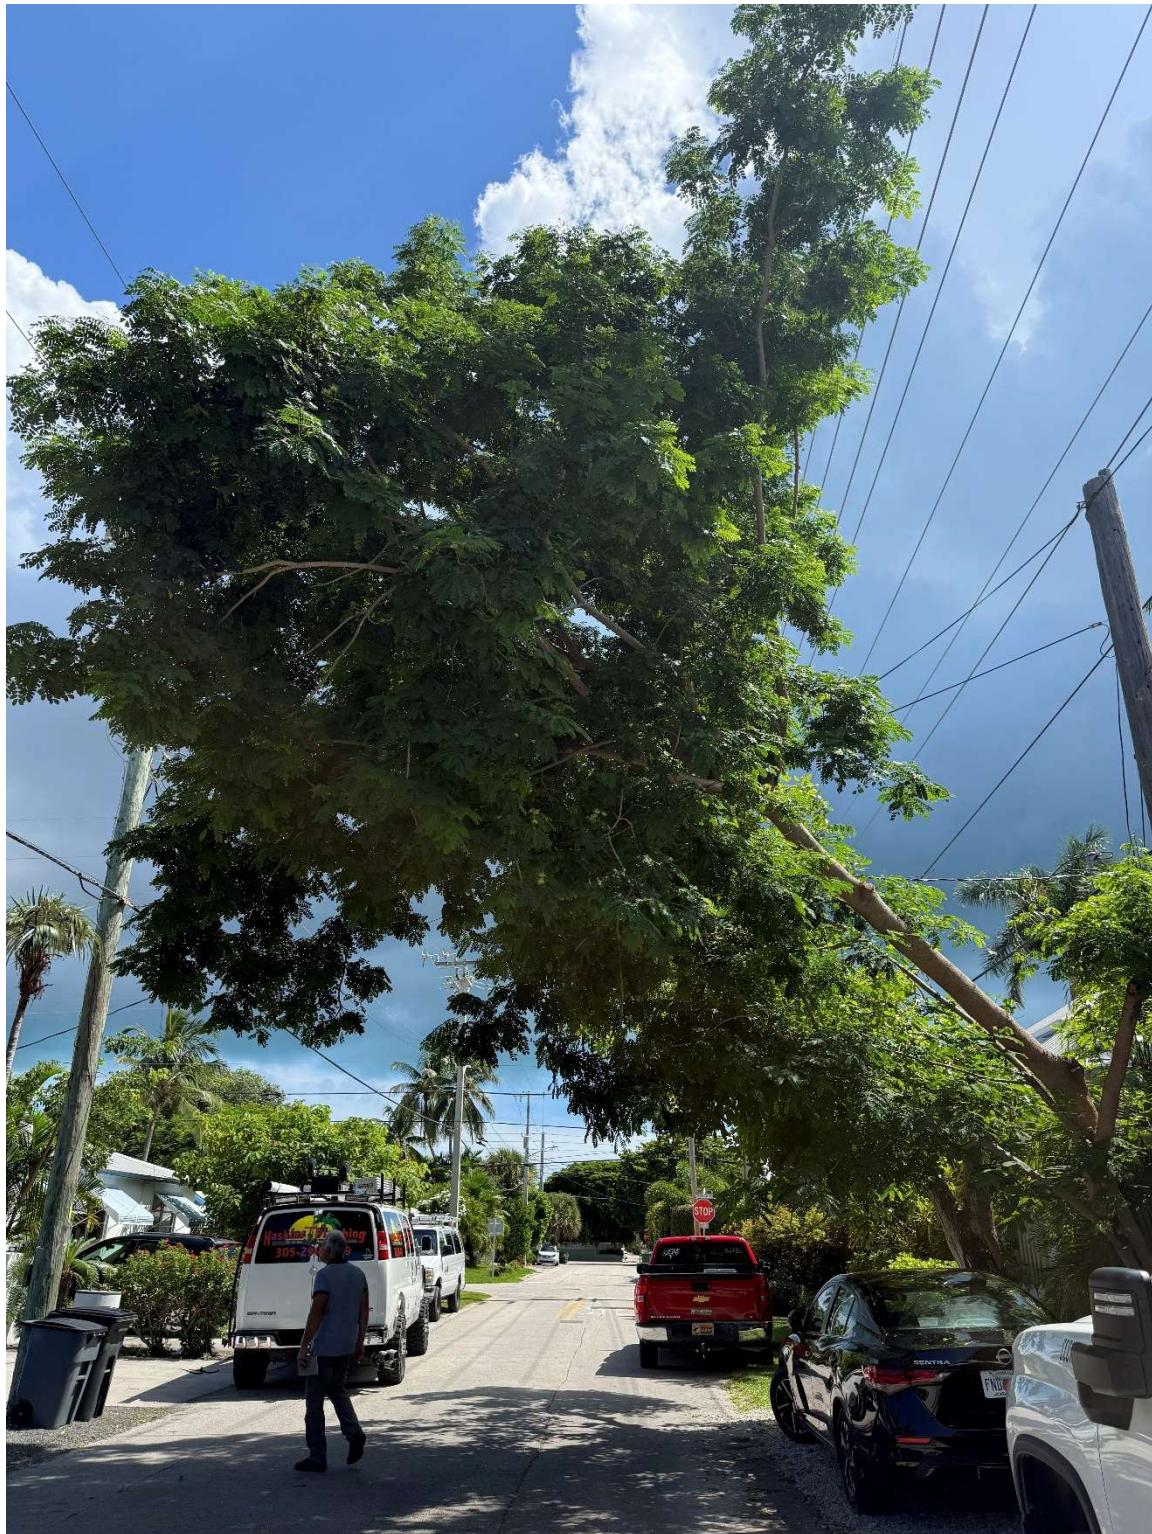
Hard pruning would reduce the risk of instability but would remove too much of the tree's canopy causing harm to the tree.
