**TREE COMMISSION TREE REMOVAL REPORT
CITY of KEY WEST**

PROPERTY: 1029 Southard St

APPLICATION NUMBER: T2025-0221

REQUEST: The applicant is requesting removal of (3) Gumbo Limbo Trees.

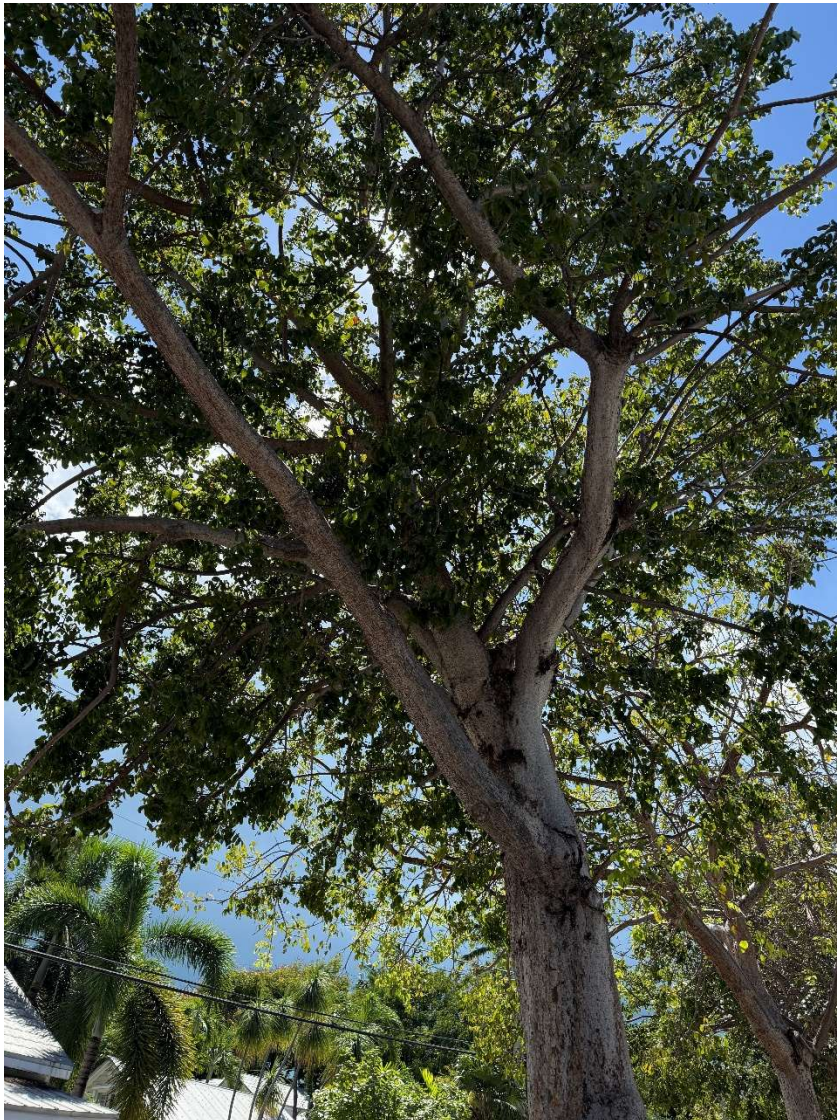
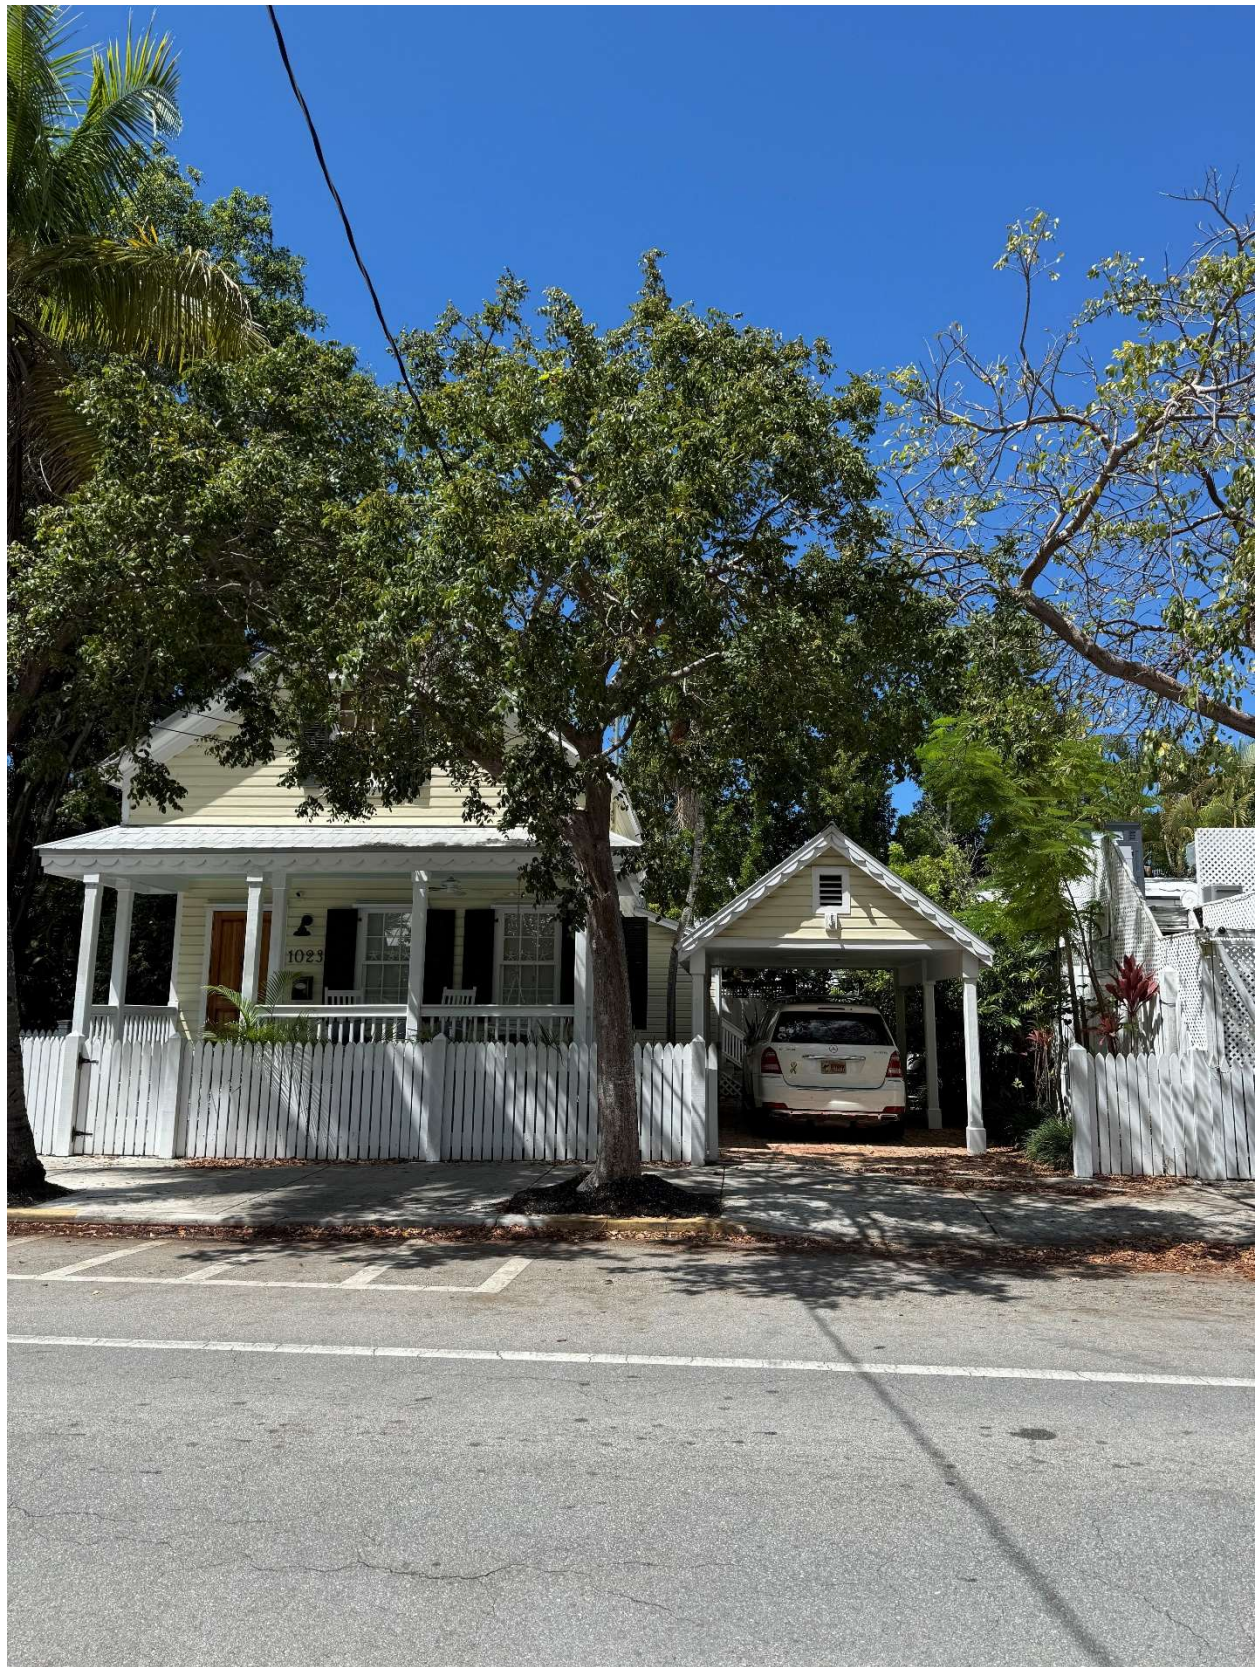
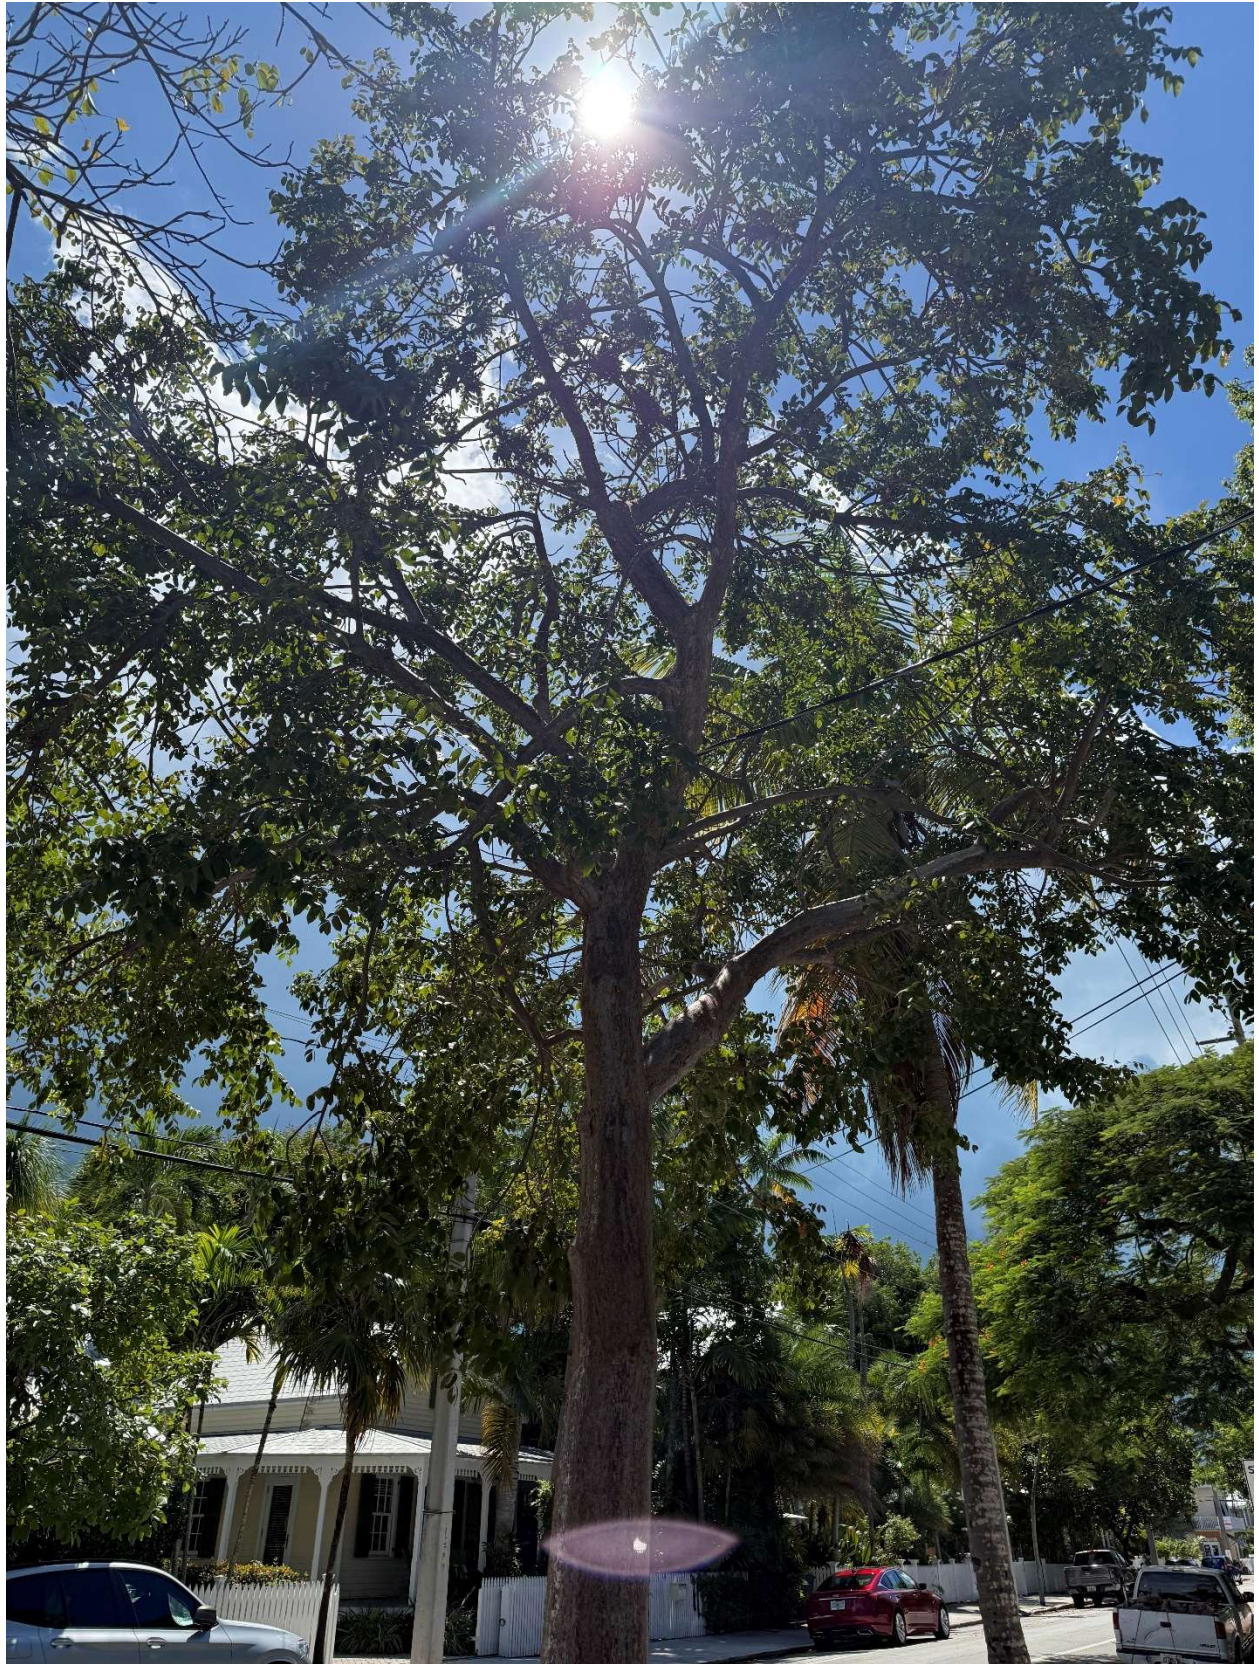
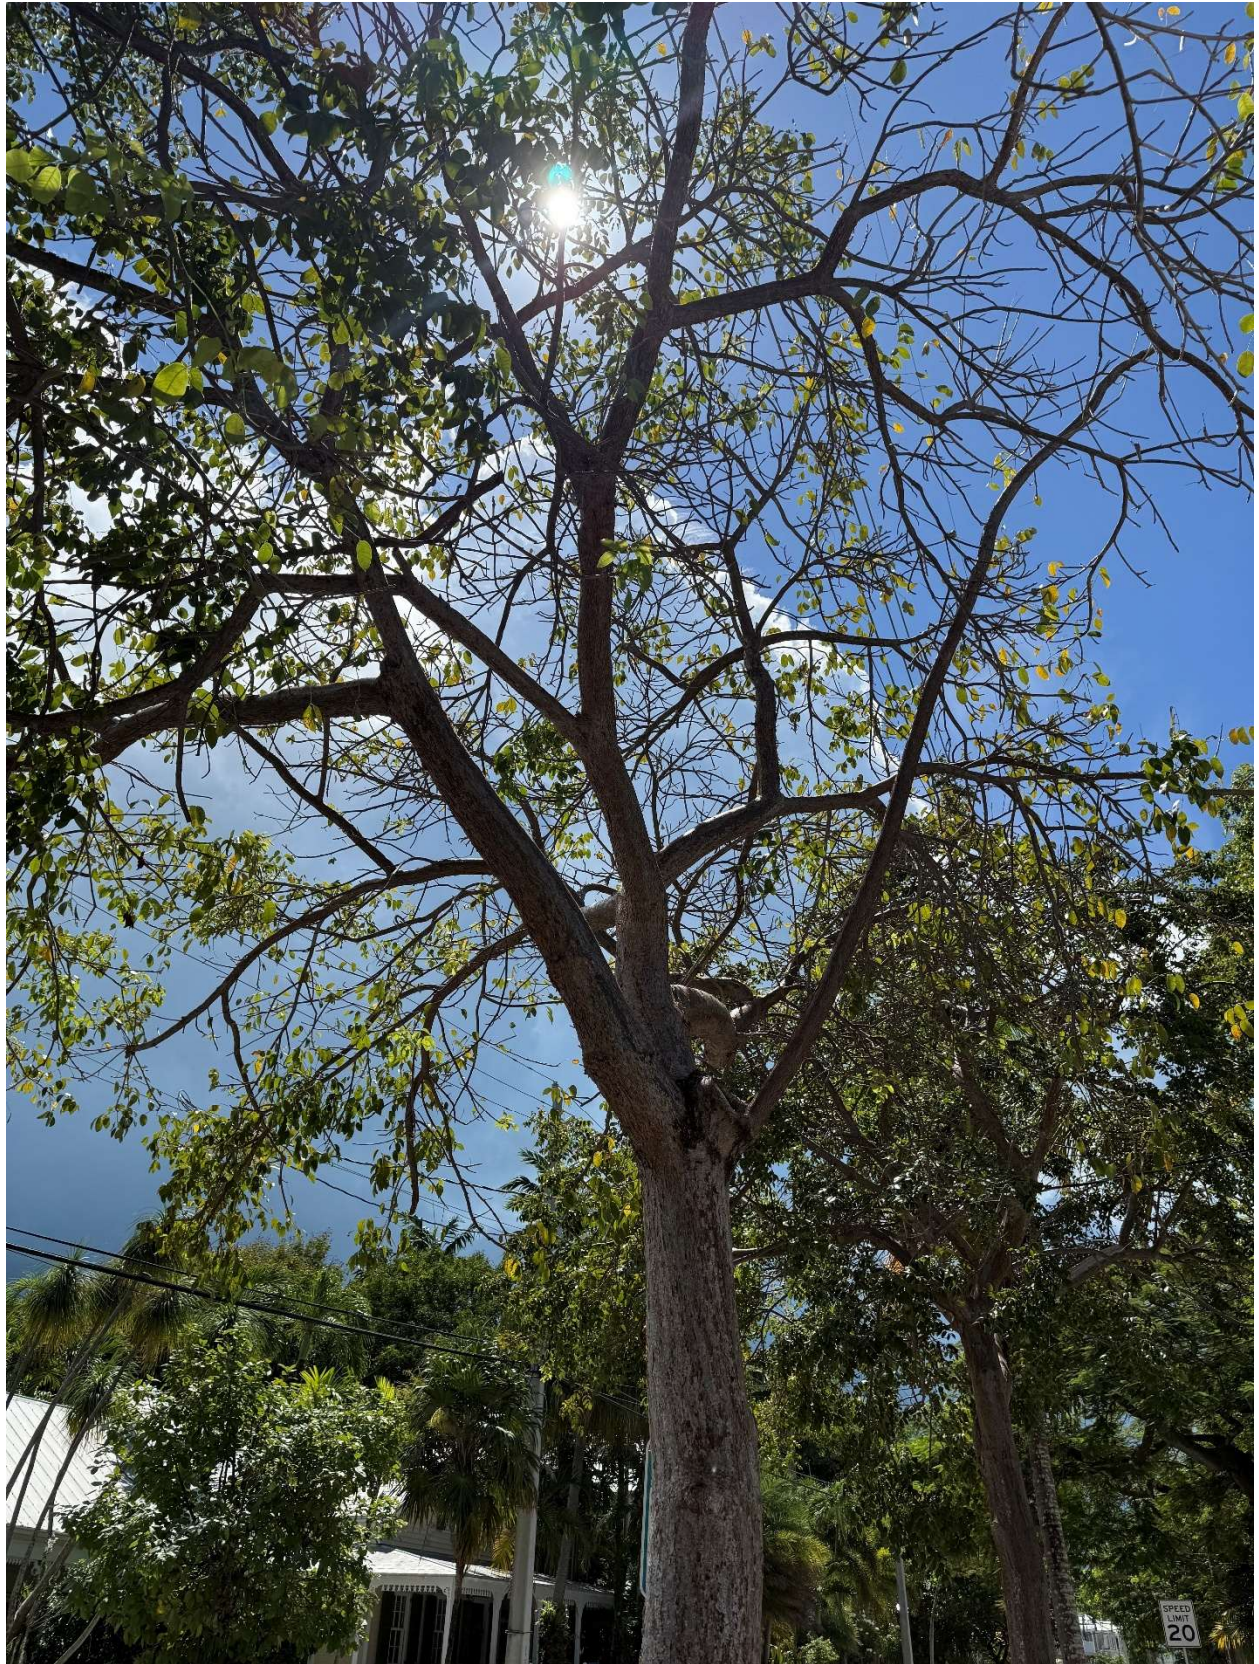
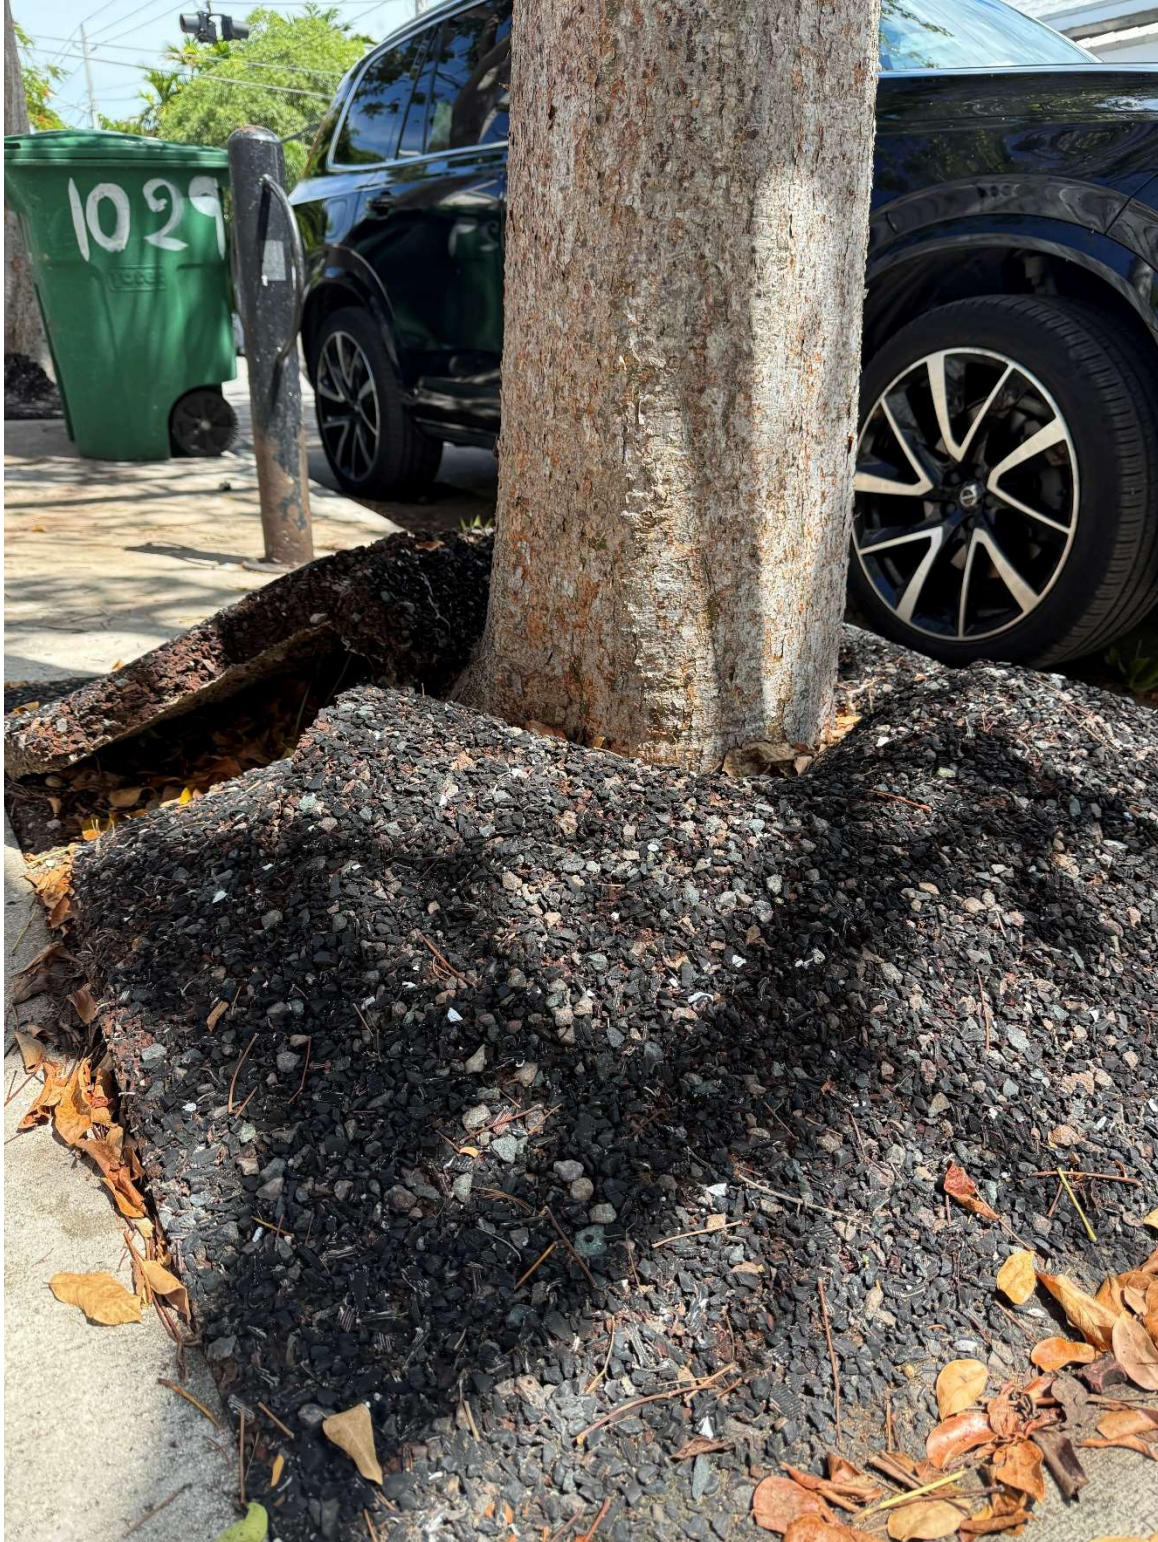
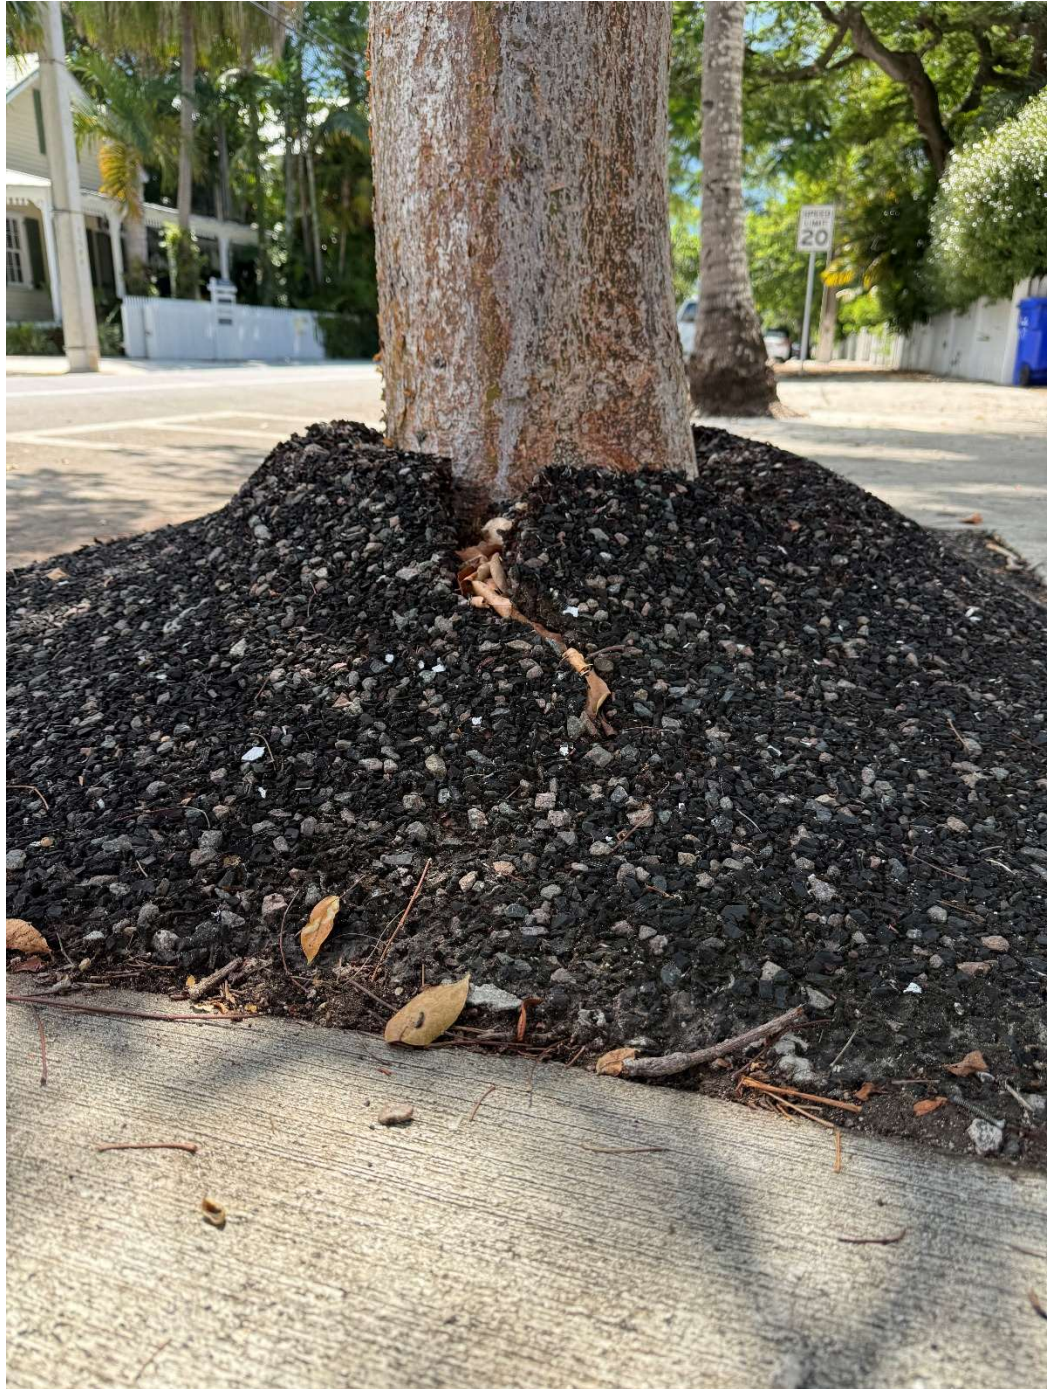
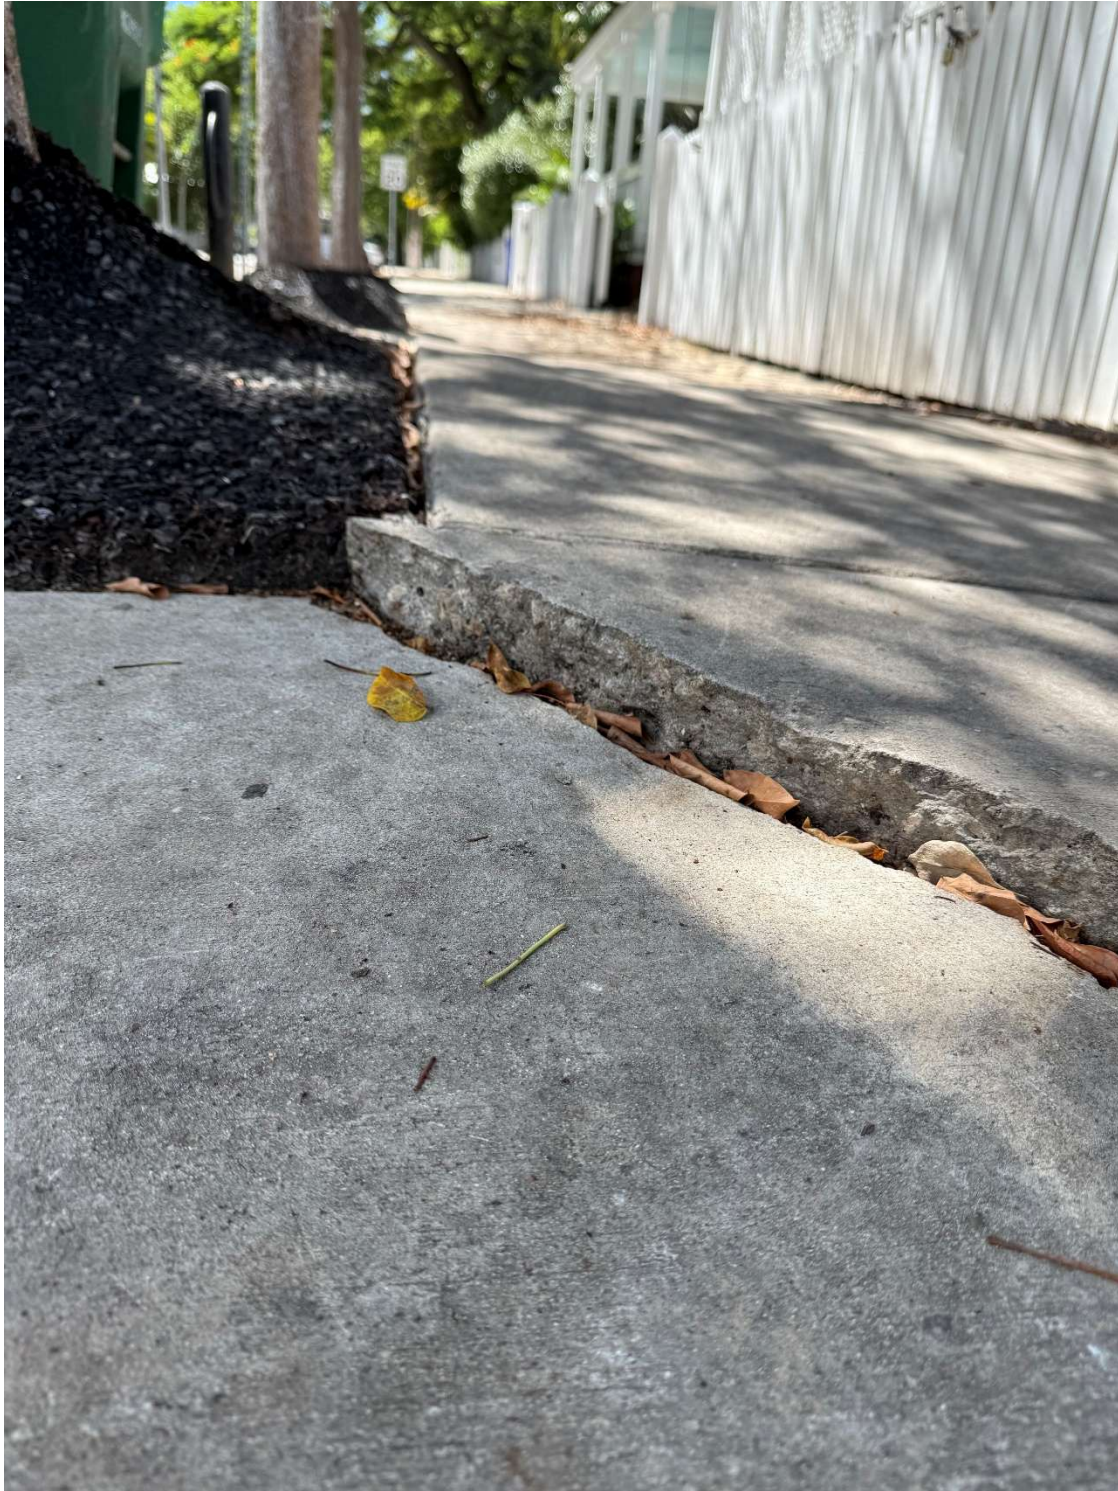
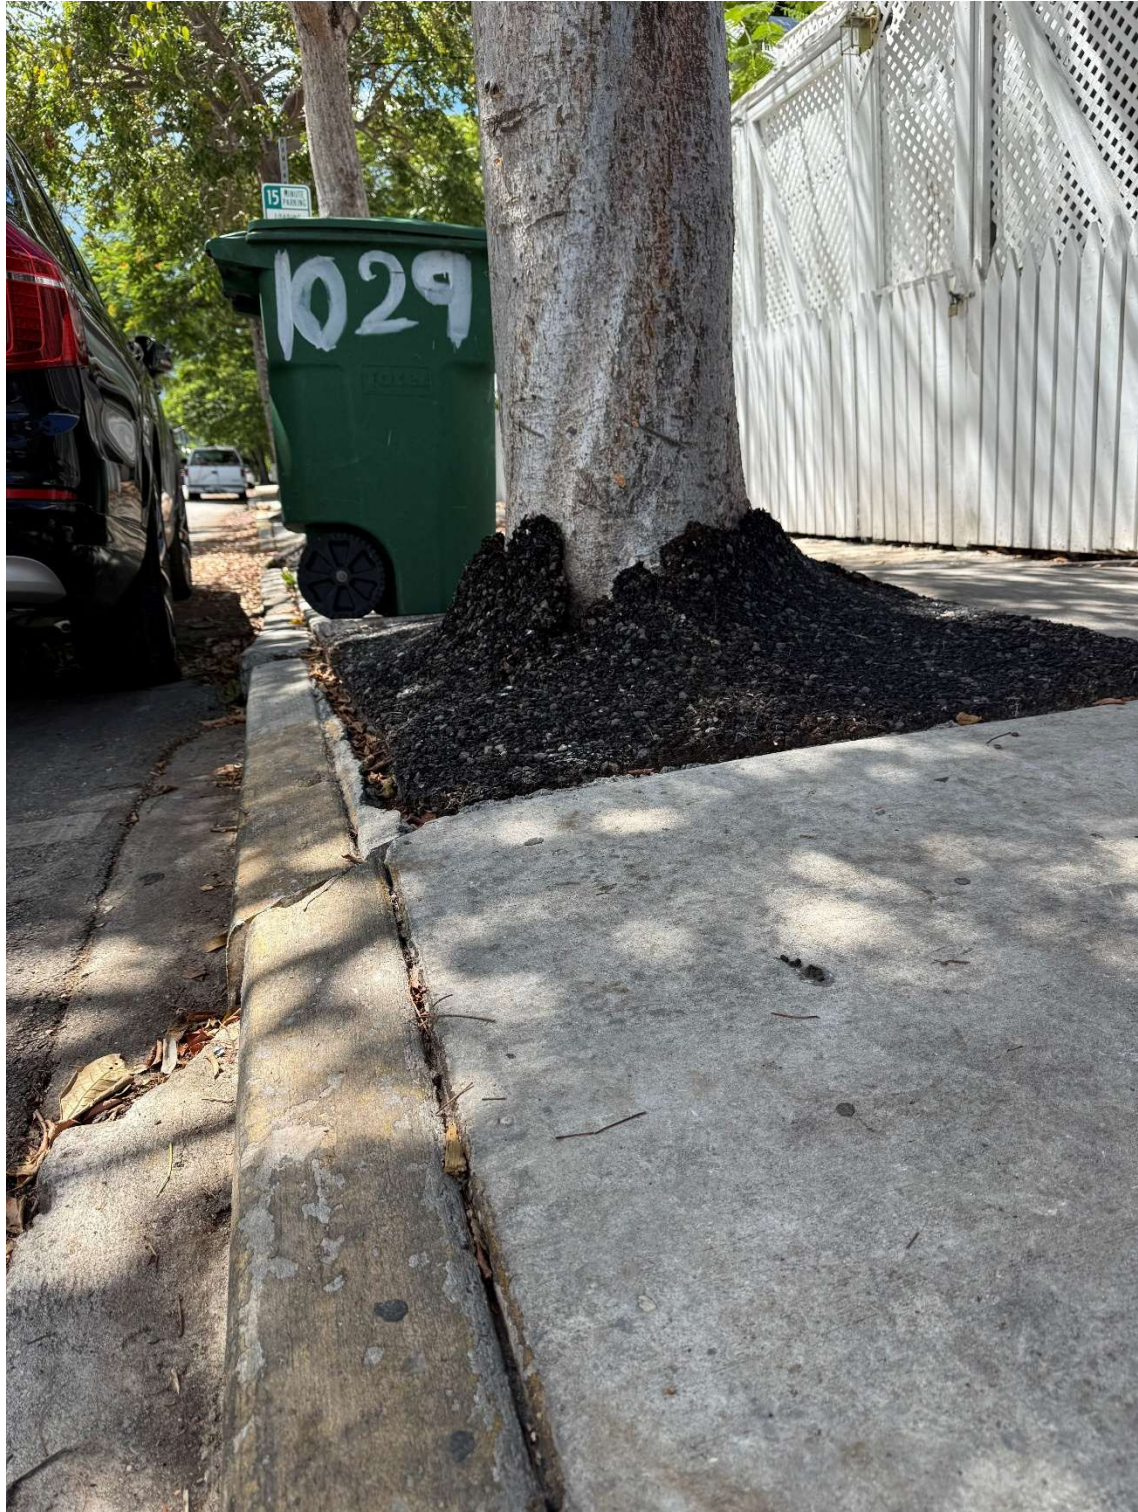
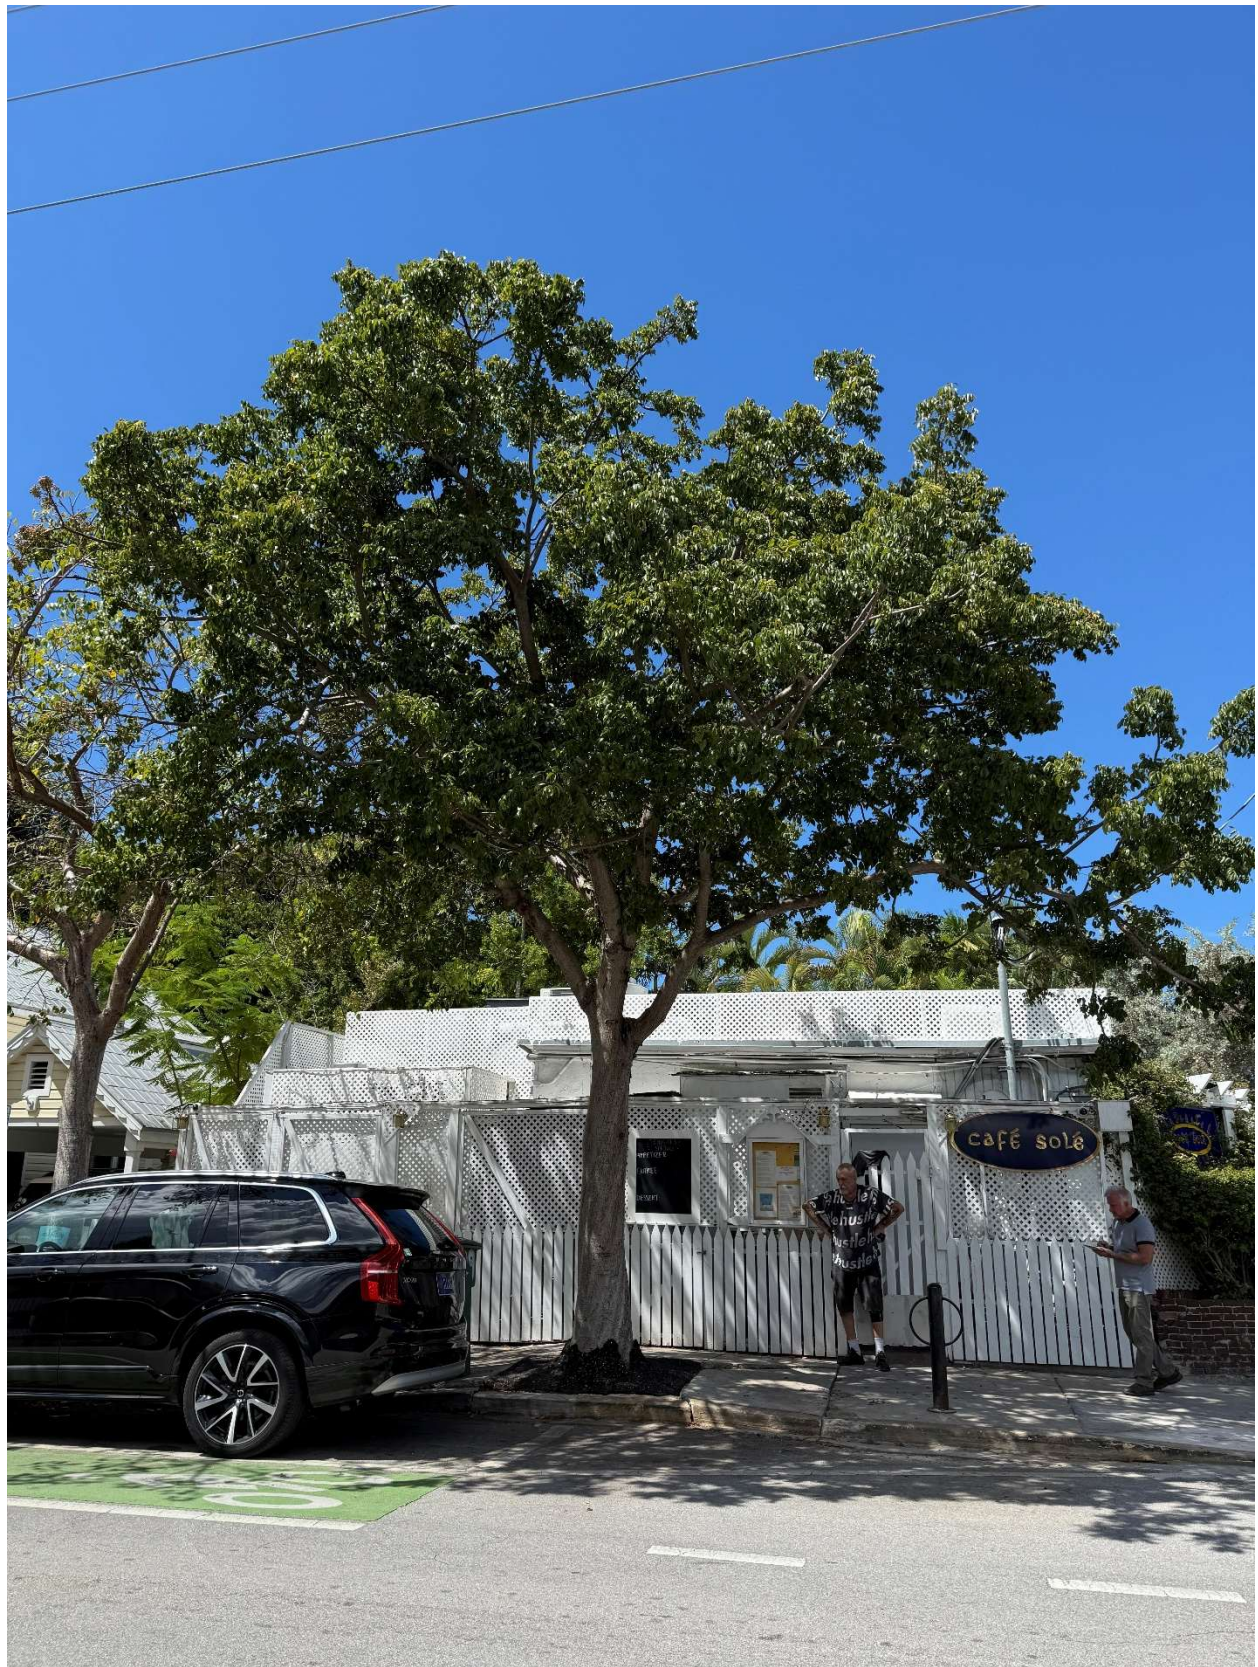
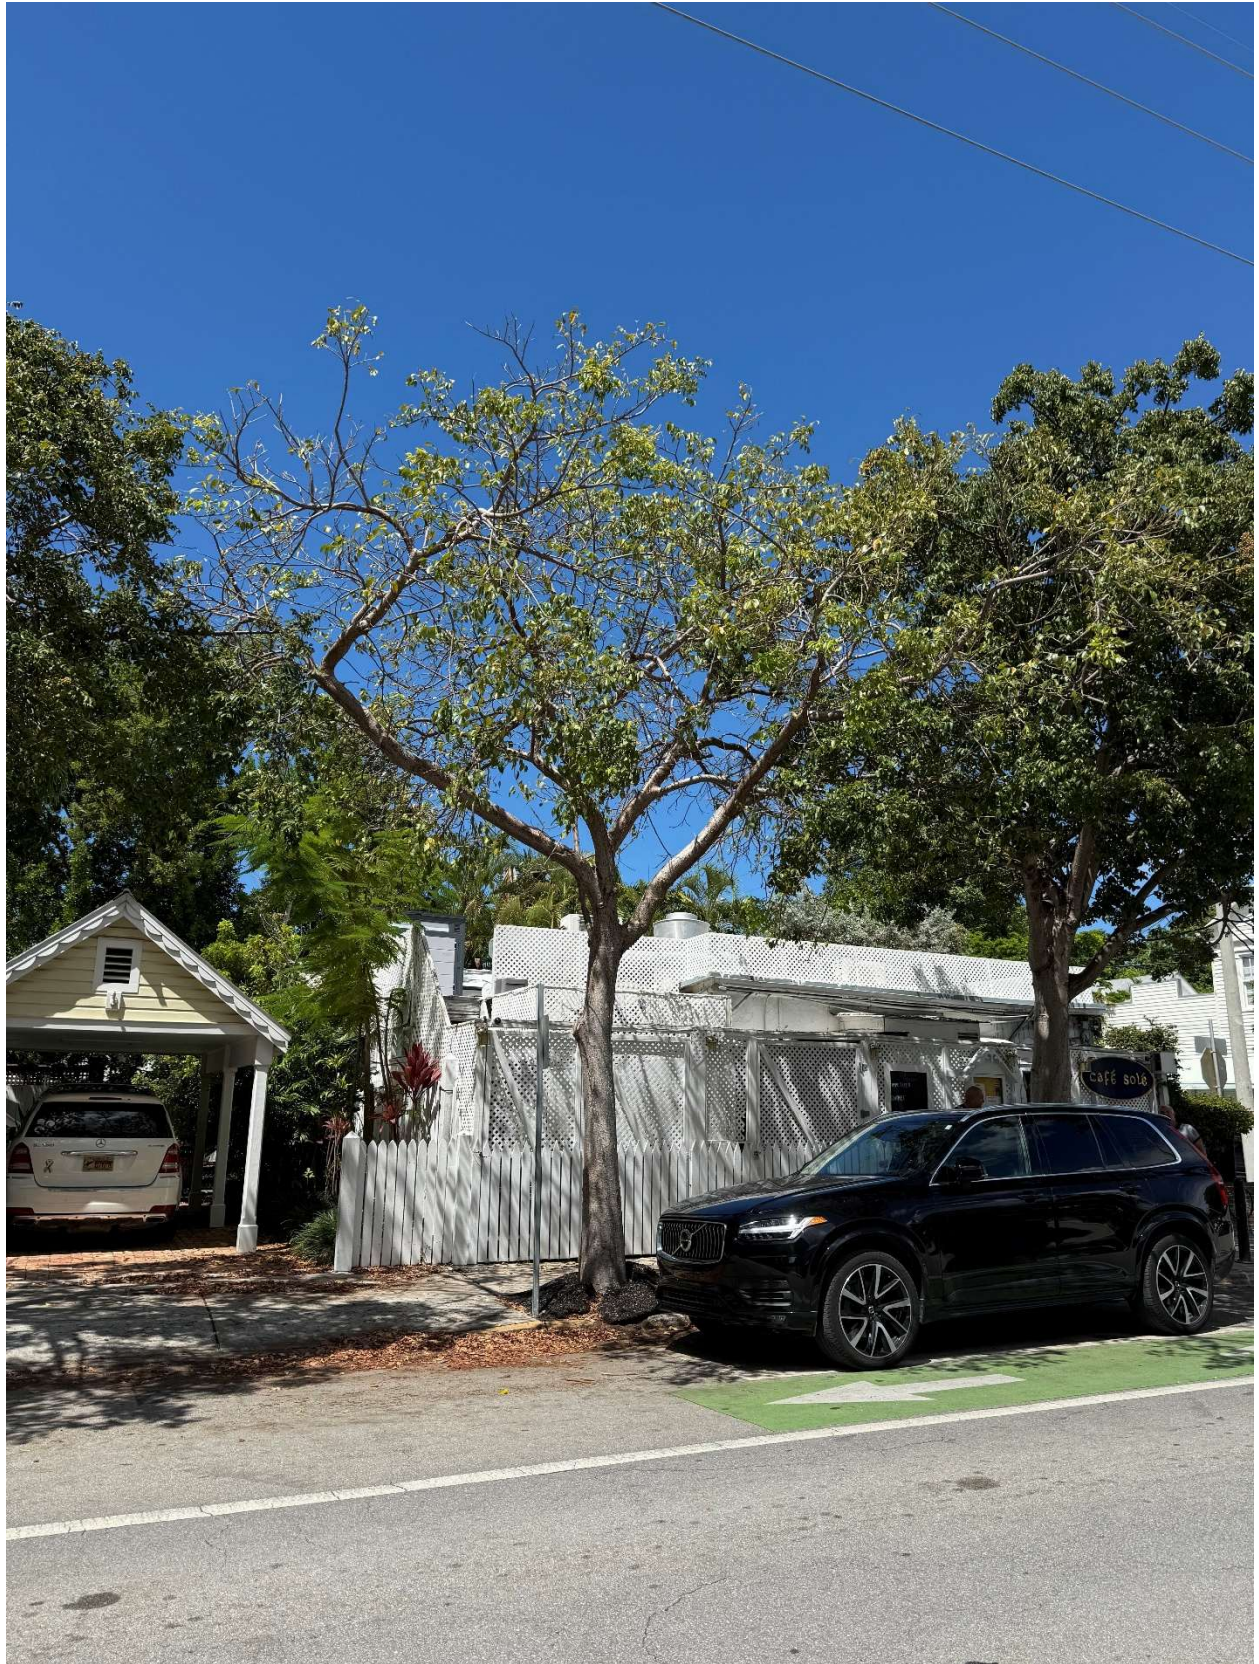
TREE ASSESSMENT and PHOTOS

Gumbo Limbo Trees are large canopy trees and have no place being planted in small ROW planters surrounded by concrete.

We were alerted to one particular tree that is causing an immediate problem. On site inspection revealed that 3 trees were all facing the same poor conditions.

NOTES: The right thing to do is to replace all 3 trees with appropriate size sub canopy trees that can live reasonably full lives and not cause sidewalk upheavals within 10 years of planting. Multiple people attested to the trees having been planted approx. 10 years ago. 2 of 3 trees are in poor health due to severe root compaction. The one with a fair canopy is destroying the sidewalk and curb.

Recommended Mitigation: Replace all 3 Gumbo Limbo Trees with an appropriate tree for each of the 3 planters.
