# **Additional Information**

**From:** John Calleja <jfckwf@gmail.com>  
**Sent:** Thursday, March 3, 2022 8:16 PM  
**To:** Karen DeMaria  
**Cc:** John Hartman  
**Subject:** [EXTERNAL] Re: Tree removal request-1404 Petronia

**From:** John Calleja <jfckwf@gmail.com>  
**Sent:** Thursday, March 3, 2022 8:19 PM  
**To:** Karen DeMaria  
**Cc:** John Hartman  
**Subject:** [EXTERNAL] Gumbo Limbo 1404 Petronia St, A

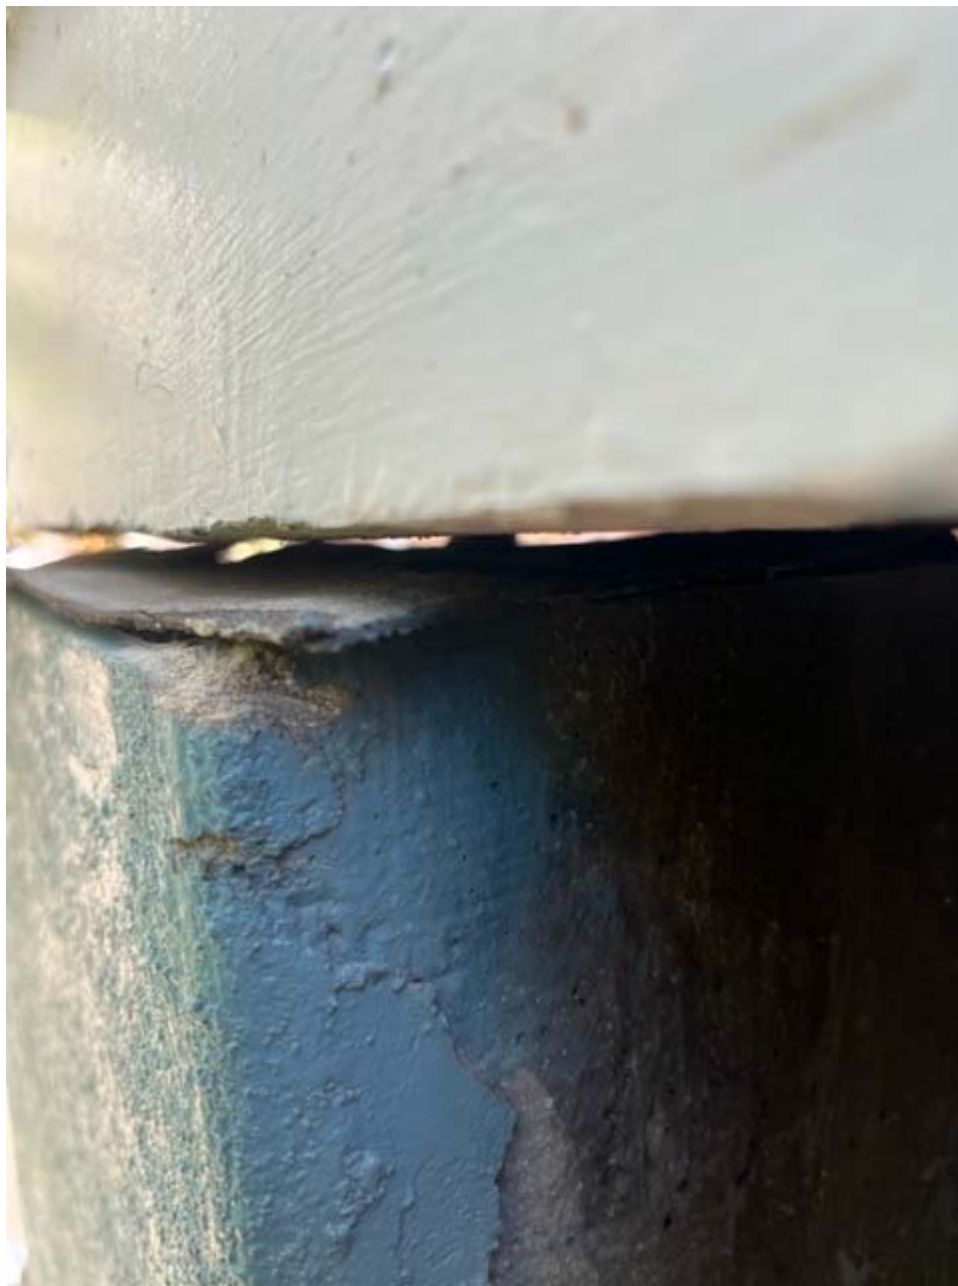
**Date:** 3 March 2022 at 14:13:17 GMT-5  
**Subject:** A

This shows the degree of lifting of the house off its support column. You can note the light coming through from the far side of the column, indicating that it has been lifted completely off the column, essentially floating on air.

At present, it is raised 3/4 inch, and progressing.

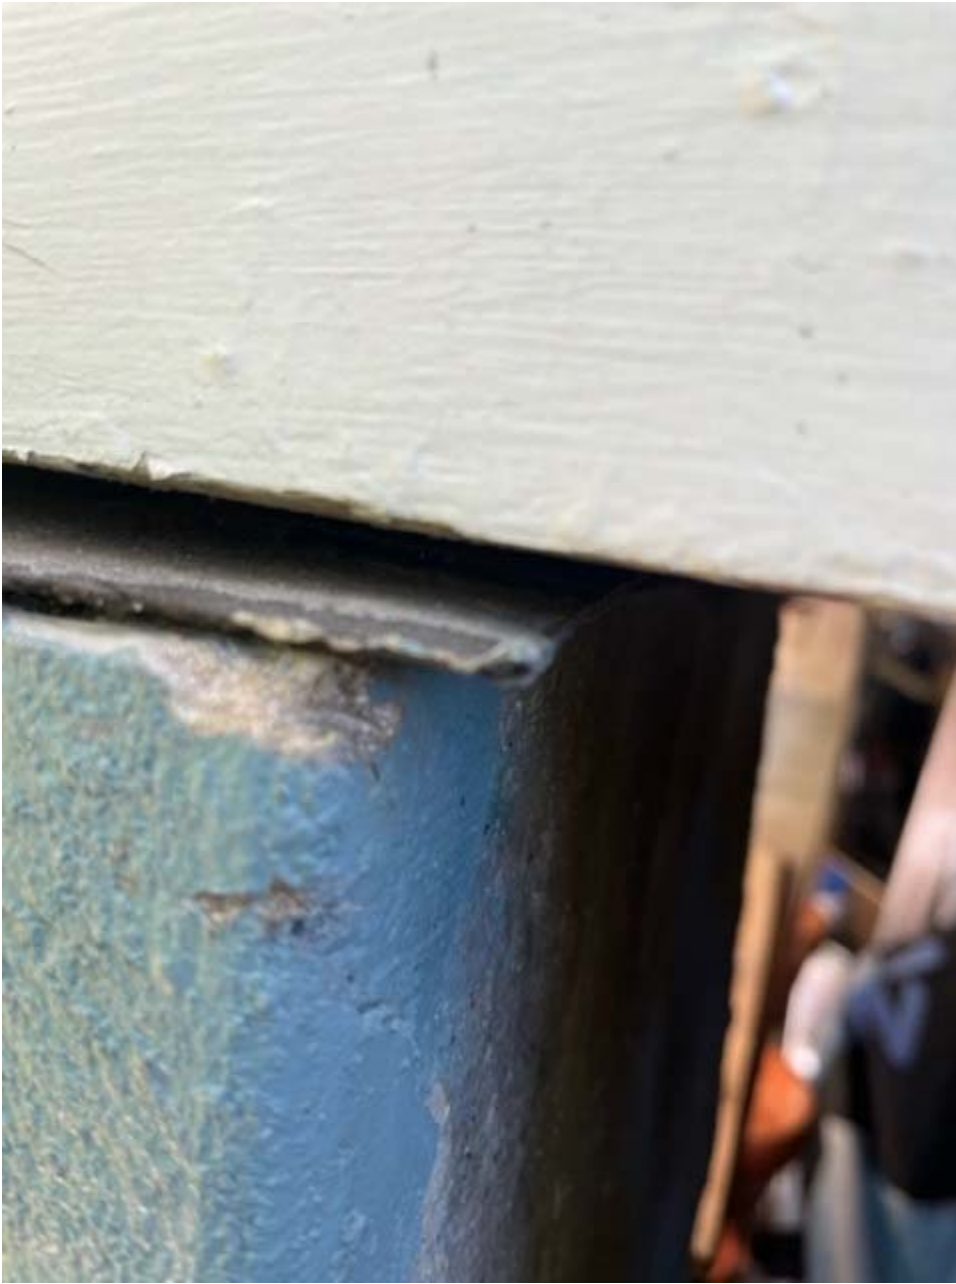
**Date:** 3 March 2022 at 14:13:30 GMT-5  
**Subject:** B

Another view showing the degree to which the house is raised.

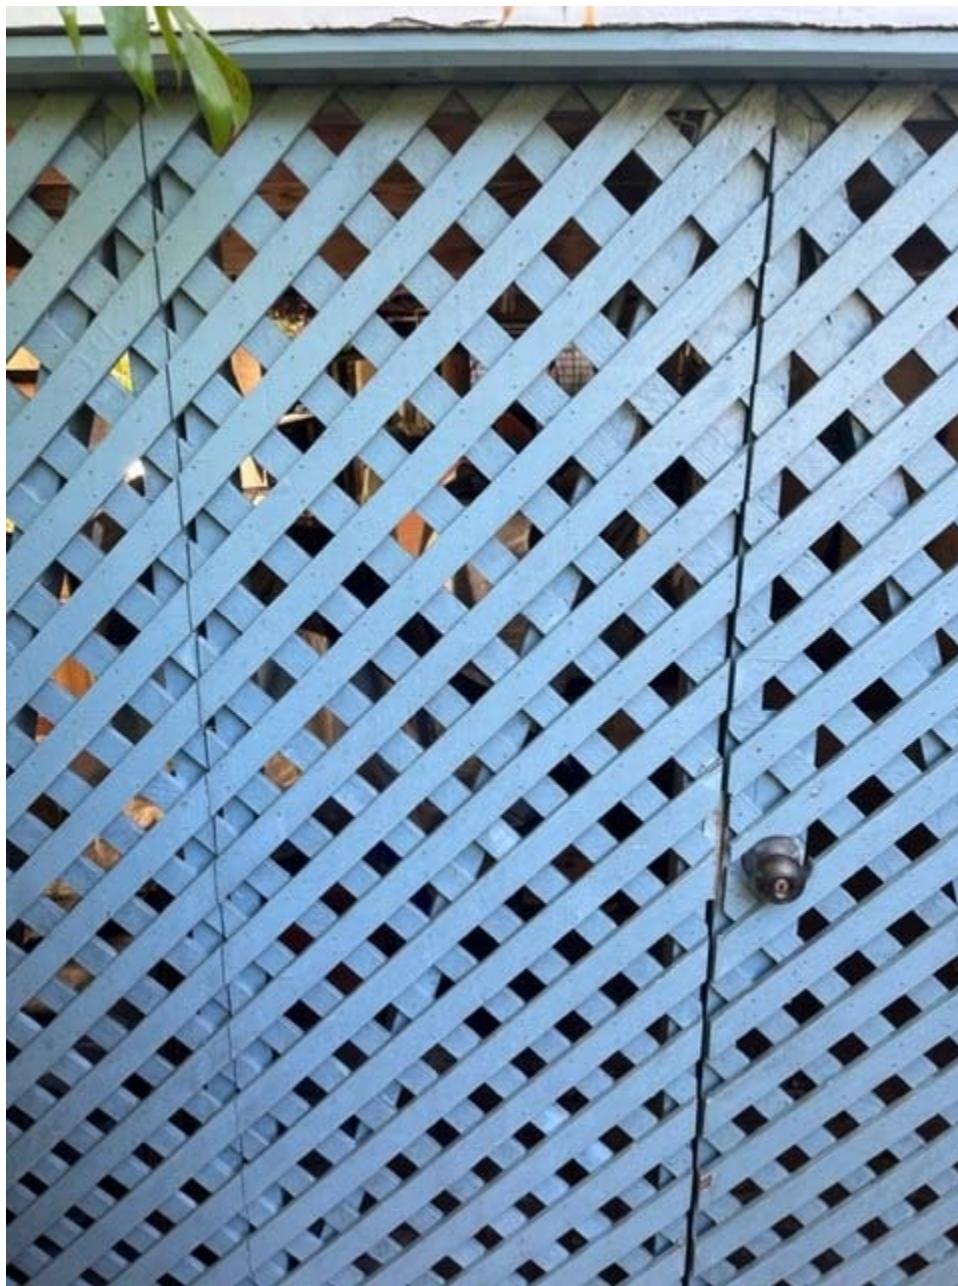
**Subject:** C

This double gate is just to the right of the raised corner. The left door is now jammed against the frame and cannot be opened. Over the years, I have repeatedly had to shave the door or reposition the hinges to maintain function, but the degree to which the house is raised now would require a significant reconstruction of the gate panels to correct the problem.
