Subject: [EXTERNAL] Goble 1406 South / T2023-0140

Subject: [EXTERNAL] Termite Damage letter from Jesus Montes / T2023-0140

City of Key West Tree Commission

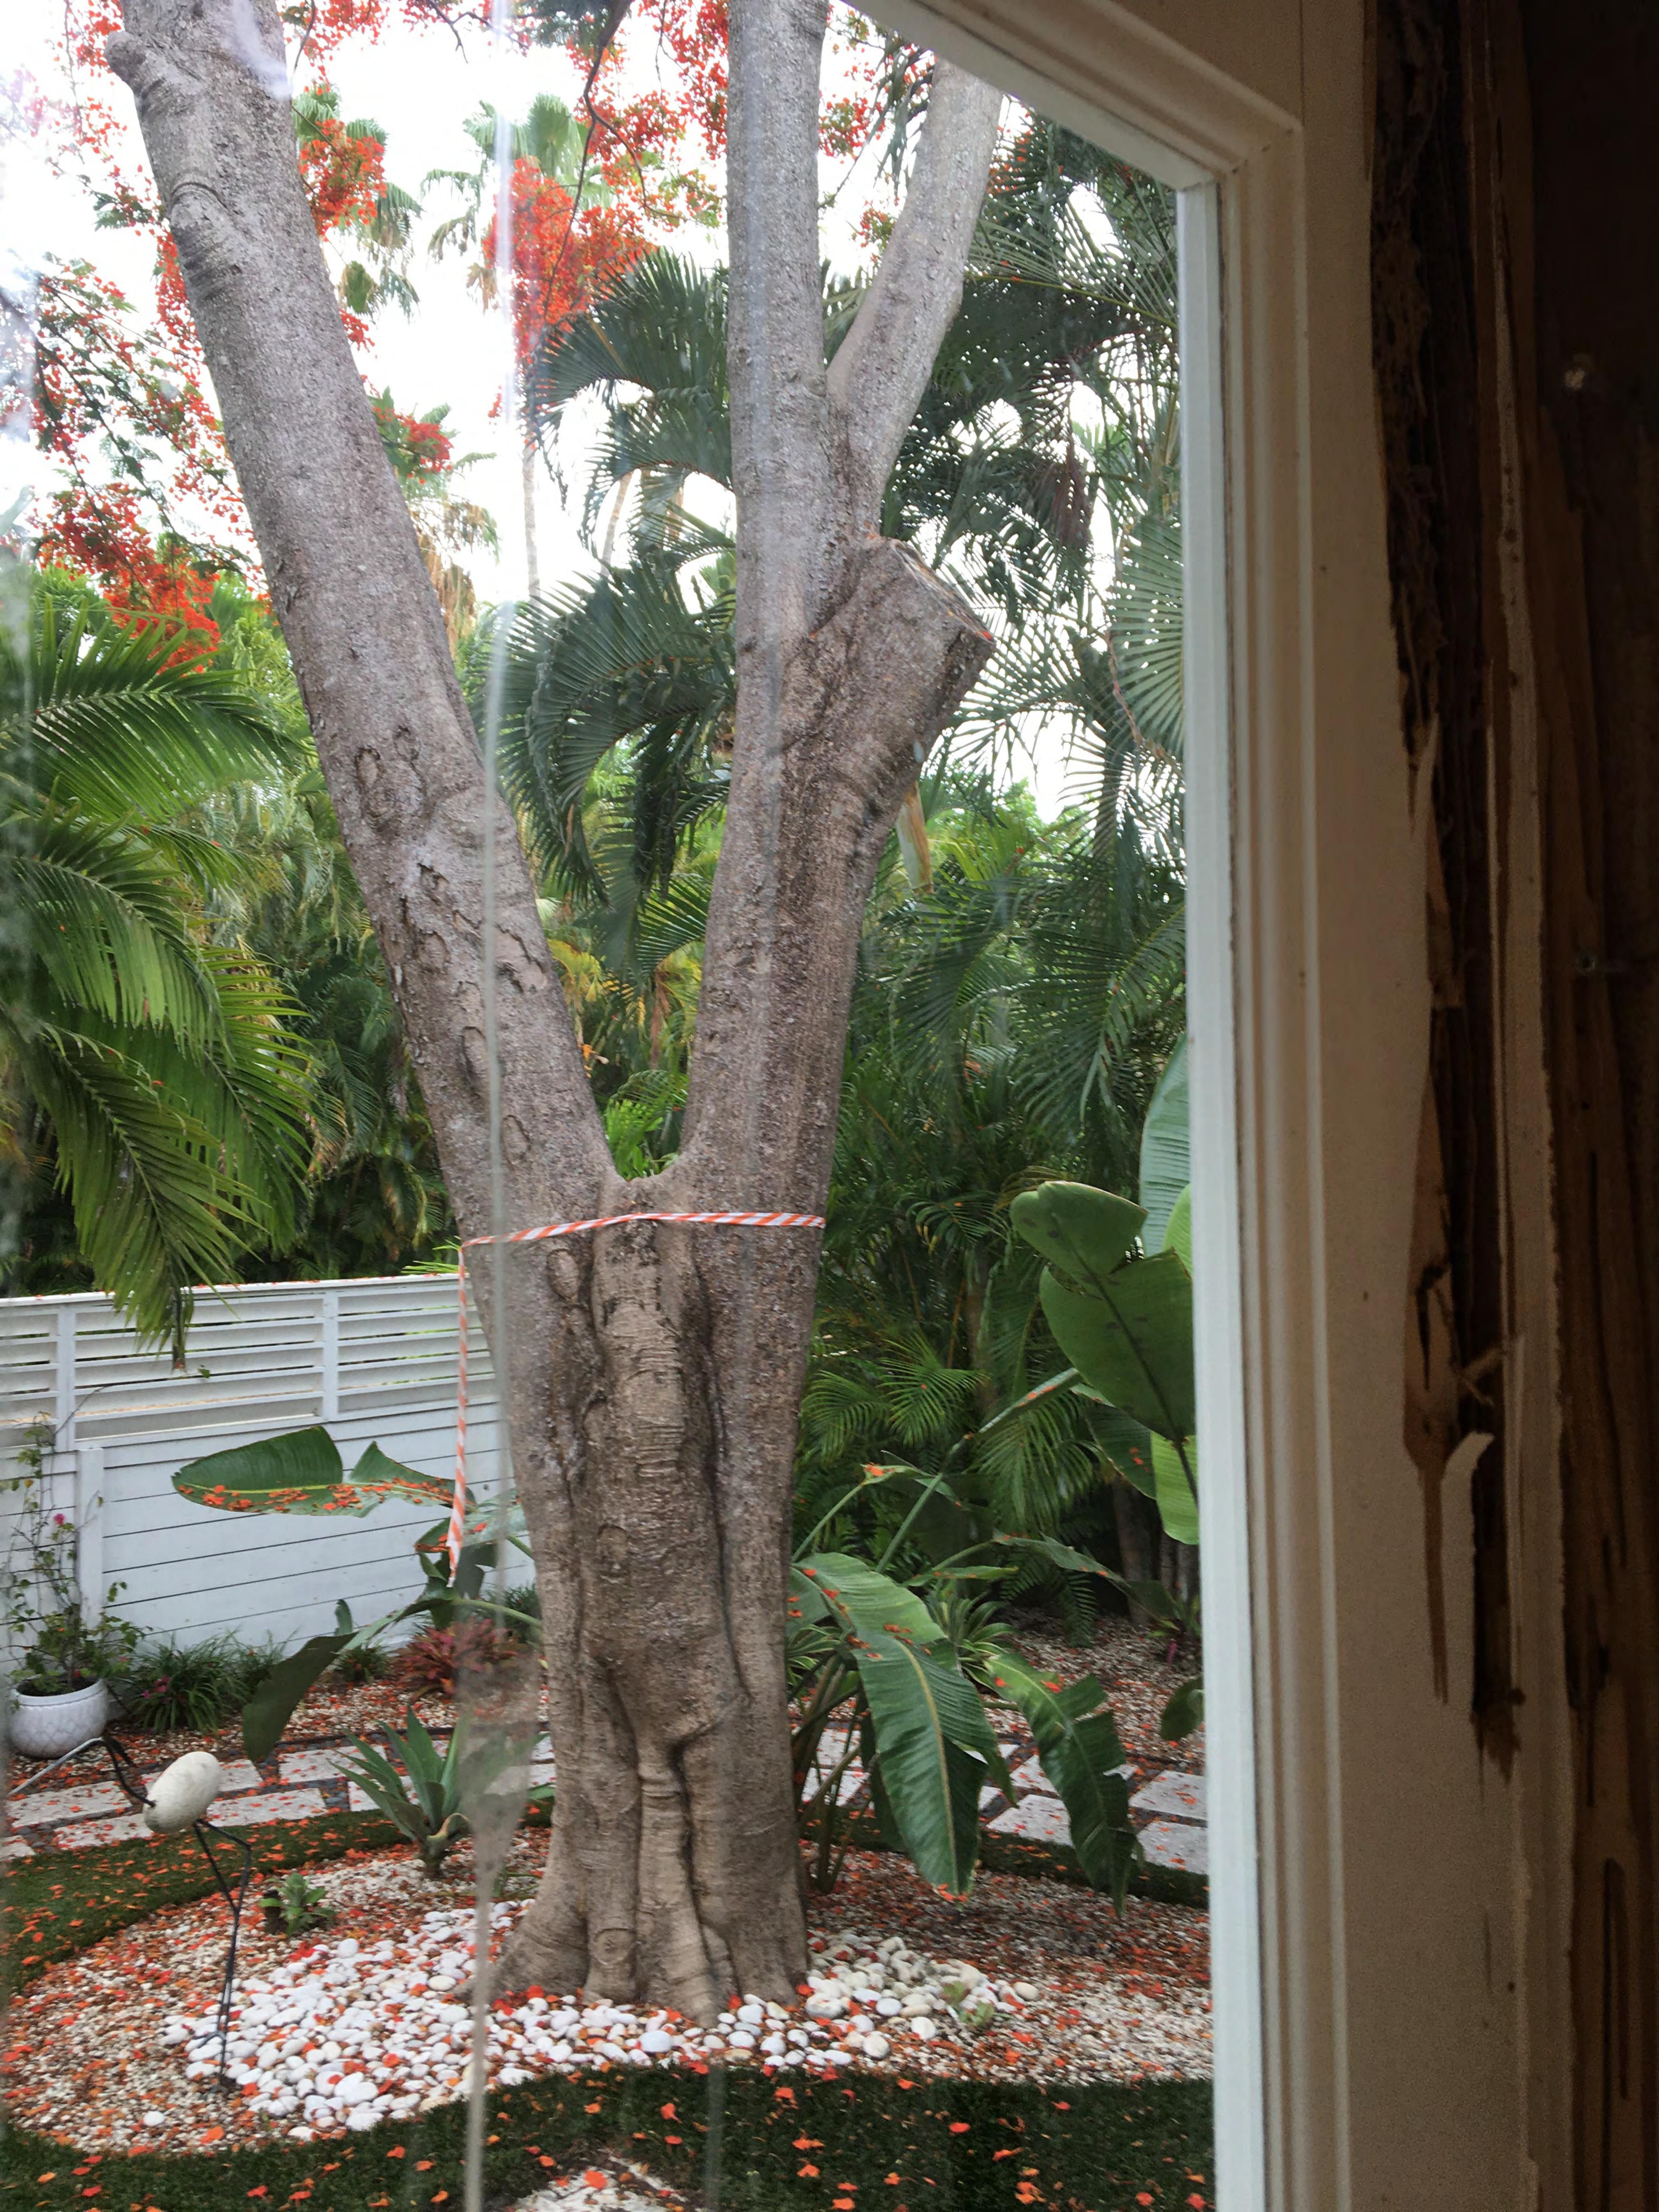
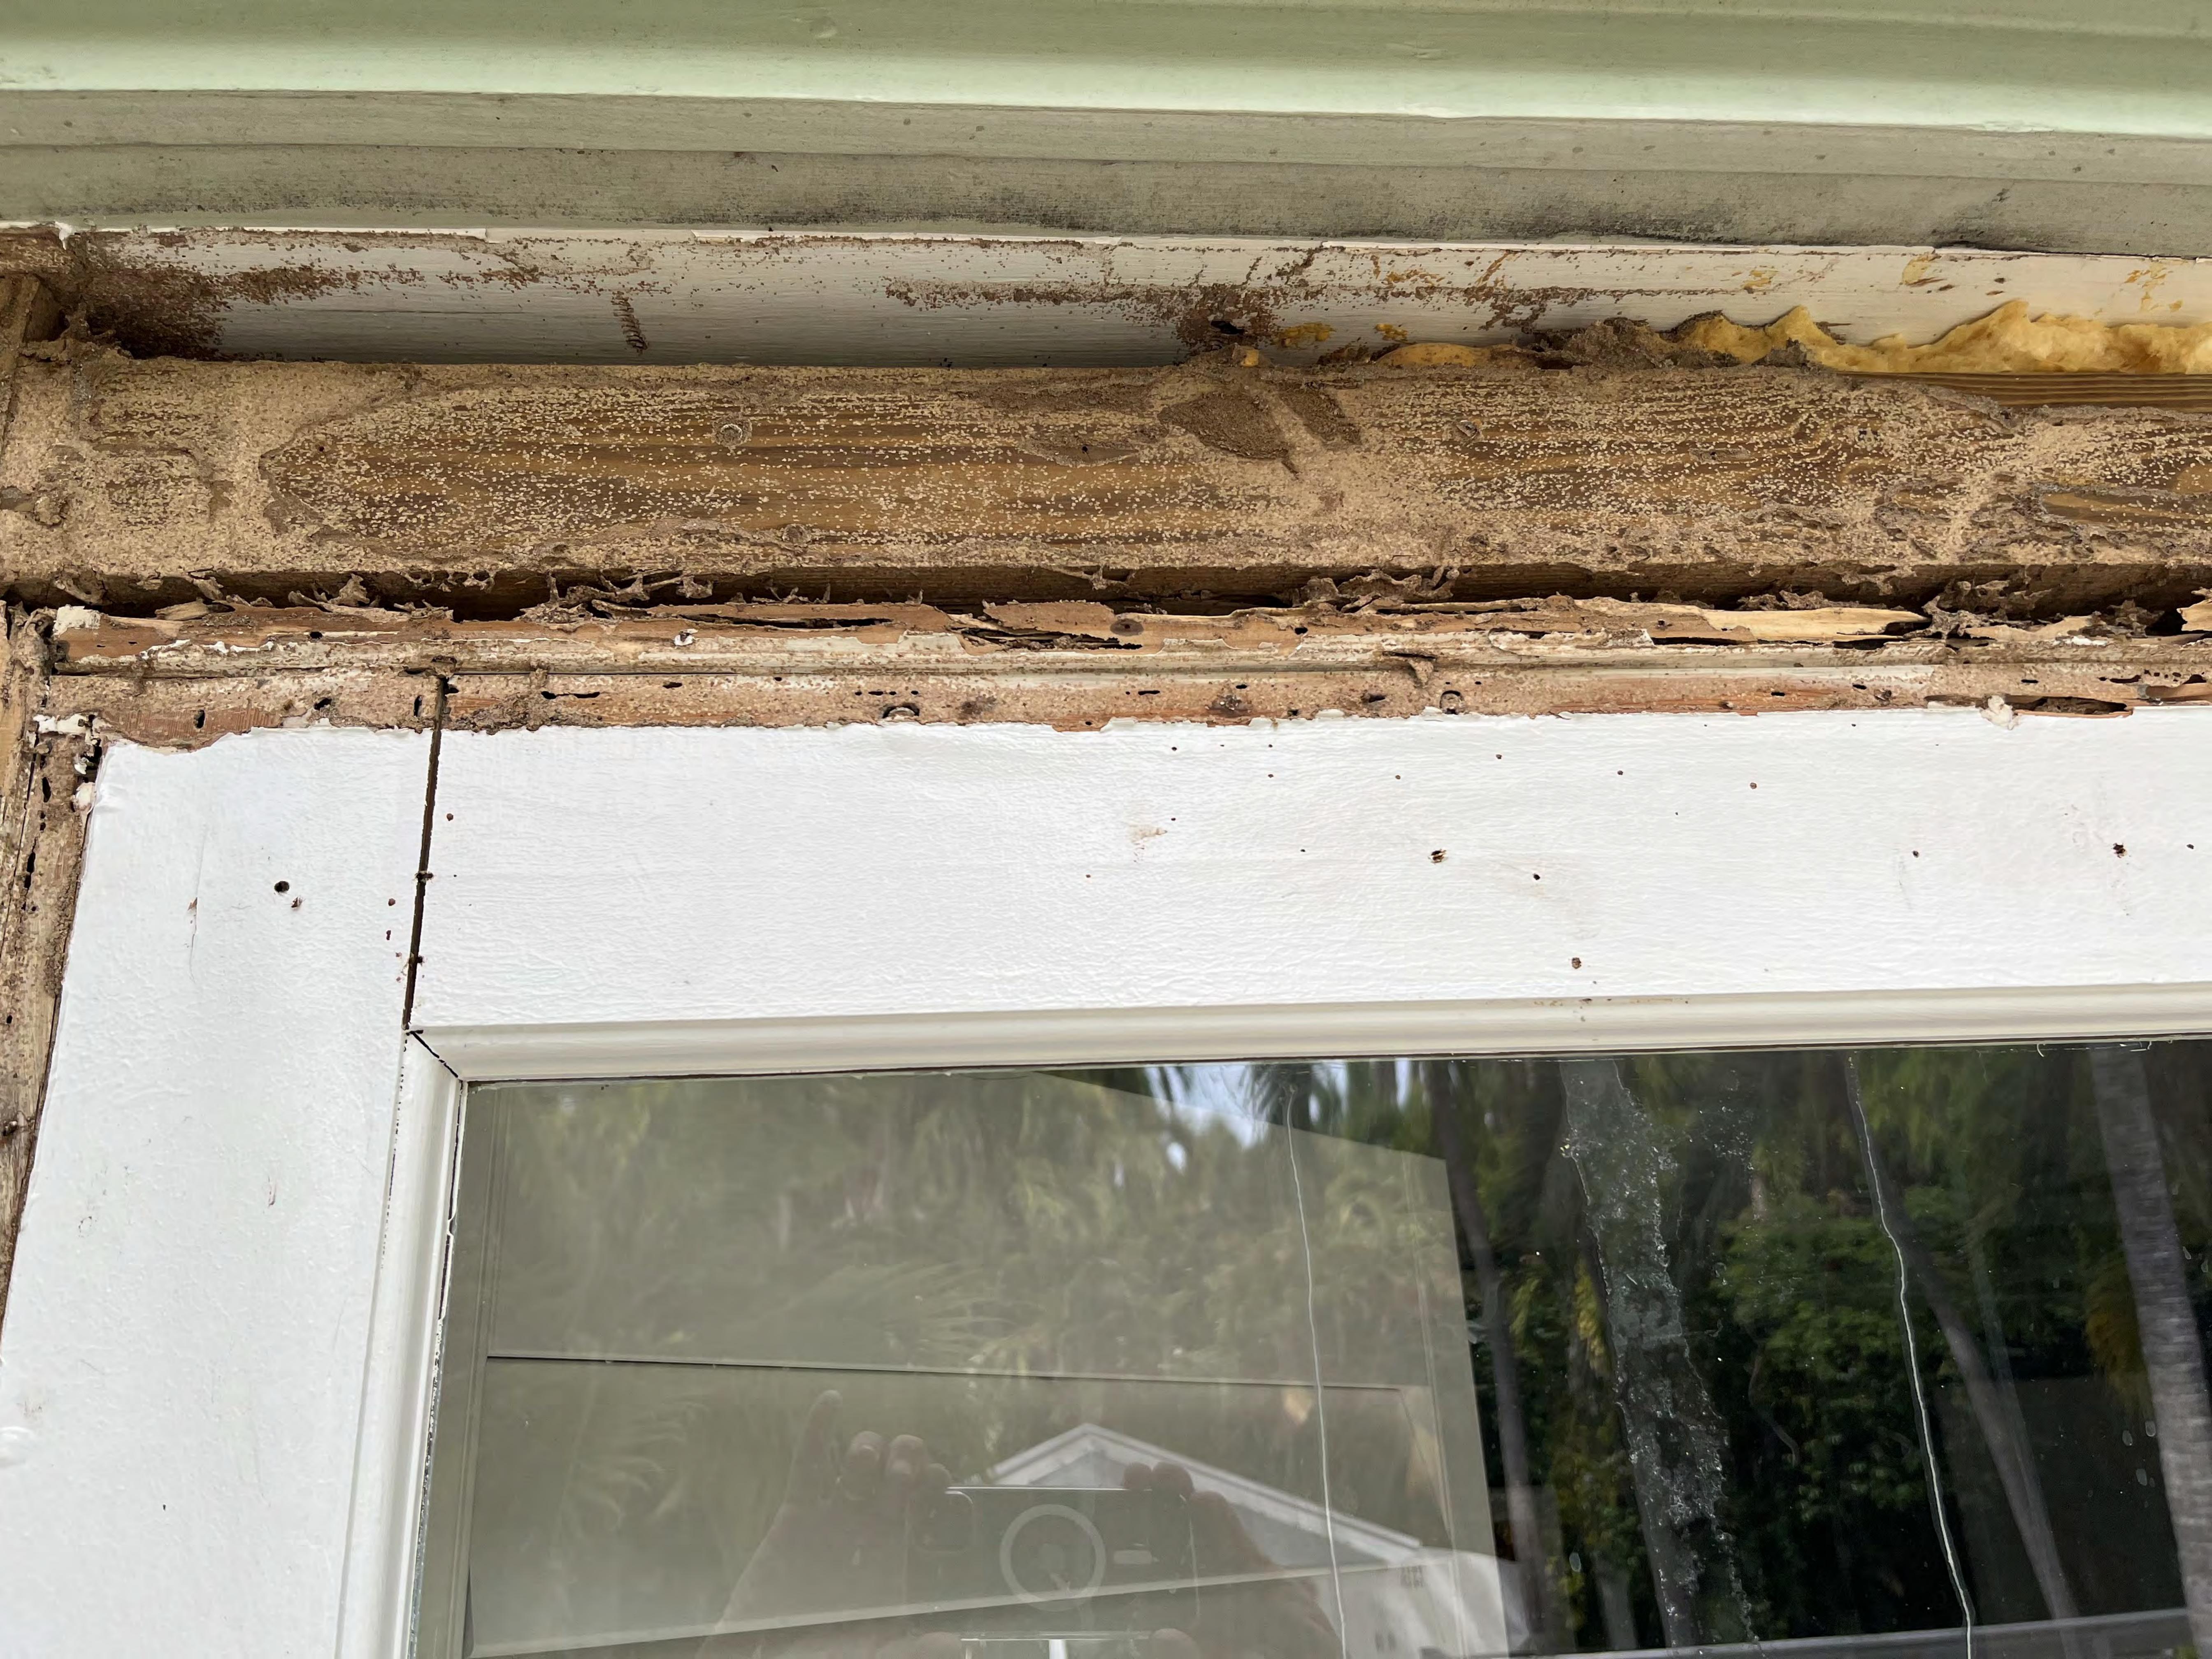
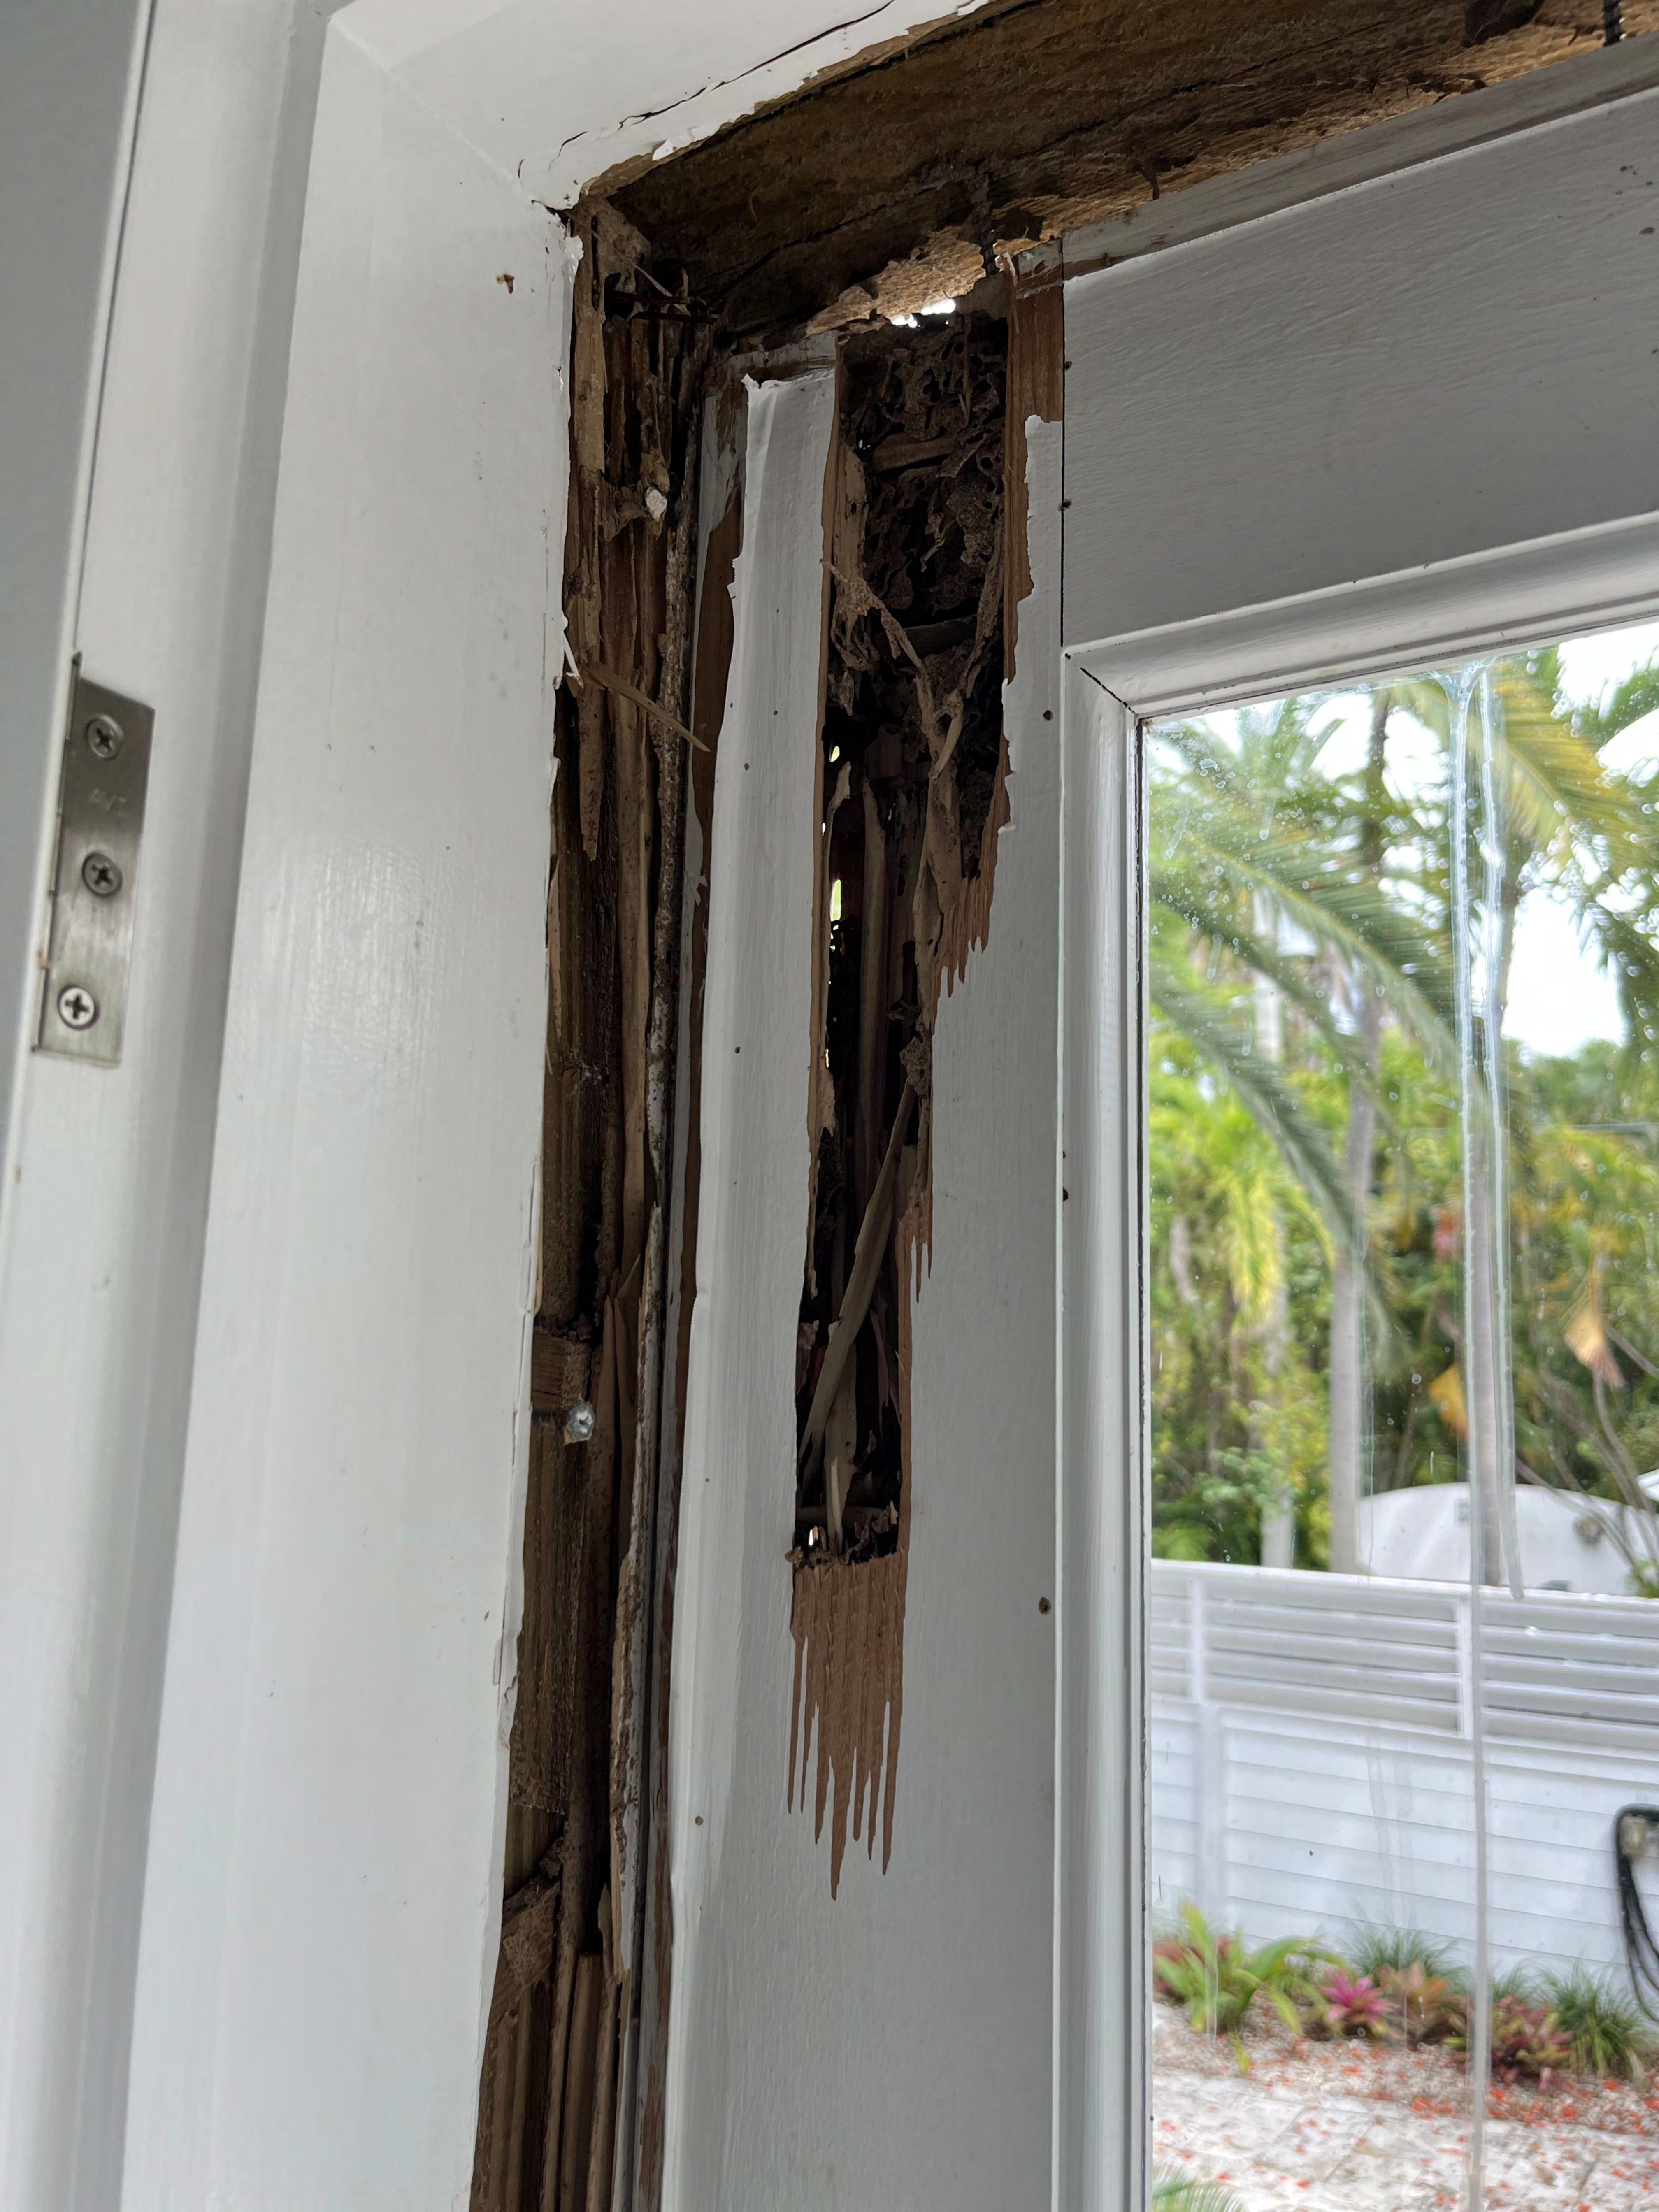
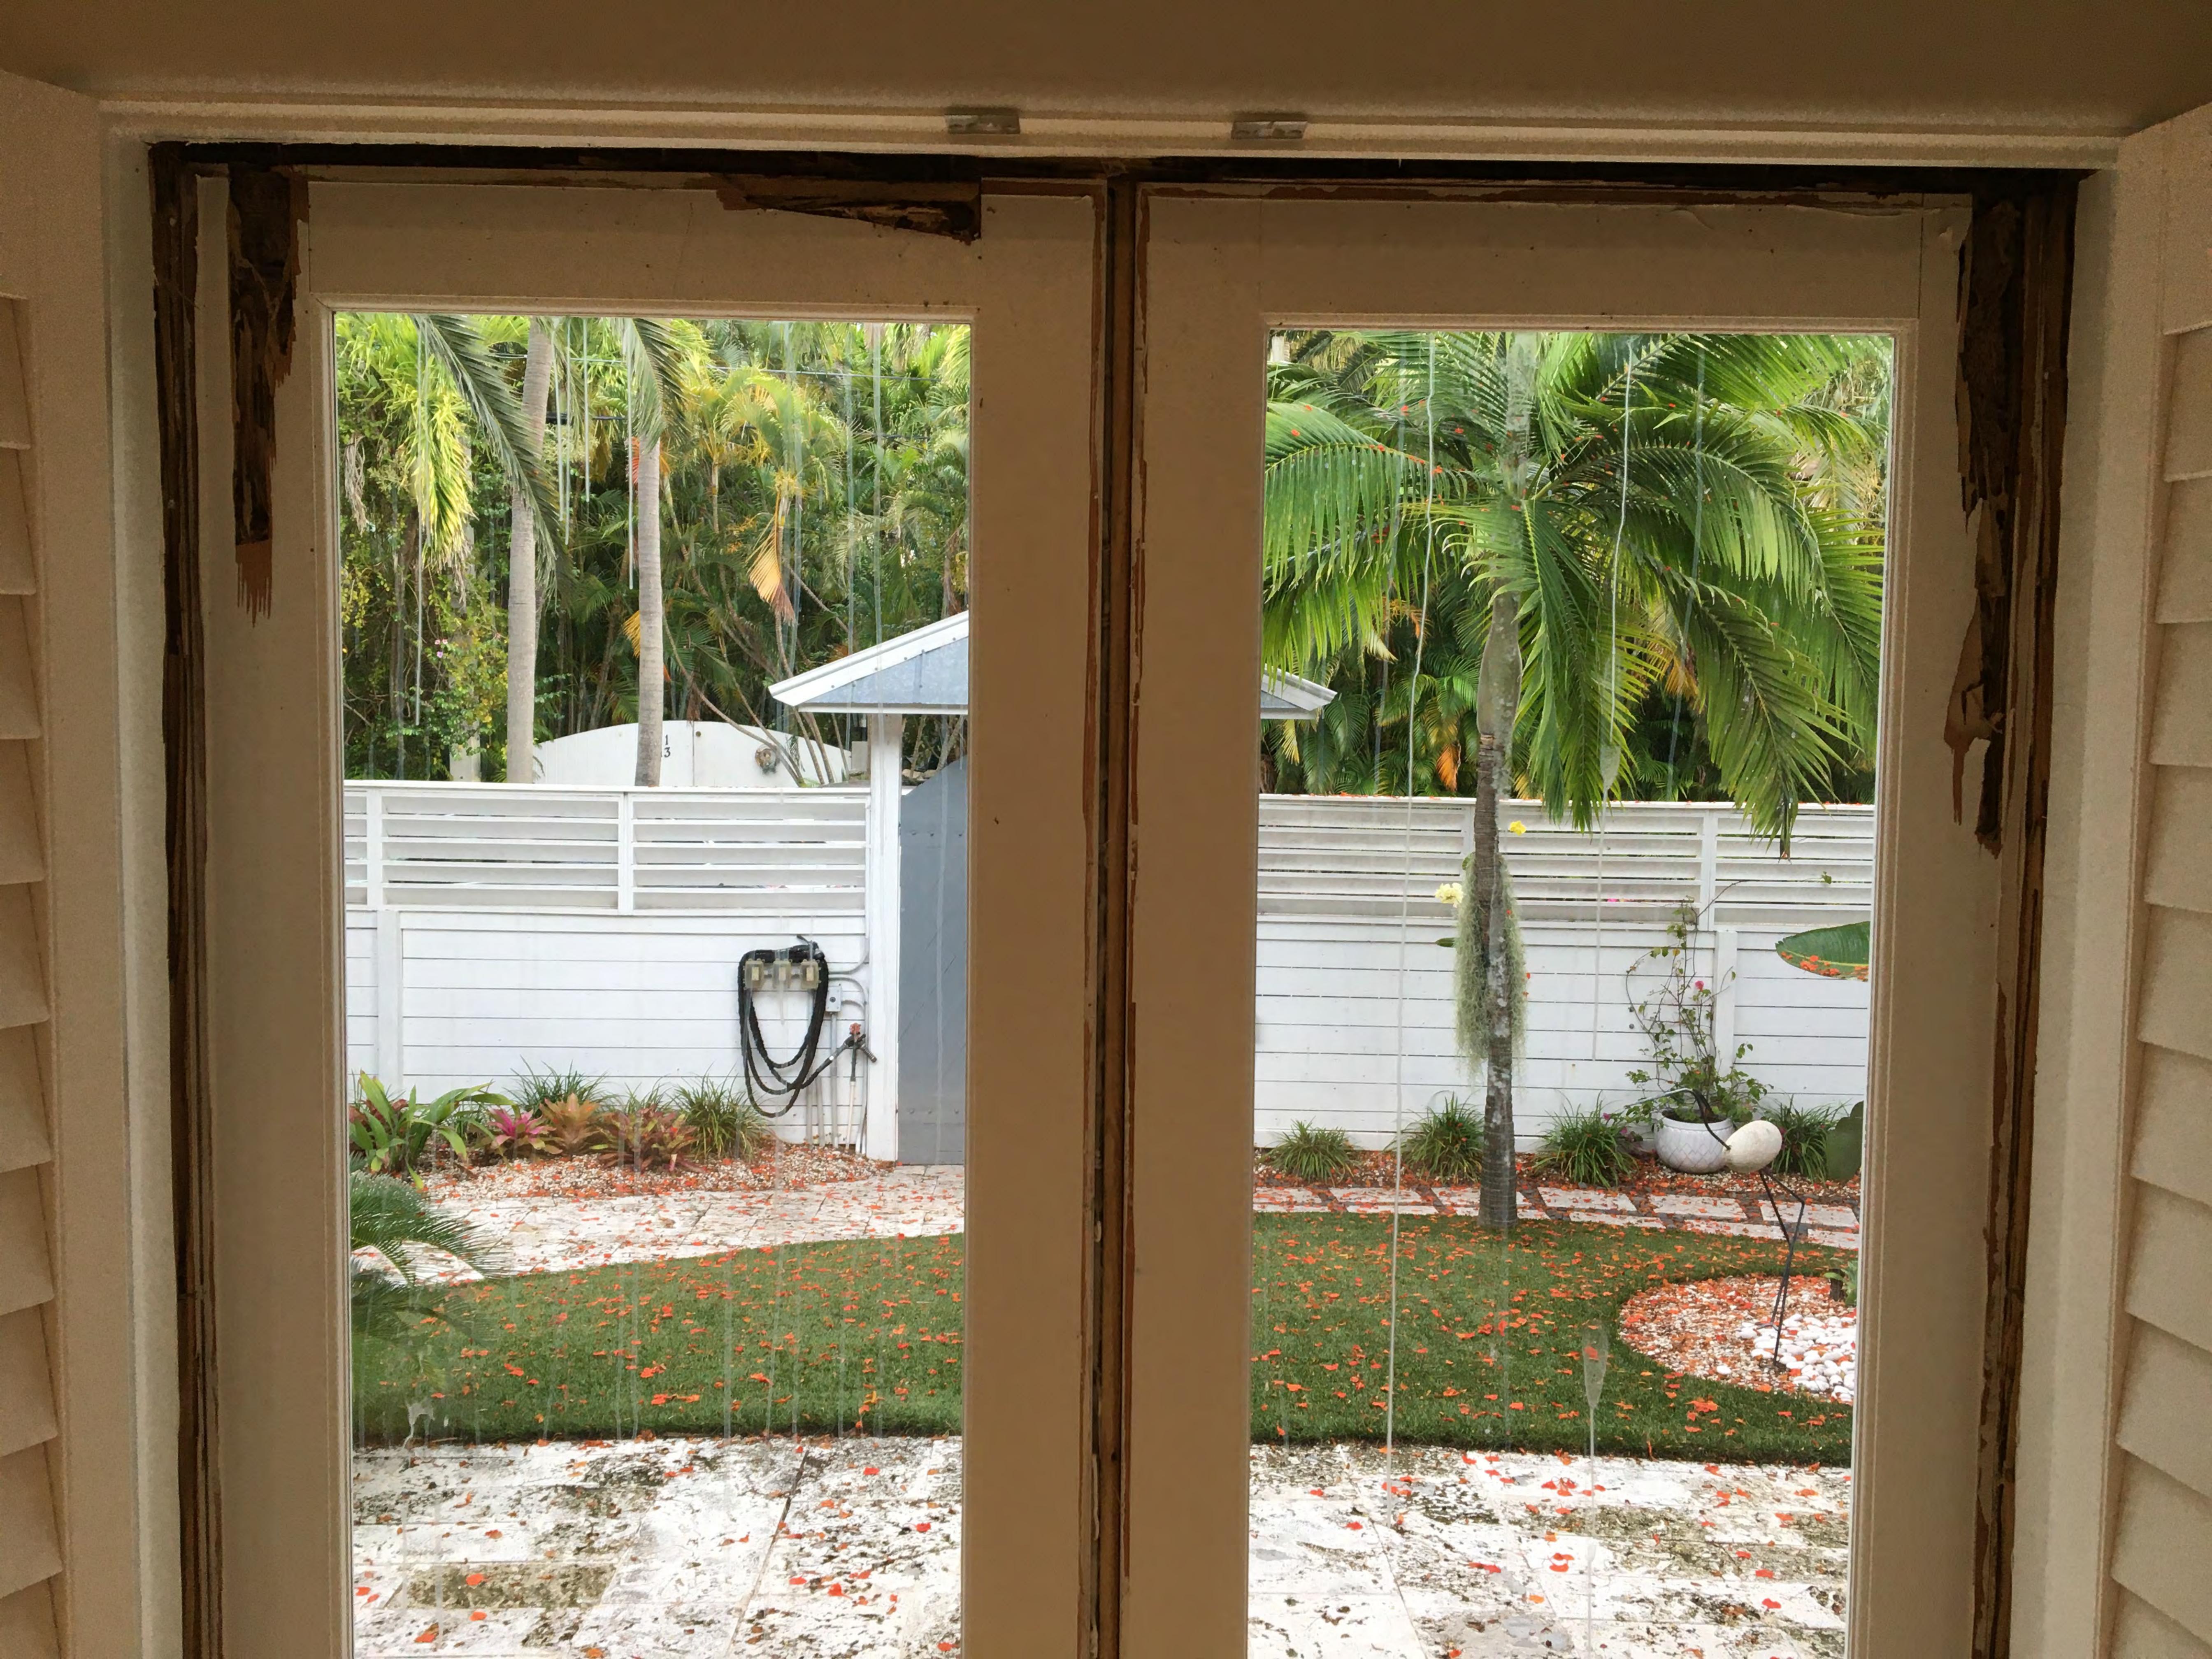
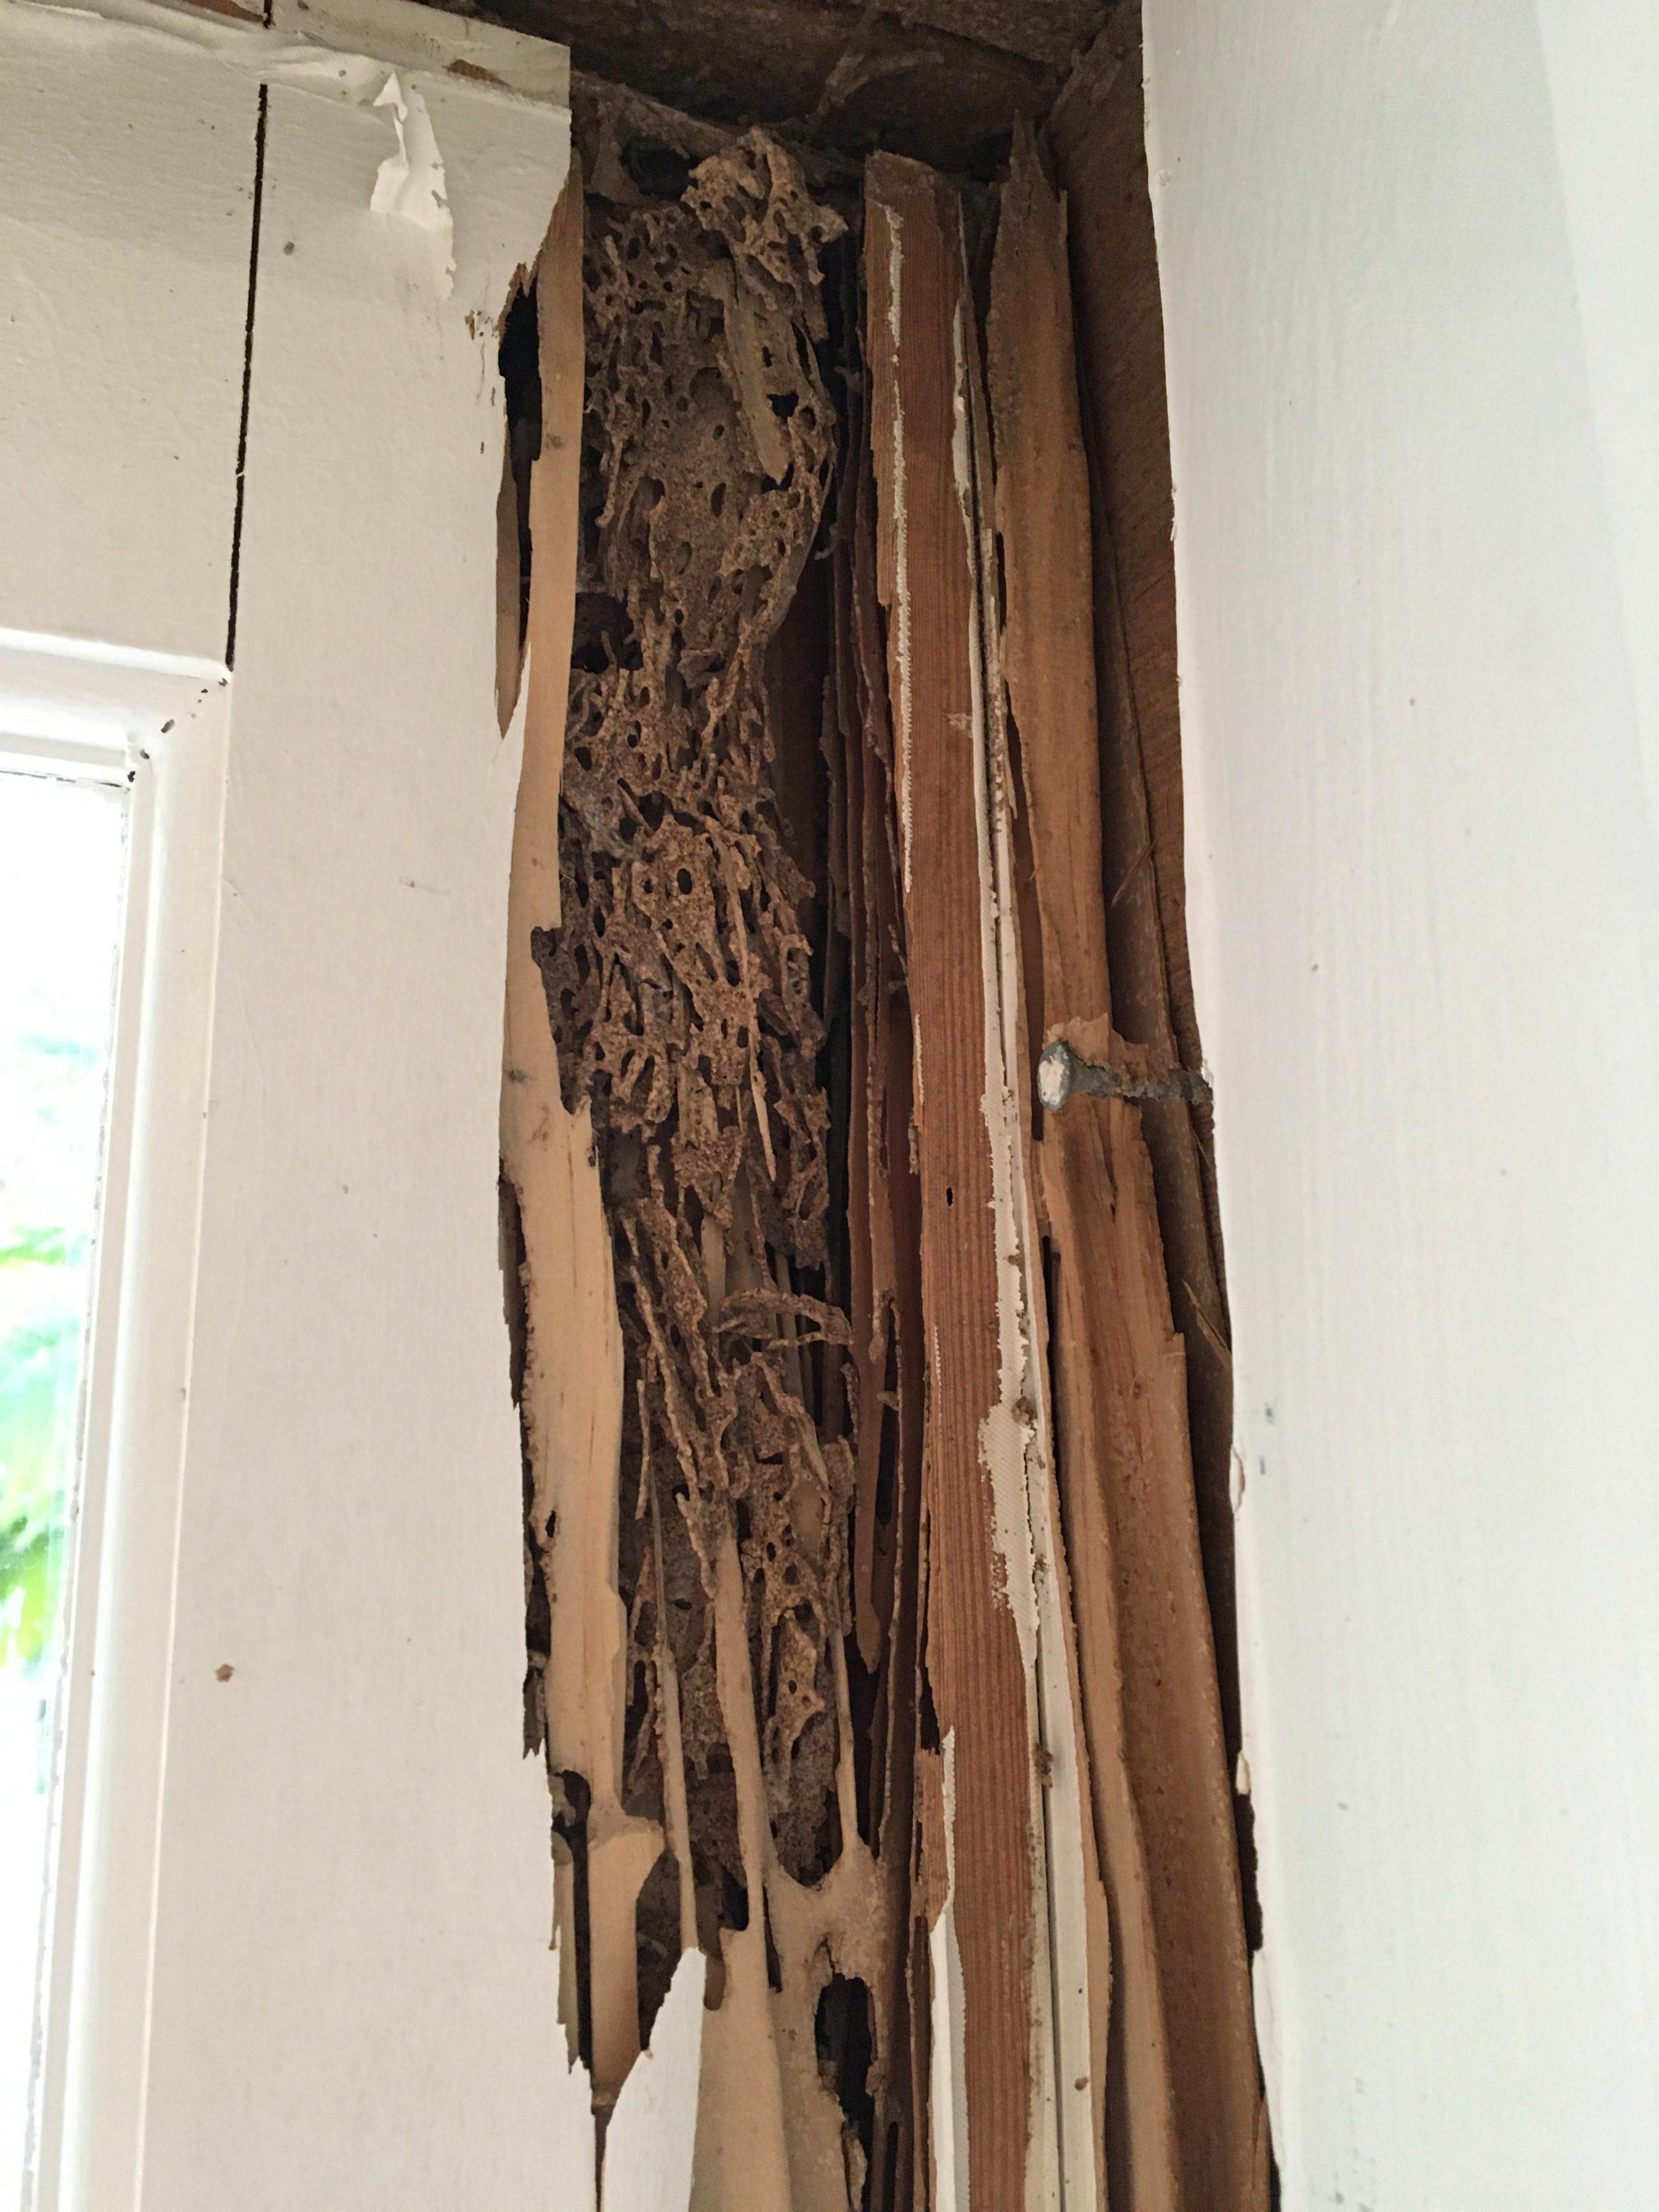
We perform annual inspections and treatment as needed at their home every April. In March this year I did a walkaround check of the house with Mr. Goble in preparation for an under house spraying update for underground Formosan termites and did not see any signs of termite damage at that time. I did notice termite mud tunnels on the Royal Poinciana tree 9' from the front center of the house and indicated to Mr. Goble that could be a damage problem source for the house. On April 19 while completing the under-house treatment we found termite tunnels on the foundation footing under the front center of the house. They were sprayed immediately.

Upon completing the inspection above ground at the front center section of the house we found active Formosan termites and substantial damage for which the Goble's have provided photographs. It is most likely that these termites came from the adjacent poinciana tree. I also knew that from Mr. Ken King's periodic trimming of the tree since 2017 that he had found termite damage progressing inside the poinciana each year.

I consequently recommended immediate removal of that tree to Mr. and Mrs. Goble.
