Schooner Western Union

## Re: 2018-01 KWBB / schooner Western Union Restoration Progress Report

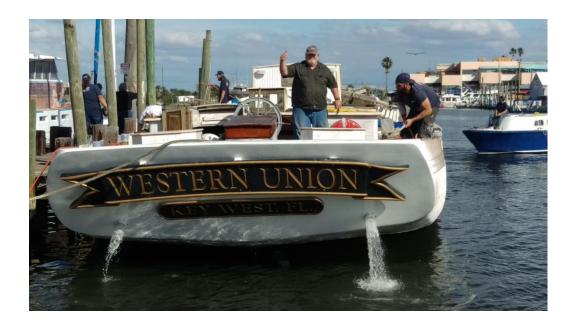
- **A.** The schooner's hull and transom repairs are now complete. The 90 ft. steel keel shoe fabrication and installation are also now complete
  - **a.** The Western Union after 15-mos. on the rails was splashed and is back where she belongs, in the water.
  - b. There are no hull seam leaks, excellent work.
