Subject: Key West Angelfish Pier Seawall Structural Assessment

CITY OF KEY WEST
PORT & MARINE SERVICES

KEY WEST GARRISON BIGHT MARINA
ANGELFISH PIER SEAWALL STRUCTURAL ASSESSMENT REPORT

Prepared By:
Tetra Tech, Inc.
759 South Federal Highway, Suite 314
Stuart, FL 34994

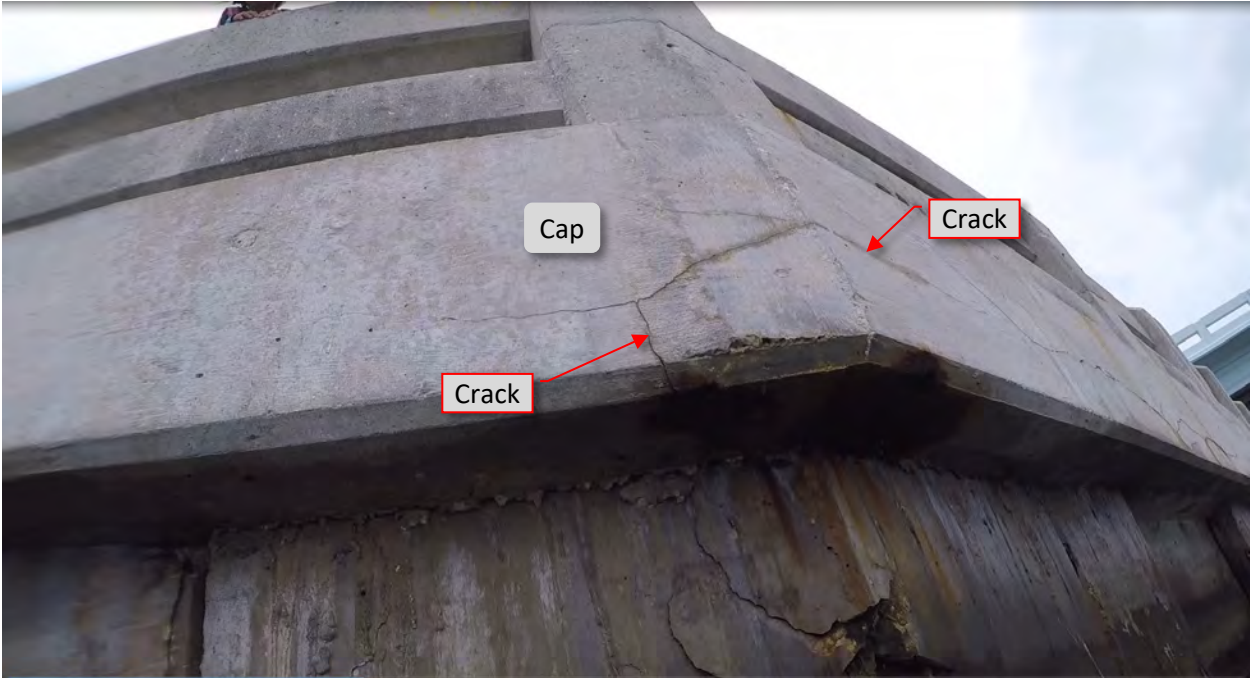
leaning out of its plane toward the water. The presence of typical cracks and spalls on the slab's and cap's exterior surfaces and varied gap widths at the slab and piling interface may directly correlate to the slab's unsupported length. Described observations are illustrated in Appendix C in Figures 127 - 129, 132, and 134. The extent of eroded backfill is unknown.

Figure 132: C11. STA 6+11. Crack at cap's vertical and bottom faces.
